**An Archaeological Historic Building
Assessment of buildings at
Lower Grange Farm, Markfield, Leicestershire
(NGR SK 498 094)**

ULAS Report No 2010-121
©2010

Pre Planning Enquiry

For: Jelson Ltd

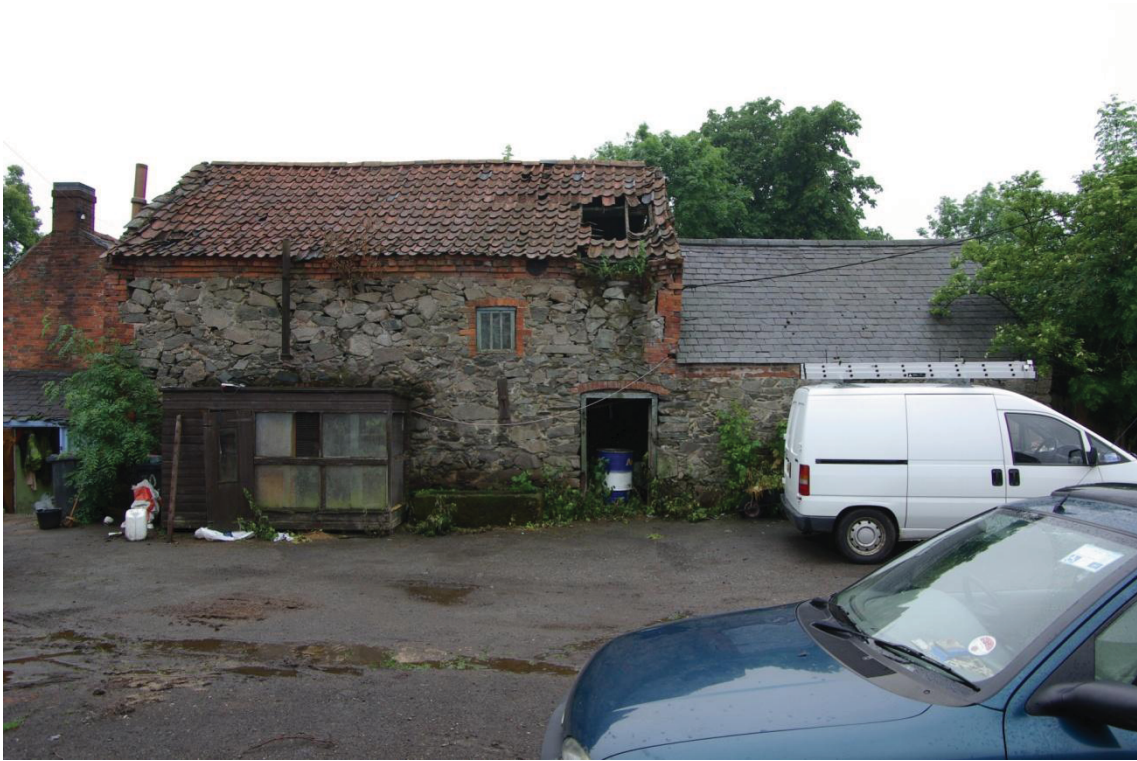
Colour Plate 1 Building 1 (looking south).

Building 1 is aligned north-west to south-east and adjoins the north-west corner of the farmhouse. It is a linear plan of two bays, the eastern of which is two-storey and the western, single-storey. The northern elevation of the building is of granite rubble construction with a red-brick eastern gable, a pantile roof to the east and Welsh slate to the west. The exposed gable between the two bays is also brick built, as is the southern elevation. The quoins, window surround and corbelling are also brick built and all the brickwork appears to be contemporary. The bricks themselves seemed to be handmade, measured 2¾ inches by 9 inches by 4½ inches and were not laid with any discernable bond pattern.

On the eastern gable there is an external chimney stack which, unusually, does not reach above the eaves and has been extended in height above this level with two lengths of ceramic drain. This unusual arrangement suggests that either the roof line has been lifted or the chimney has been altered, a straight joint visible in the chimney suggesting it may be the latter.

On the eastern part of the building, there is saw-tooth corbelling at eaves height, part of which has been removed in order to fit a cast iron tie bar. There is no such corbelling on the western part of the building and it is likely therefore that this was also once of two stories but has been reduced, entailing the construction of the western brick gable of the eastern bay. The latter has brick quoins at first floor only, presumably cut into the pre-existing granite wall.

A detailed internal examination of the building was not possible due concerns over the condition of the roofs. A limited view through an open door indicated the partition walls were all brick built and the painted plaster finish of the first floor suggests this part, at least, had an original domestic function.

The limited view of the easternmost roof structure suggested it was a bolted king post truss.

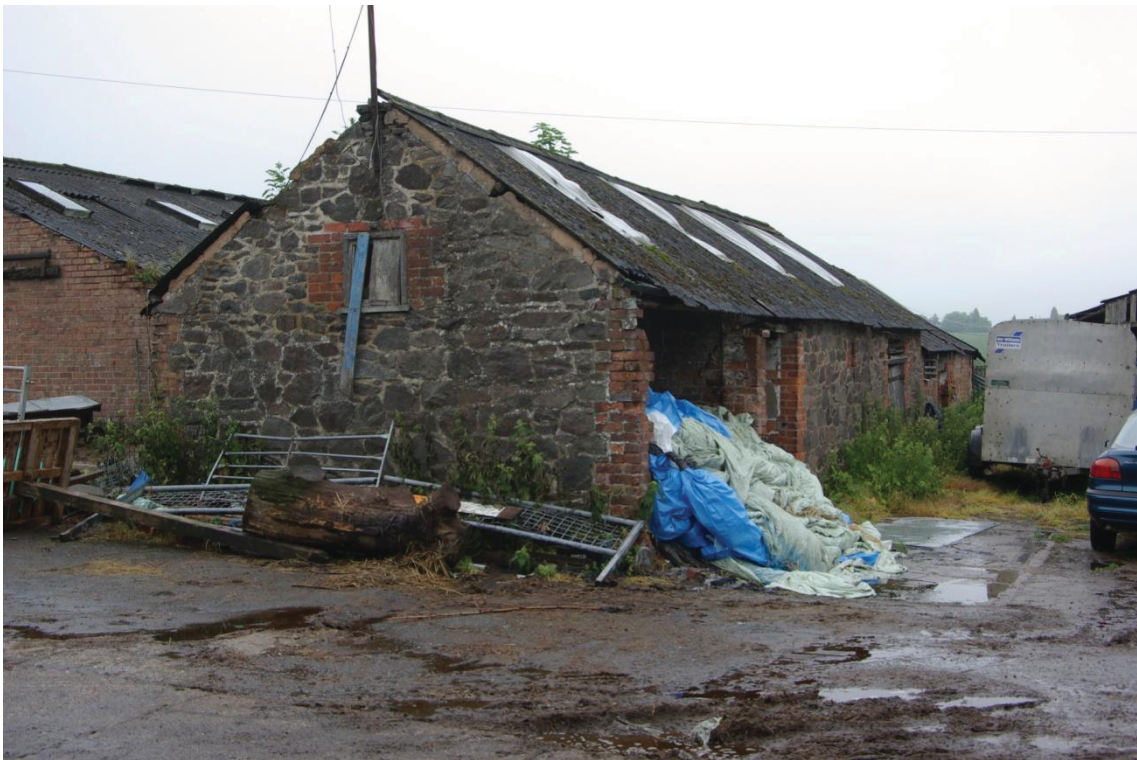
Colour Plate 2 Building 2 (looking east-north-east).

Building 2, to the north-east of building 1, is a linear building of three bays, again aligned north-west to south-east. It is of granite rubble construction with a corrugated asbestos cement sheet roof. The quoins and window surrounds are of the same red brick seen within Building 1. The roof is a bolted king post with raking struts.

There is no clear evidence of the building's original function. There is a wide entrance with a pedestrian door nearby on the westernmost end, suggesting this may have originally been a cart shed. The easternmost bay, which has a lower roofline has a number of stalls, but these are clearly later additions. The partition wall between the larger eastern bays is granite rubble and is likely to be original. The partition wall within between the middle bay and the westernmost bay is brick and may be a later addition.

Again the building is in a ruinous condition with the eastern gable wall partially collapsed and a large collapse in the northern wall which has caused one of the roof trusses to drop.

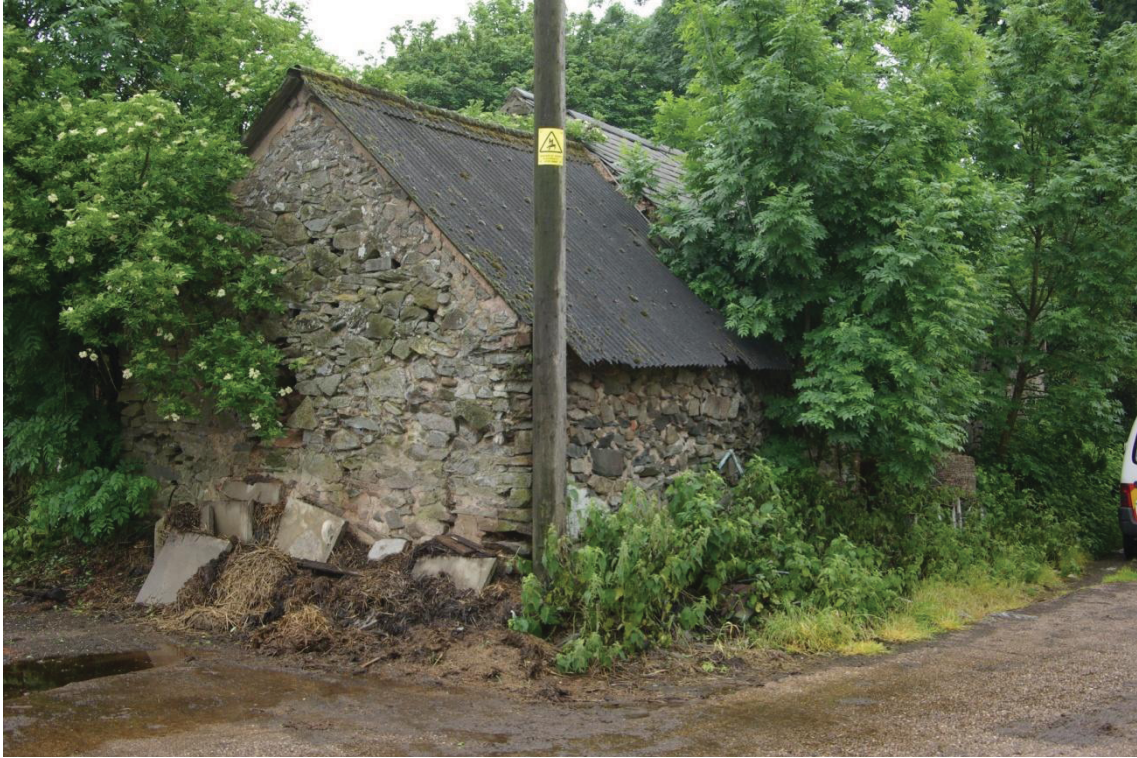
Colour Plate 3 Building 3 (looking south).

Building 3 lies to the north-west of Building 1, at right angles, on a north-east to south-west alignment. It is a linear range of two bays, again of granite rubble construction with a roof of corrugated asbestos cement sheets and Welsh slate. The southern bay is the larger of the two, with a large central door and was originally likely to be a threshing barn, the roof is a bolted king post with raking struts, supporting Welsh Slate roof.

There appears to be a straight joint between the two bays, indicating they are not contemporary. The stonework of the smaller northern bay is much rougher and poorly finished and the pitch of the roof is noticeably steeper. It is difficult to ascertain whether this bay is a poorly built later extension or an earlier retained building which may originally have been thatched.

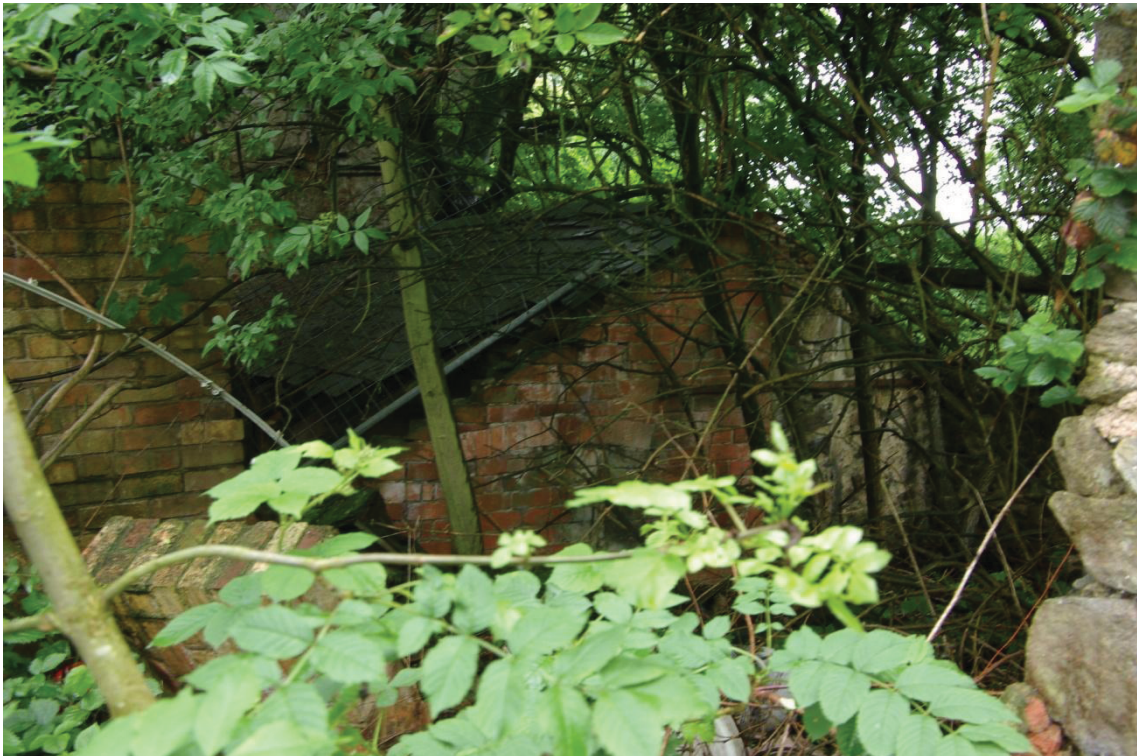
Colour Plate 4 Building 4 (looking south-east).

Building 4 is located to the north-west of the farmhouse and is almost completely concealed by undergrowth and other buildings so no detailed assessment was possible. It appears to be a largely brick construction with a Welsh slate roof with a ruined gable of granite rubble to the west, possibly the remains of another building.

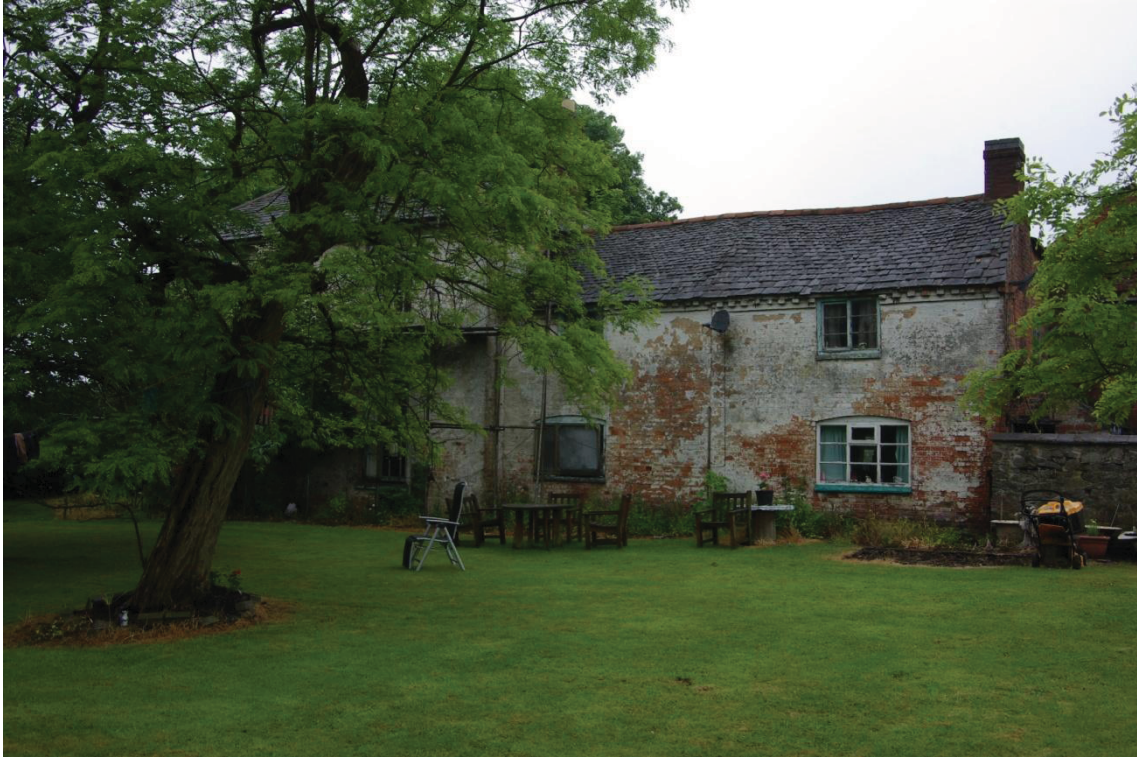
Colour Plate 5 Farmhouse (looking west-south-west).

The farmhouse is to be retained within the proposed planning application. As it is still occupied, internal examination was not possible. A rapid external assessment of this structure indicates at least three likely phases of building. There appear to be two smaller, possibly earlier, cottages to the north, both in painted red brick (brick dimensions 2¼ x 8½ x 4½inch). The roofs are local Swithland slate with gable chimneys. There is a straight joint between the two cottages, suggesting they are not contemporary.

The southernmost part of the farmhouse is considerably larger and was originally a much grander building. Again it is in painted red brick (brick dimensions 3 x 9 x 4inch); the bricks appear later than those used within the cottages. The roof once again is Swithland slate and hipped. There is a large central chimney.

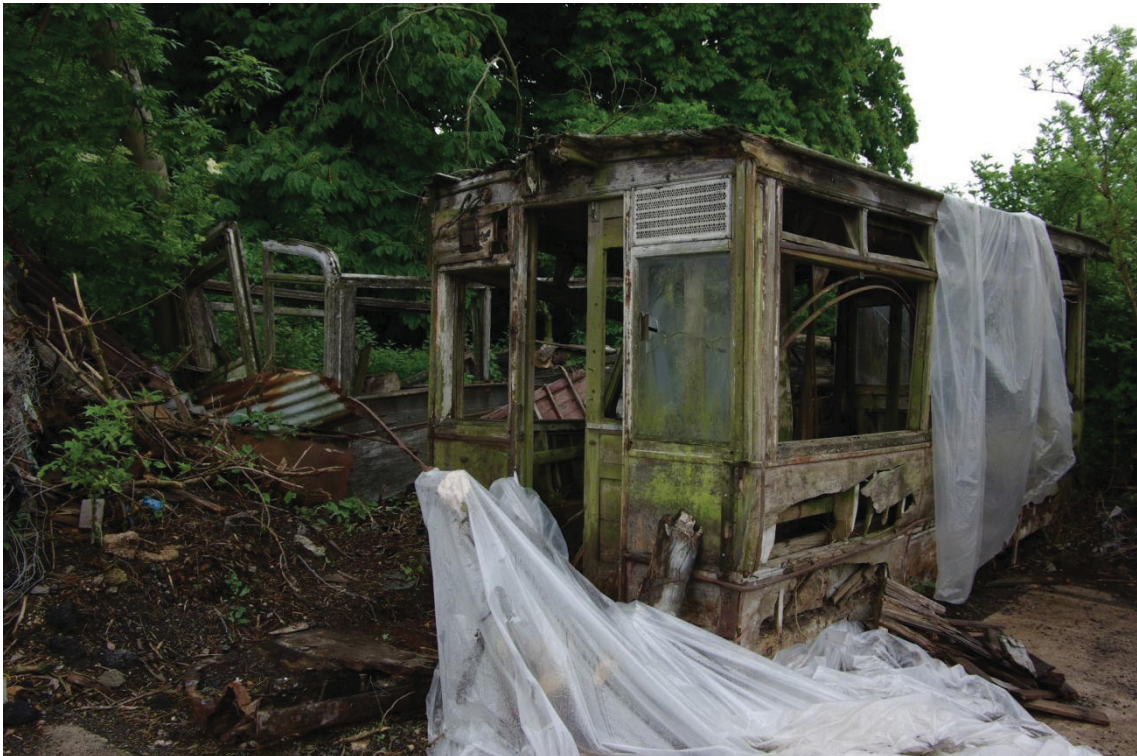
Colour Plate 6 Tram remains.

Most interesting, however, are the remains of two Leicester trams, car 31 and car 27, originally brought to the farm for use as chicken coops. Parts of these cars had also been re-used within a number of buildings on the site. The Leicester tramway system ceased operation in November 1949 and most of the cars – all double-decked and dating from 1902– were broken up for scrap, with a few being recycled for other purposes. The latter included car 76, now the sole intact survivor of the fleet, used as a cricket pavilion in Yorkshire before being rescued and restored at the National Tramway Museum at Crich, Derbyshire. During the restoration it is understood that some parts, such as the staircases, were salvaged by enthusiasts from the trams on this site. Although in a state of near complete dereliction, these trams are the only other known survivors apart from the one at Crich.

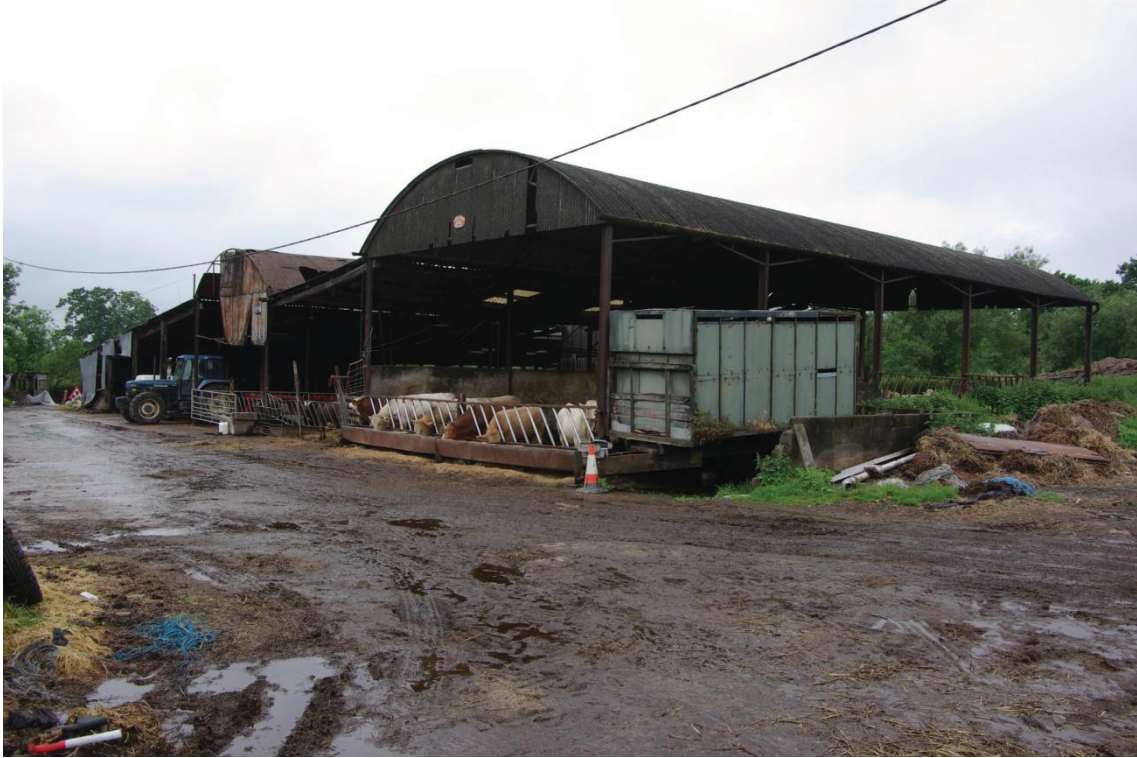
Colour Plate 7 Modern farm buildings.

There are a number of other buildings within the proposed development area, mostly mass-produced late 20th-century structures, including two Dutch Barns and two other corrugated asbestos-cement-clad steel-framed buildings. There is also an owner-built structure of recycled telegraph poles and corrugated tinned sheets. Such buildings are of little historic or architectural interest, but do illustrate the 20th-century development of the farm.
