**An Historic Building Analytical Survey  
(Level 3) of the St John's Block and  
East Wing, Walsall Manor Hospital,  
Pleck Road, Walsall.  
NGR: SP0316 8455 centre**

ULAS Report No. 2010-105  
©2010

**For: Skanska UK plc**

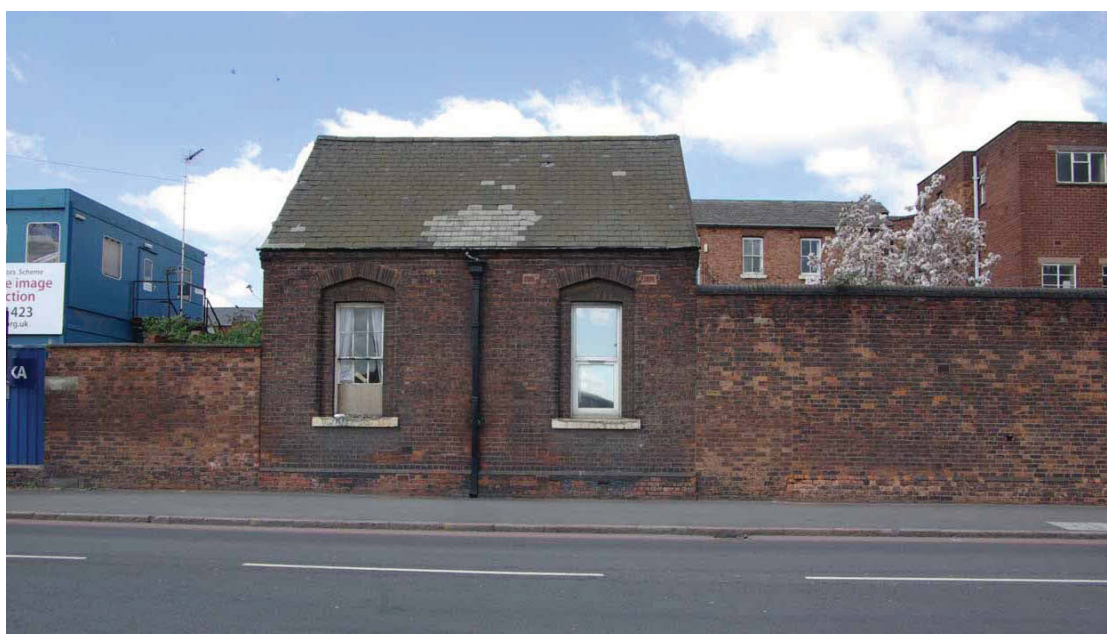
Figure 26 Pleck Road boundary wall and east receiving ward  
Looking west

The brick built boundary wall running along Pleck Road shows a number of phases along its length which survives from the north edge of the covered corridor southwards to approximately 4m beyond the limit of the receiving ward. Against the gable end of the east arm the bricks are laid in an English bond with a straight joint against a further stretch laid in a Flemish Garden wall bond built up to the eastern end of the receiving ward. There is evidence of a small doorway, now blocked, leading into the courtyard in front of the receiving wards (fig. 26).

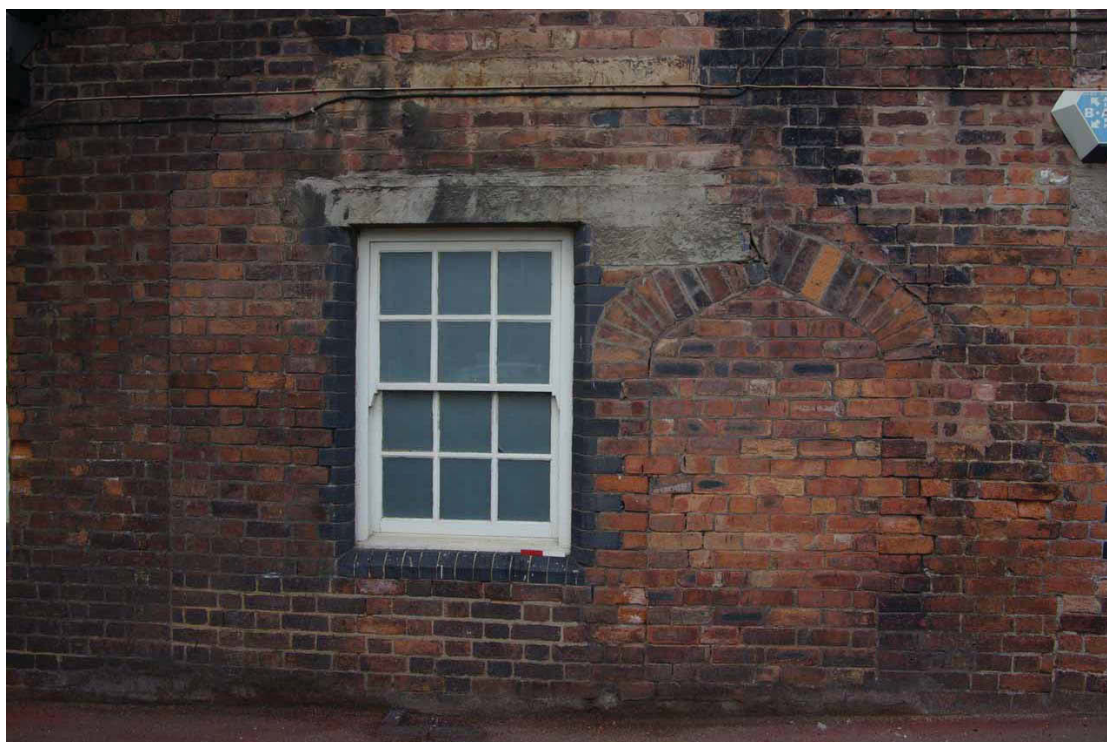
The western arm extending from the southern cruciform tower has three stories and six equally spaced bays. On the north face of the arm the easternmost ground floor window has been blocked and also shows evidence of having been modified to be used as a door. The adjacent two windows are multi-paned vertical sliding sashes. Beyond these, to the west, are two similar but shorter sash windows with concrete lintels and blue brick detailing around the sides. An irregular vertical joint in the brickwork between the third and fourth windows joins a horizontal joint just above ground floor lintel height indicating that this arm was originally constructed as a single storied building of only three bays (fig. 31). West of the vertical joint and smaller sash window is a blocked doorway with a Tudor style brick arched head

Figure 31 North elevation, southernmost arm. Vertical joint and blocked door  
Looking south

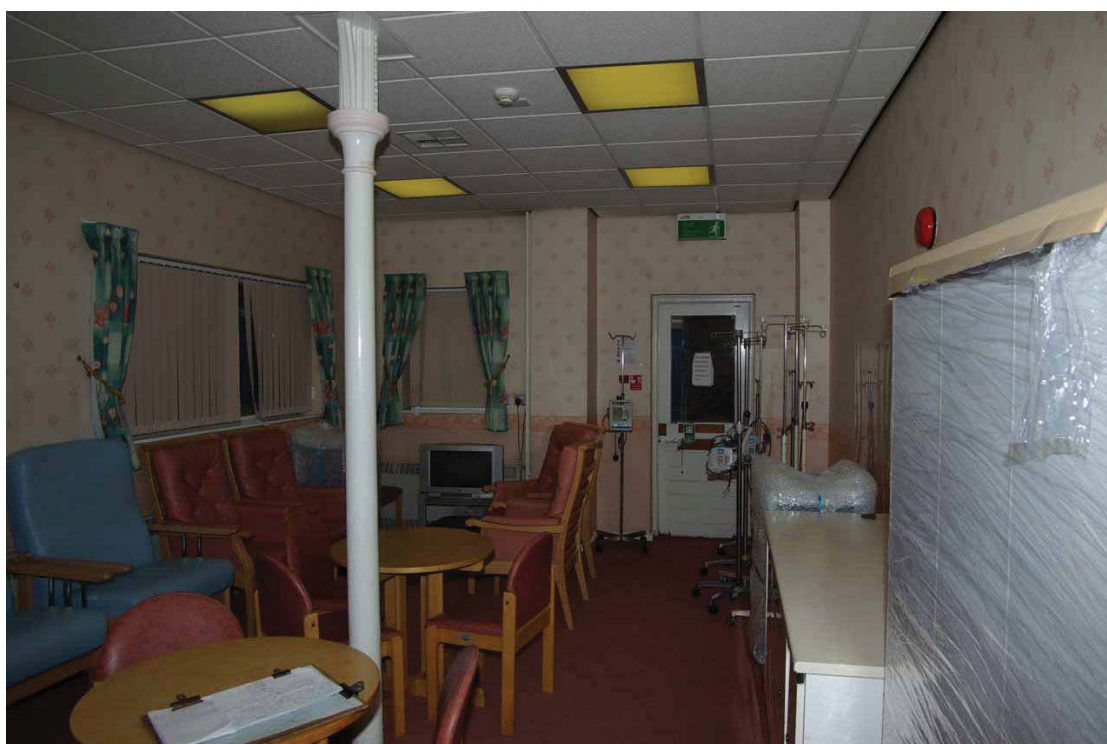
Figure 58 Surviving cast iron post in 1902 ground floor ward  
Looking south west

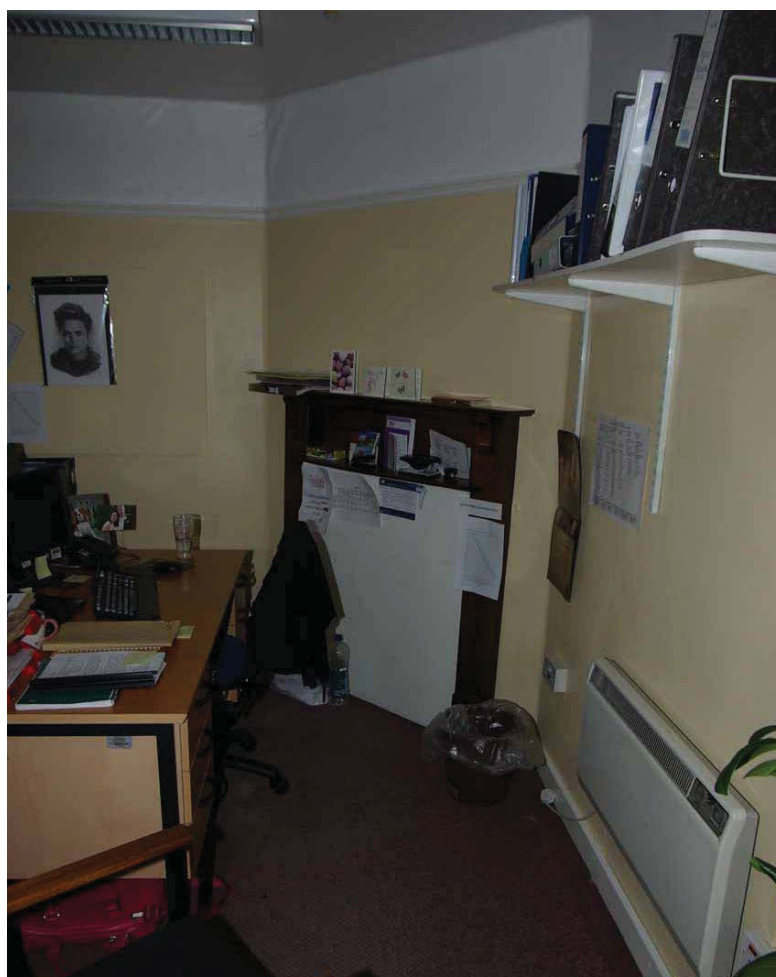
Internally the details are the same as noted in the 1896 range although the stairs in the central block are in a different position and are slightly wider and grander matching the rather more affluent air of this range. The second floor of the central block has seven small rooms with a large fireplace set at an angle in the corner of each room (fig. 60).

Figure 60 East Wing second floor 1902 range. Office fireplace  
Looking south
