An Archaeological Watching Brief Carried Out at Park House, Stoke Golding, Leicestershire, NGR SP 398 970.

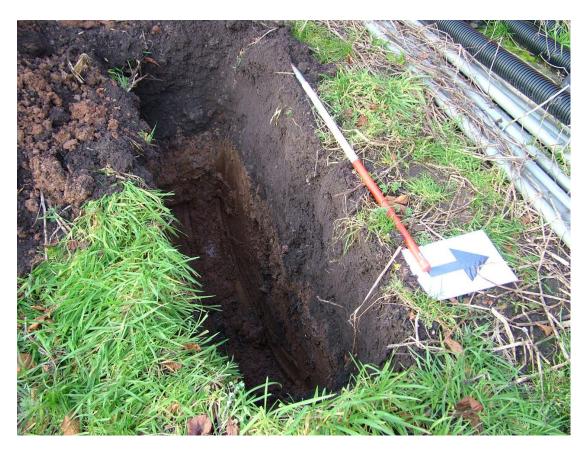
The remainder of the exposed section consisted of orangey-brown glacial clay (test-pit 2) and orange coarse sand (test-pit 3), both of which continued to an unknown depth.

Figure 3 – Section of test pit 2

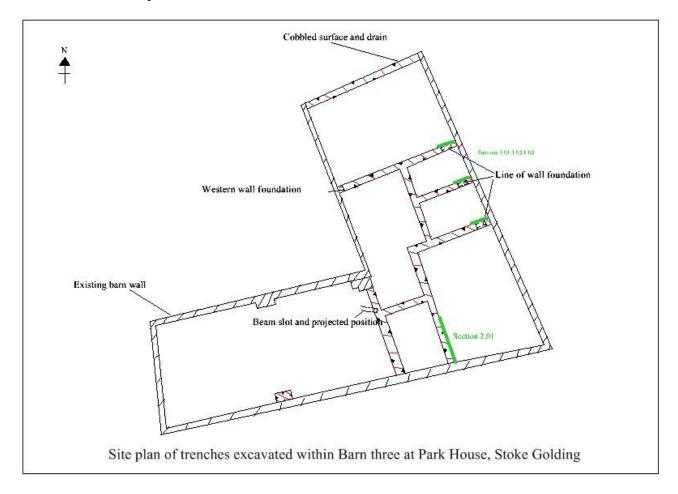
Figure 5. Trenches excavated within the eastern barn, illustrated using the 1:100 plans supplied.

Foundation trenches were to be excavated to house additional supports for underpinning the current brick walls. A series of interconnecting trenches were dug, most to a depth of one metre and a width of 0.45 metres. In the westernmost section of the barn, there was a thin layer of silty clay top soil and beneath this a layer of orangey light brown, essentially clay sub soil, no features were identified. In the easternmost wing of the barn, the picture was much more complex. The recent barn surface had been stripped to reveal a considerable depth of flecked mid brown clayey silt, containing demolition rubble, mainly mortar with some tile, brick and lime plaster (Figure 6). This lay above a layer of greyish mid brown silty clay with frequent charcoal flecks, occasional large pebbles and brick fragments (4). This in turn lay above the orangey light brown natural clay identified in the western half of the barn. The edges of the spread were difficult to define, but seemed to thin towards the west and appeared to merge as if levelled, rather than cut and filled.

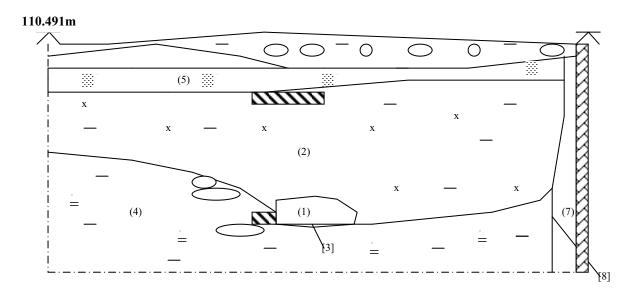
Also in the eastern wing of the barn, were a series of footings, which appeared in three trenches as a linear feature running north south parallel to the current east wall of the barn (Figure 5). The foundations which remained were, largely, in two courses and whilst compact, the variety of materials and nature in which the foundations had been constructed, did not suggest a robust weight bearing structure. The main materials used were pieces of rough hewn granite and sandstone of various sizes, but also used as packing, were pieces of brick and flint and small boulders. There was some mortar evident, but this was largely on the upper surface and it did not appear to be the primary bonding material. The foundations appeared to have been set in the layer of greyish mid brown clay (4) evident across the eastern end of the barn.

Figure 6. Section 3.02 showing the single course of wall footings (1) and related contexts drawn at a scale of 1:10.

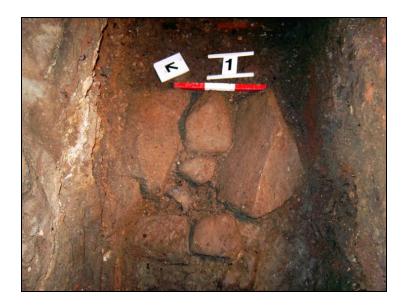
Figure 7. Photograph showing exposed wall foundations in the east of the barn and running north south.

Sitting above the foundations was a demolition layer, characterised by mortar and lime plaster. As some of the upper foundation stones had similar coloured mortar adhering to them, it seems likely that a simple, possibly timber structure, had been constructed directly on to the foundations stones. The demolition debris had certainly been cut by the east wall of the current barn. The barn itself probably dates from the nineteenth century (Richards 2006) and this structure certainly pre-dates the barn.

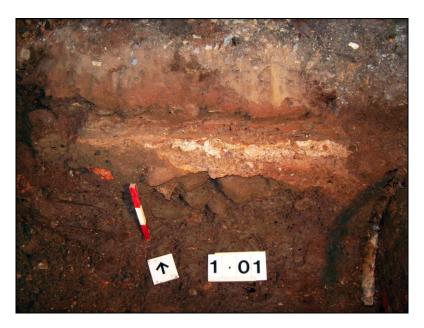
Figure 8. Photograph of section 1.01 showing wall foundation capped by demolition layer.

An assessment of the finds (Appendix A) from the demolition layers (5) and (2) demonstrated some fragments of Chilvers Coton fabric C ware of medieval date. Also identified, however, were post medieval earthenware and 17th -18th century clay pipe, suggesting that the medieval tile may have been re-deposited. The foundations

themselves (1) contained fragments of Chilvers Coton nib tile, a sherd of black ware c. 1650-1750 and a piece of bottle glass of later 17th to early 18th century. The greyish silty clay layer into which the foundations were set, contained hand made brick of late medieval or early post medieval date and further Chilvers Coton ware.

It seems likely that the Chilvers Coton tile was brought from another site and re-used in the preparatory levelling and construction of an earlier barn structure. Records relating to the history of Park House (Hall 2005) suggest that an early medieval manor house stood on the site, to be replaced in 1637 by one built by William Trimnell. This house in turn was replaced shortly after, in the reign of Queen Anne and again at the end of the nineteenth century. There are, however, remnants of the medieval foundations (Webster 1969).

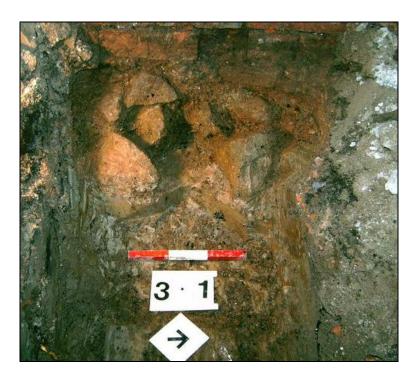
A similar parallel foundation was found almost beneath the west wall of the barn. The construction methods and materials were alike, although there was a considerable height differential between these and the footings to the east. The reduced levels were 110.814m to the east and 111.152m to the west, a difference of 0.338 metres. Whilst both foundations were laid in the same layer and there could have been some settlement of the ground, it is difficult to relate the walls with any certainty. If the walls were related, the structure would have been slightly narrower than the current barn.

Figure 9. Foundation below the current wall on the western side.

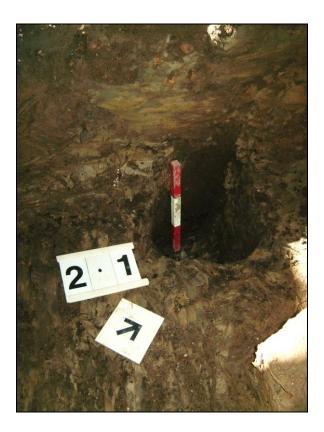
Also identified and lying between the east and west portions of the barn, were the remains of a beam, lying within a possible slot. The trench only allowed a section across the end of the beam and a slot was suggested rather a post hole, because of the angle at which it lay. The beam lay in isolation, there were no related contexts other that it too lay within the greyish mid brown silty clay. It lay outside the line of the foundations at an acute angle to these and does not have an obvious relationship to them. As it lay within the possible levelling layer (4), it may have been dumped rather than deliberately placed.

Figure 10. Remains of a beam lying in centre of the current east barn.

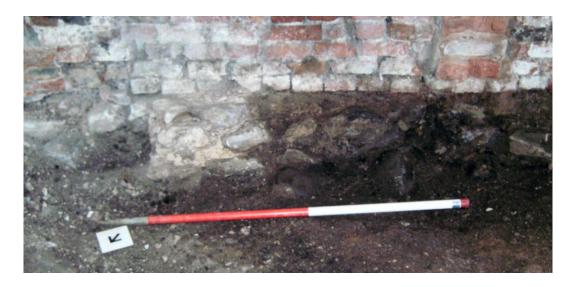
A further visit observed foundation trenches excavated for partition walling within barn two, the central barn (Figure 13). A concrete floor had already been removed to reveal a layer of clayey silt and building rubble, plaster, charcoal and brick. Also evident were the foundations of the southern wall which had been extended widthways in recent times. Elsewhere, the current brick walls were laid upon two courses of sandstone foundations.

Figure 11. The southern wall foundations of Barn 2.

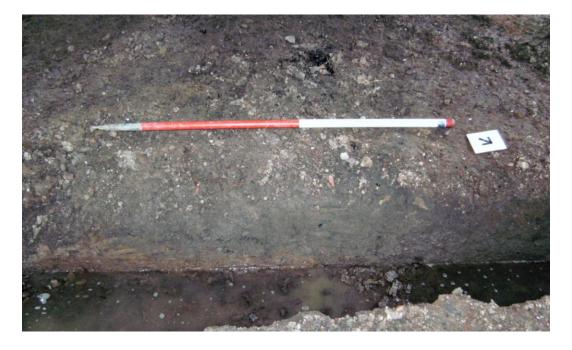
The layer of demolition rubble may relate to the wall extension, as brick similar to the fabric of the current walls was evident amongst the rubble. The foundation trenches excavated were 0.45 metres wide and 0.4 metres deep. At the southern end, natural clay was reached after 0.25 metres of demolition material.

Figure 12. The demolition layer above the natural clay, in the southern end of Barn 2.

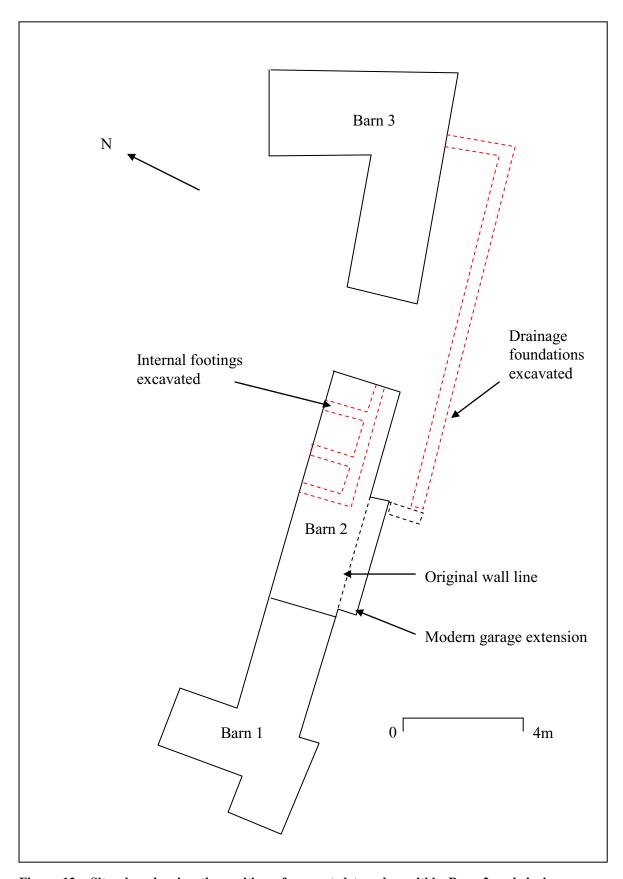
Figure 13. Site plan showing the position of excavated trenches within Barn 2 and drainage trenches to the south of the barns.

On a separate occasion, a series of drainage trenches were dug connecting the two barns on the southern side (Figure 13). The total length excavated was approximately 34.0 metres, the average width 0.45 metres and the average depth 0.80 metres. The trenches revealed on average 0.40 metres of top soil and a mixed interface with the yellow brown natural clay. No features or deposits of archaeological significance were recorded within these trenches.
