**Historic Building Survey
of Units A and B, Bindleys Yard,
School Lane, Market Harborough,
Leicestershire**

Conservation Area Consent: 08/00854/CON

For: Oastlodge Limited

**Historic Building Survey of Units A and B, Bindleys Yard, School Lane,
Market Harborough, Leicestershire (SP 732 872)**

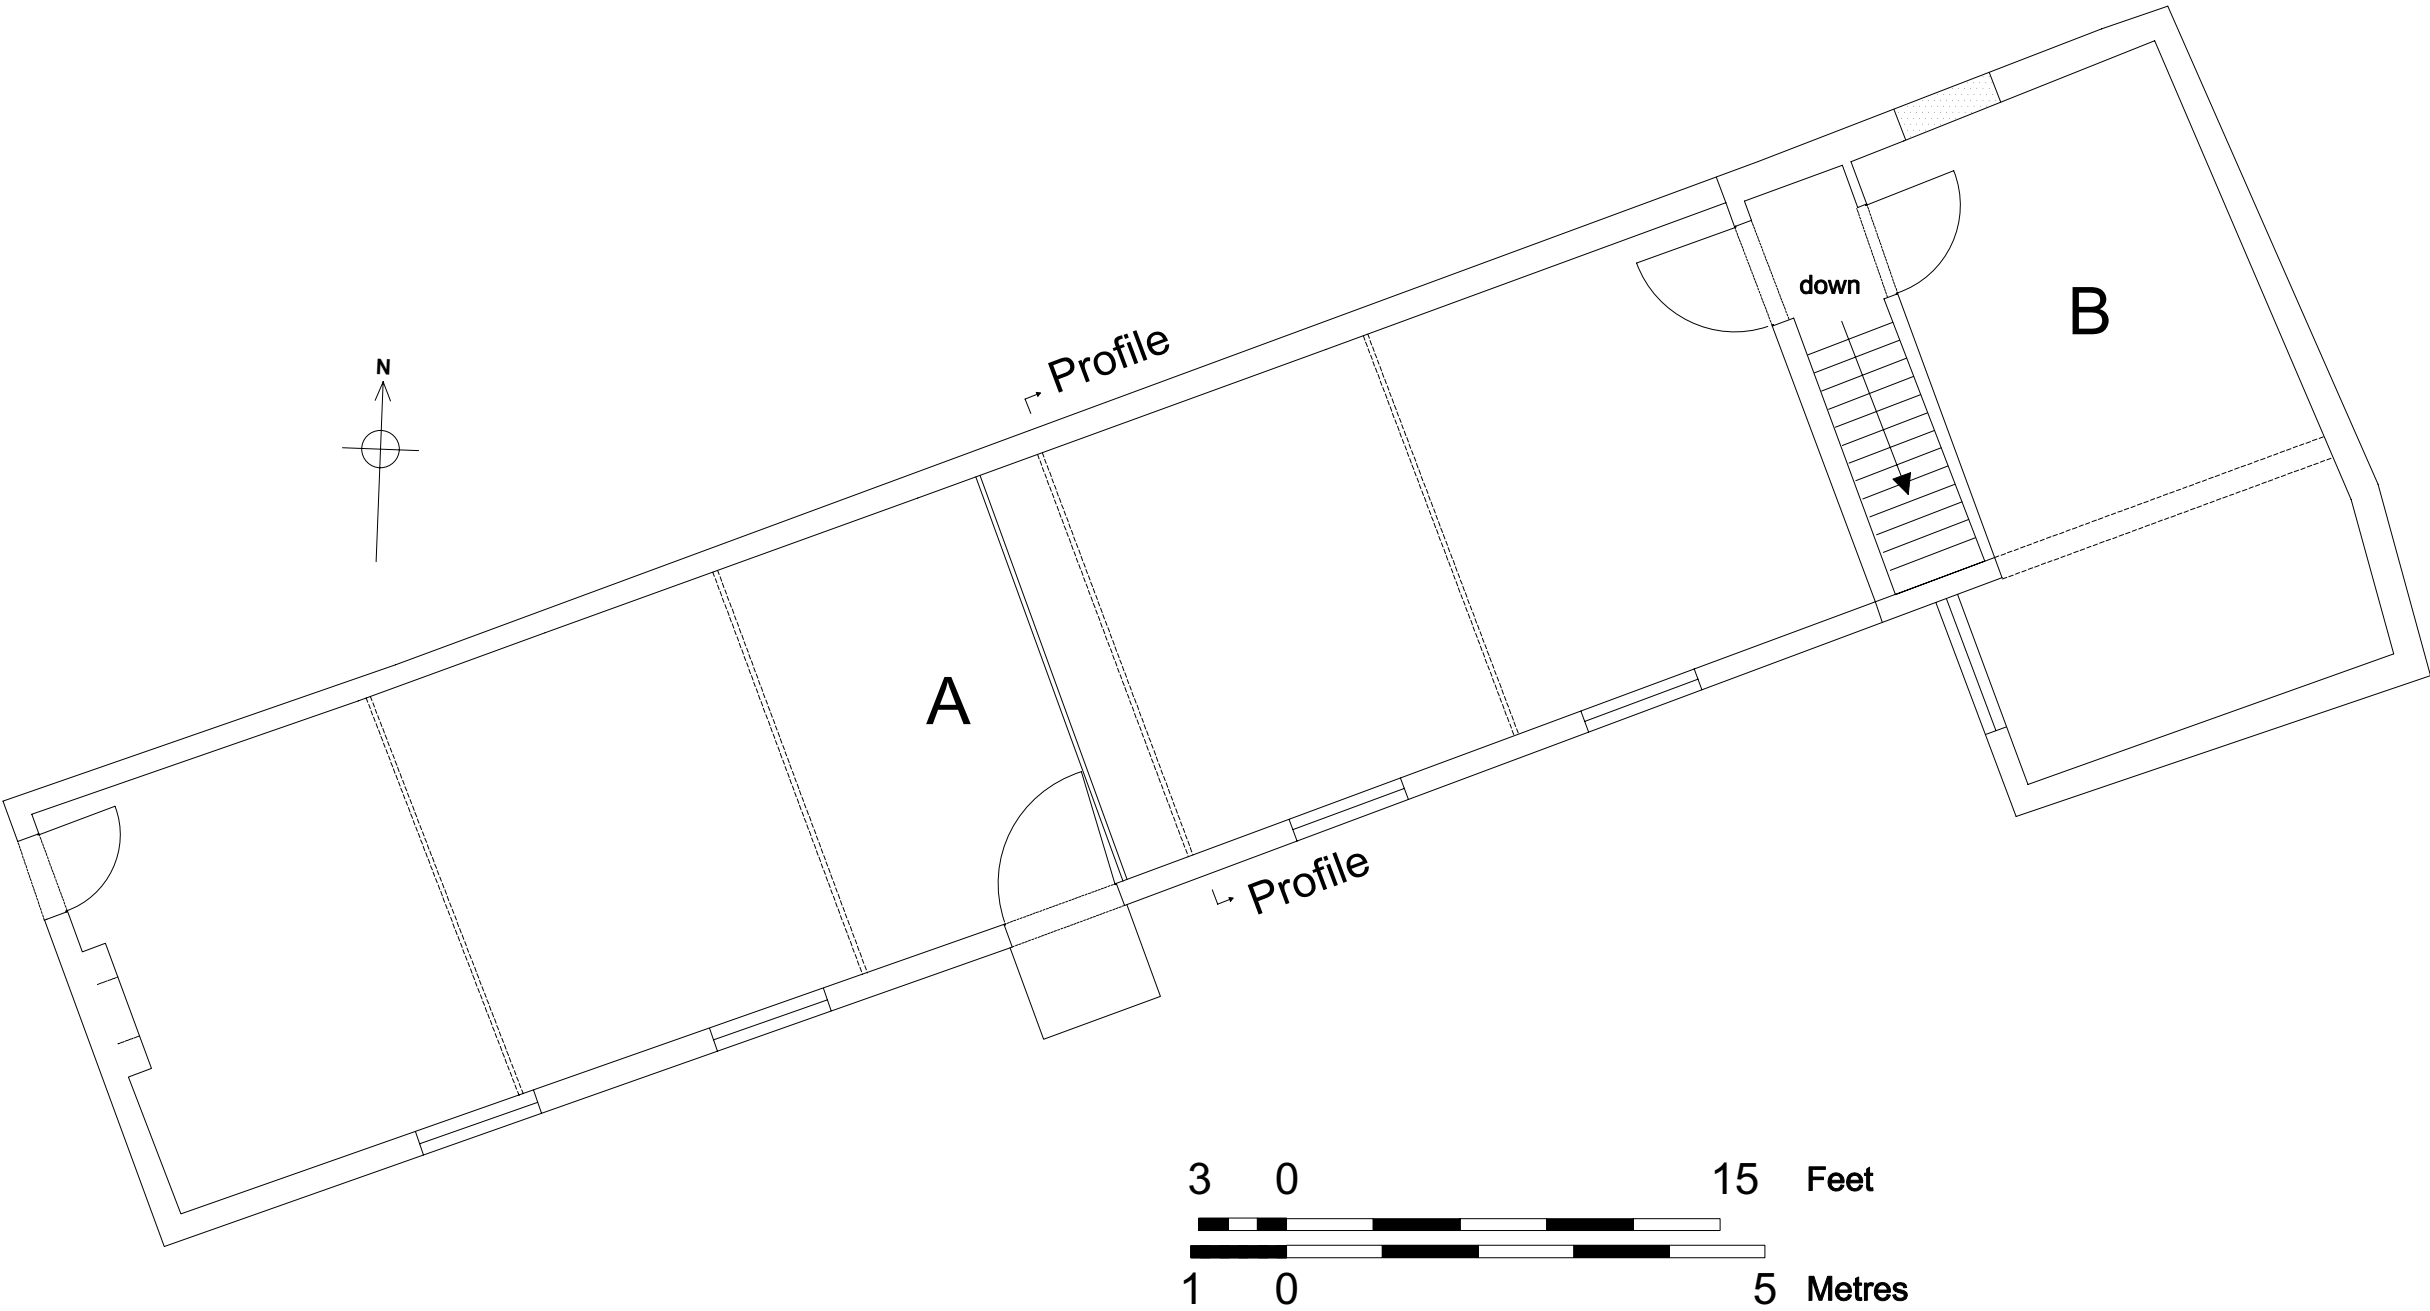
Figure 7 First Floor in Plan.

The first floor area has been opened up to create a single large room (*Figures 7 & 19*), with the remains of a stud partition wall close to the centre, immediately to the east of the loading door. A fireplace opening in the west gable wall appears to have housed an integral cast iron grate/surround, though this has been removed. In the east wall there is a four-panelled door, opening onto an inserted staircase within Unit B (see below). The provision of a fireplace, sash windows and panelled internal door suggest the first floor may, in part at least, have provided domestic accommodation; in contrast the loading door suggests a storage or other ancillary function.

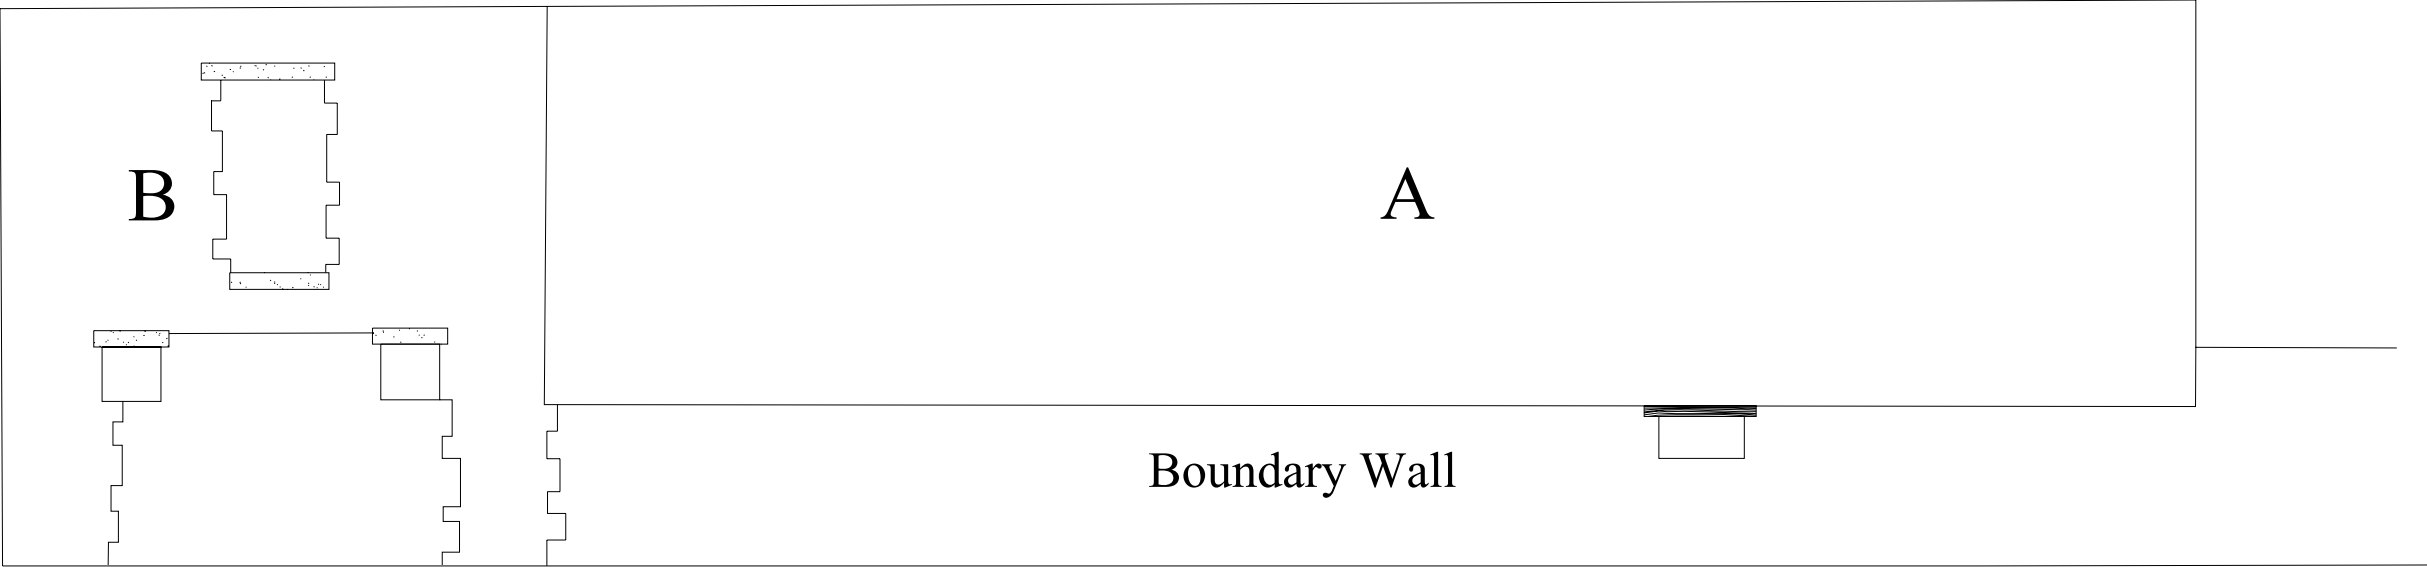
Figure 9 Sketch of Rear Elevation Showing Major Events (Not to Scale).

In the north elevation it is apparent that an earlier brick boundary wall, between this plot and Talbot Yard to the north, has been incorporated into Unit A (*Figure 9 & 12*). There is also a low blocked window with timber lintel in this elevation. The west gable wall has an external staircase giving access to a first floor doorway that is located to one side of an internal chimneystack. The stack is supported on the ground storey by internal brick piers.

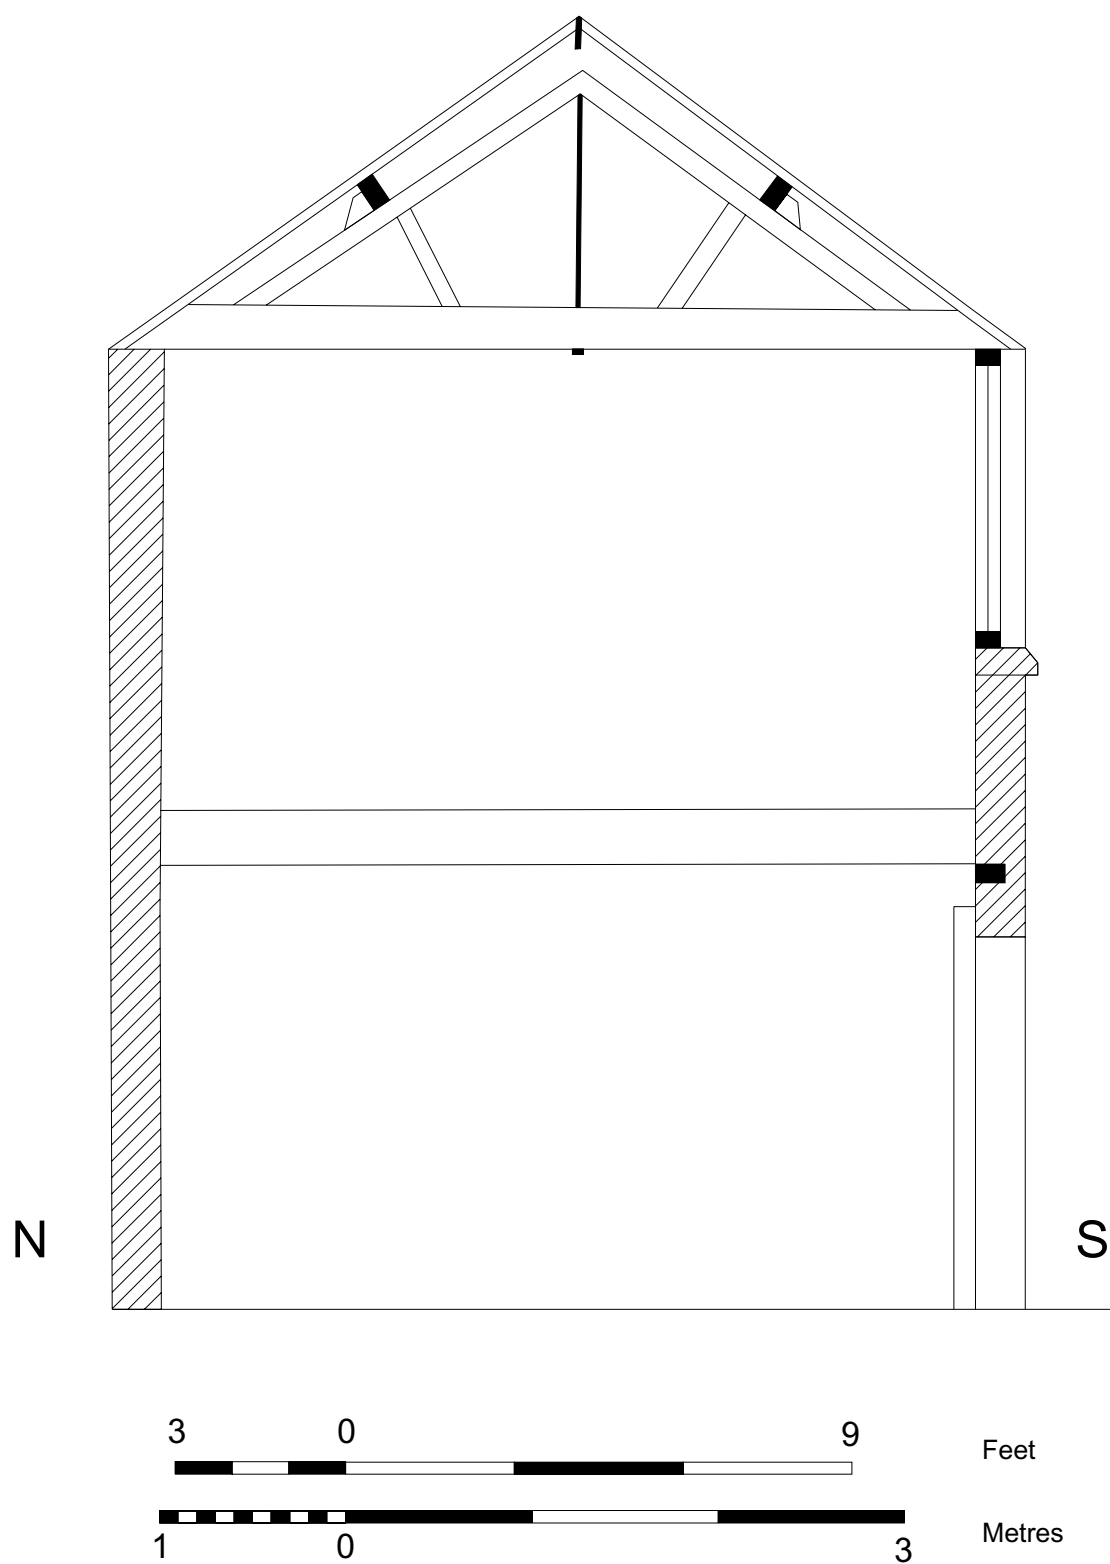
Figure 10 Profile Unit A.

The trussed rafter roof consists of four approximately equally spaced trusses of similar design, as illustrated in (*Figure 10*). This variant on the king post truss, in which the king post is replaced by an iron rod (Peters' type 5a), came into common use after about 1865 (Peters 1988, 29; Campbell 2000). The purlins are carried on cleats fixed to the principals.

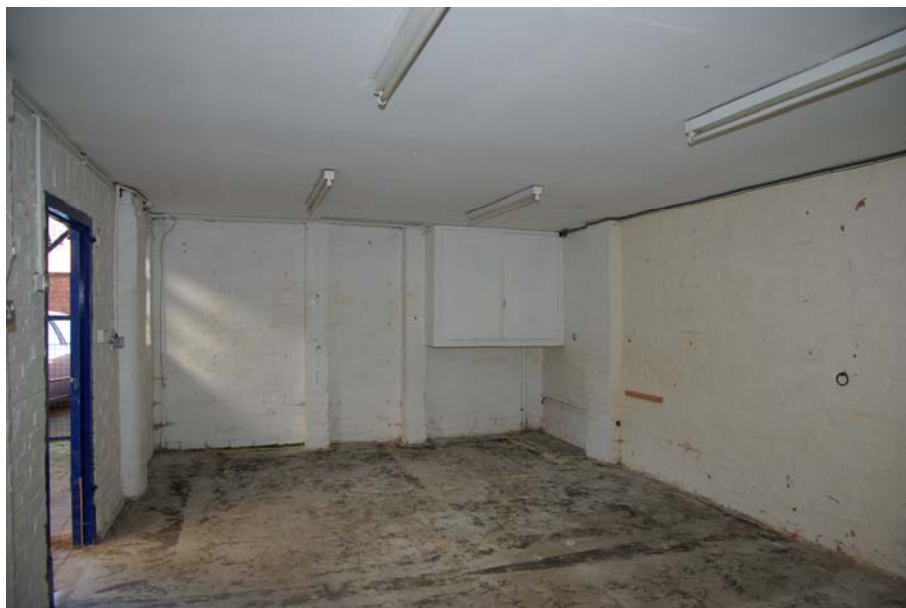
Figure 17 Unit A Blocked Openings in Right Hand (Eastern) Gable.

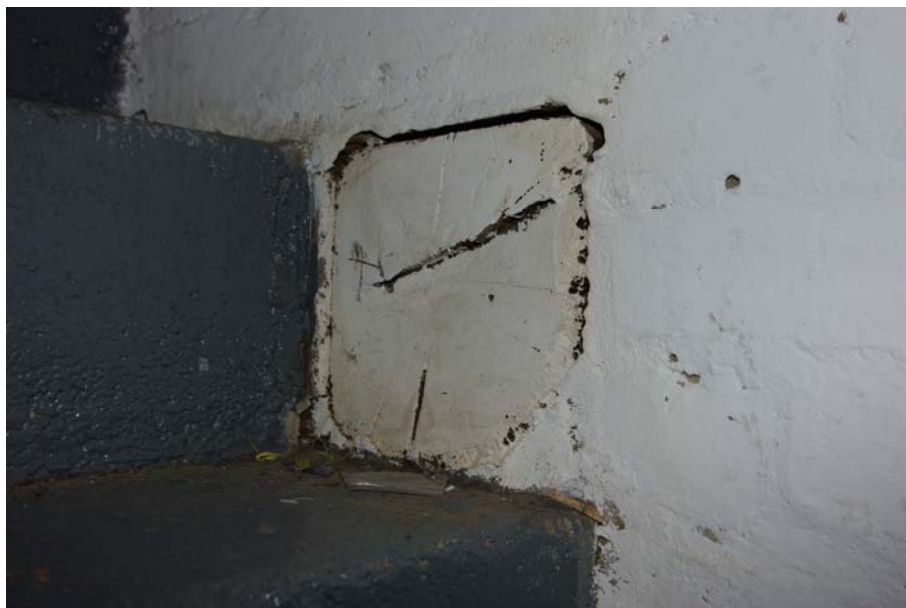
Figure 18 Unit B Axial Beam Seen in Stair Wall

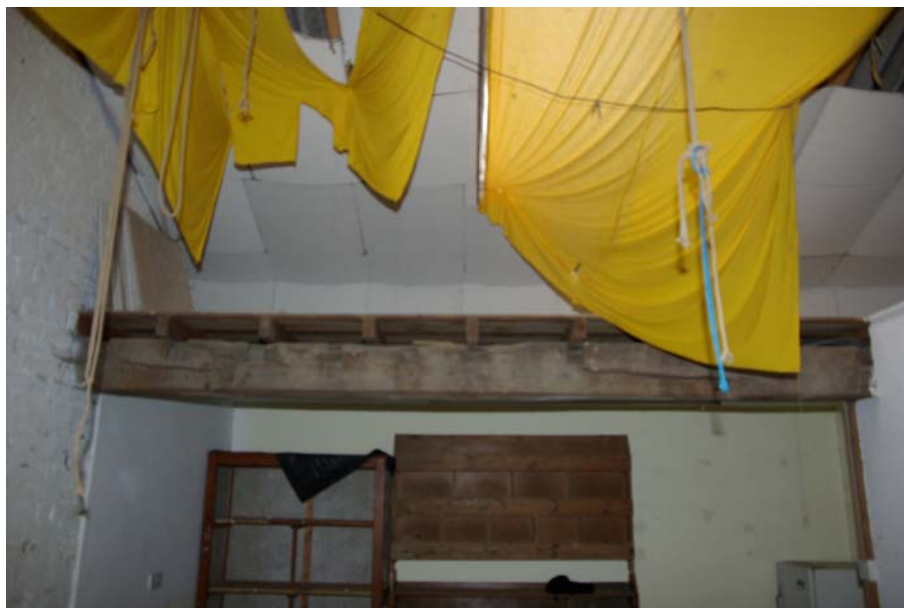
Figure 20 Unit B Wall Plate Showing Position of Original Wall.
