**A Photographic Survey of Building 2,
254 Braunstone Lane,
Braunstone Town, Leicestershire.**

Planning Application: 07/0768/1/PX

For: Parkers of Leicester Ltd

**University of Leicester
Archaeological Services**

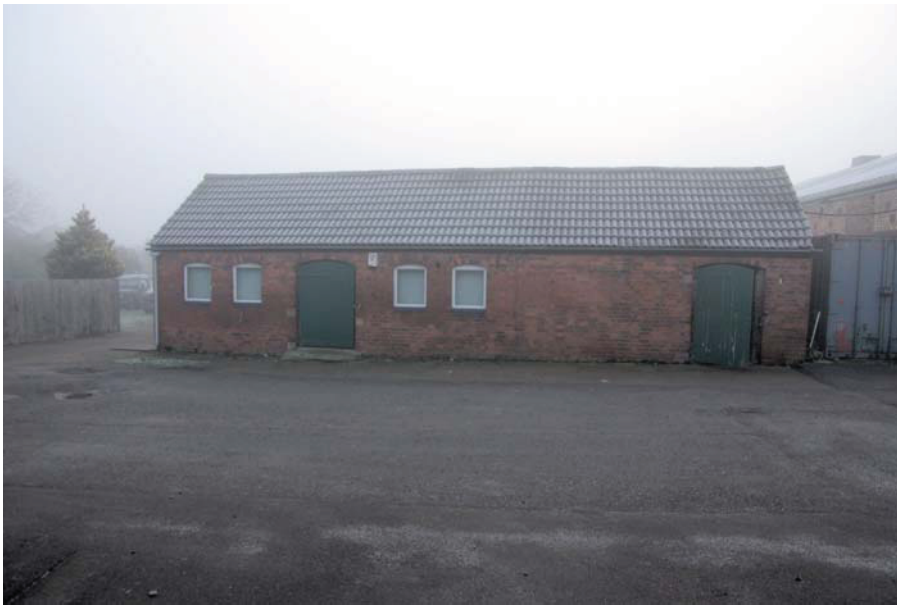
Building 2 consists of a single-storey twin-bay red brick building aligned north-east to south-west, fronting to the north-west (*Figure 8*). The bricks appear to be handmade measuring 9 ¼ inch by 3 inch, with relatively large inclusions, suggesting an early date of manufacture, possibly pre 1850. The bond is a Flemish Garden Wall bond, showing extensive cement mortar re-pointing although traces of an earlier lime mortar can be seen in places. There is no damp proof course, which is not unusual for agricultural buildings, while there is a hole at ground level to the left of the building, the lowest point, which would have originally served as a drain (*Figure 10*).

Figure 8 Front Elevation (looking south-east).

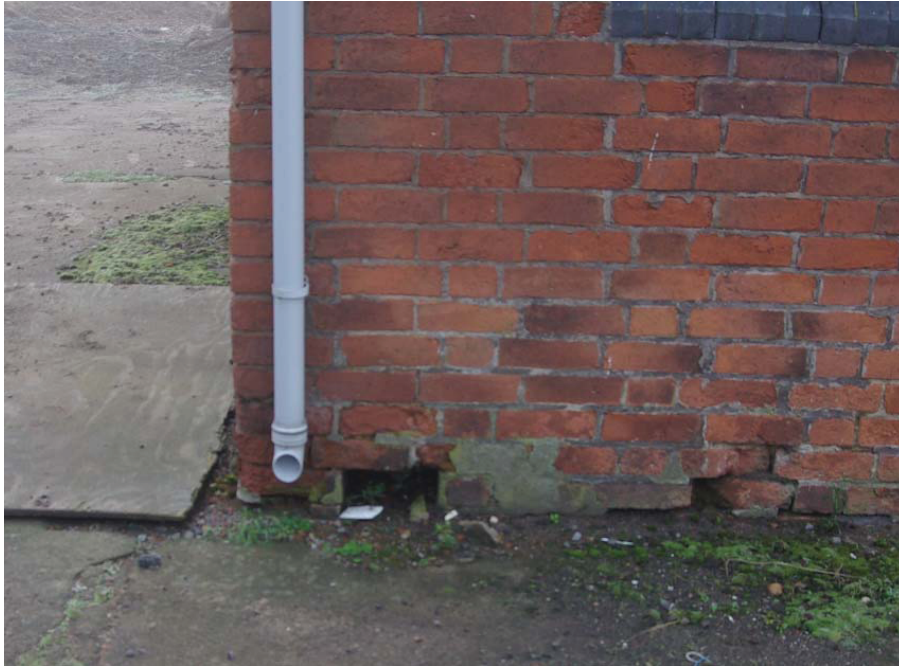
Figure 10 Original open drain on front (north-western) elevation.

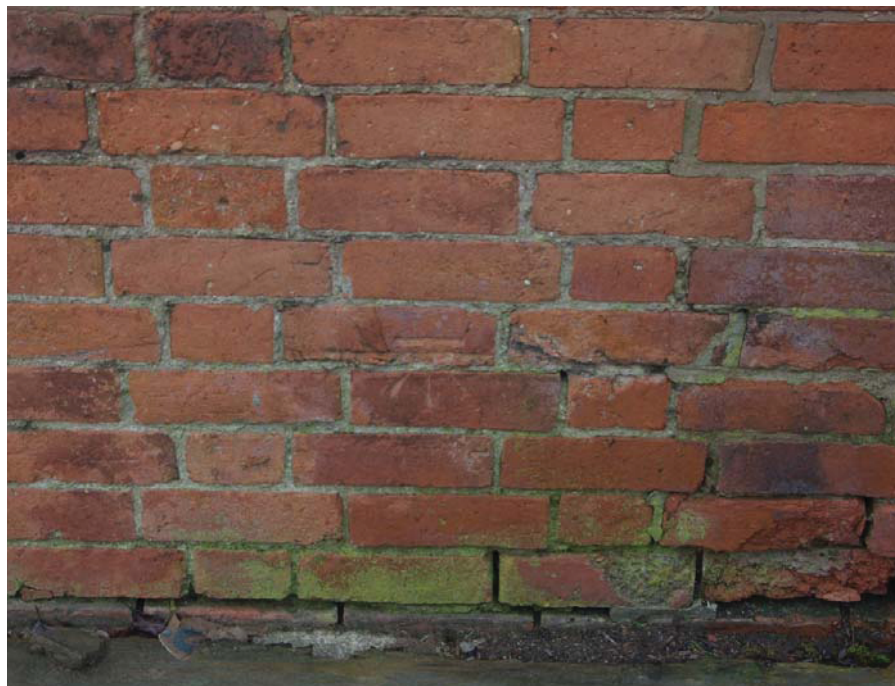
An Ordnance Survey benchmark has been carved on the north-eastern gable, the exact date of which is unknown, but may relate to the second geodetic levelling carried out by the Ordnance Survey between 1912 and 1921 (*Figure 11*).

Figure 11 Ordnance Survey Benchmark on north-east gable.

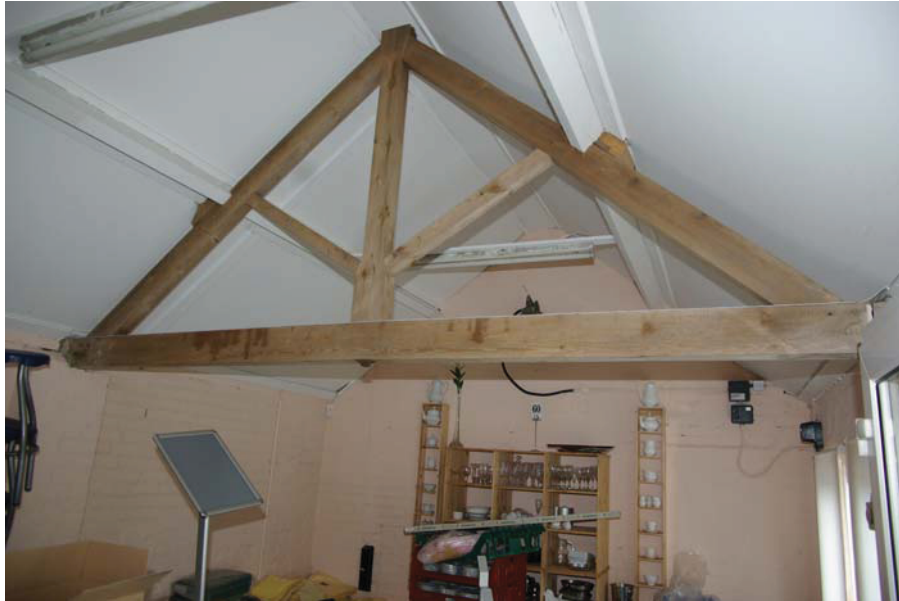
With the exception of a very recent dry wall partition to the north-east, internally, the building is little altered having been converted to commercial rather than agricultural use. The roof is a single bolted king-post design with raking struts (*Figure 12*) carrying purlins in a soft wood. There is a full height brick-built partition wall between the two bays with a blocked central pitching hole and a blocked doorway adjacent to the front wall (*Figure 13*), which may suggest that one bay is later than the other, although there is no visible joint on the external walls. Limited remains of cast iron drinking troughs can be seen on the rear wall within room A. There are new concrete floors throughout.

Figure 12 Roof Truss in Room 1.

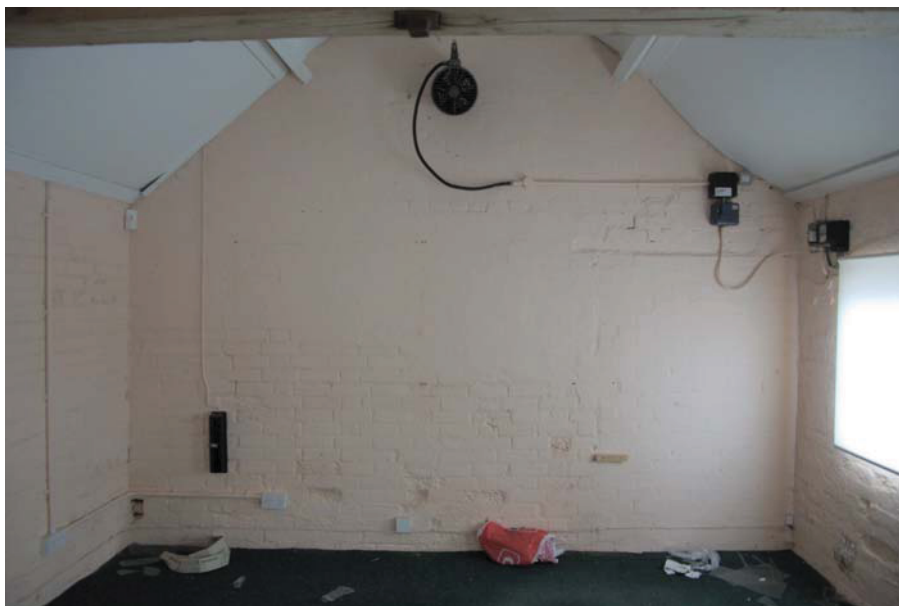
Figure 13 Blocked Openings in partition wall.

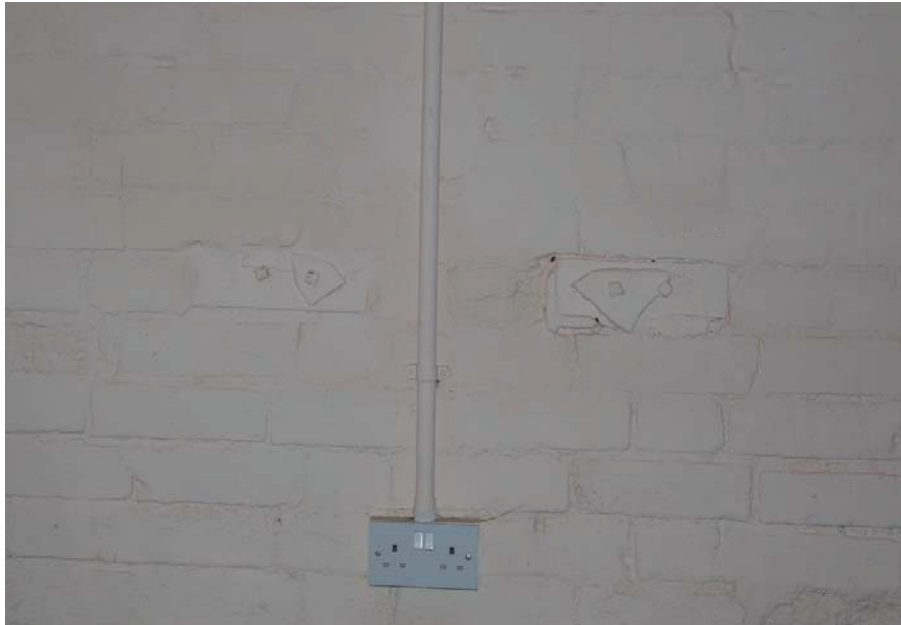
Figure 14 Remains of feeding troughs (Room 1).

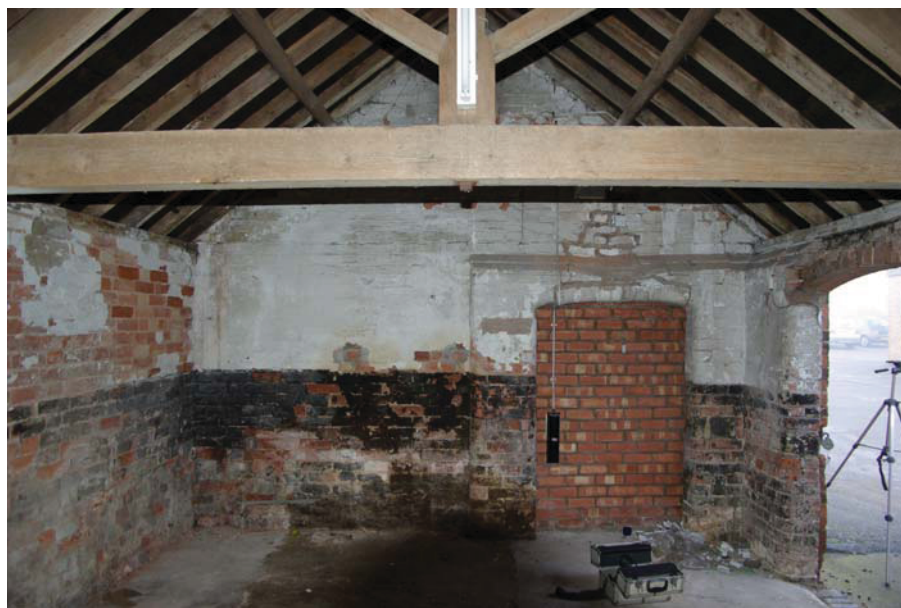
The south-western bay (Room B) has remained largely unaltered. The blocked openings are clearly visible in both the partition wall and the gable wall (*Figure 15*). There are original bull-nosed brick piers and reveals on the blocked gable door. The roof truss is identical in design. Again the floor is of relatively recent concrete.

Figure 15 Interior showing south-western gable of Room 2.
