**A Photographic Survey of an Outbuilding
At Halstead Grange, Halstead,
Leicestershire
(NGR SK 748 057)**

ULAS Report Number 2009-087

**A Photographic Survey of an Outbuilding at Halstead Grange, Halstead,
Leicestershire, (NGR SK 748 057).**

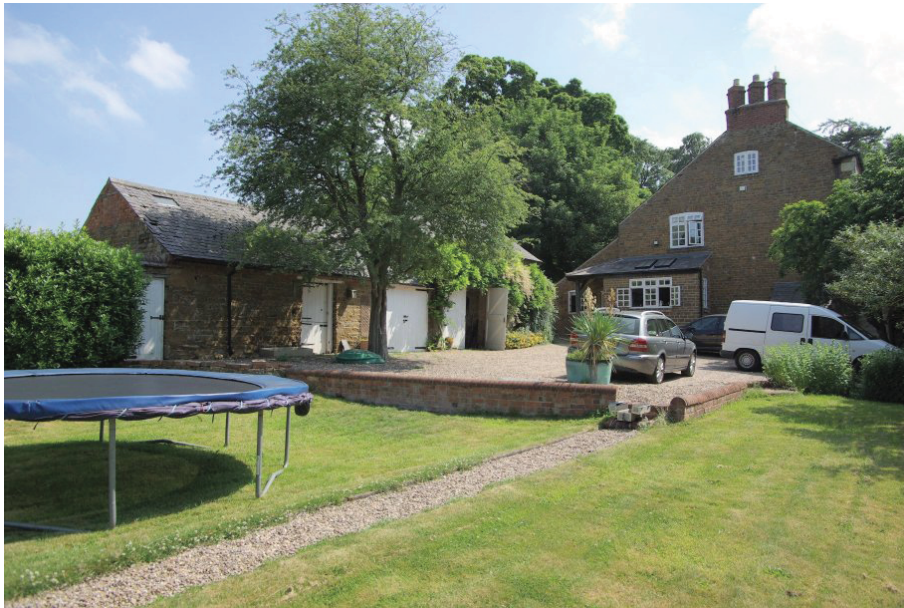
Figure 5 Outbuilding & Halstead Grange.

The outbuilding consists of a linear range of three bays in coursed local iron stone with a pitched roof of Welsh Slate facing Oakham Road to the south (*Figures 2 & 5*); the outbuilding is on the same alignment as the Grange but set back, to the north by approximately 3-4 metres. The easternmost part of the building has a first floor while the rest of the building is single-storied. There is a single stable door as well as two double doors and a window on the southern elevation; there are no doors on the northern elevation, only a window at first floor level. On the western gable there is a single pedestrian door towards its southern end; thirteen courses of red brick have been added to the apex of the gable (*Figure 6*) and a pitching hole or window within the brickwork has also been blocked with similar red bricks. On the eastern gable there is also a single pedestrian door, slightly left of centre, and a window just below eaves level towards the apex of the gable.

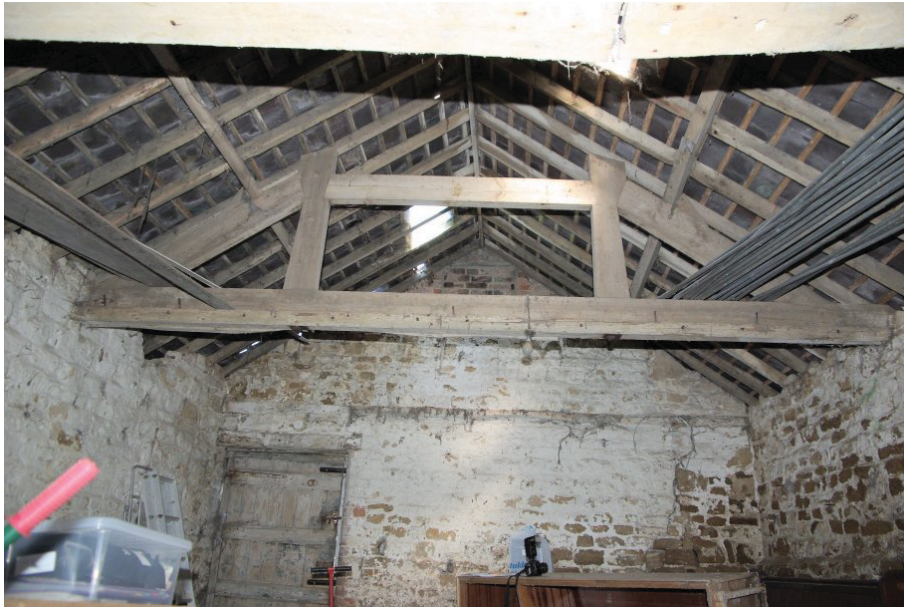
Figure 7 Queen Post Truss in bay *a*.

The roof is a Queen Post design (*Figure 7*) in bolted soft wood, apparently machine sawn; this is certainly not as early as the 19th century and is therefore not the original roof. A stump of a roughly shaped and possibly original tie beam protrudes slightly from the southern wall above the single door. Evidence of the building's more recent agricultural past can be seen with the use of plastic Ammonium Nitrate fertiliser sacks instead of roofing felt on parts of the roof, a far from uncommon practice on farm buildings. Further evidence of the new roof can also be seen externally on the southern elevation where the eaves have been raised with addition of bull-nosed brick corbelling.

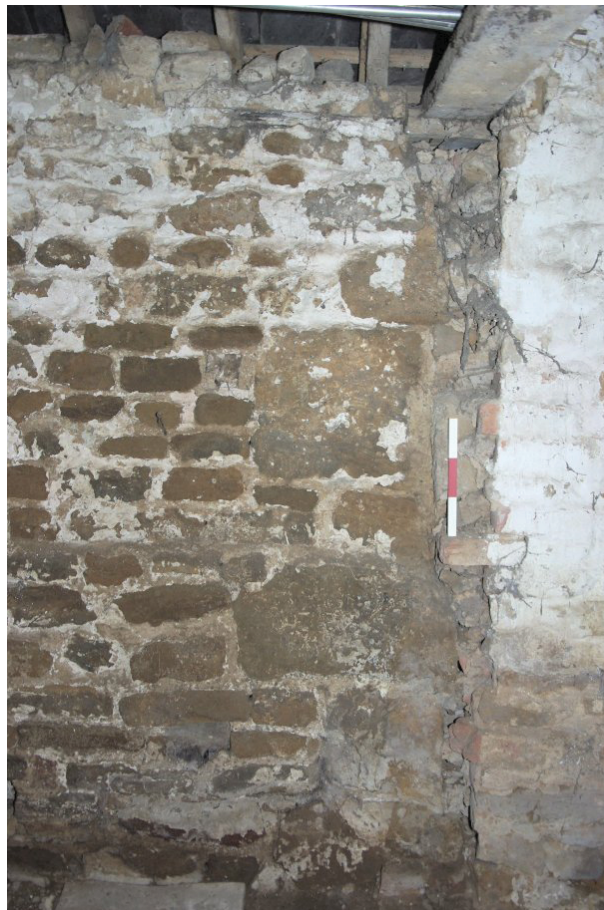
Figure 8 Straight Joint & Quoins in Northern Wall, Bay *a*.

A closer examination of the stonework suggests a number of different phases to the building, the most clear of which is the straight joint in the stonework on the northern elevation (*Figure 3 on plan, Figure 8, internal & Figure 9, external*). The external northern wall of bays *a* and *b* appears to be a single phase with quoins at first floor level; there is, however, what appears to be a straight joint visible internally between *a* and *b* casting doubt upon this. Also, there is a partially blocked arrow slit opening on the rear wall which is visible internally, but not externally (*Figure 3*), it is possible that a new 'skin' has been added to this rear wall, the stonework, has after all been finished

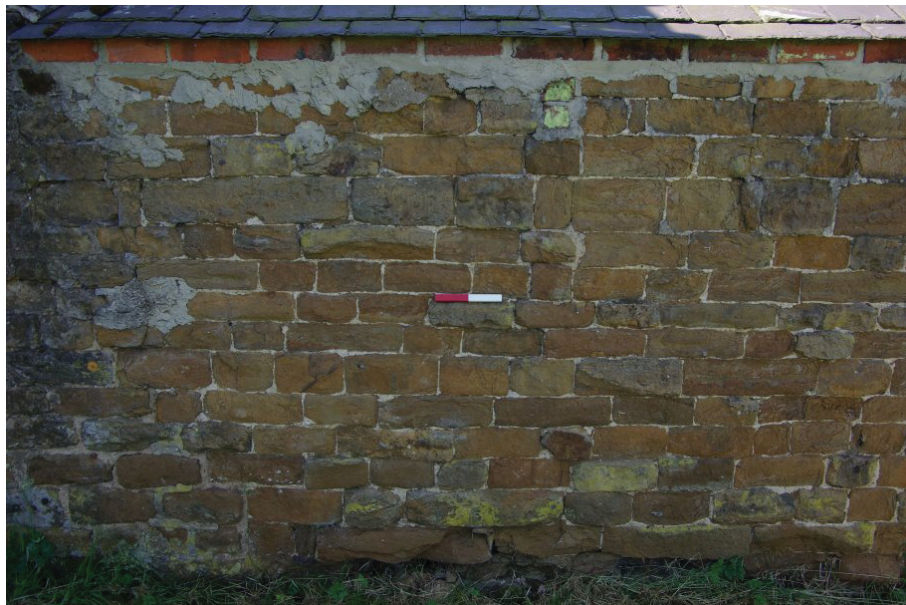
Figure 10 Quality of Stonework on Northern Wall.

to a very high standard (*Figure 10*), possibly even too high a standard for an outbuilding.

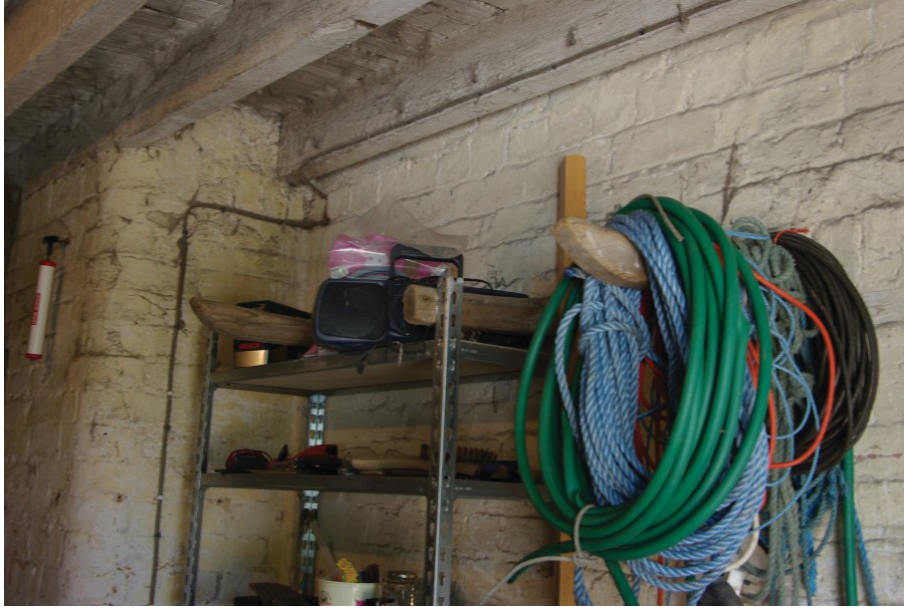
Figure 11 Saddle Tree, Bay *b*.

There is an original stone-built wall between bays *a* and *b*, the partitions between *b c* and *d* on the other hand are clearly later in date and are of red brick, probably early 20th century in date and not tied into the main exterior walls. Bay *b* is accessed via a large carriage door on the southern elevation and is the full width of the building; the floor is laid in brick in a herring bone pattern, with slight evidence of wheel ruts (presumably from iron tyres) just about visible. There are three original saddle trees (*Figure 11*) on the right hand wall adjacent to the door, suggesting an original equine use, most likely a cart shed and track room.

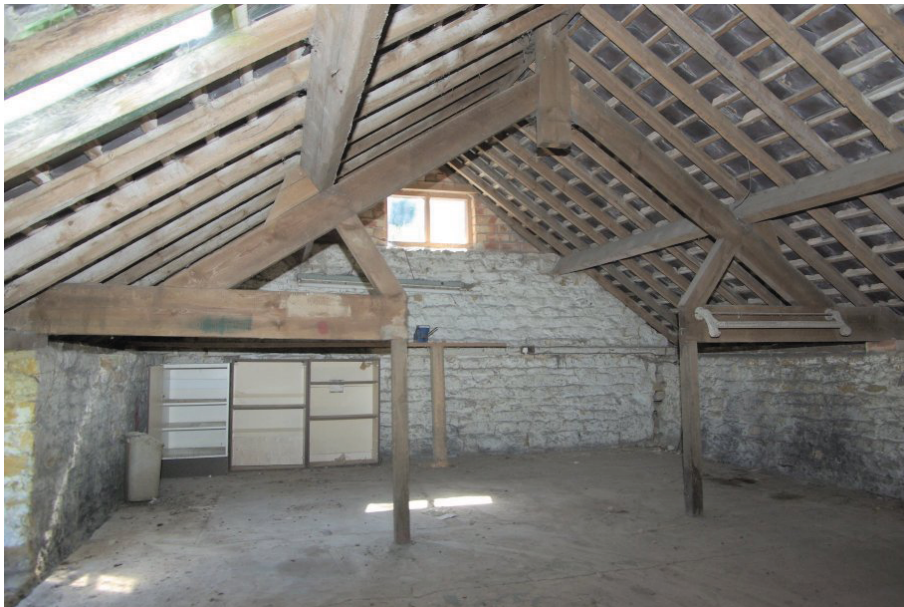
Figure 12 Modified Truss, *e*.

Access to the first floor (*e*) is via an open staircase within *b*, the floor is gypsum. As with the roof within *a*, once again the timbers are modern, indicating that this roof is also a recent replacement. In this instance, the roof truss was originally a king post design, however, no doubt to improve access to the space the truss has been modified with both the king post and the tie beam having been cut out (*Figure 12*), new struts were then added carrying the tie beam to the inserted brick wall at ground floor level. Despite losing the vast majority of its strength and structural integrity the truss seems to have survived remarkable well.

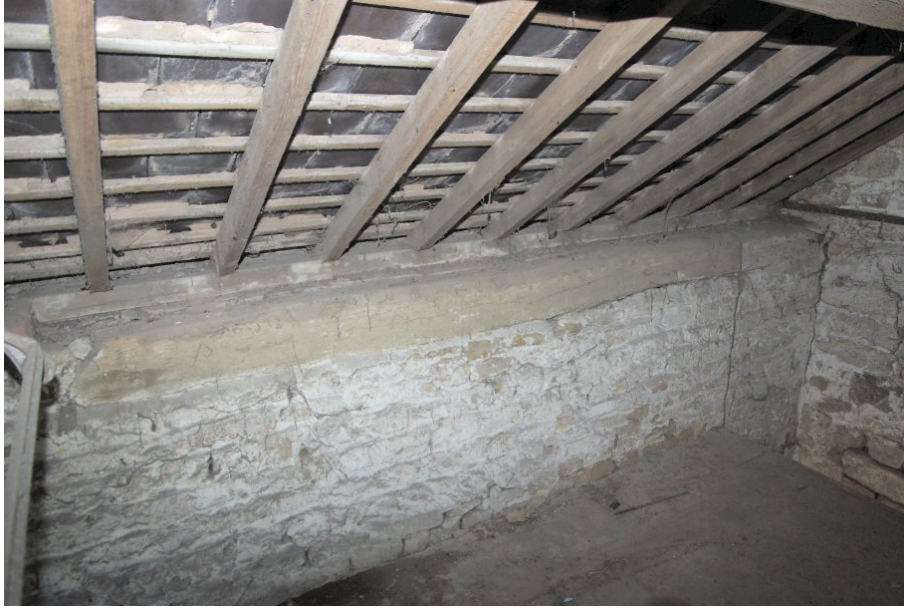
Figure 13 Re-used Tie Beam in Southern Wall of *e*.

Also of interest is the partial wall plate within the southernmost wall (*Figures 3 & 13*), it is obvious that this was originally a tie beam from a king post roof truss, the tapered ends and the trench for the king post are clearly visible. A bolt, possibly the original king post bolt has been inverted and now sits within the stone work. The dimensions of this beam, 3.42 metres does not match the existing building, the beam therefore,

originated from another building, possibly an earlier phase of this building or another building all together. Earlier edition maps do record a building in the paddock to the north west, which by the turn of the twentieth century has disappeared.
