**A Photographic Survey of the Former
BUSM Factory, Ross Walk,
Leicester
(NGR SK 5909 0643)**

For: Westleigh Homes

ULAS Report Number 2009-096

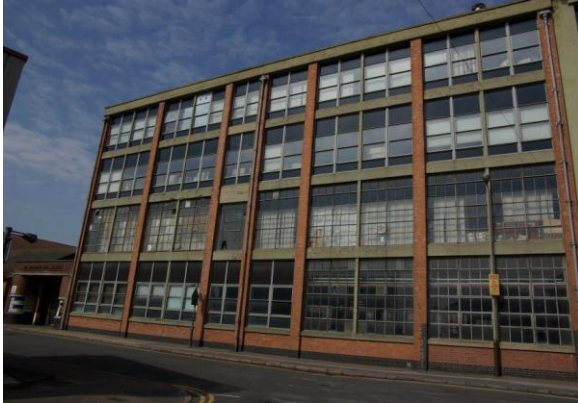
Figure 3 Building 32, Ross Walk Frontage.

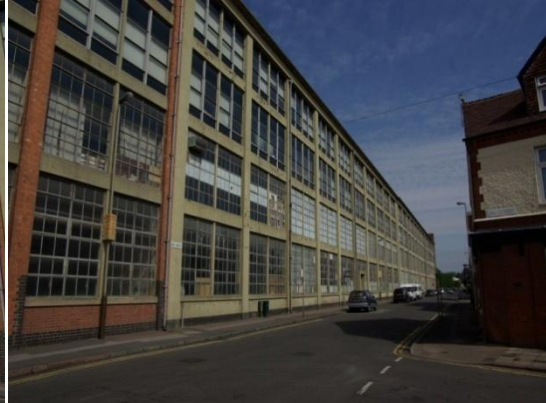
Figure 4 Buildings 39 & 96, Ross Walk Frontage.

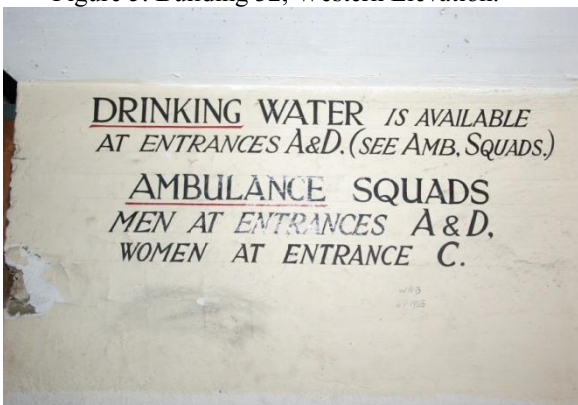
provide greater protection from bombing. There are a number of World War II signs which have not been painted over still visible within the cellar (*Figure 7*). There is also an extensive network of wall and ceiling mounted ducts providing ventilation, for which original plans and instructions dating to 1939 still survive, framed in one of the rooms. All of the doors appear to date from this period and have one way opening vents and rather large and overly ornate latches.

Figure 7 Building 96, WWII Sign in Cellar.

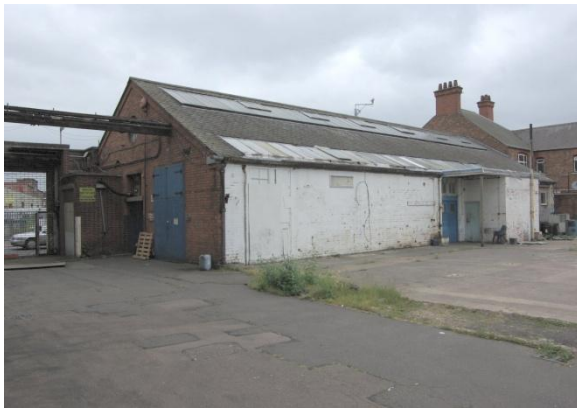
The western elevation of 33 is painted white; this might support the site plan (*Figures 9 & 52*) which records a number of since demolished buildings adjoining this western elevation. One of these was an apparently temporary building of tubular steel built during World War II and only recently demolished (Malcolm Kyle Pers. Comm).

Figure 9 Building 33, West elevation.

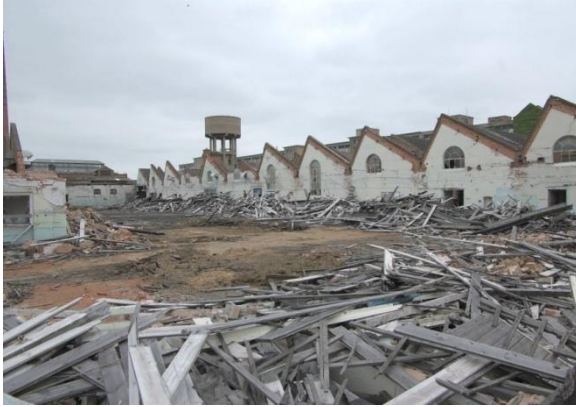
Figure 17 Building 44 showing limited remains.

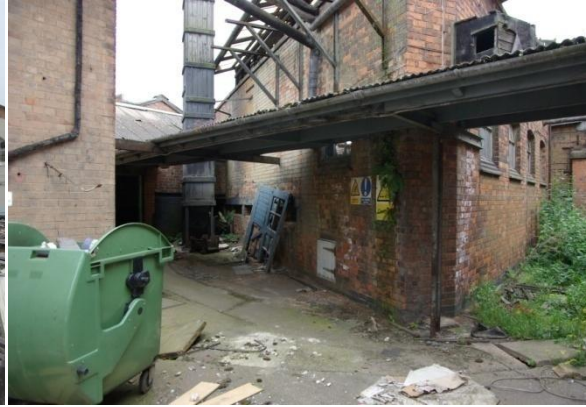
One of the most significant features of this building was the unusual angle of the one of the northern gables (*Figure 18*). Early cartographic sources record an unusual boundary following the same alignment and it appears, therefore, that the building respected this boundary. Extensive traces of camouflage paint can still be seen on the exterior faces of the building; this is evidence of the factory's World War II history when the factory produced mounts for naval guns and coastal artillery, not the Spitfire parts, most claim were produced at the factory (Malcolm Kyle pers. comm.). It is quite common to claim that during the war a particular factory was turned over to Spitfire production, where in fact the reality was much more mundane, perhaps it is only natural for people to want to be associated with something more glamorous.

Figure 18 Building 44, showing the unusual angle of the northern gable.

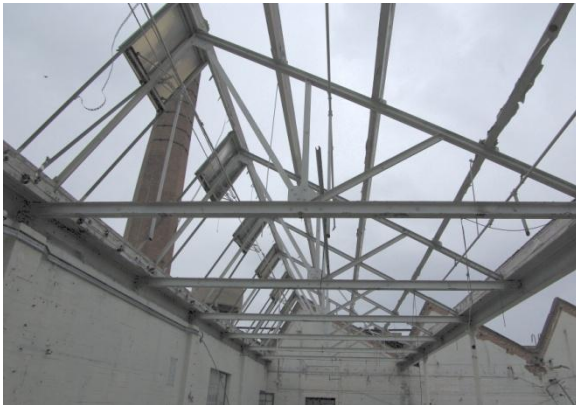
Figure 19 Building 44: Remains of roof structure.

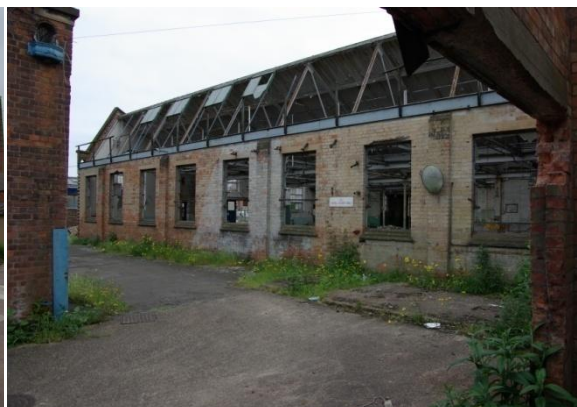
Externally further remnants of camouflaging can be seen on the northern elevation along with blanks left in the brickwork to allow the building to be extended to the north, should the need have arisen (*Figure 22*).

Figure 22 Building 46, Northern elevation with Camouflage.

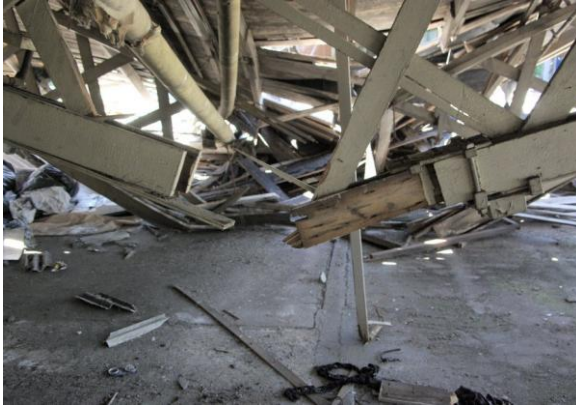
Building 54 is largely open-sided supported on concrete columns, while Building 55, on the other hand has red-brick walls with Crittall-style windows. Discolouration visible on the trusses also suggests that the building had been partitioned lengthways (*Figure 27*). Interestingly one of the northernmost trusses of building has suffered a structural failure causing the roof to collapse (*Figure 29*); whether this was caused by an impact or a design or build flaw is unclear.

Figure 29 Building 54 Failure in Belfast Truss.

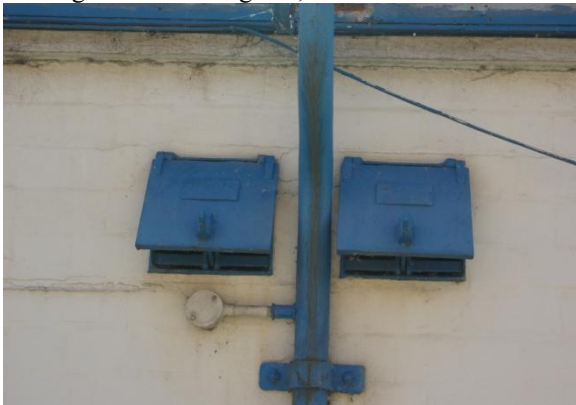
Figure 43 Building 72a; closing air vents.

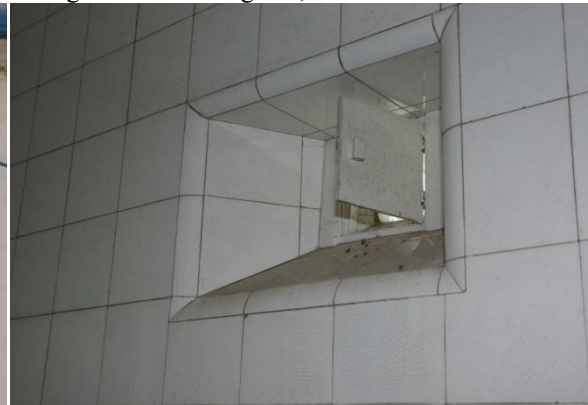
Internally, there are still *in-situ* black out covers over the smaller windows and skylights (*Figure 44*) as well as a clear division of space with two large treatment rooms with floor to ceiling tiled walls and tiled floors where decontamination would be carried out. There are smaller treatment rooms and offices off these larger rooms.

Figure 44 Building 72a: internal black out cover.

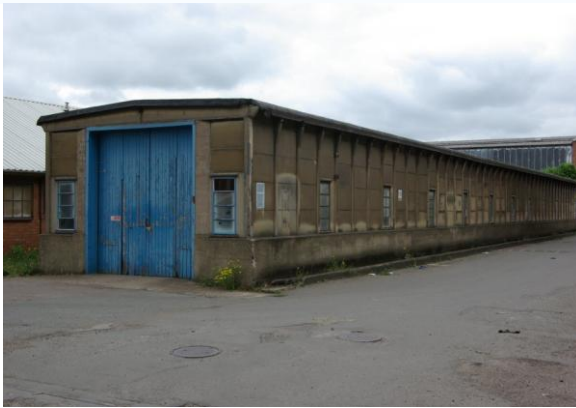
Figure 47 Building 110, southern & eastern elevations.

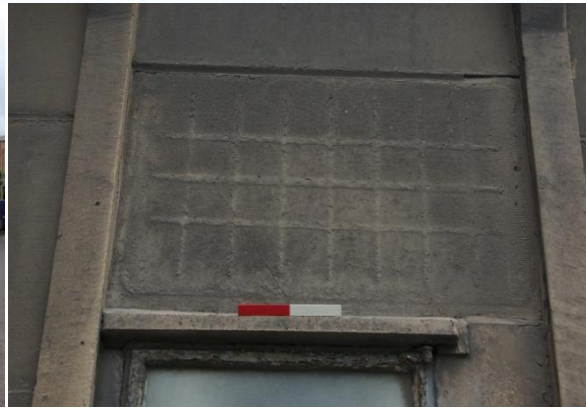
Like 72A, Building 110, despite its appearance, is one of the more interesting buildings within the proposed development area (*Figure 47*). The building is of pre-fabricated reinforced concrete, known as a BCF (Basalt Continuous Fibre). As re-enforced buildings, being pre-fabricated in a factory for on-site assembly means they can range in size from one or two bays up to the very large example seen here. Such buildings were used extensively during World War II, although this was assembled in 1938. Redundancy and corrosion of the re-enforcing fibres causing the concrete to disintegrate (of which there are very clear examples visible on this building) means examples of this type of building are becoming rare. Experimentation with basalt fibres re-enforcing only began in the US in 1923 (Newby 2001), so this building is an early example. It soon became apparent that the basalt fibres were very prone to alkali reaction within Portland cement causing the concrete to rapidly disintegrate (Dhir et al 2002). Although Building 110 has a number of visible reactions it is nowhere near as severe as in other cases (*Figure 48*). It is possible, therefore that there is a slight difference in this early building which has slowed the rate of alkali reaction.

Figure 48 Building 110, detail of alkaline reaction.

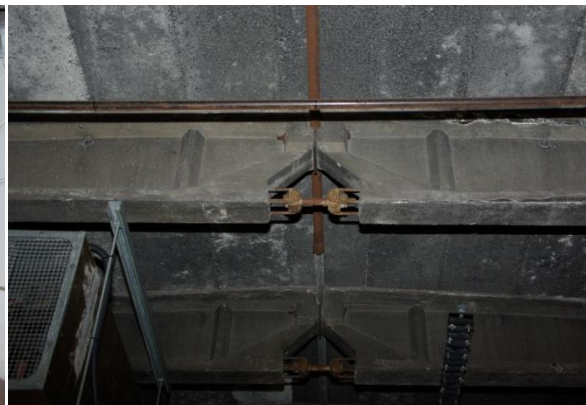
Figure 50 Building 110; construction detail.
