**An Historic Building Record of an outbuilding
situated within the curtilage of the grade II
Listed Building, Church Farm, Orton on the Hill
Leicestershire (SK 303 038)**

University of Leicester Archaeological Services

Report No. 2006/072 ©2006

**CHURCH FARM
ORTON-on-the-HILL
Leicestershire**

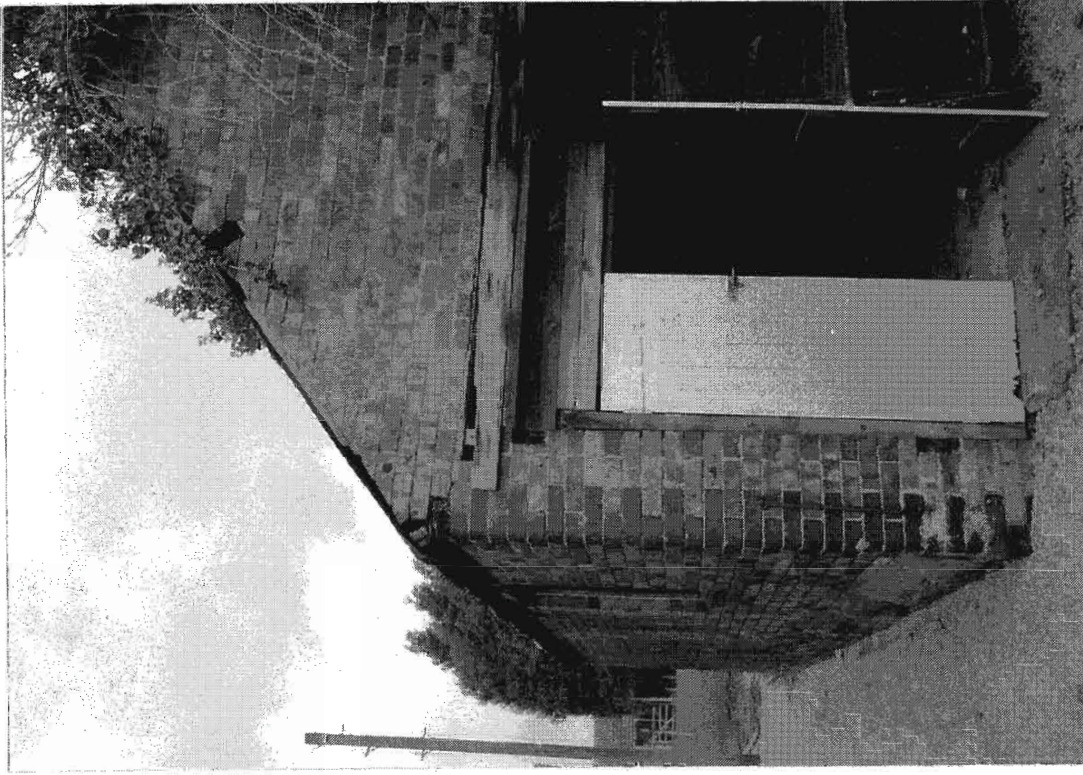
The brickwork of the south-west corner of the outbuilding's gable rises in a series of bull-nosed, blue bricks, (*see Plate 2*). On the south-west side, the outbuilding's brickwork runs for a further bays length to a brick, interval pier, after which the wall has been crudely cut away. The brick wall on the opposite, i.e., north-east side, runs continuously for two bays, the bay intervals being defined by brick piers. All the walling described rises to wall-plate height. At the north-west end of the second bay opposed brick piers support a deal truss that is linked by single purlins and a ridge piece to the transverse brick wall separating the first and second bays, (*see Plate 3*). This truss is the only example surviving within the entire range, (*see Roof Truss Note below*).

Plate 2 Detail of part of the south-east gable of the outbuilding, showing bull-nose bricks at the corner. All the brickwork visible is late 19th century in origin and comes from the 'Haunchwood' brickyards.

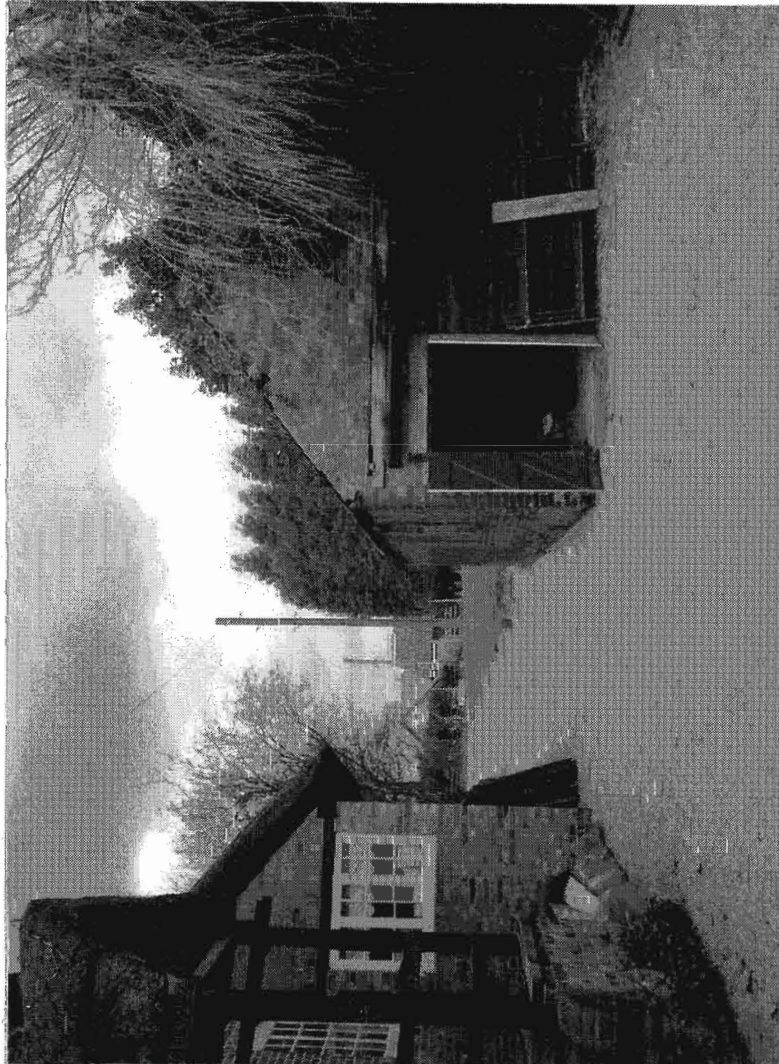
Plate 1 General view of the outbuilding (right) from the south-east with Church Farm visible to the left of the photograph.

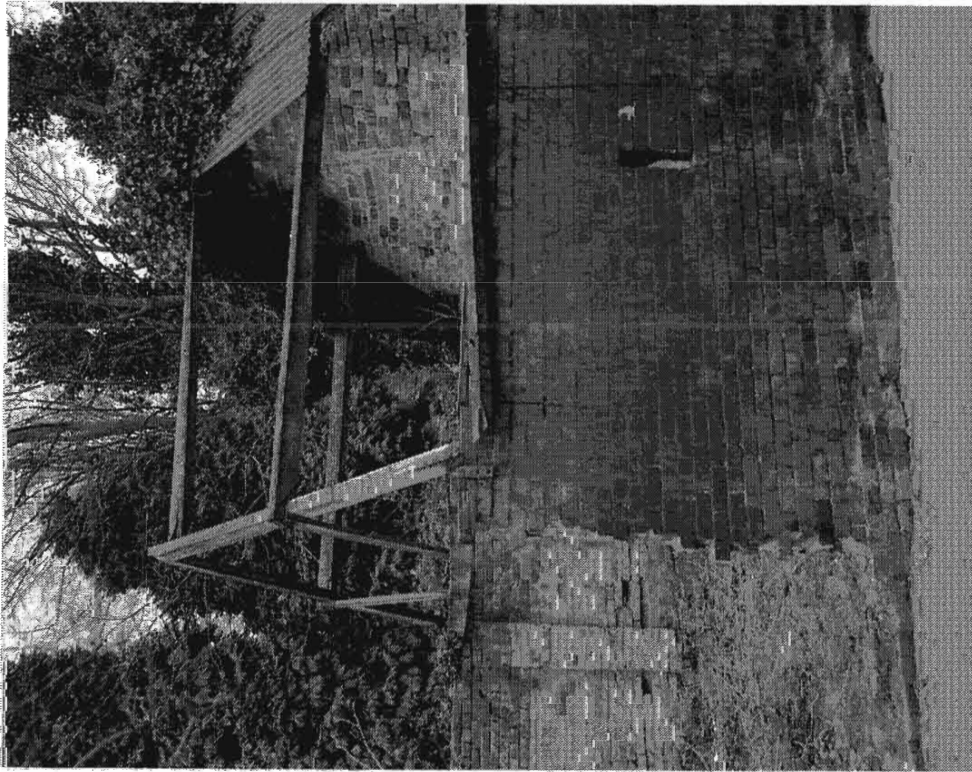
Only one deal, roof truss survives in the present, outbuilding range. This is situated at the north-west end of Bay 2, (see Plates 3, 9). The tie-beam of the truss is set on top of brick piers and is strapped to the wall-plate by what appear to be re-used cart strakes. The raked struts are lap jointed to the tie-beam and at the other end they are lap jointed to the side of the principal rafters, (see Plate 3). Single, side purlins are notch jointed onto the topside of the principal rafters. The principal rafters are set alongside not on top of the tie-beam with their feet are nailed to the topside of the wall-plate.

Plate 3 Detail view of side-wall of Bay 2 of the outbuilding showing the only surviving truss set on top of brick piers. The lap jointing of the raked raked struts and the notched joint of the nearside purlin are clearly visible. The end of the metal strap that clasps the tie-beam to the wall-plate and is bolted into the brickwork of the side-wall can also be seen

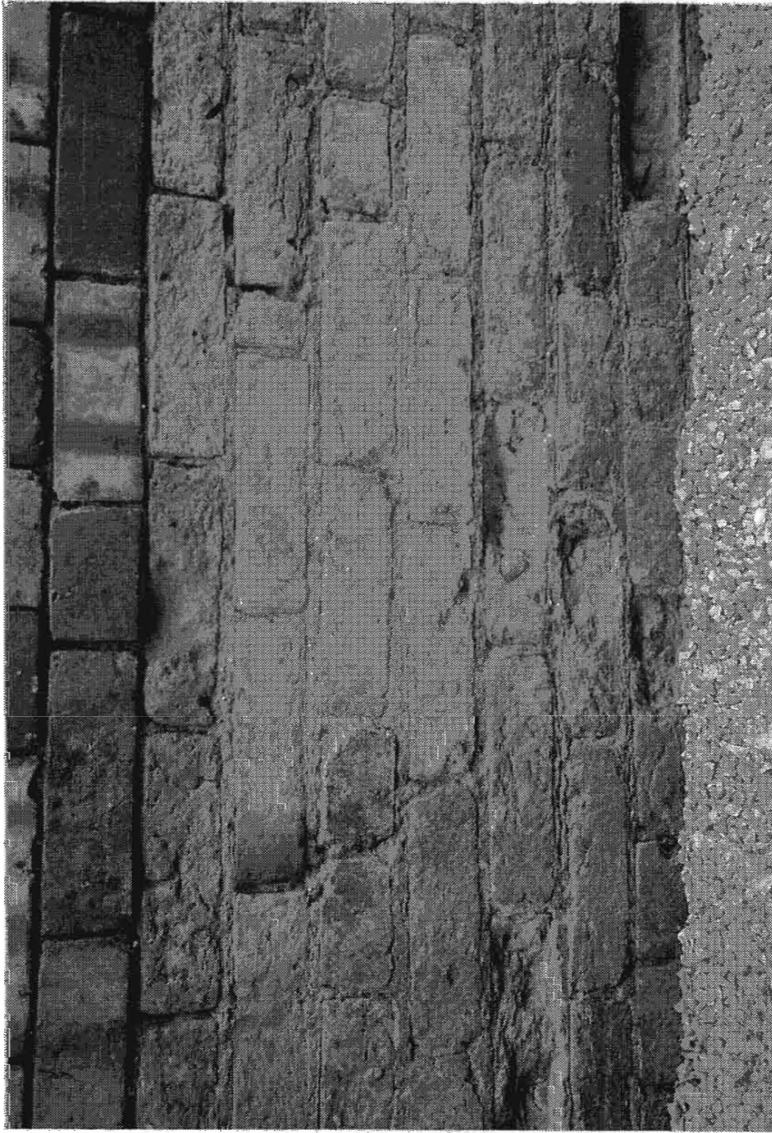
The existing brickwork of the survey building consists of two distinct series of brick. It appears that, with the exception of some of its lower courses, an earlier, 19th century brick building was dismantled and the present brick building was raised from its upper courses during the final quarter of the 19th century. The quality of earlier brickwork which survives in the lower six or seven courses of brickwork of the south-west wall are of inferior quality and were probably produced in the immediate vicinity of Orton. These bricks are narrower in section, many have substantial pebbles trapped within them while others are 'soft', i.e., have failed to achieve the necessary temperature level to completely change their state and subsequent frost and weather action has eroded them, (*see Plate 4*), all these features are characteristic of bricks commonly considered to be 'seconds.'

Plate 4 Detail of the two series of brick used in the side-walls of the outbuilding. This shows seven of the earlier, lower courses with examples of 'soft' bricks and others with large foreign bodies, in this case pebbles, caught in the fabric of the brick. From the base rows five and six also contain examples of 'warped' bricks. The top two rows in the photograph are 'Haunchwood' the striped effect on the bricks is a phenomena associated with their being burned in an industrial kiln.

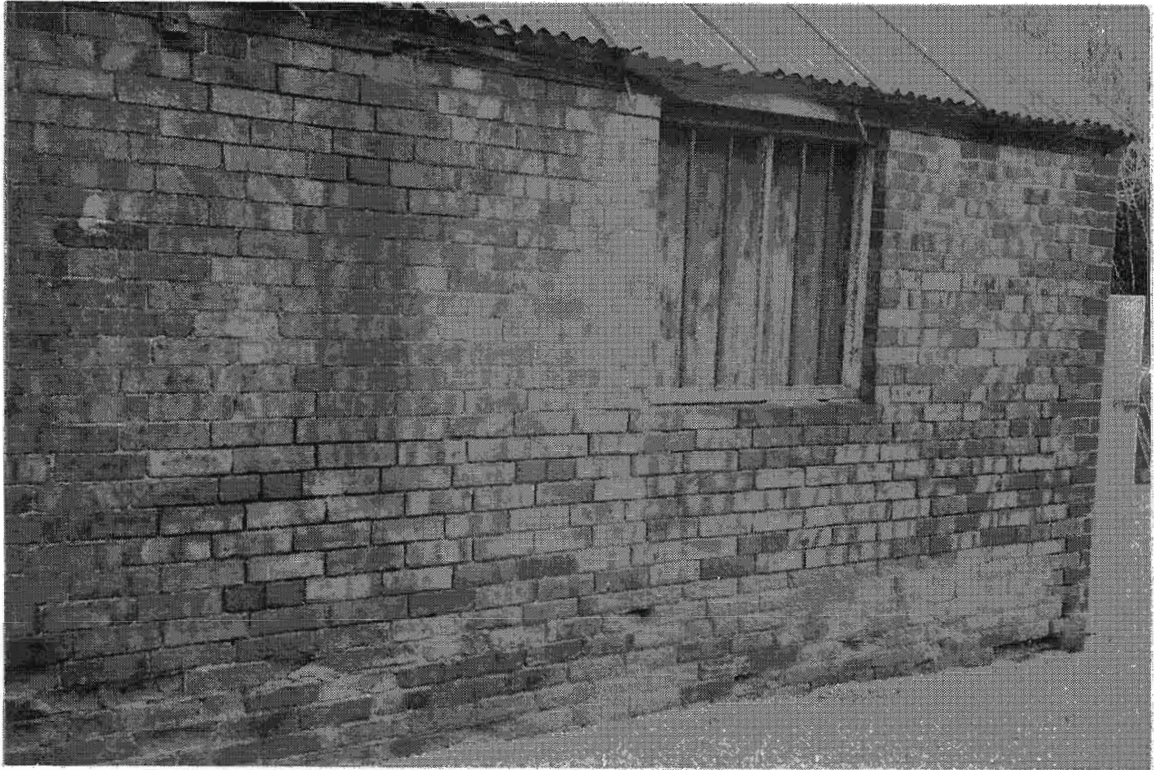
The upper sections of the outbuilding's walls are raised in 'Haunchwood' bricks. On the farmhouse, south-west side they rise through twenty-two courses to the wall-plate, (*see Plate 5*). On the Churchyard side, where several more courses of the earlier brick wall survive there ten courses of 'Haunchwood' bricks to the wall-plate. 'Haunchwood' bricks were a 19th century, industrially produced brick derived from the brick earths associated with the coal seams of the Nuneaton district. The finished bricks were characterised by a deep, reddish-purple pigmentation. At Church Farm the 'Haunchwood' sections of walling in the outbuilding contain so many examples of reduced, warped, dried and cracked specimens there can be little doubt they too are 'seconds', (*see Plate 6*). Although no conventional bond is identifiable in the brick courses of either series, the 'Haunchwood' brickwork repeatedly uses a four course rise consisting of a course of two headers with three stretchers alternating with

three courses of stretchers which appears to be an idiosyncratic form of Flemish Garden Wall Bond, (see Plate 5).

Plate 5 Brick side-wall of Bay 1, south-west elevation, showing the two-light window with metal glazing bars. The greater part of the brickwork is from the second phase and shows 'Haunchwood' brick being raised in a single bonding course of two headers and three stretchers alternating with three rows of stretchers, a variant form of Flemish Garden Wall Bond. The corrugated iron roof is also visible.

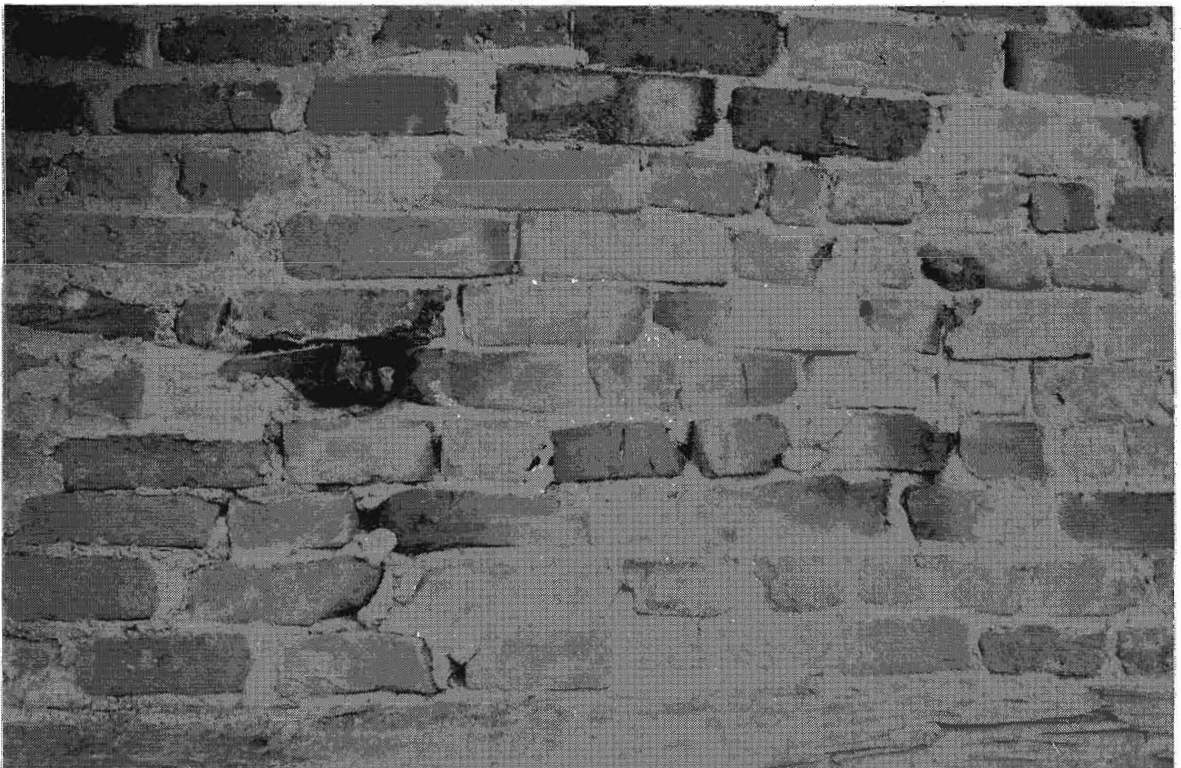
Plate 6 Detail of a section of the transverse wall between Bays 1 and 2, showing the inferior quality of bricks used which includes, warped, cracked and flared forms, all characteristic of 'seconds'.

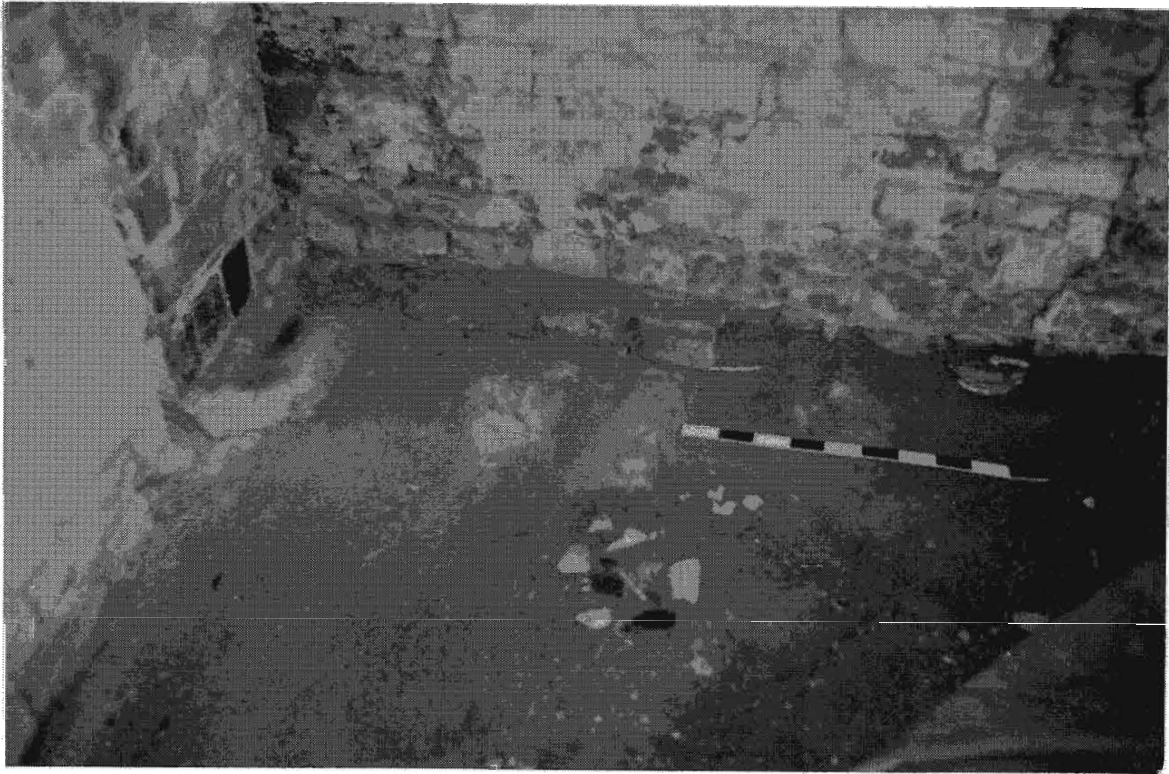
The front elevation, i.e. the north-east end gable wall of the outbuilding is built into the stone boundary wall of the Churchyard but inside the building the stone wall has been replaced by a brick wall which is set slightly further back. It is at this point that the brick wall forms the Churchyard wall. By substituting brick walls for the original stone wall of the Churchyard a small amount of additional space was obtained and this arrangement runs the length of Bays 1 and 2. Confirmation of this encroachment was obtained by removing the accumulated surface dirt and soil to reveal sections of the original stone wall's stone plinth, the outer part of which now form the base of the rear, brick wall. In addition it is noted that the north-east end of the brick partition wall between Bays 1 and 2 stops short of the present, north-east, boundary wall and a short section, approximately 38cms, (15 inches), of later brick fills this gap. The width of this later fill is identical with that of the exposed, footing section of stone wall visible in Bay 1. Stone also under-pins the section of transverse wall where it meets the rear wall of the outbuilding. This detail can be seen on both sides of the partition wall, (see Plates 7, 8). Three sherds of 'Mochaware' of a type similar to that produced at Church Gresley, Derbyshire during the 19th century as well as pancheon ware, transfer blue earthenware, buff bodied, domestic ware, broken clay pipe stems and some slivers of glass were recovered from voids within the stone base of the brick wall in Bay 1.

Plate 7 Detail of the base of the rear, brick, boundary wall in Bay 1 showing a base line of stone wall that appears to be all that is left of an earlier stone, boundary wall that has been taken down to provide a base for the present, brick wall and also giving additional space within the building. The base of a large, creamware bowl can be seen trapped in the footings of the stone wall directly above the right-hand end of the scale, other loose sherds of 'Mocha,' pancheon and transfer blue ware are laid out on the floor. The surviving stone footings can be seen underpinning the later, inserted brick work in the first part of the return angle in the top left of the photograph.

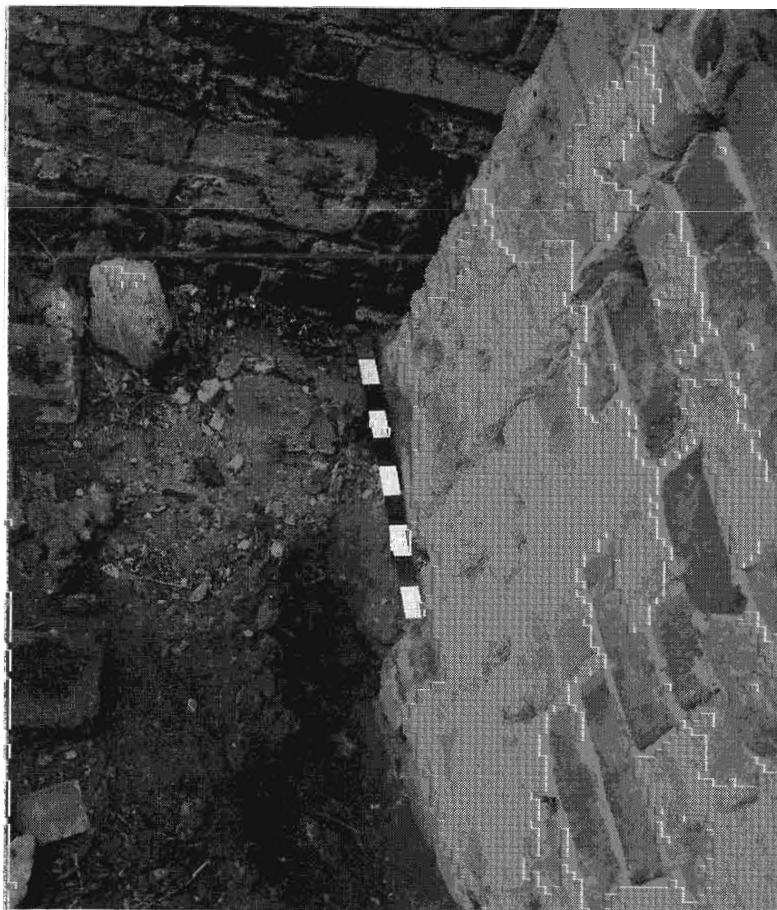
Plate 8 Detail of the same feature at the base of the transverse brick wall in Bay 2 also showing the stonework under the rear boundary wall and the narrow inserted section of brick indicating the width of the removed, stone walling of the original, rear boundary wall. [Scale = 50cms]

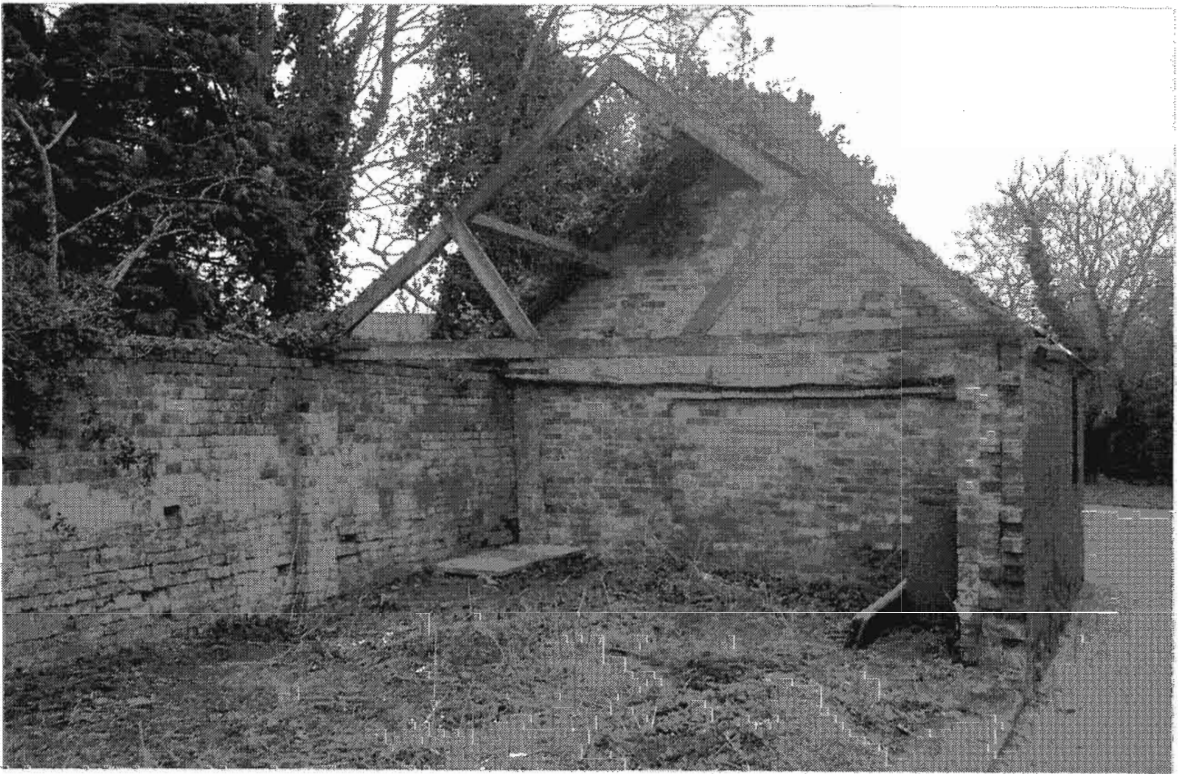
Plate 9 General view of the ruinous condition of Bay 2 of the Outbuilding, looking from the north-west and showing the single, surviving deal, truss and the rear, brick boundary wall with the Churchyard behind. Also shows a large, hardwood beam spanning the bay close to the transverse wall between Bays 1 and 2.

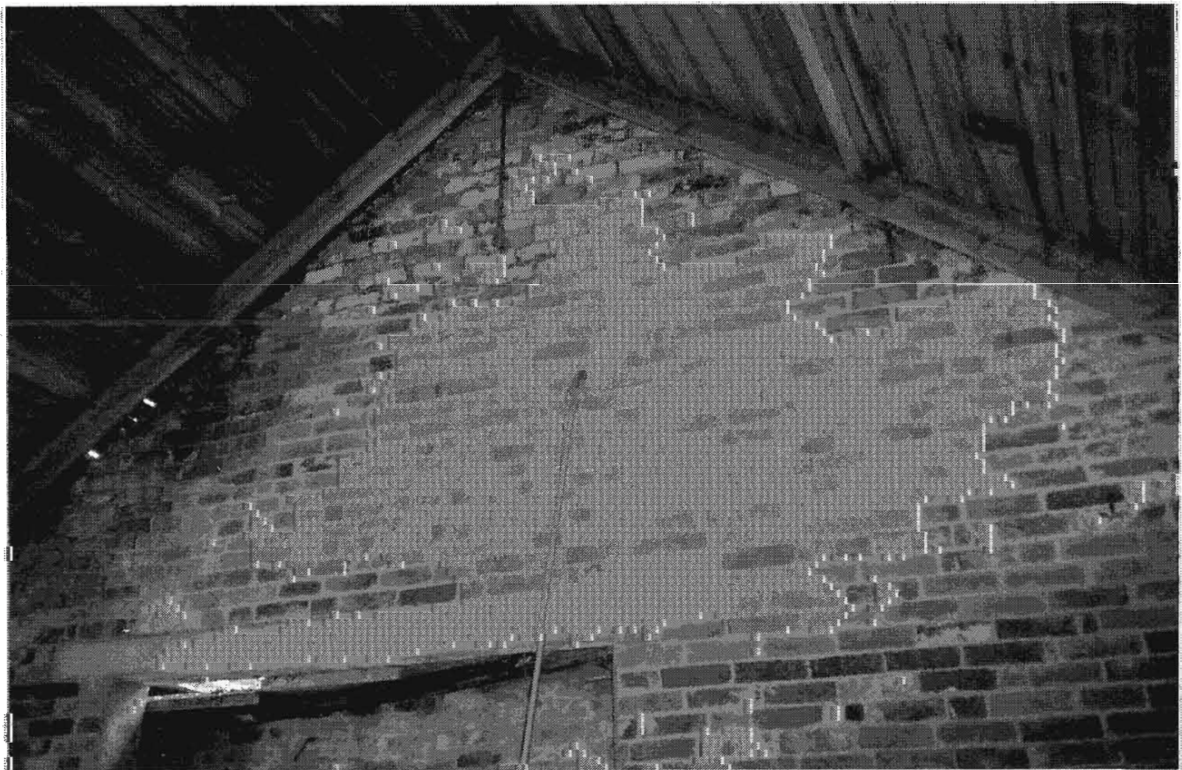
Bay 1, which is situated at the north-east end of the outbuilding range is covered with corrugated iron underneath which there is a lining of tongue and groove boarding, (see Plate 10).

Plate 10 Interior detail of Bay 1 showing the tongue and groove boarded underside of the corrugated iron roof. The brickwork is part of the transverse wall between Bays 1 and 2.
