**An Archaeological Impact Assessment of
47 and 49 Market Street,
Ashby-de-la-Zouch,
Leicestershire (NGR: SK 357 167)**

University of Leicester Archaeological Services

Report 2005-056

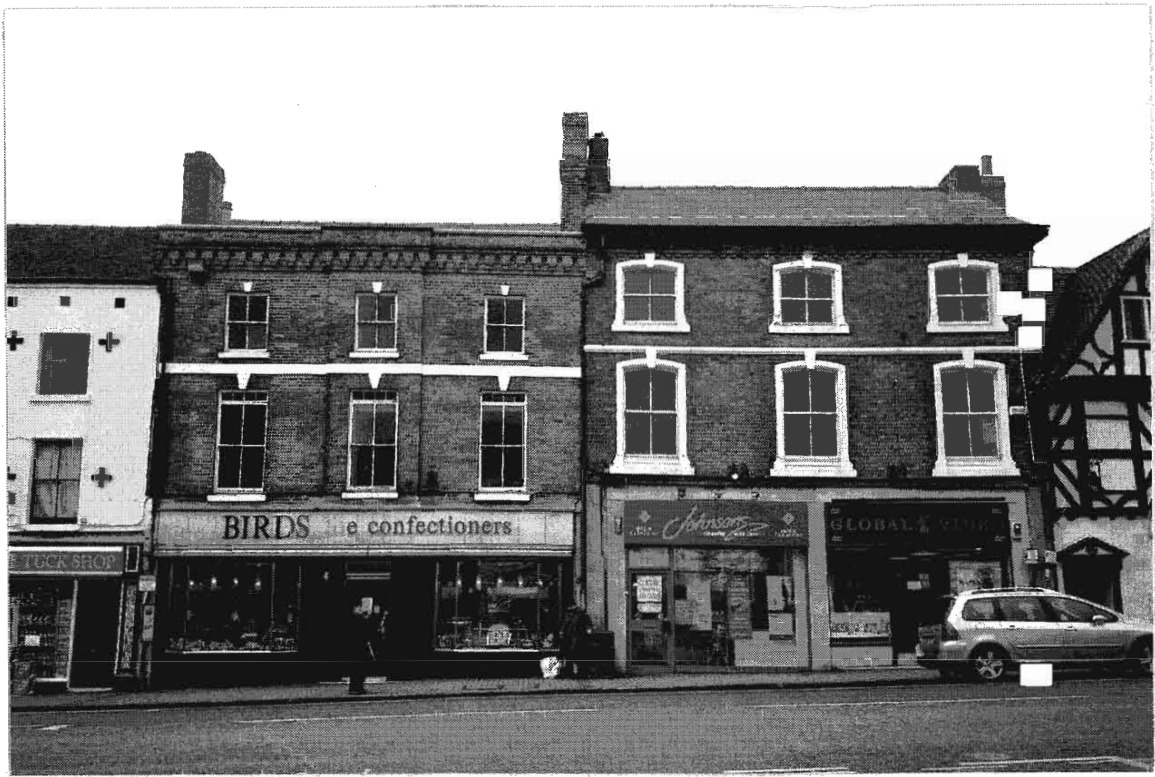
The three bay, brick frontage of No 47 has a slightly projecting centre section, (*see Plate 1*). A rendered plat band now painted white separates the first and second floors. Modern shop fascias mean it has not been possible to establish whether a similar feature exists between the ground and first floor.

Plate 1 Front elevations of 47 (left) and 49 (right) Market Street, Ashby-de-la-Zouch.

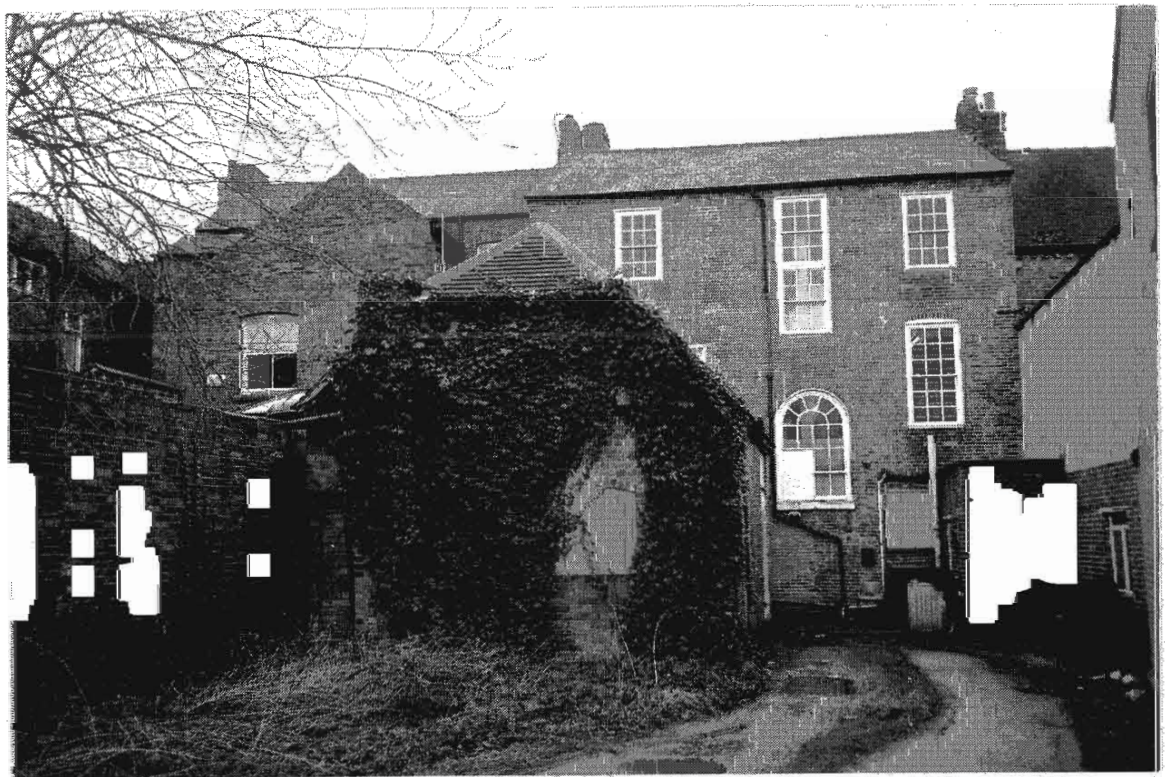
The rear of No.47 retains most of its 18th century brickwork, which is raised in Flemish Garden Wall Bond and some of the windows. The brickwork on the rear elevation contains a number of 'flared' bricks. Sample dimensions of the bricks (n=15) range between 180 < 225mm x 100<115mm x 50<58mm. Within the wall there are tell-tale areas suggesting access points have been altered. A small 20th century brick unit has been added along the property boundary with No. 45 Market Street, overall the rear elevation of the property retains a substantial part of its original features.

The main area affected is that directly below the semi-circular arched window lighting the internal staircase, (see *Plate 1*).

This proposal requires the removal of a section of existing brick wall at yard level and installing new doorways. The area of brickwork affected shows evidence of having been re-furbished and part of it has been disturbed by the installation of a large box mounted to the wall. The impact of these alterations is relatively slight, though it should be pointed out that the doorways shown on the Proposal drawings are completely out of sympathy with the period of the structure.

Plate 2 Rear elevation of 47 Market Street, showing earlier features including semi-circular headed window below which a new entrance is to be made for the first and second floor accommodation. The single storey, half-hip gable end in the foreground is the store area of No 47. The rear gable of No 49 Market Street is visible in the left, background..

Create new ground floor doorways at rear of property to form separate access to ground and first floor accommodation.

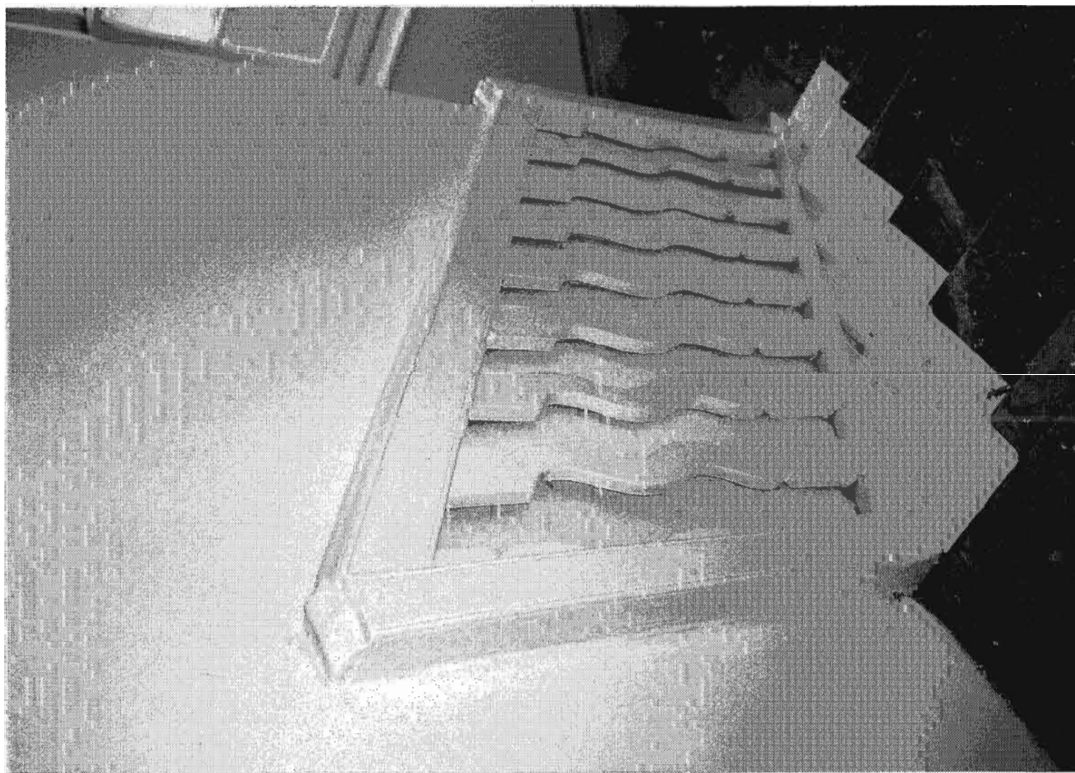
These proposed works eliminate an early 18th century feature of the house and represent significant loss of historic fabric within the surviving building.

Plate 3 47 Market Street, staircase detail showing wavy, splat balusters moulded handrail and square newels. Stairs from first to second floor.

Replace existing staircase from first to second floor

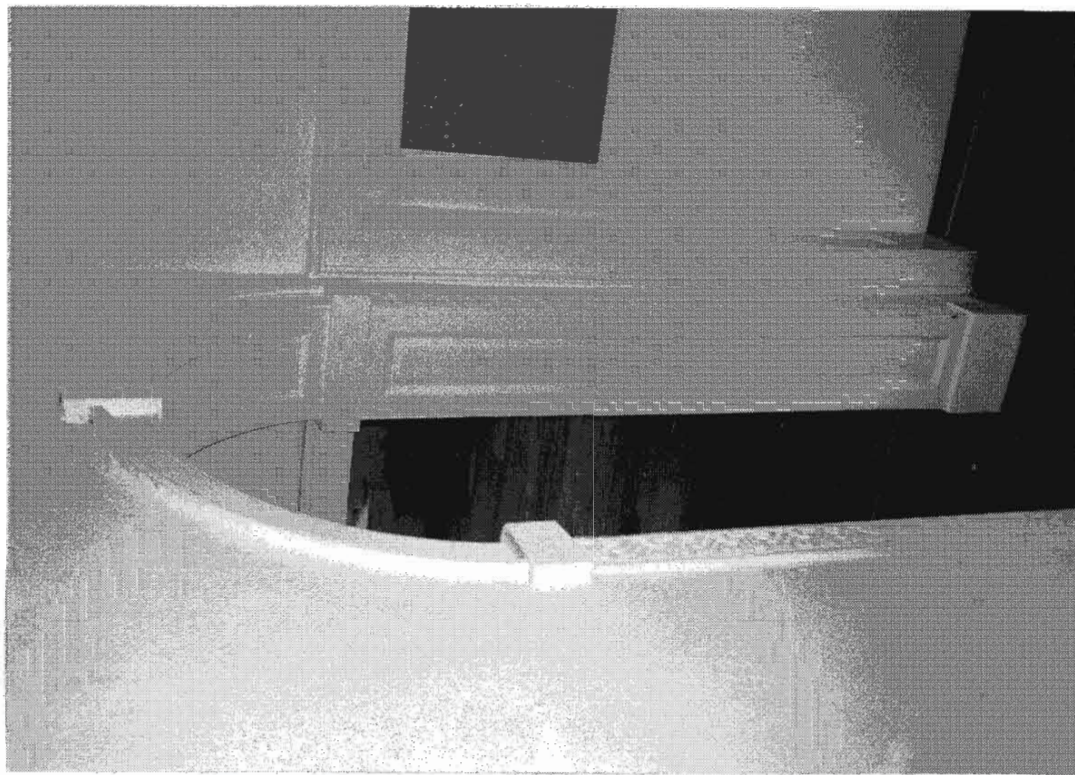
The landing at 1st floor level gives access to two front and two rear chambers. A semi-circular headed archway spans the landing area. The arch has imitation raised, plaster panel decoration on its inside face. The outer faces of the arch are decorated with a plaster relief, mid-18th century, Chinese fret pattern, a feature not previously recorded in Ashby, (*see Plates 4, 5*).

Removal of this unique, decorative feature would represent a major loss of historic detailing from the surviving decorative detailing of the first floor area of this property.

Plate 4 Landing arch with semi-circular head and Chinese fret Pattern, 47 Market Street.

Remove first floor, landing arch, (*see Plates 4, 5*).

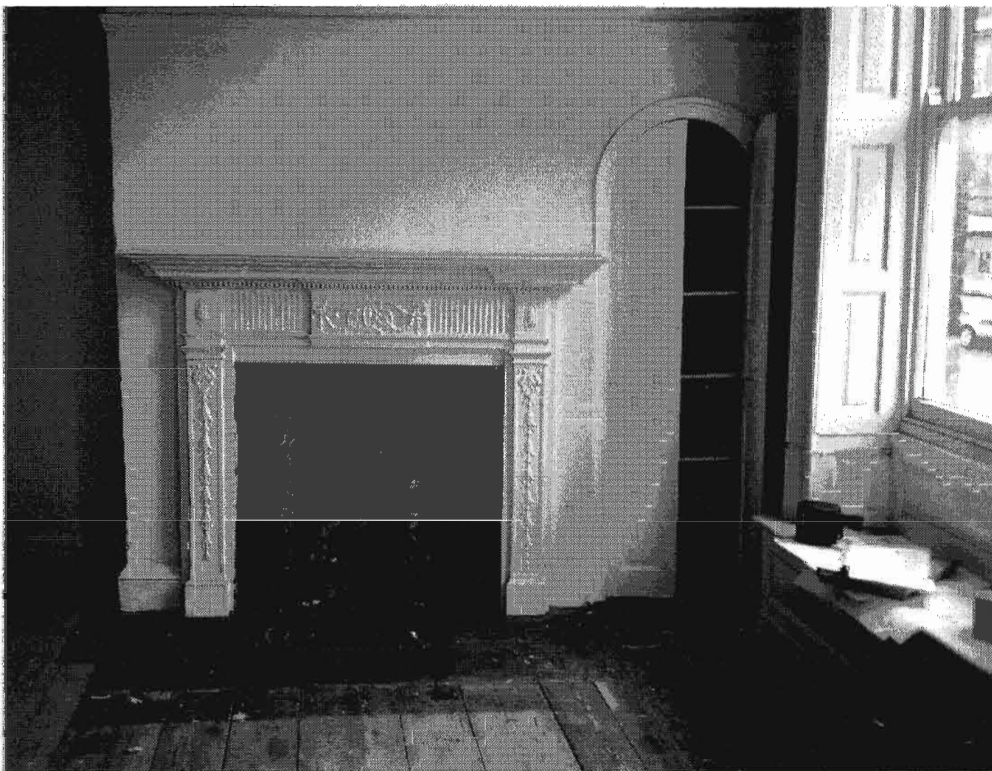
The two front chambers at 1st Floor have high ceilings and retain a number of refined features characteristic of 'living over the shop' accommodation of the 18th and 19th centuries. An elegant fireplace surround remains *in situ* in the room adjacent to No. 49, a semi-circular headed wall cupboard with two leaf door having three raised panels is situated to the right of this fireplace, (*see Plate 6*). The cupboard door panels are of identical form to those of the sets of window shutters which survive on this floor. All the windows have panelled seats set into them. In the room adjacent to 45 Market Street there is a plain wooden surround to the fireplace and the remnants of a cast-iron grate.

Plate 6 Fireplace, wall cupboard, window shutters and seat panelling. First floor 47 Market Street.

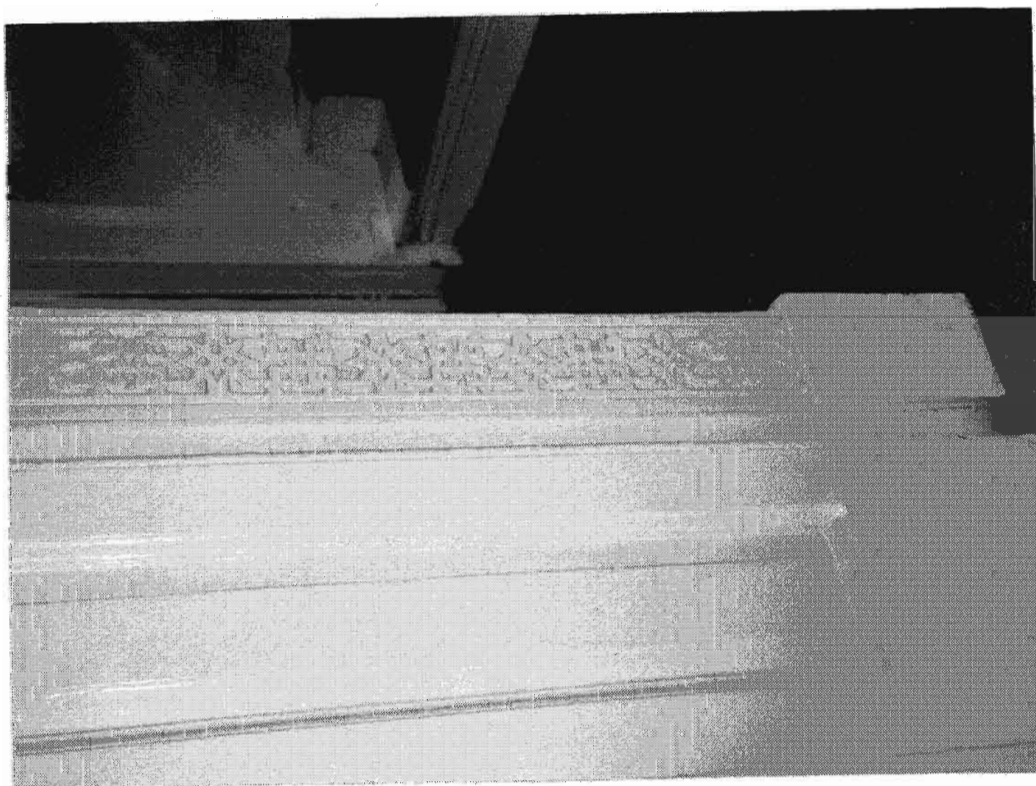
Plate 5 Detail of Chinese fret pattern on first floor landing archway 47 Market Street.

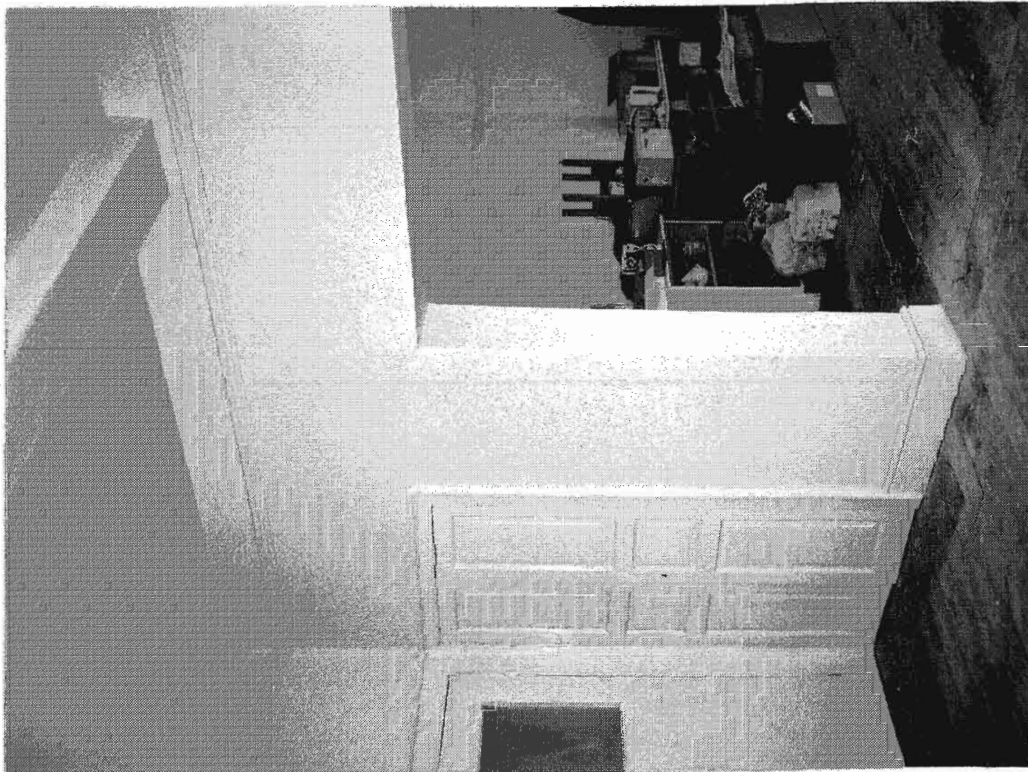
The first floor room overlooking Market Street has deal boarded floors and was originally two separate areas but at some time during the 20th century a large section of the partition wall was removed to create a through lounge. The original passing door, enabling internal movement to be made between the two rooms, has now been converted into a shallow China and glass cupboard (*see Plate 7*).

This re-instates part of the original 18th and 19th century, social and domestic arrangements of this floor.

Plate 7 Detail, first floor, front room area 47 Market Street, showing a section of partition wall removed to form a through lounge. The original, internal passing door between the two rooms, now a cupboard, is to the left of the opening

Re-instate the partition wall between the two first floor rooms on the Market Street elevation.

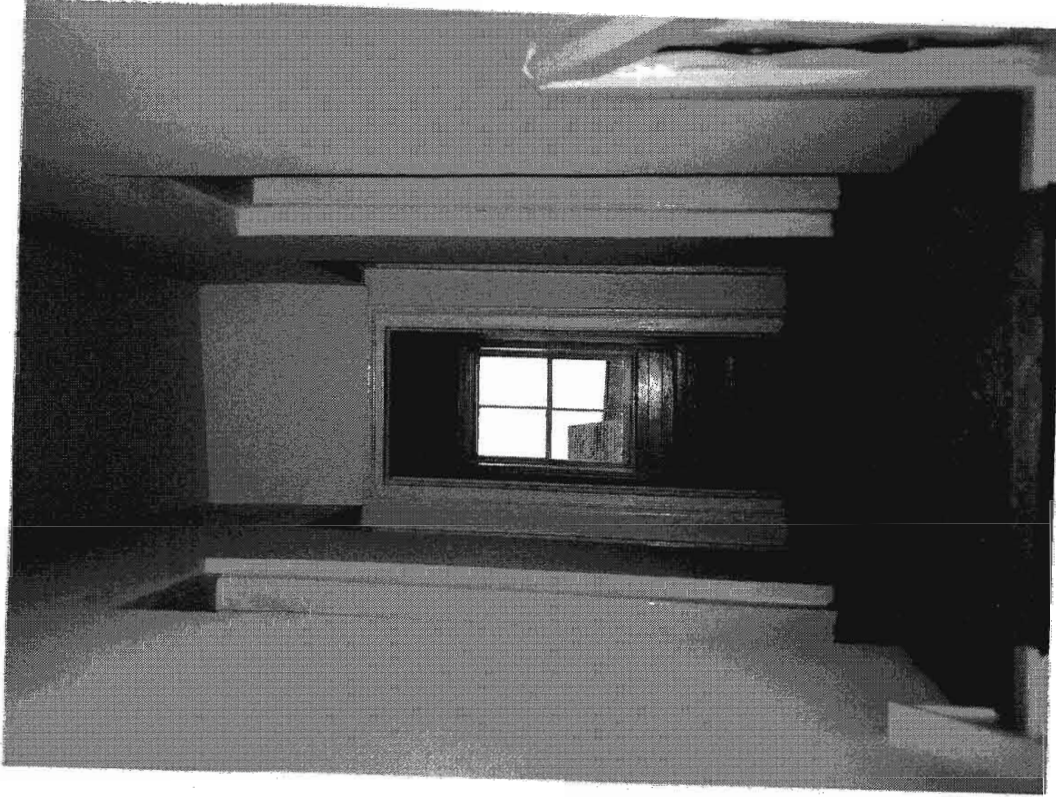
(1) The section of wall to be removed is that which retains a substantial deal beam that appears to be part of a bolted truss, within its fabric. This survey did not establish whether the beam retains a structural role in relation to the present roof or not. (2) The proposed works show the doorway into the existing Store to be sealed off flush with the wall. Consideration should be given to arranging this closure to enable a marker detail of the previous role of the area as a doorway to be made.

Plate 8 View of second floor landing area with store cupboard directly ahead. This door is to be replaced with a wall.

[Second Floor] (1) Remove the partition wall between the second floor chamber and the store area noted at the head of the stairs, (*see Plate 8*), and (2) close the existing doorway into the Store area.

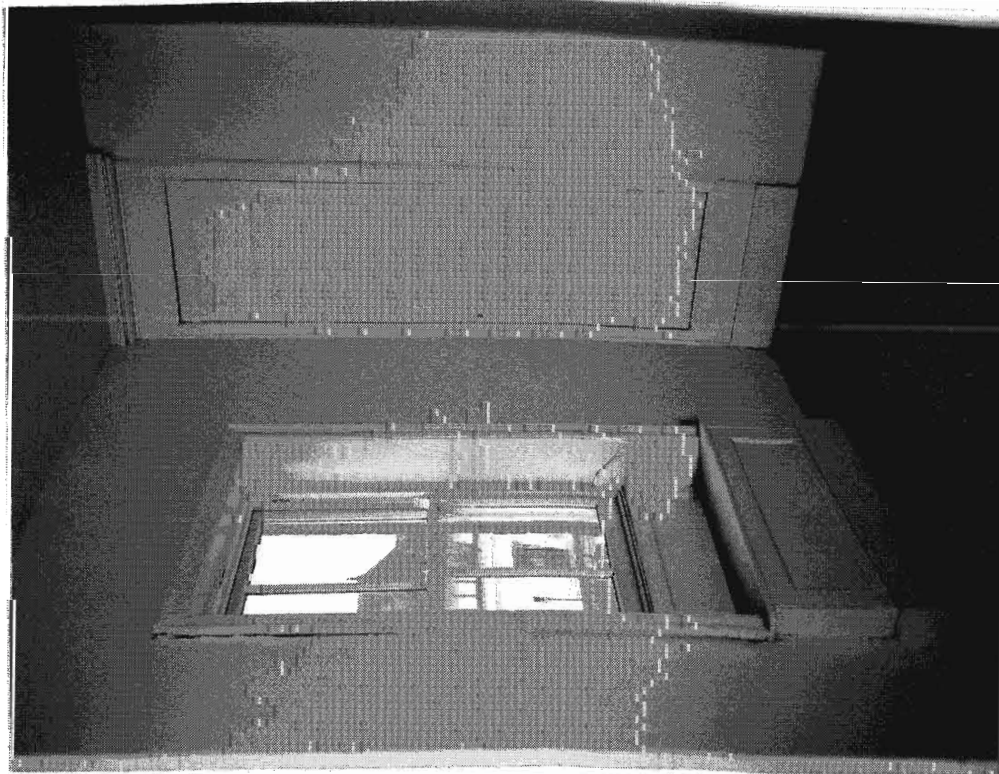
Neither of the front, upper chambers have retained their fireplaces. A wall-cupboard adjacent to the party wall with No.45 appears contemporary with that noted at 1st floor. Both chamber windows have panelling set beneath them as if for a window seat. An ogee shaped section of wood, probably in imitation of a settle arm, is planted alongside the inner face of the window. Which is panelled to form a window seat, (*see Plate 9*).

Plate 9 Second floor, 47 Market Street, showing wall cupboard and reduced window seat form at this level.

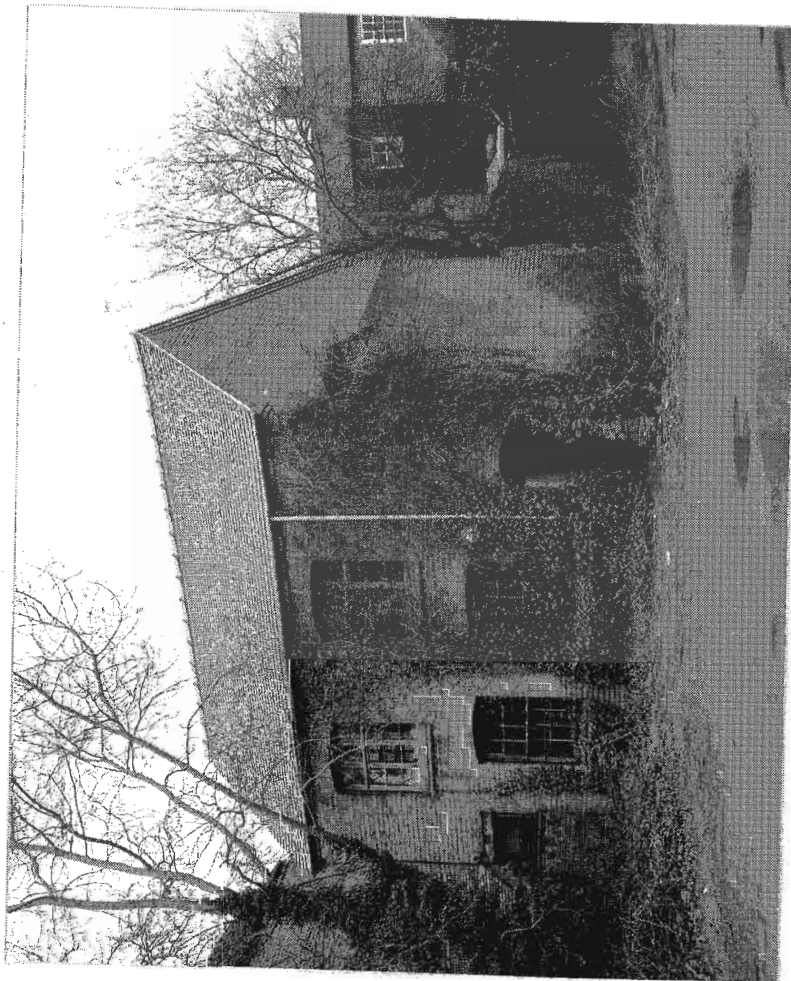
Partway down the plot there is a detached, two storey, double-depth, brick building, which has a clay tile roof on the front bay and a modern tile roof on the rear, (*see Plates 10, 11*), this building is described on the Plans as 'Warehouse.' The rear part of this building now spans the width of the plot with part of the first floor over-sailing a passageway at ground floor level, *Fig.3*, shows that in 1883 the rear section of the 'Warehouse' was of identical size to the front. The 1883 map also shows the 'Warehouse' with a glass roofed area adjacent to it on the south side. No evidence of this feature now survives. Behind the 'Warehouse' there was reverted evidence of what had once been an extensive garden area. Access could not be gained to this building. Like 47 Market Street, the north end of the burgage plot of No 49 had been severed and formed a series of separate buildings.

Plate 10 Rear view of the 'Warehouse' at the rear of 49 Market Street. This building has been extended to span the entire width of the plot, the passageway through the building is by means of the archway on the right.

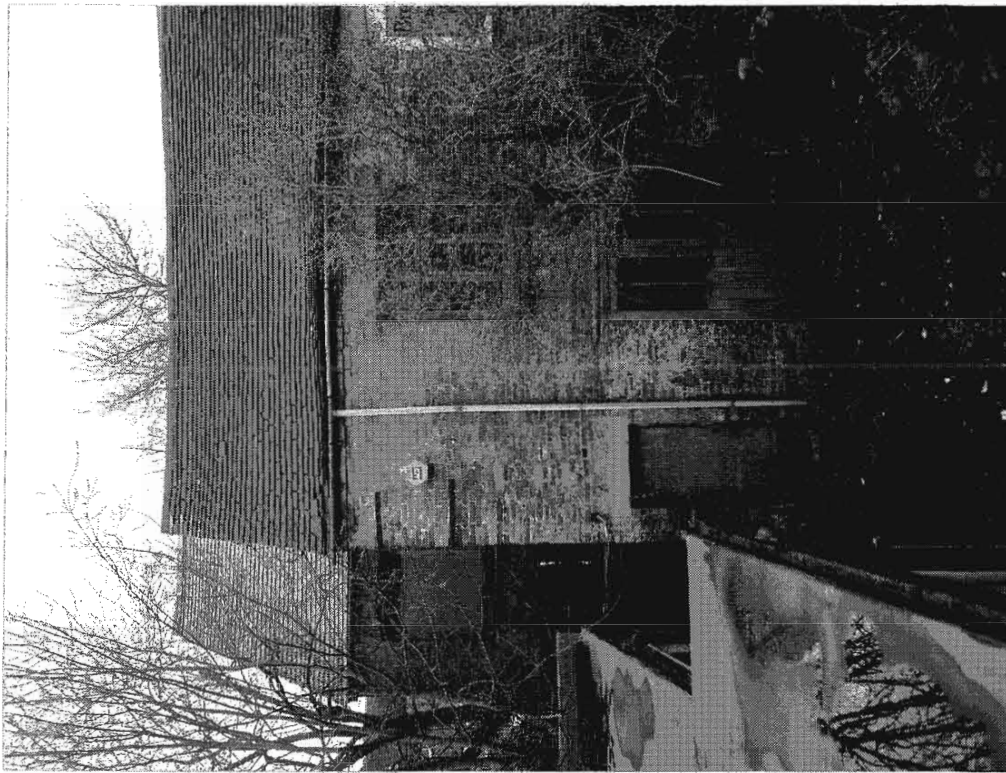
Plate 11 Front view of the 'Warehouse' behind 49 Market Street, with the later extension of the rear part of the building showing behind

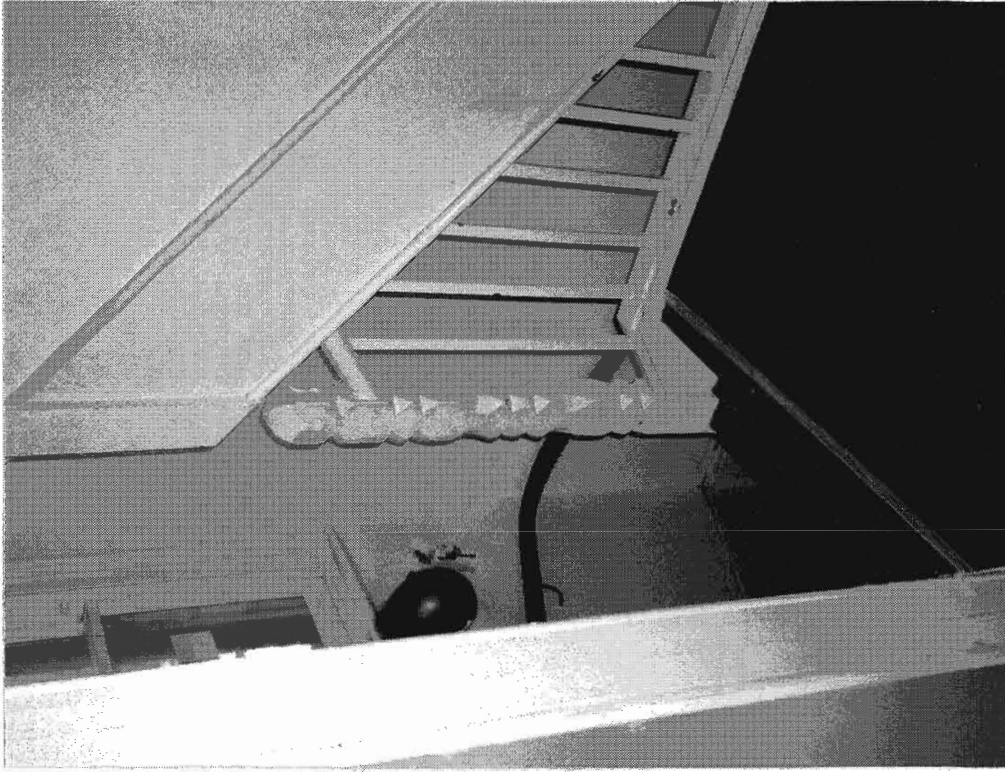
activities at first and second floor levels during the late 19th and first decade of the 20th century more radical alterations seem attributable to business uses at first floor level during the second half of the 20th century. The only major feature that has retained any dateable detail was the staircase. This consists of a series of scalloped and notched newels with faceted finials, stick balusters and a rounded handrail - detailing normally associated with carpentry of the second half of the 19th century, possibly 1885 \pm 10, (see *Plate 12*). The staircase surround and glazing bars of the staircase window situated between ground and first floor appears to be of a similar period.

It seems probable that any re-configuration will jeopardise the lower section of this staircase but in the absence of precise information no further comment can be made.

Plate 12 Staircase detail in 49 Market Street, showing the scalloped newel with faceted finial, stick baluster and round handrail.

Re-configure bottom of stairs – subject to statutory approval
