**A Historic Buildings Assessment  
of farm buildings at Crown Hills Farm,  
Station Road, Stoke Golding,  
Leicestershire (SP 3933 9725).**

**University of Leicester Archaeological Services  
Report 2006-003 ©2006**

1.1 A planning application (05/00874/FUL) has been made by Savage Hayward Architects for the residential redevelopment of farm buildings associated with Crown Hills Farm, Station Road, Stoke Golding, Leicestershire SP 3933 9725. This document comprises the results of a Historic Buildings Impact Assessment, which was requested by the Senior Planning Archaeologist at Leicestershire County Council, Heritage Services, in order to determine the importance of the farm buildings and to establish the impact that the proposed works might have on their historic fabric.

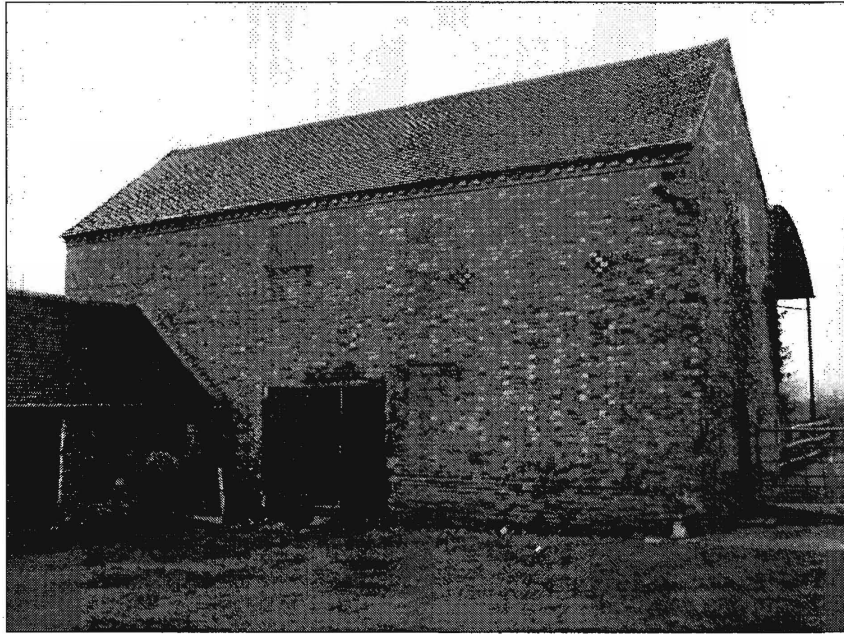
Barn 5 is a large, brick-built threshing barn, of three-bay length and reaching two storeys in height, although the internal structural arrangement is open to the rafters. The farmyard elevation is plain: a single entrance is located within the centre bay, at ground floor level, consisting of a segmental arch-headed opening which house a pair of modern, ledged and braced timber doors. At first floor level, a to the left of

the entrance is a single, segmental arch-headed window opening, presently blocked with timber planking. To the right of the entrance, at first floor level, are two vents, composed of nine 'breather' holes in diamond-pattern formation. There is dentillation to the eaves-course and the roof covering is of flat, clay tiles. Barn 6 (see below) adjoins the threshing barn at the left-hand bay, projecting southwards at right angles to the farmyard.

Plate 1. Barn 5, Courtyard elevation. Looking north.

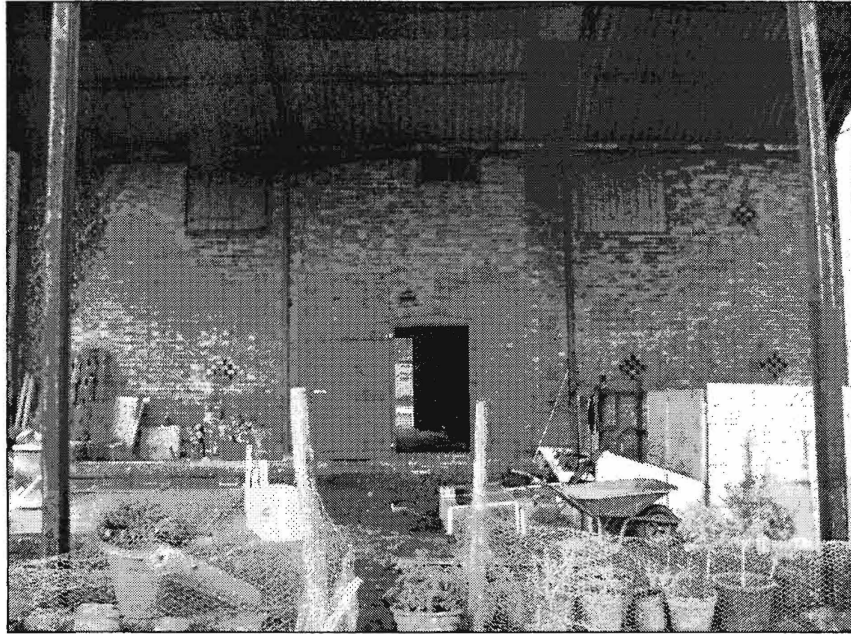
The north facing, rear elevation has a full-length 'dutch-barn' extension, with curved, corrugated iron roof covering, projecting out towards the north. The brick-built element has a ground floor entrance within the centre bay, to correspond with that on the front elevation. This also has a segmental arch-headed opening and houses a single, late, ledged and braced timber door. At first floor level, a segmental arch-headed window opening is located in each of the outer bays. The opening to the left has a timber shutter, with apparently early strap-hinges: the opening to the right is blocked with timber planking. Also at first floor level, above the entrance, is an off-centred timber-framed, glazed window opening, partially concealed by the dutch-barn extension. Three diamond-pattern vents, similarly styled to those on the front elevation, are located to the right of the entrance; a fourth is located on the left-hand side and a final, plainer vent is located above the entrance.

Plate 2. Barn 5, Rear elevation. Looking south.

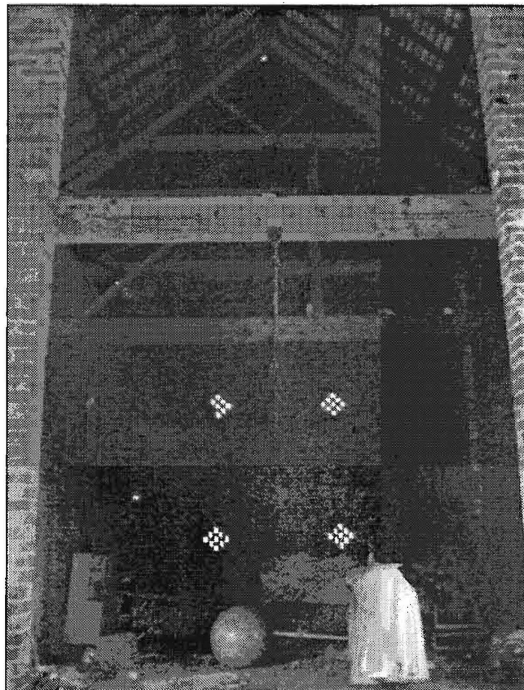
Plate 3. Barn 5, Truss 2. Looking west.

The internal arrangement comprises three bays, presumably originating as a central threshing bay, flanked on either side by bays for storage, which are defined by two principal roof trusses. Truss 1, on the eastern side, has a central king bolt, flanked by a pair of V-struts which rise from the tie-beam to meet the underside of the

principals. Truss 2 is more complicated: here the tie-beam is lowered, to incorporate framing for a doorway – evidence for a removed floor at tie-beam level, possibly for used for storage of hay or grain. A central king bolt rises from the collar which, in turn forms the head of the door and supports a pair of V-struts which rise to meet the underside of the principals, at the point where the upper purlins rest.

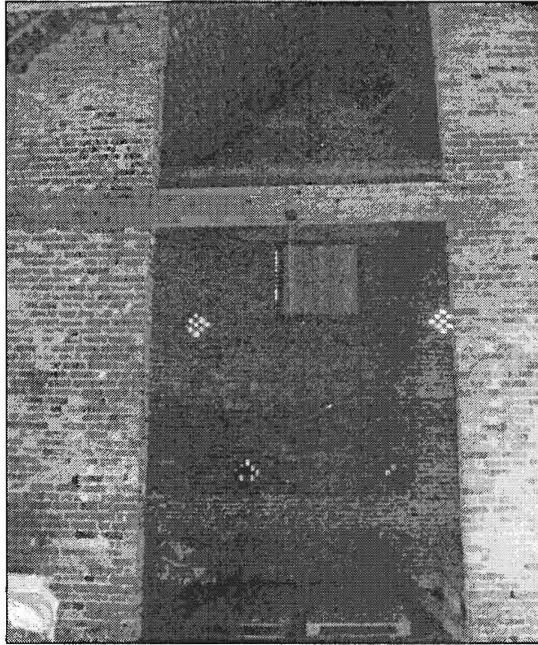
Plate 4. Barn 5, Truss 1, looking east.

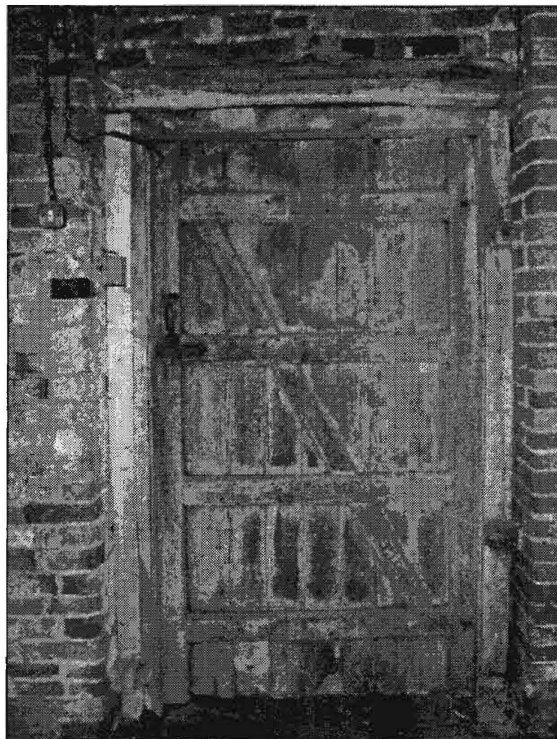
Plate 5. Communicating door between Barns 5 and 6. Looking south.

Set into the southern wall, within the western bay is a doorway through to Barn 6. This is an early opening, with timber door head and rounded bricks to the jambs.

Within the opening is an early ledged and braced timber door, which has early wrought-iron strap hinges, handle and latch.

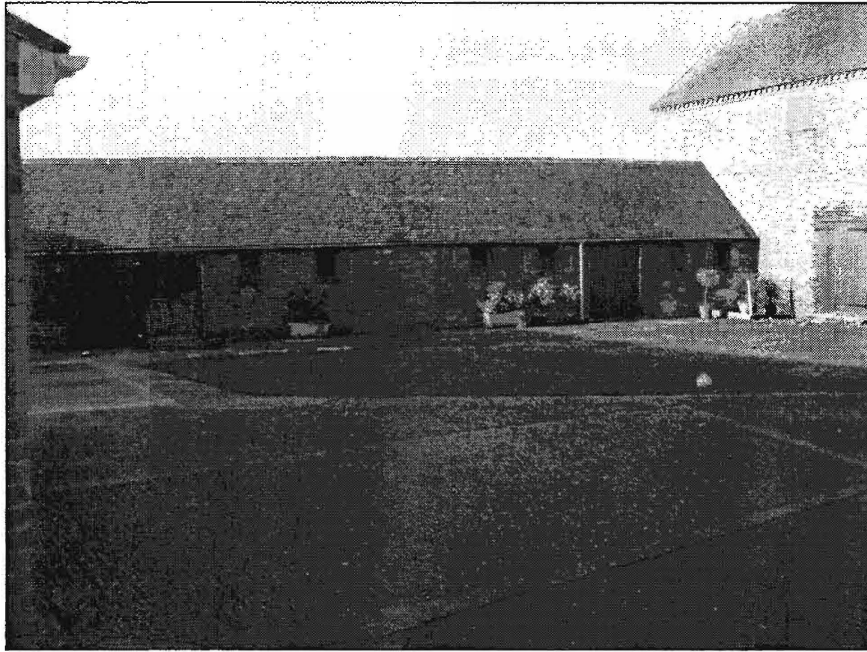
Plate 6. Barn 6, looking west.

Barn 6 is a single storey cow-house of red-brick construction, consisting of eight-bays, which are separated internally by seven king-post roof trusses. The farmyard elevation presently has two door openings, one at either end of the range, each with a recent timber plank and batten door: in the centre of the range is evidence for a third doorway, now blocked with brick.

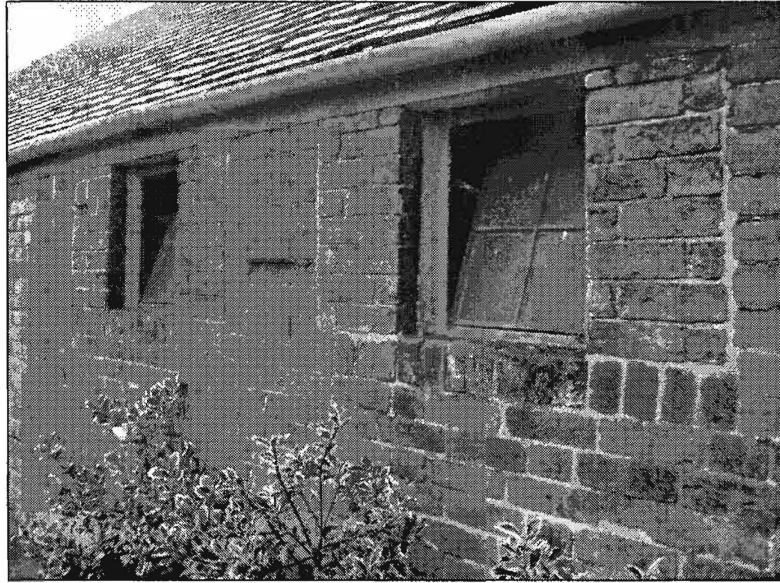
There are eight, square window openings, two on either side of each original doorway. There is brickwork blocking on either side of each window, and the indication is that each opening was made narrower, possibly around the turn of the 20th century, in order to provide increased support for the roof structure. The present openings house 4-pane, iron-frame windows, of apparent turn of the 20th century date also.

Plate 7. Partially blocked window openings, Barn 6. Looking southwest.

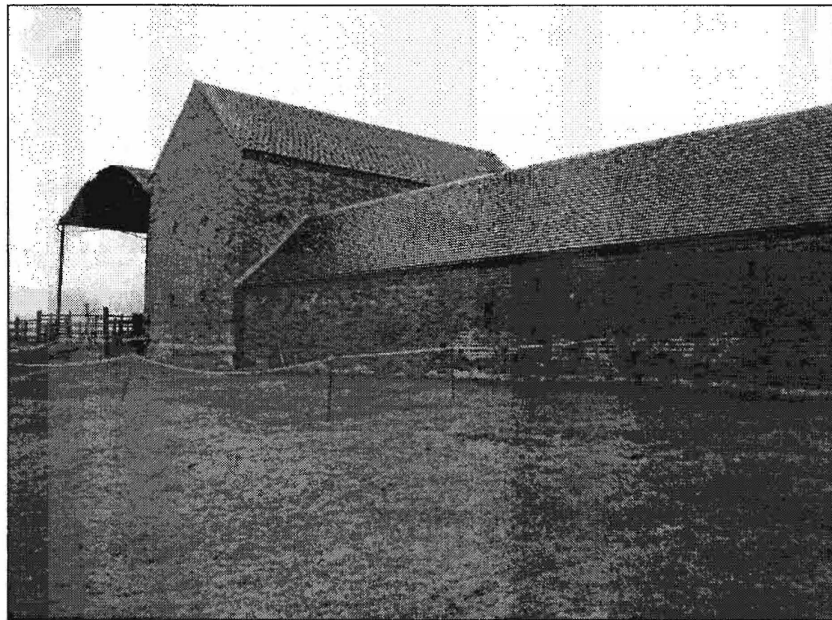
Plate 8. Barn 6, rear elevation. Looking north-east.

The west-facing, rear elevation is plain, with no openings present. At the southern end of the range there is evidence for the removal of a structure which would once have projected out from the wall towards the west- the present owner confirmed this to be the case and stated that the demolished building had been a pigsty. Evidence for a second structure, in the form of supports for timber joists and changes in the brickwork, is located further to the north. Map evidence (see 5.3, above) indicates that this was a long barn, aligned with Barn 6 and built between 1903 and 1929, demolished by 1963.

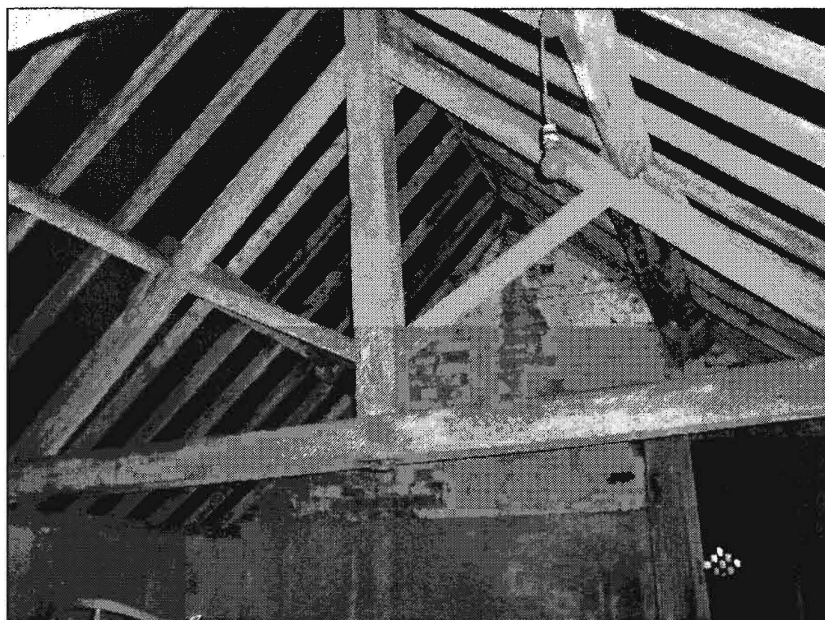
Inside the barn, on the eastern side, a single, longitudinal feeding passage runs along the full length of the building, with the western side divided into a number of stalls, separated by concrete partitions. Vertical iron bars, for the tethering of cattle, are fixed to the partitions and concrete mangers are located in between. Seven suspended king-post roof trusses divide the barn into eight bays - each truss is identical and of conventional form, comprising a central king-post bolted to the tie-beam, with a pair of raking braces which rise to meet the underside of the principals. The principals are bolted to the tie-beam and rise to meet the king-post, supporting a single order of purlins which are carried on cleats. Rafters are carried on the backs of the purlins and are replacement timbers.

Plate 9. Barn 6 roof truss. Looking north.

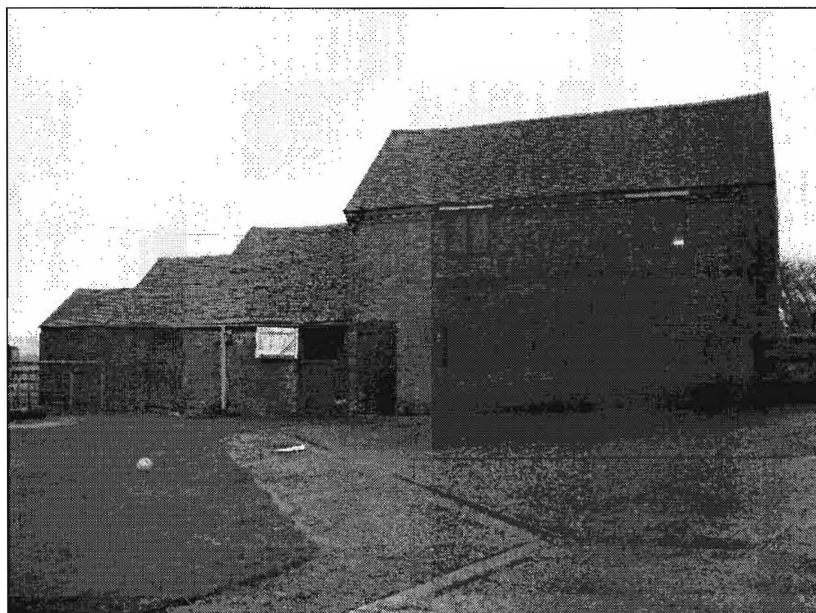
Barns 1-4 form a single range, aligned north/south and located along the eastern boundary of the farmyard. Each building diminishes in height from south to north, in accordance with the natural downward slope of the land in that direction. Barns 3 and 4, located to the northern end of the range are constructed of darker brick than Barns 1 and 2, which may indicate that the range was constructed during two phases- precise dating for their construction, however, is not known.

Plate 10. Barns 1-4 (from right to left). Looking east.

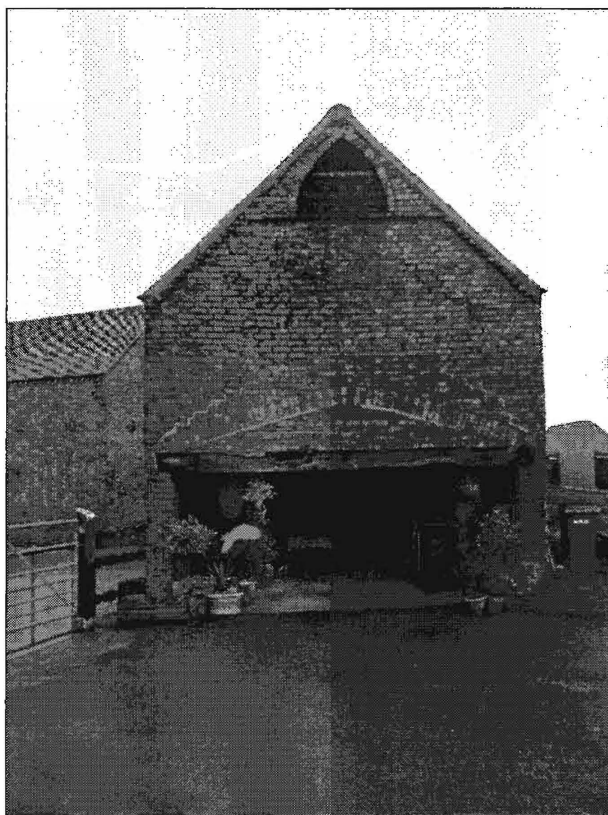
Plate 11 . Barn 1. Looking north.

Barn 1 is located at the southern end of the range and is of two storeys, with ground floor cart-shed and granary above. The cart-entrance is located at the south-facing gable end; above this are entrance holes for a pigeon-loft, which is located within the roof space (Plate 11). The farmyard elevation is plain: a single, segmental arch-headed doorway is located at ground floor level, at the northern end of the building,

which opens onto a flight of brick steps that lead up to the first floor granary. Two glazed window openings, with modern casements are located at first floor level; these interrupt a dentillated eaves course that is carried around the building to each elevation. The rear, east facing elevation has a single window opening, located at first floor level, towards the southern end of the building. The roof covering is of flat, clay tile.

The south-facing cart-entrance consists of a wide opening, with timber lintel and is topped by a relieving arch in rough brickwork. Inside the cart-house, the floor structure for the upper storey is visible and consists of a series of transverse beams which support the floor joists. The reed bedding for lime-ash flooring material can be seen between the joists. Evidence for a centrally-located supporting timber post, now removed, can be seen at the position of the first transverse beam.

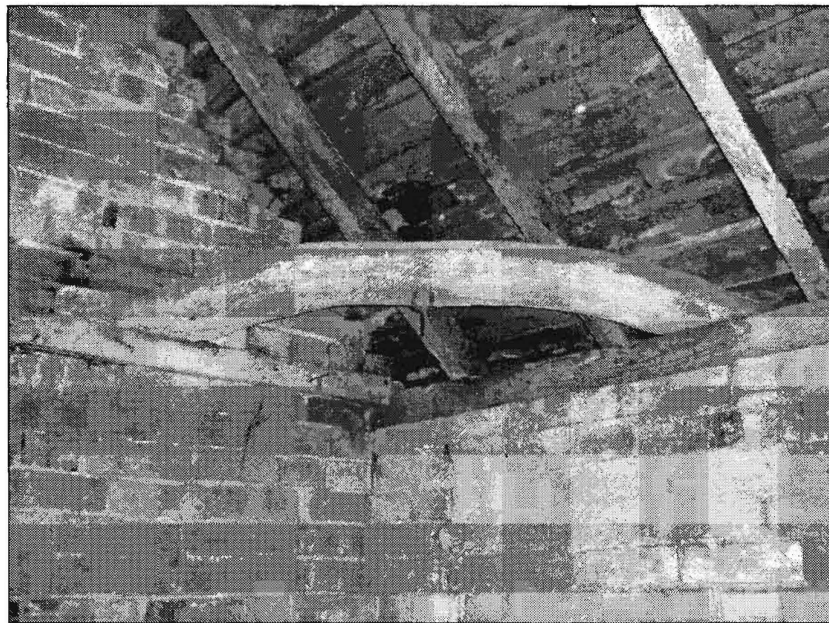
Brick steps located at the northern end of the building lead up to the first floor level. The first floor is composed of three bays, defined by two roof trusses. At the top of the stairs, a length of re-used timber has been bolted to the wall-plates of the northern gable-end wall and the east-facing side wall, to form a hoist that would have been used to assist in raising heavy items up the steps to the first floor level (Plate 12).

Plate 12. Barn 1 winch. Looking northeast.

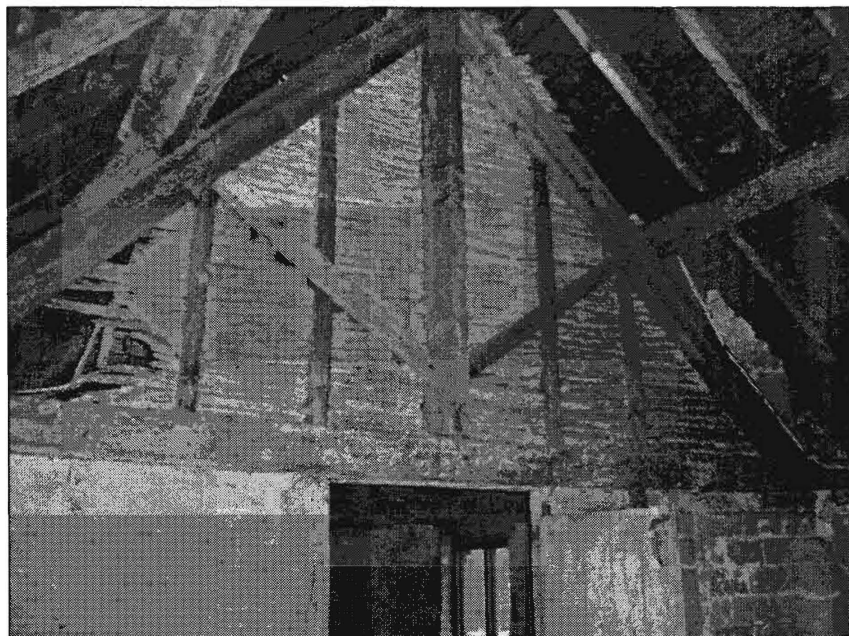
Truss 1, located at the northern end is of conventional king-post form similar to that observed within Barn 6 (above), with a pair of raking braces, rising from king-post to meet the underside of the principals. A series of vertical staves are positioned between the collar and principals, which provide a support for lath and plaster infill. The truss is infilled below the collar beam, to form two enclosed spaces; a centrally located doorway opening, with early plank and batten door, provides access between them.

Plate 13. Barn 1, Truss 1. Looking south.

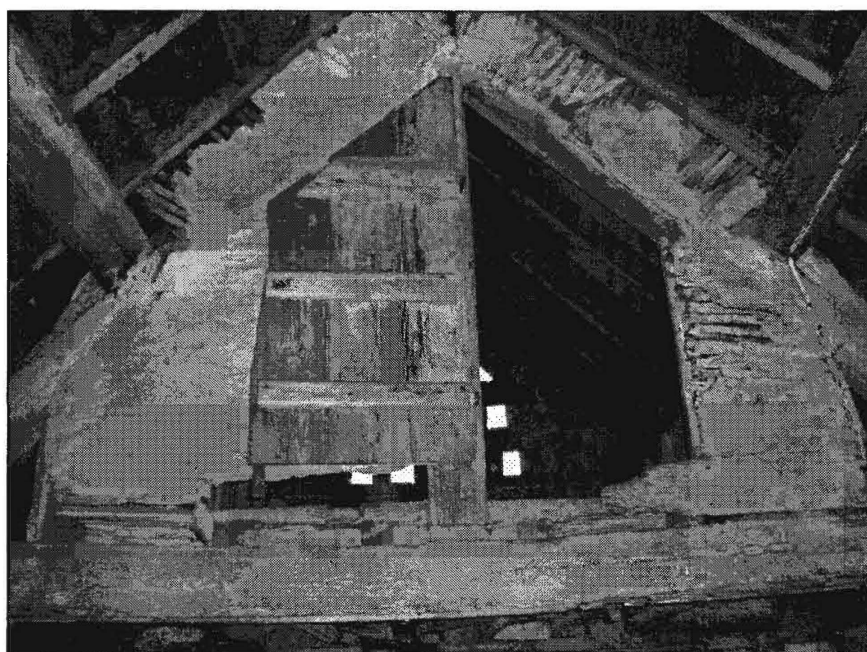
Truss 2 is also of king-post form and is blocked with panels of lath and plaster infill to form the north wall of a pigeon loft, housed entirely within the roof structure. The collar beam here provides support for a number of floor joists which are set into the southern gable-end wall. The king-post forms one side of a small opening into the nesting area, which houses a plank and batten door; access for birds is provided by means of a number of holes in the southern gable-end wall of the building. The loft is fully enclosed on the eastern and western sides by means of lath and plaster partitions.

Plate 14. Barn 1 Truss 2 and Pigeon loft, looking south.

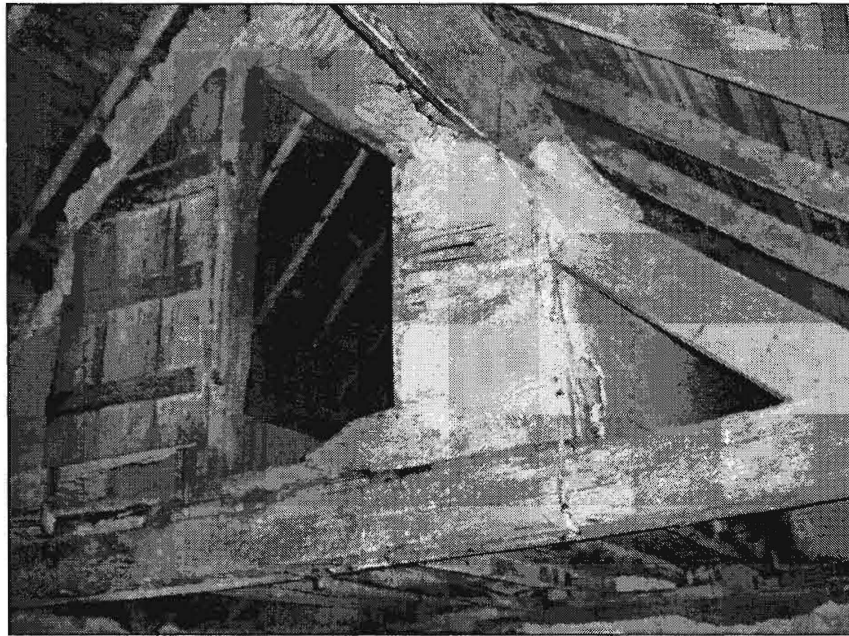
Plate 15. Barn 1 Pigeon loft, looking southeast.

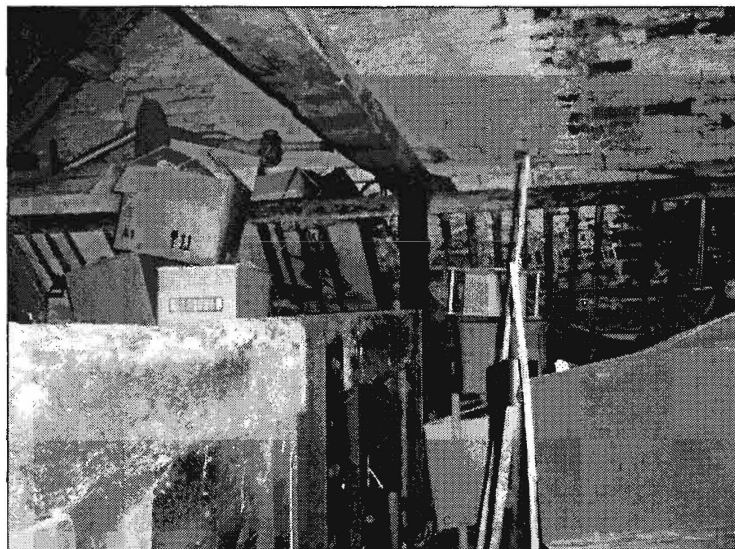
Barn 2 is a single storey stable block, extending from the northern gable end of Barn 1 and is of similar style, with dentillated eaves course to the farmyard elevation and to the north-facing gable end. The farmyard elevation has a single door opening, which houses a timber, plank and batten stable door; a single, glazed window opening is located on the rear, east facing elevation. The eaves course to the rear elevation is plain. Internally, there is a north/south timber partition to form separate stalls for two horses, with a timber hayrack located along the northern wall.

Plate 16. Barn 2. Looking north.

Along the southern wall are two segmental arch-arch headed openings onto storage space beneath the Barn 1 staircase. These are presently blocked with timber planks.

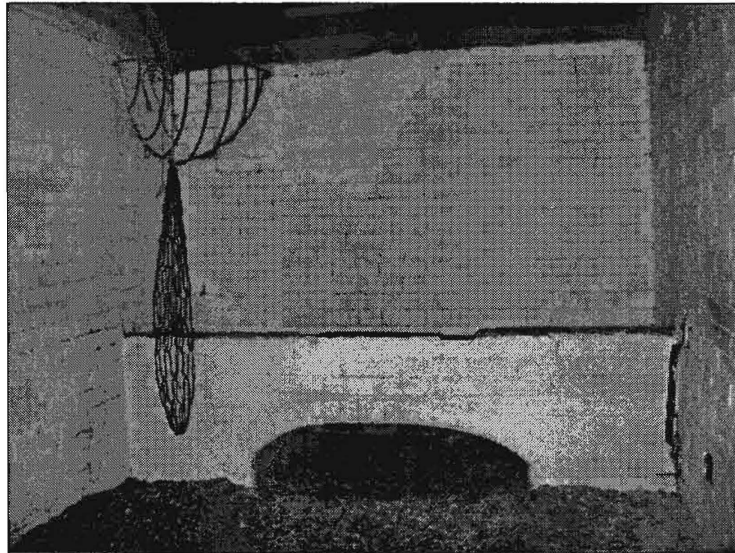
Barn 3 is a single storey loose box, extending from the northern gable-end wall of Barn 2. A single doorway on the west-facing, farmyard elevation houses a modern timber, plank and batten stable door. There is dentillated brickwork to the north facing gable-end, to follow the line of the roof. Inside, the brickwork is painted white and there is an early brick-built manger along the eastern wall, with segmental arch-headed alcove providing storage beneath. A cast iron hay-rack is fixed to the north-eastern corner.

Plate17. Barn 3, looking east.

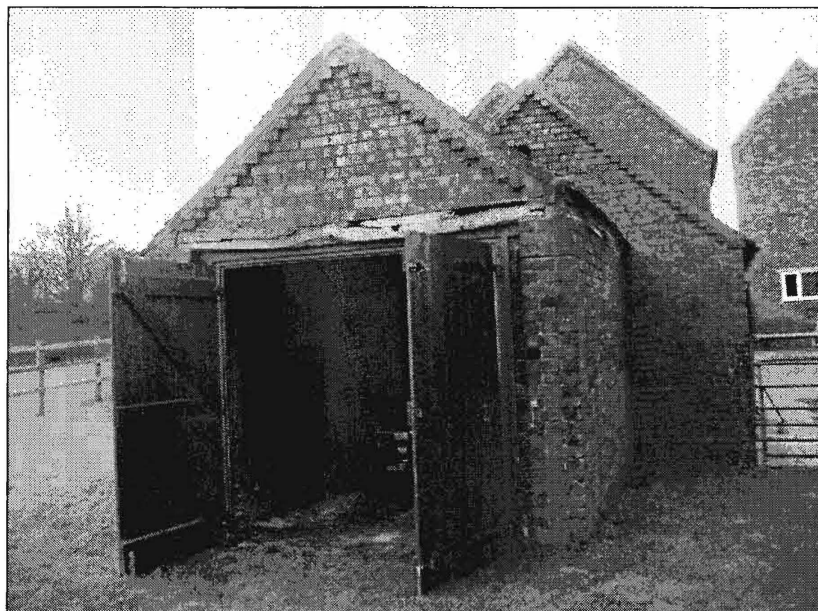
Plate 18. Barn 4, looking south.

Barn 4 is located at the northern end of the range of buildings, extending from the northern gable-end wall of Barn 3. This consists of a single storey cart shed, with cart entrance located at the northern gable-end wall. The cart entrance has an early timber lintel and houses a pair of modern, ledged and braced timber doors. Above the lintel are three horizontal bands of blue brick, which span the gable to meet decorative, dentillated brickwork, also of blue brick, which follows the line of the roof.
