**The Old House, 16 Station Road,
Littlethorpe, Leicestershire:
Historic Building Impact Assessment**

ULAS Report Number 2008-034

University of Leicester Archaeological Services has been commissioned by DCI Architecture Ltd on behalf of J & N Builders Ltd to produce an Historic Building Impact Assessment for the Old House, 16 Station Road, Littlethorpe, Leicestershire (NGR: SP 541 970). The Impact Assessment has been requested by the Blaby District Conservation Officer, in respect of proposals to update the accommodation that will involve alterations and repairs to the building requiring planning and listed building consent. Assessment follows the guidelines set out in the English Heritage document *Informed Conservation: Understanding historic buildings and their landscapes for conservation* (Clark 2001).

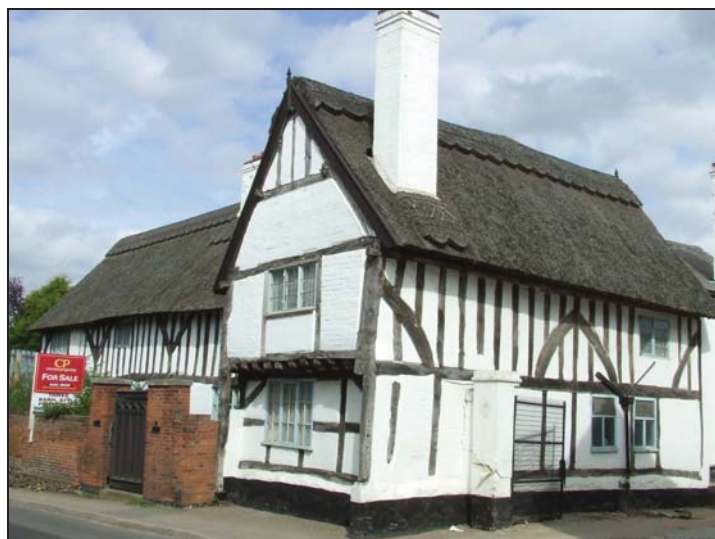
Photo 1. The Old House 16 Station Road, Littlethorpe. 15th century cross-wing **A** in foreground with 16th century range **B** to left.

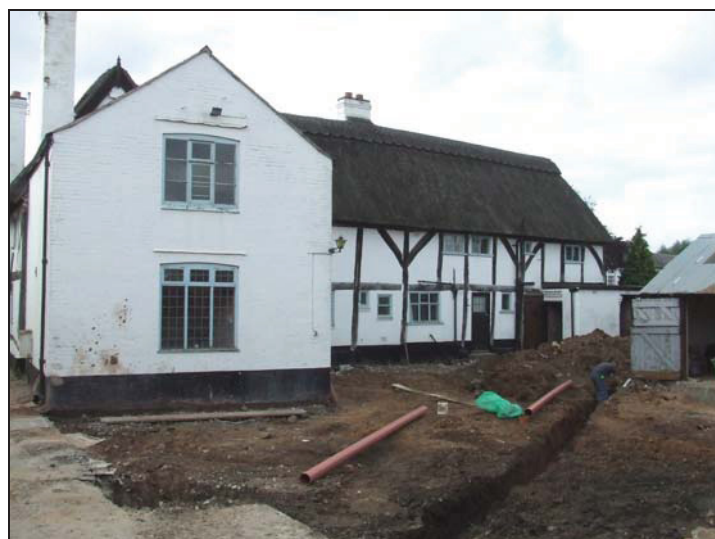
Photo 2. Rear of the building with brick-built range **C** on left, timber-framed range **B** with rectangular panelling and attached to this on the right the single-storey brick-built outhouse **D**.

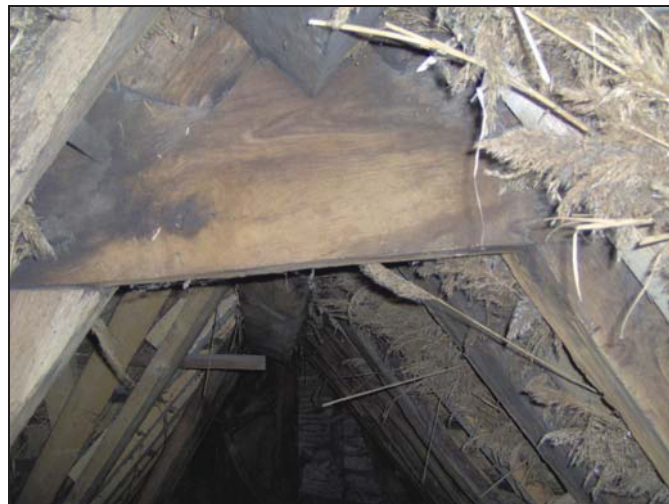
Photo 4. South cross-wing (range A), central roof truss: apex detail.

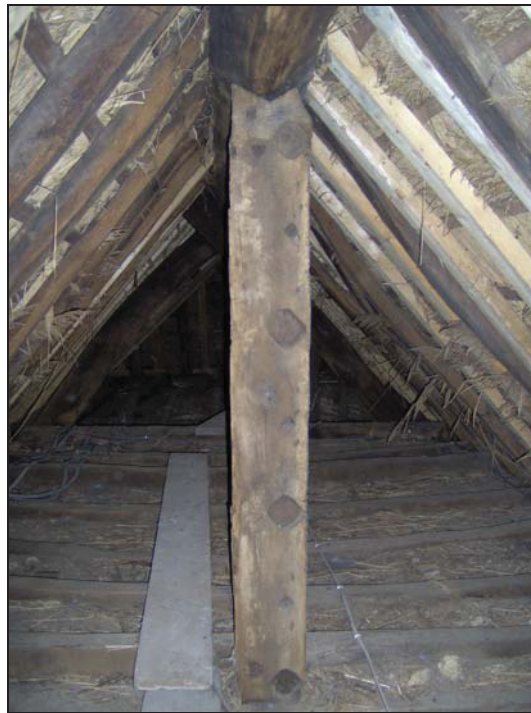
Photo 5. Hall range **B**, timber from mullioned window reused in roof space.

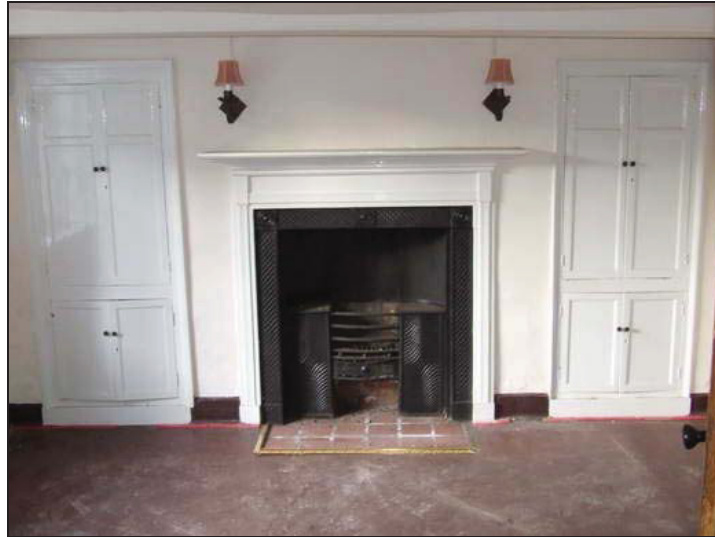
Photo 6. Fireplace and fitted cupboards in room G6.

- The south wall of the dining room, initially earmarked for removal, will be retained. Fireplace, fitted cupboards and high-level shelving in this room should all be retained (Photo 6). Query proposals for heating.

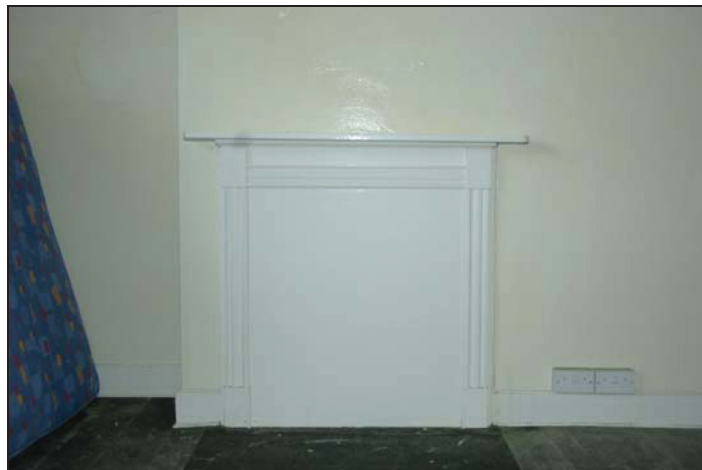
Photo 7. Early 19th century fire surround in room F4 (range C).

- The creation of a dressing room and en suite will alter the proportions of room F4 but the fabric impact is unlikely to be significant. There does not appear to be any provision of natural light to the dressing room or en suite, unless roof lights are proposed. Plumbing to the en suite should be arranged to minimise impact on the built fabric. Retention of the existing fire surround and skirting is advised (Photo 7).

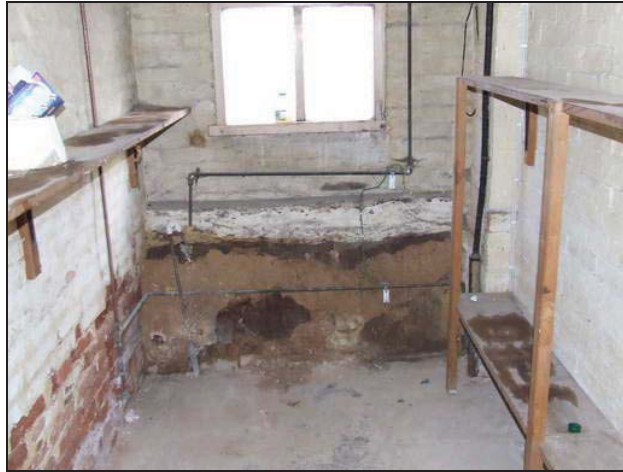
Photo 8. G2 proposed cloakroom.

- Formation of new wall and door in G2 creating cloakroom: no significant impact.
- Provision of plumbing to the cloakroom and utility should be sensitive to early built fabric; waste in particular will presumably be routed through the stone plinth of the south wall of the 15th century range (Photo 8), this should be designed to minimise the impact.
- Note that the plank and batten door to G3 is early and should ideally be retained *in situ* or reused elsewhere (Photo 9).

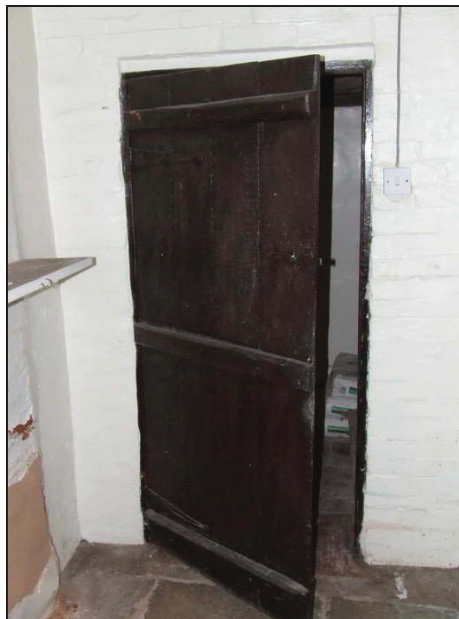
Photo 9. G3 plank and batten door.

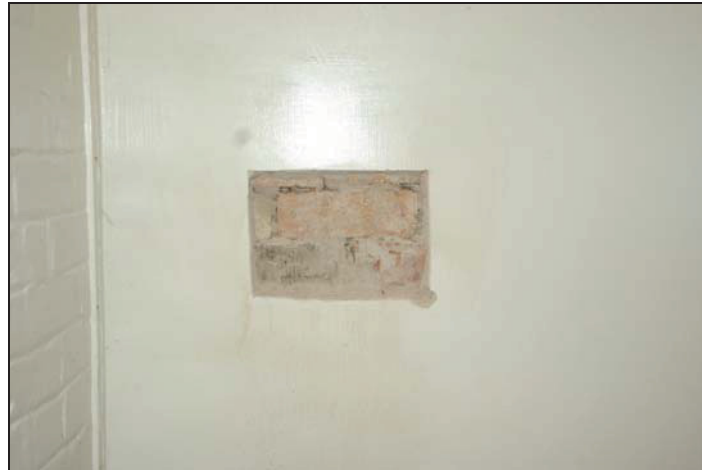
Photo 10. Wall between G7 and G8 proposed for removal.

- In order to provide a ground floor link between the two halves of the building it is proposed to remove the existing washroom facilities and form an opening in the wall between G7 and G8. The nature of the wall fabric at this point was uncertain and an opening was made to assess its significance in order to clarify the potential impact (Photo 10). The wall is composed of 20th century brickwork bonded with cement mortar and coated in gypsum plaster. Creation of an opening at this point will not affect any early built fabric and will have the beneficial impact of reuniting the two halves of the building.
- The 19th century 4-panel door into G7 and its surround (Photo 11) are of some quality and match other doors in this part of the house; consideration should be given to retention *in situ* or reuse elsewhere within the building (eg as the proposed new doorway in G5, see above).

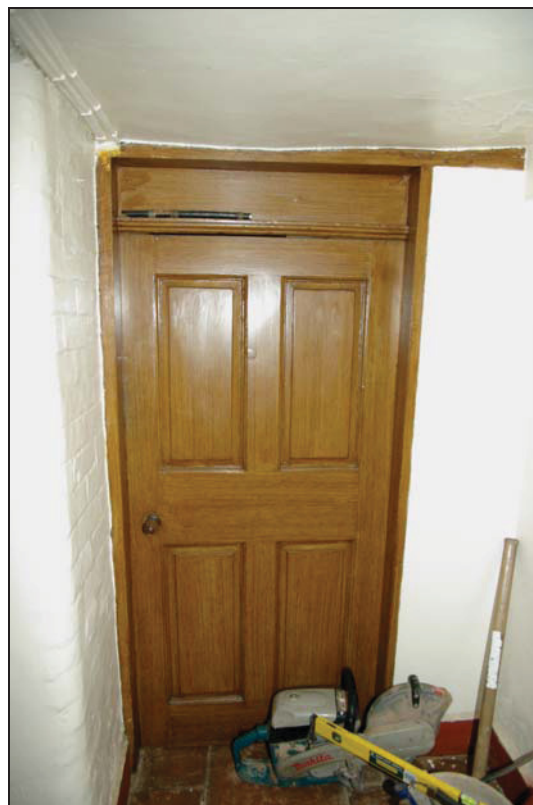
Photo 11. 19th century door & surround to G7.

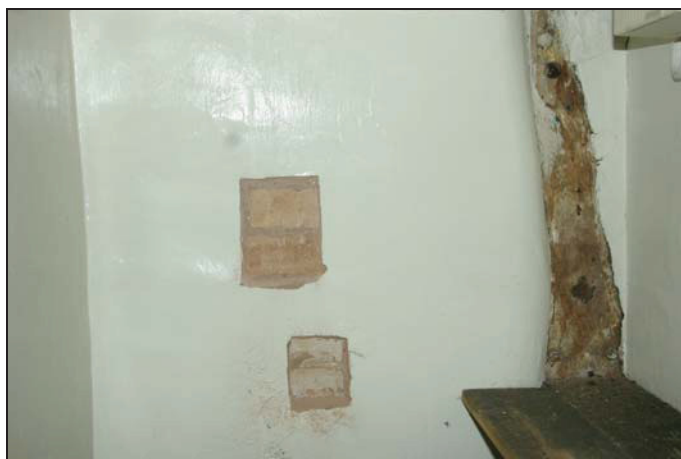
Photo 12. G10 cupboard, proposed new doorway: 20th century brick infill and 16th century stud. Note pegs securing rails (now missing) just above level of shelf.

- Creation of new doorway between G10 cupboard and G11. The wall fabric at this point is 16th century timber-framing with infill consisting of 20th century machine-made brick. The doorway would be formed adjacent to an *in situ* stud and below a girding beam at first floor level. The stud has peg-hole evidence for a rail which, if *in situ* would run across the proposed opening. Intrusive investigation at this point served to clarify that this rail has been removed at some time in the past and that there is no earlier fabric trapped within the brickwork of the wall (Photos 12 & 13). Care should be exercised when removing the infill to avoid damage to the 16th century timberwork. The adjacent stud is not vertical and some packing will be required between this and the door frame, again care should be exercised to avoid damage.

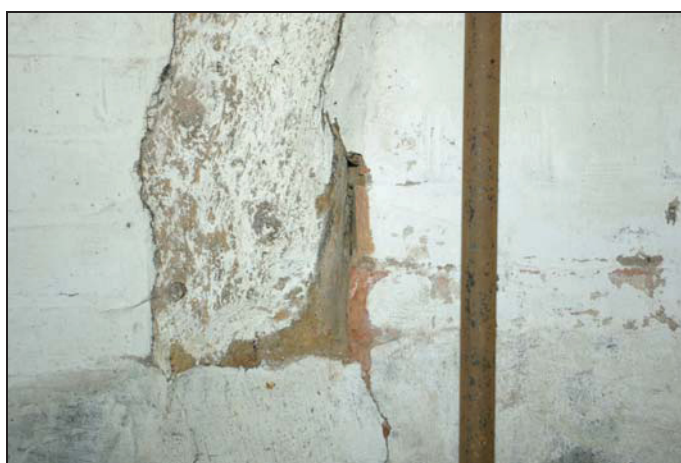
Photo 13. G11 proposed new doorway: intrusive investigation confirming that rail is no longer *in situ*.

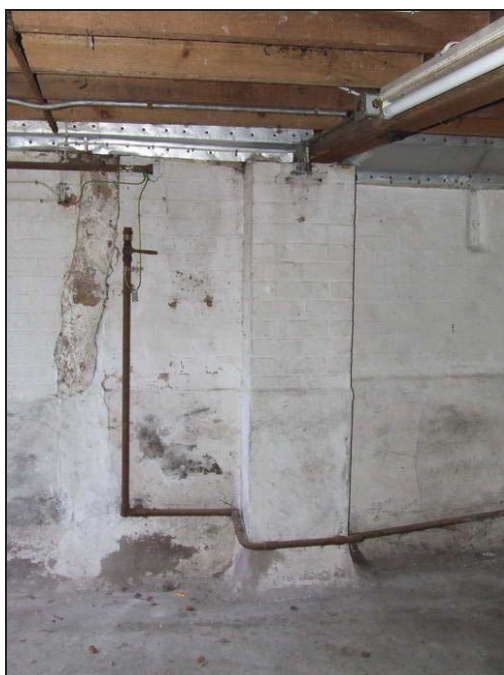
Photo 14. G11 proposed new doorway: brick pier and 16th century stud & rail (partly masked by metal sheeting).

- It is proposed to reduce in size the brick pier carrying the steel I-beam which supports the modern first floor structure above room G11, in order to form an opening wide enough for the doorway (Photo 14). The pier is later in date than the brick infill to the adjacent wall and is not tied in to the wall fabric. Subject to verification by the structural engineer, it should be possible to halve the width of the pier without affecting the I-beam or the first floor structure, providing the width necessary to form the doorway. The creation of a doorway at this point is not considered to represent a significant adverse impact and will facilitate the use of this room as a living space, which is more appropriate in the context of the building as a family home (as opposed to its former use as an agricultural store).

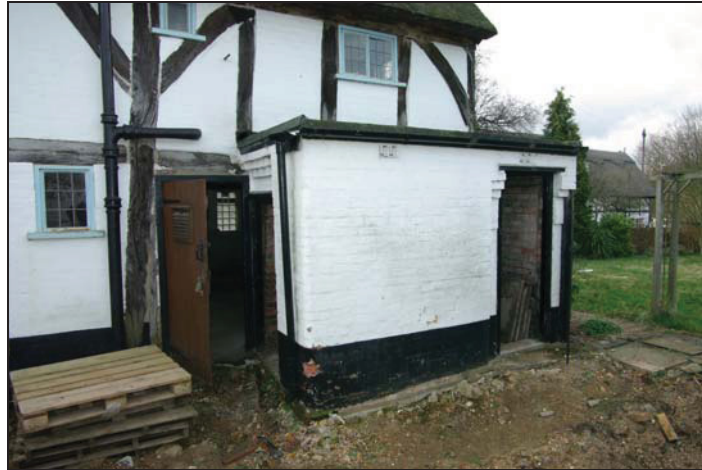
Photo 15. Outhouse (range D).

- This is an addition of the late 19th century and has subsequently been altered (Photo 15). There are no compelling grounds to argue for its retention and removal would have the beneficial impact of exposing to view the 16th century timber framing it currently obscures (Photo 16). Query details of any proposed weatherproofing or remedial work to the timbers.

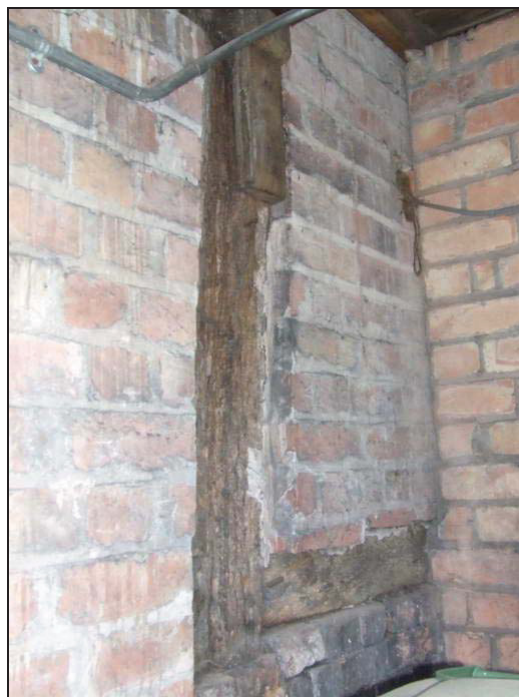
Photo 16. 16th century timberwork presently obscured by outhouse (range D).

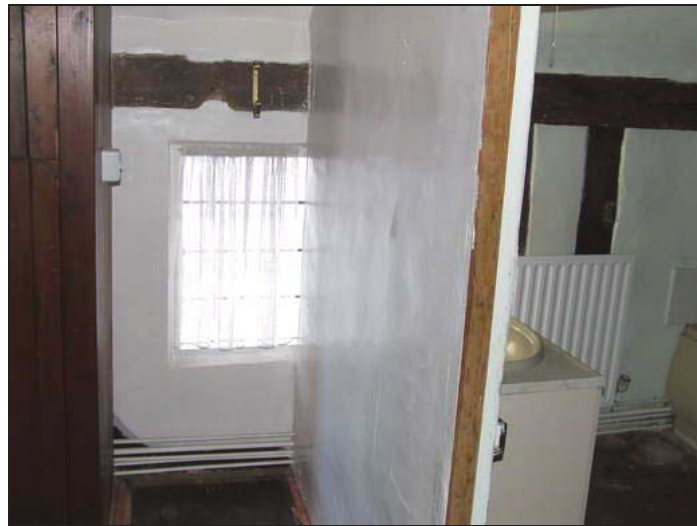
Photo 17. Partition wall between landing F2 and bathroom F3.

- Inserted stud walls form a bathroom F3 within the 15th century cross-wing. The east wall of this cuts across a two-light window and defines a restricted landing area at the top of the stairs (Photo 17). It is proposed to move this wall, enlarging the landing area and exposing the whole of the window. Limited intrusive investigation was undertaken to determine the character and date of the stud walls forming the bathroom. These were found to consist of lime plaster on reeds, fixed to a series of trimmed roundwood poles. The plaster is painted blue grey over a series of earlier finishes (Photo 18). Subsequently the internal wall faces have been covered in plasterboard. These partition walls are likely to date to the 18th or early 19th century; perhaps this room was created as an additional bedroom around the time that the north end of the house was partitioned off as separate dwelling. The development plans will result in the removal of the east wall and partial truncation of the north wall. Re-siting the proposed new doorway from the south to the east wall will permit the retention of a substantial part of the north wall intact, ensuring that fabric evidence remains of this aspect of the building's history. The impact on those sections that will be lost could be adequately mitigated by recording prior to removal.

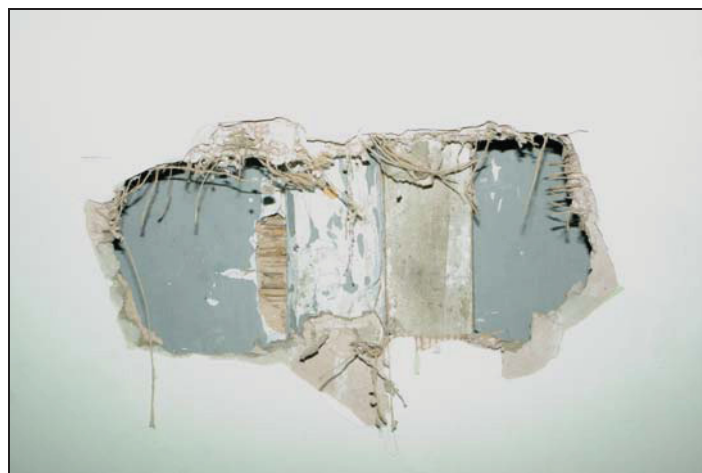
Photo 18. Fabric of stud partition wall between landing F2 and bathroom F3.

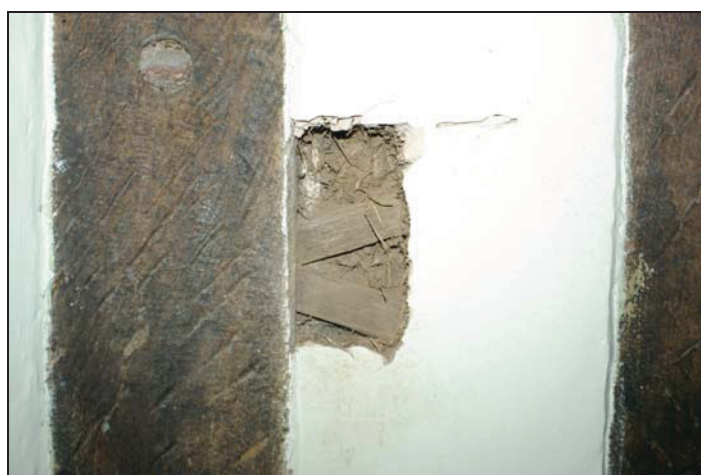
Photo 19. Daub on split lath infill to south wall of 15th century range within bathroom F3.

- **Supplement:** the revised drawings propose the complete removal of the inserted partition walls forming bathroom F3, returning the landing area to its earlier proportions. The bathroom would be relocated within room F4 (see below). This arrangement overcomes the issues of providing natural light and ventilation to the bathroom and the routing of services within this 'sensitive' part of the building. It also creates a less restricted, well-lit first floor landing. Removing the bathroom from this area also has the longer term benefit of avoiding incremental damage from the inevitable periodic replacement of sanitary accommodation. Similarly any long term effects of prolonged exposure to a damp atmosphere on early timberwork, infill and thatch will be avoided. Removing the early stud walls will remove evidence of an episode in the history of the building; however this could be adequately mitigated by providing a record of this area in its present state prior to alteration.

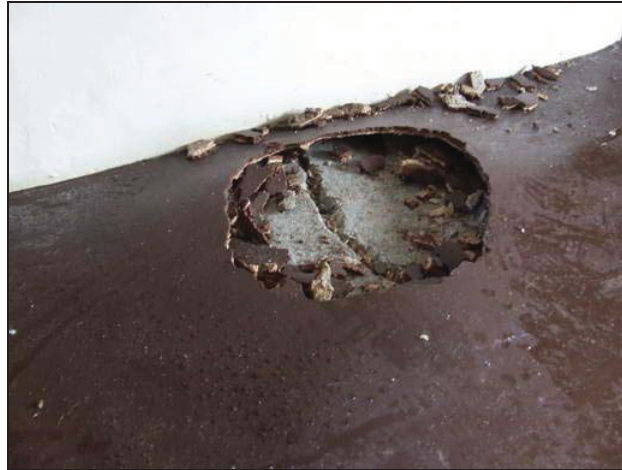
- The first floor structure in this room is of gypsum or lime-ash type. It is covered with a mid 20th century 'liquid linoleum' finish which has lifted in several areas, apparently as a result of damp penetration (Photo 20). Remedial work is likely to require the removal of the 'liquid linoleum' covering. In an area where the earlier surface is visible, this is cracked, though in general it appears to be level and may survive in reasonably good condition. If this is the case, the best approach will be to uncover the original surface (assuming the liquid linoleum can be removed without damage to the underlying surface) and carry out localised repairs as necessary; repair is likely to require specialist attention.

Photo 20. Room F5: gypsum or lime-ash type floor and later 'liquid linoleum' finish.

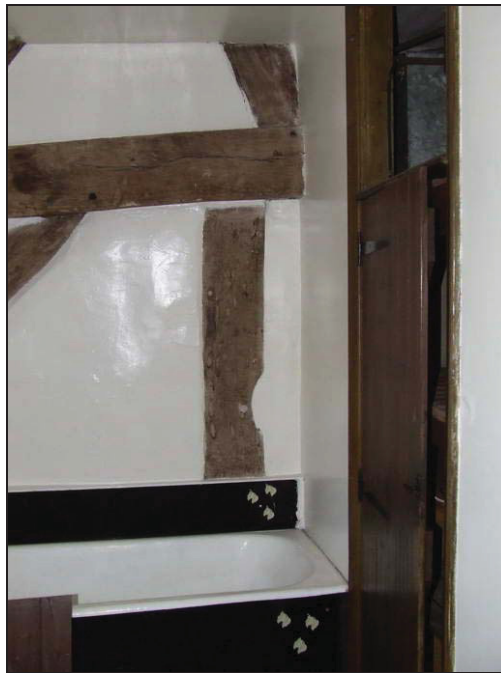
Photo 21. Timber framing in wall between F5 & F7.

- Doorway between F5 & F7 (see also F7 below). It is proposed to create a doorway in the wall between bedroom F5 and the present airing cupboard within bathroom F7 to provide a first floor link between the two halves of the building. The proposed doorway would be located adjacent to the chimneystack. The wall at this point is timber-framed, as seen within room F7 (Photo 21), however the nature of the infill material was uncertain. Limited intrusive investigation was undertaken in order to clarify this issue. Two areas were opened up within room F5 (Photo 22). This revealed a blocked doorway at the point where the new doorway is proposed. The jambs are formed by softwood timbers notched into the 16th century tiebeam and nailed; these timbers have a simple bead moulding. The door head is formed by a softwood timber fixed to the underside of the tiebeam. The dimensions of the doorway are c.1.83m (6ft) high and 0.72m (28¼ in) wide. The doorframe is comparable with that leading into this room from the adjacent landing area F2 and is likely to be 18th century in date. The blocking consists of brickwork that is probably not later than the mid 19th century, bonded with straw-tempered lime mortar. The blocking presumably dates to the time that the house was sub-divided. Re-opening this doorway will re-unite the two halves of the building, representing a beneficial impact. The existing frame should be retained and reused.

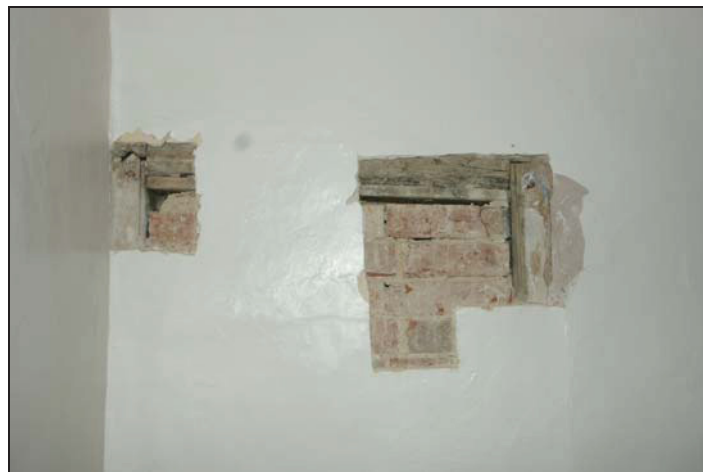
Photo 22. Blocked doorway in wall between F5 & F7 revealed by intrusive investigation.

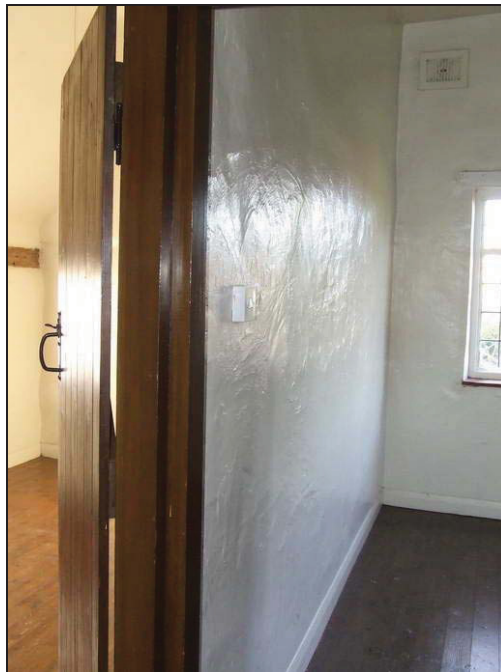
Photo 23. Inserted wall separating rooms F9 & F10 proposed for removal.

- Removal of wall between bedrooms F9 & F10 and wall between bedroom F10 & W.C. and erection of new walls to form one bedroom with en suite and separate bathroom. The existing wall between bedrooms F9 and F10 is of 20th century construction, carried on the steel I-beam visible from below in G11. Intrusive investigation was not undertaken but it is likely to be brick-built. Its removal will not have any significant impact upon the historic character or fabric of the building. Similarly revisions to the sanitary accommodation need not significantly impact upon historic fabric, however careful consideration of the siting of fittings and routing of services is required. The first floor in this area consists of modern boards. It was noted at the time of the survey that live woodworm was present in the modern doors to bedroom F10 and the adjacent W.C. Insertion of the small window in the present W.C. has damaged one of the structural braces to the timber frame, as well as being visually unpleasing to the exterior; any proposals to alter the current arrangement should avoid further damage to the structural member.
