**An Archaeological Historic
Building survey for
Canterbury House Coach House,
117 Main Street,
Higham on the Hill,
Leicestershire.
NGR: SP 384 955**

ULAS Report No. 2010-081
©2010

ULAS Report Number 2010-081

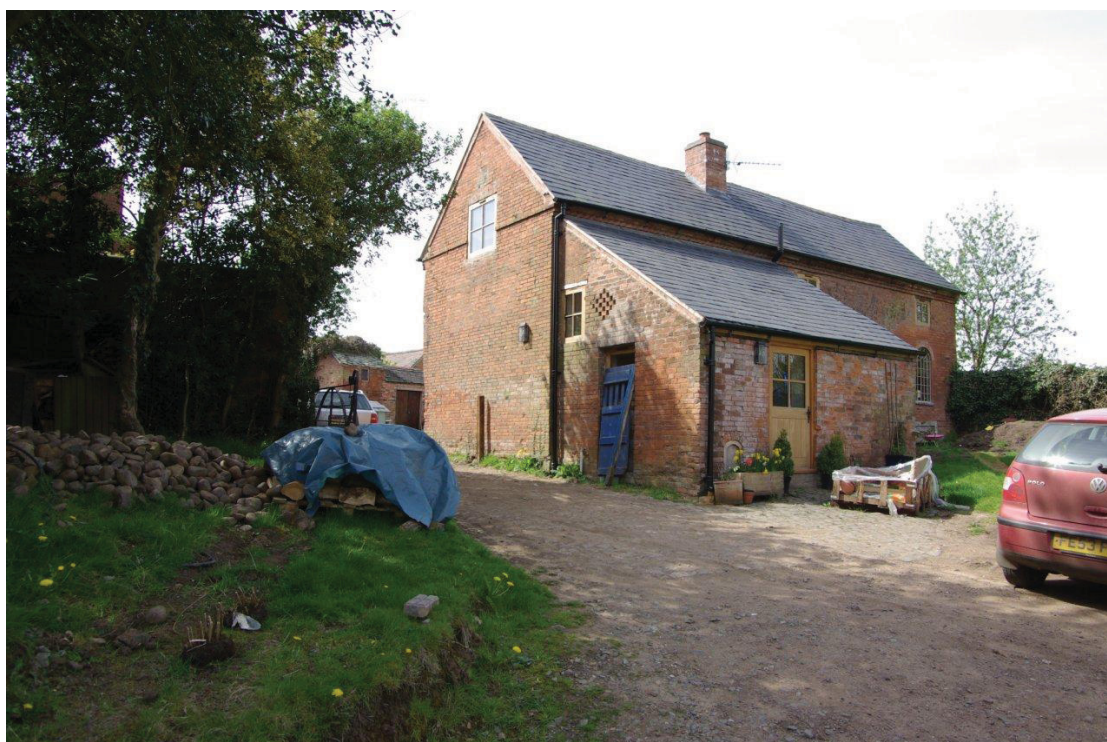
As mentioned above, the building is reached from a driveway leading from Main Street with the north elevation facing towards the Rectory building (fig. 7).

Figure 7 Coach House from the entrance drive (after renovation)
Looking south west

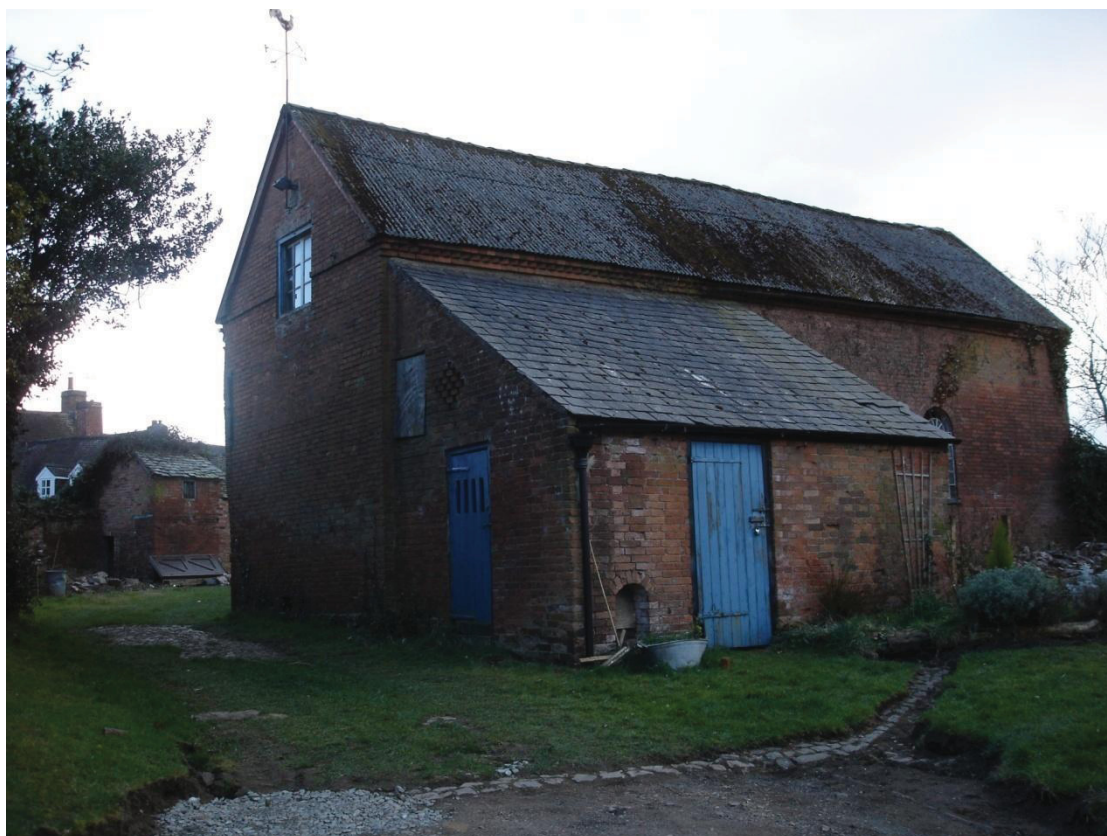
Figure 9 North and east elevations before renovation
Looking south west

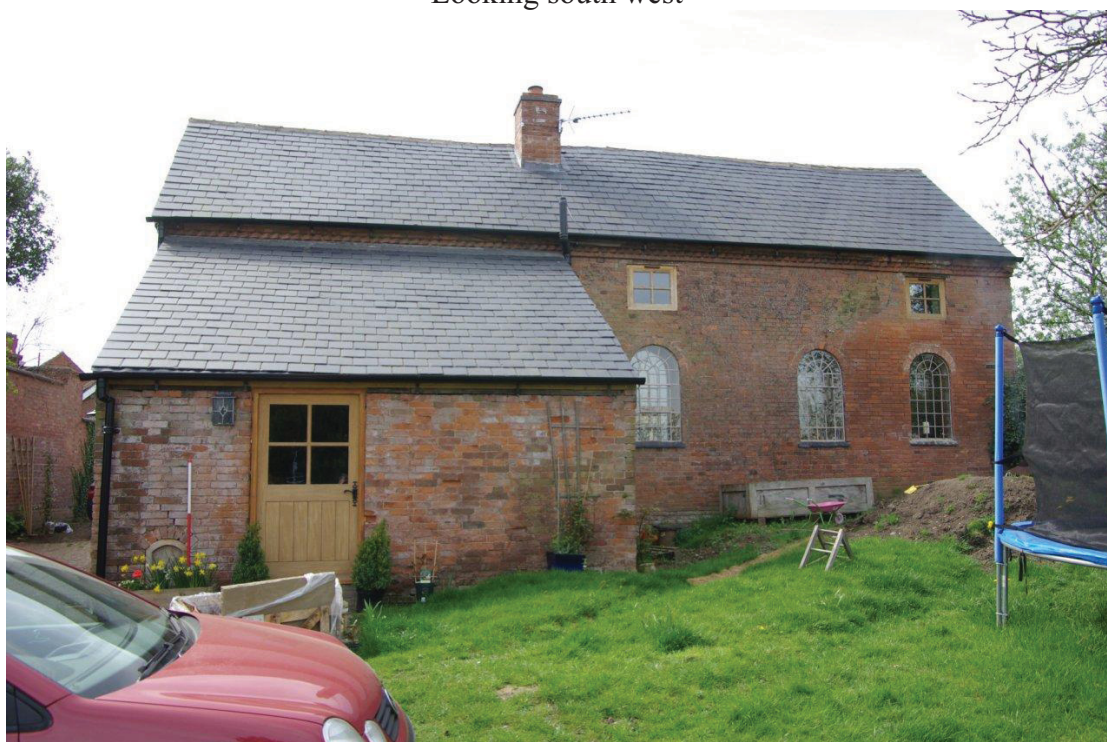
Figure 10 North elevation after renovation
Looking south. 1m scale

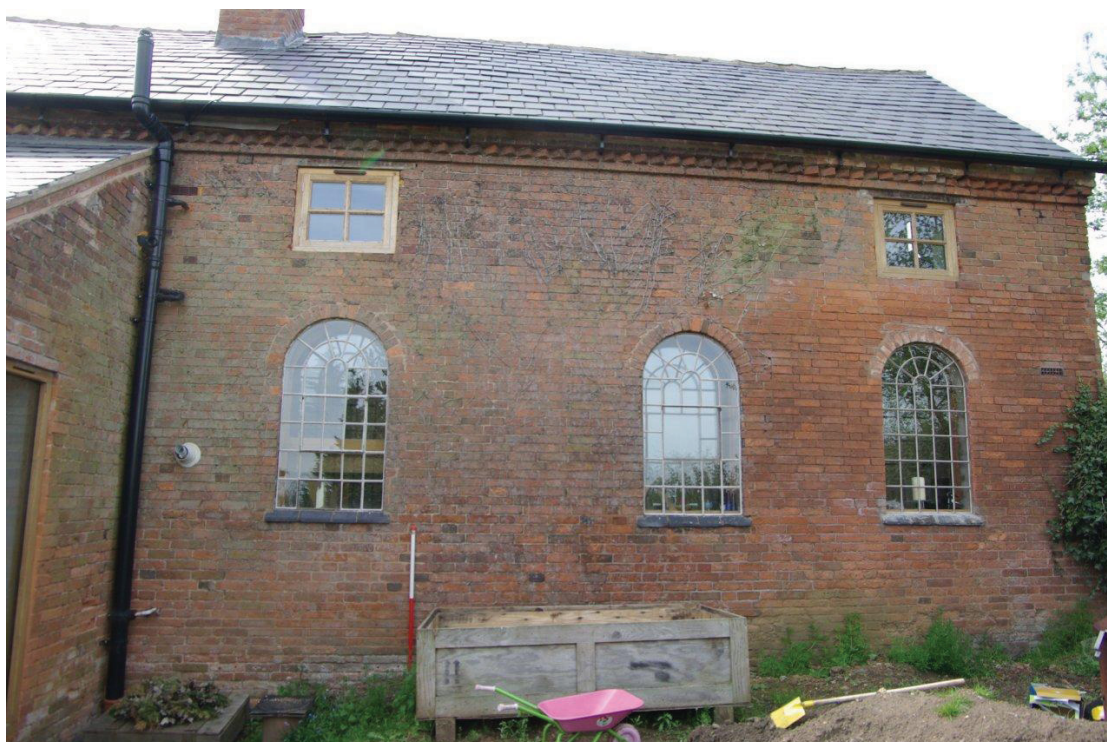
Figure 11 North elevation detail after insertion of new windows
New windows are first floor on left and ground floor on left
Looking south. 1m scale

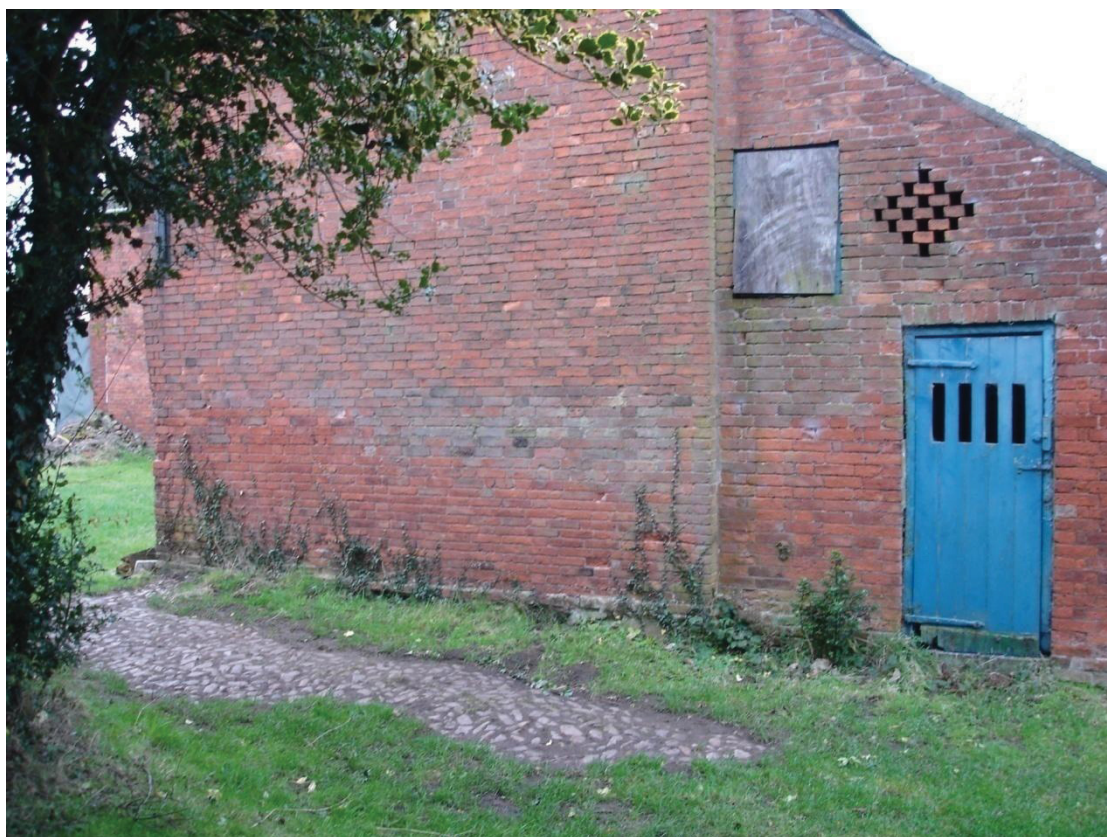
Prior to renovation the north elevation had two cast iron framed arched windows at ground floor level and evidence of a small rectangular window on the first floor which had been blocked with later brickwork (figs. 9, 10 and 11). Later renovation has reopened this window and a matching arched window has been inserted on the western side. A single storey lean-to structure is butt jointed against the eastern half of this elevation and has a small arched opening at floor level which appears to have been used for coal. Access to this structure was by a single doorway on the northern elevation and a single doorway into the coal house on the eastern elevation. Missing bricks form a diamond-shaped vent on the eastern side of the lean-to (fig.12).

Figure 12 East elevation and lean-to
Looking south-west

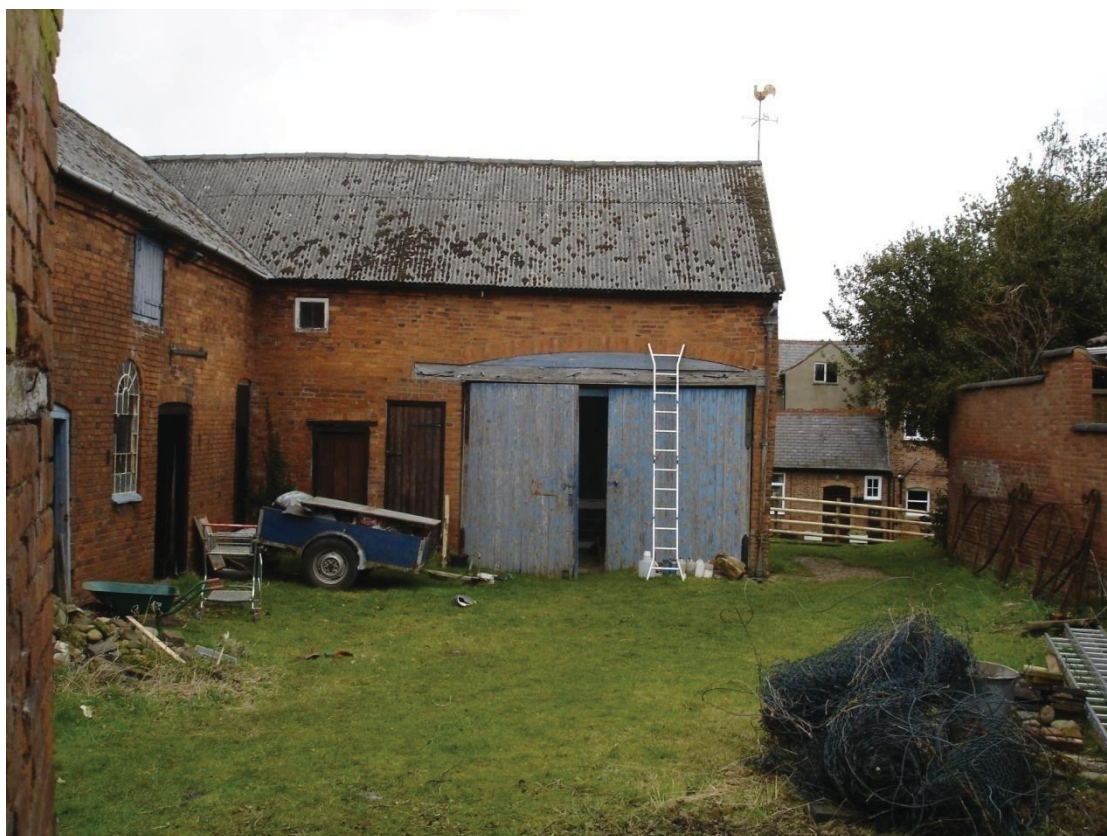
Figure 13 South elevation of east to west wing before renovation
Looking north

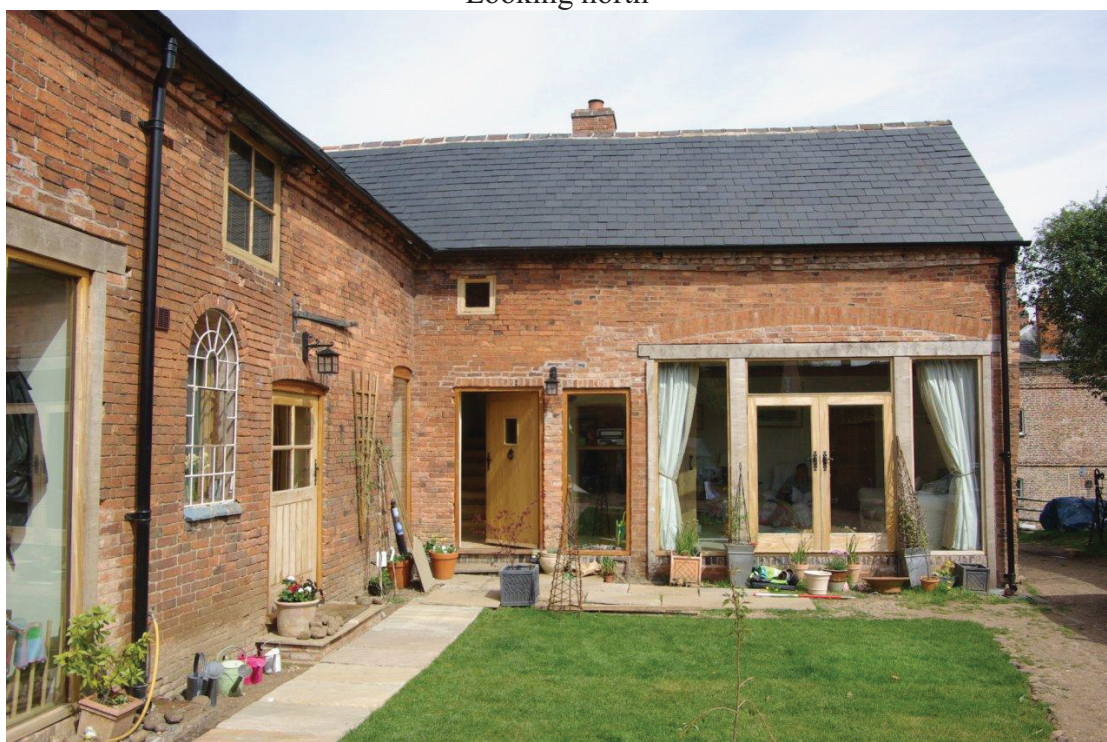
Figure 14 South elevation of east to west wing after renovation
Looking north

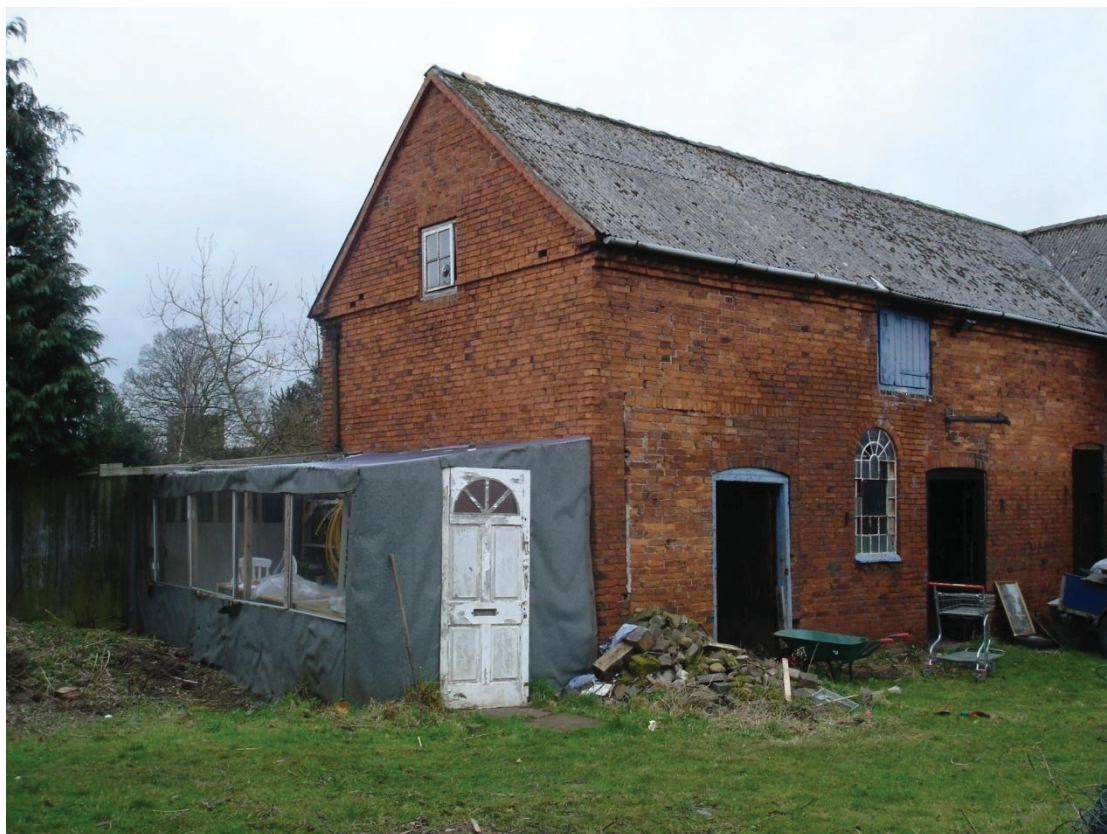
Figure 15 East and south elevations of north to south wing before renovation
Looking north-west

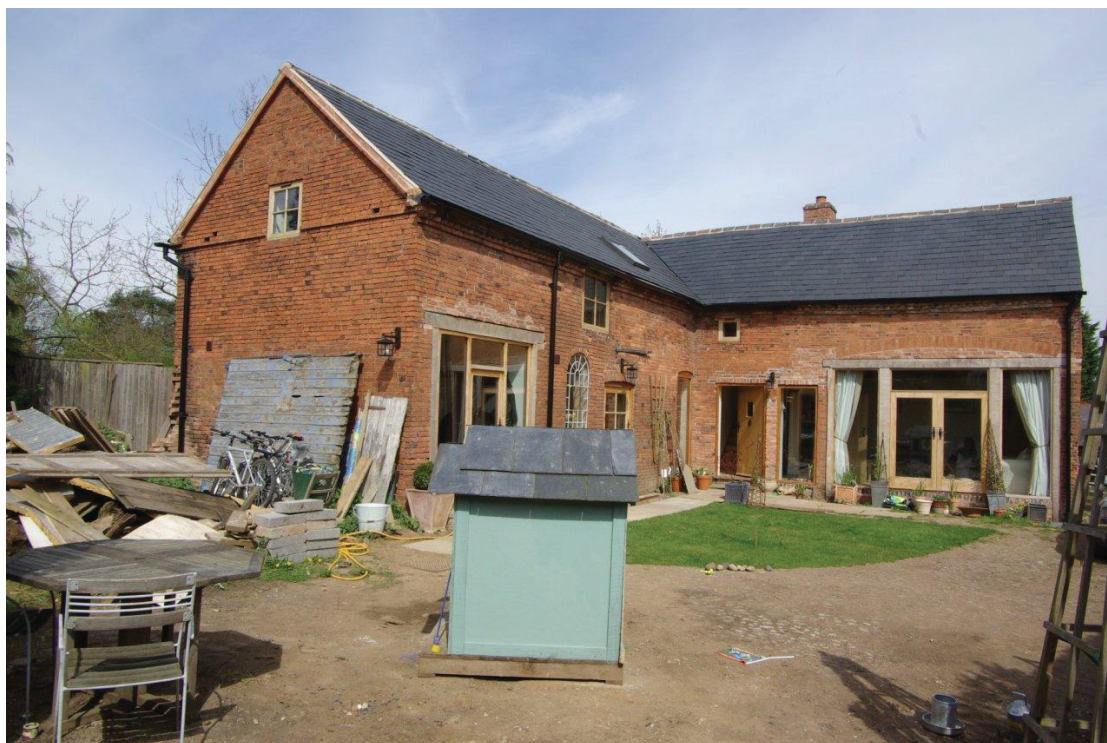
Figure 16 Southern end of building with wall stub visible
Looking north-west

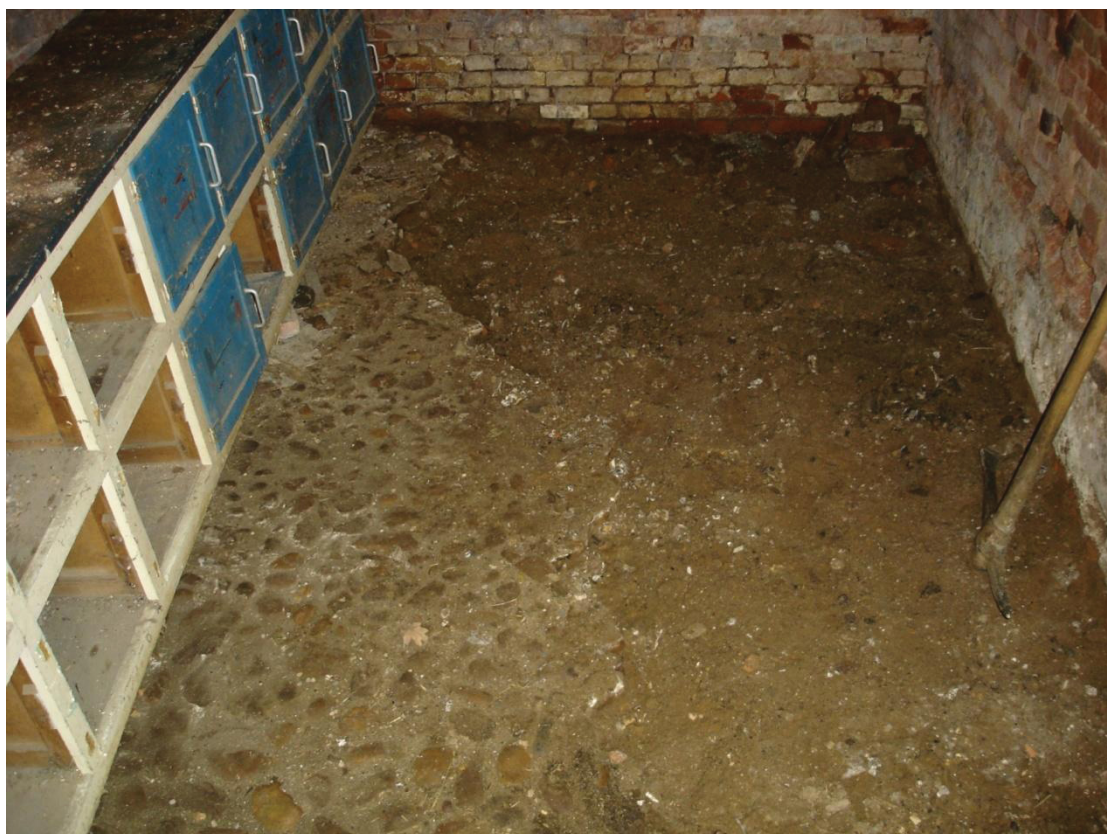
Downstairs the floor plan is divided into five main rooms in addition to the lean-to. The southernmost room, accessed by the blocked double doorway, had a river washed cobbled floor similar in style to the courtyard (fig. 17). Some of the floor joists have been replaced either indicating a floor repair or a hatch up to the first floor. The adjacent stable had rectangular blue brick stable paviments on the floor and a wooden loosebox in the northern end (figs. 18 and 19). During the renovation this room has subsequently been divided into two with a set of stairs leading to the first floor.

Figure 17 South end room floor being removed
Looking west

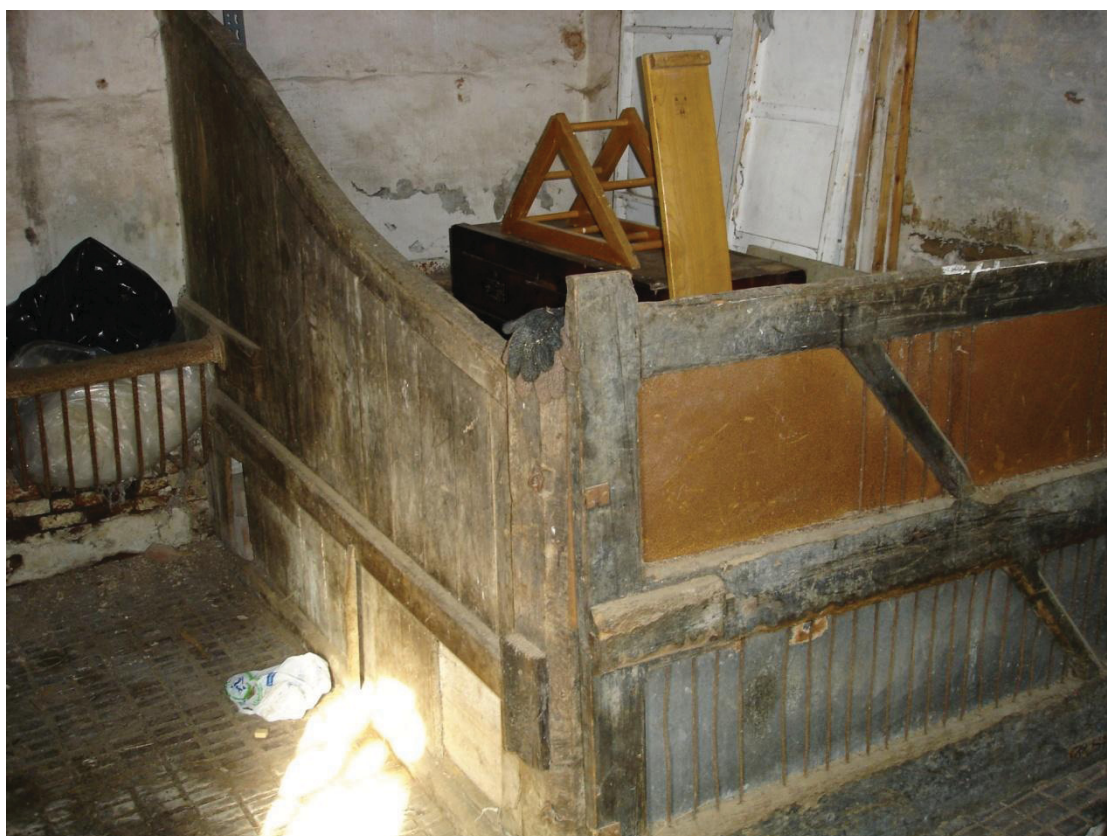
Figure 18 Loose box in stable
Looking north-west

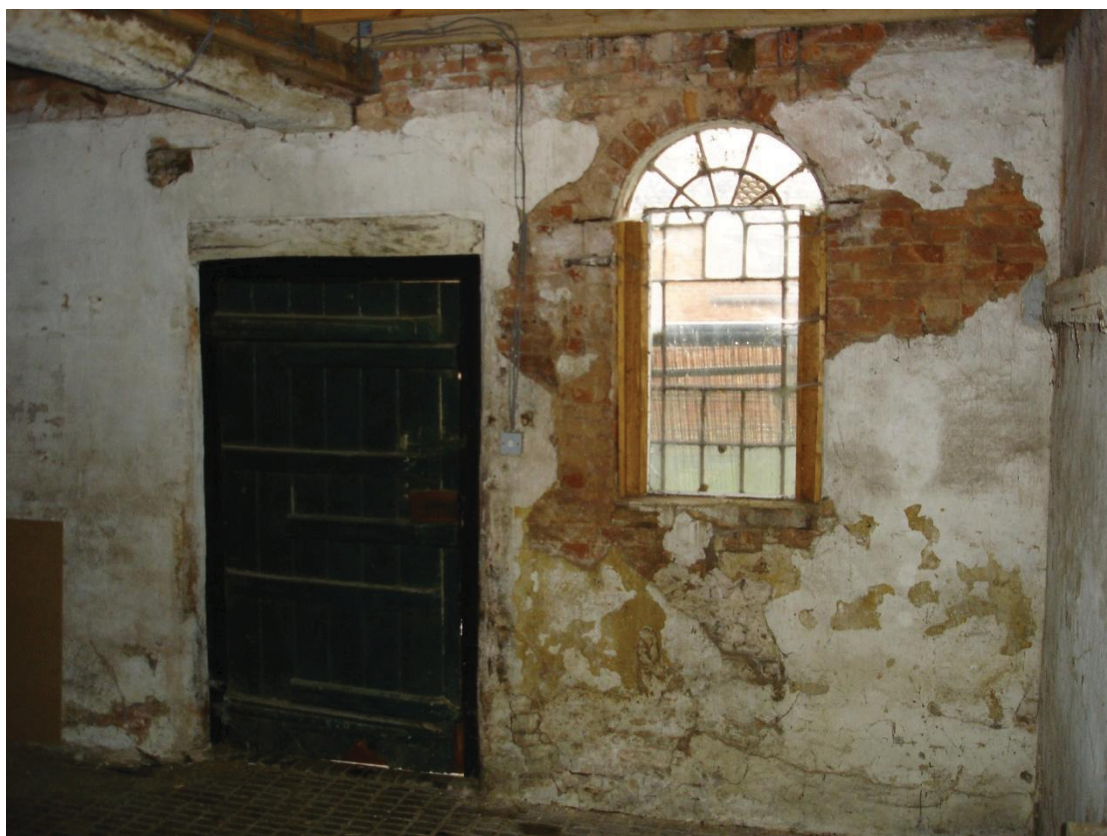
Figure 19 Stable window and door detail
Looking east

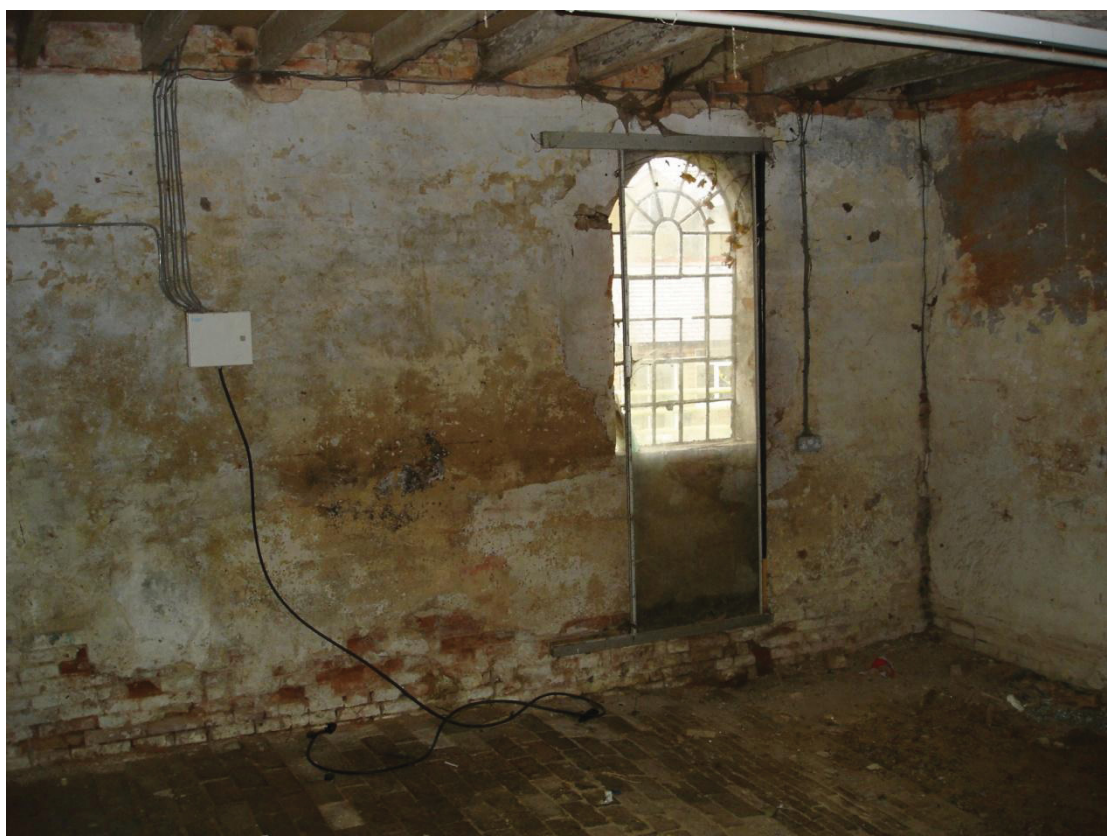
The north-eastern corner room had a brick-paved floor and substantial chamfered timber beams in the ceiling. There is no indication of the former use of this room (fig. 20). A narrow room to the east of this may have been used as a store or tack room. Immediately to the east of this a narrow set of wooden stairs, accessed from the courtyard, led up to the first floor. The coach store, at the eastern end of the east to west wing, is a large open room with a chamfered timber beam running across the centre of the ceiling. Wooden pegs set around the walls indicate where harnesses and fittings were stored (fig. 21). A large wooden lintel over a fireplace on the west wall has a number of slots for floor joists and has clearly been reused from elsewhere (fig. 22).

Figure 20 North-east corner room
Looking north-east

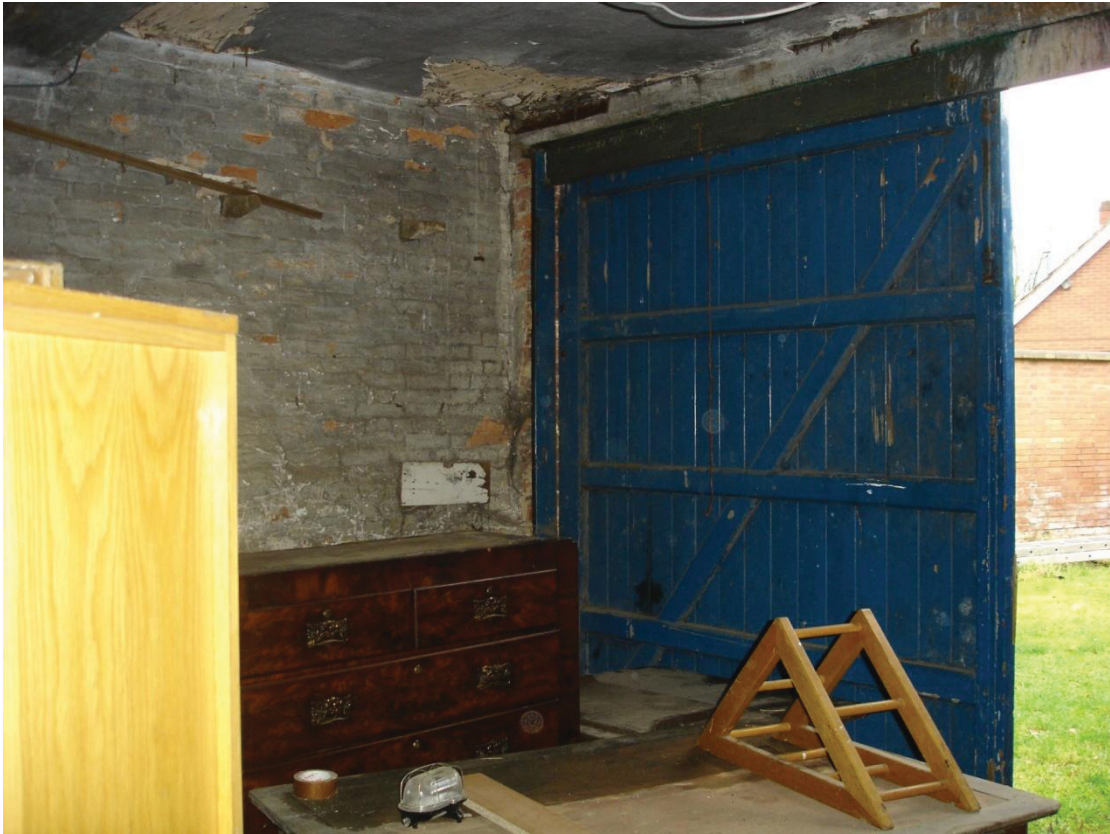
Figure 21 Outside doors of coach store, note wooden pegs on wall
Looking south-east

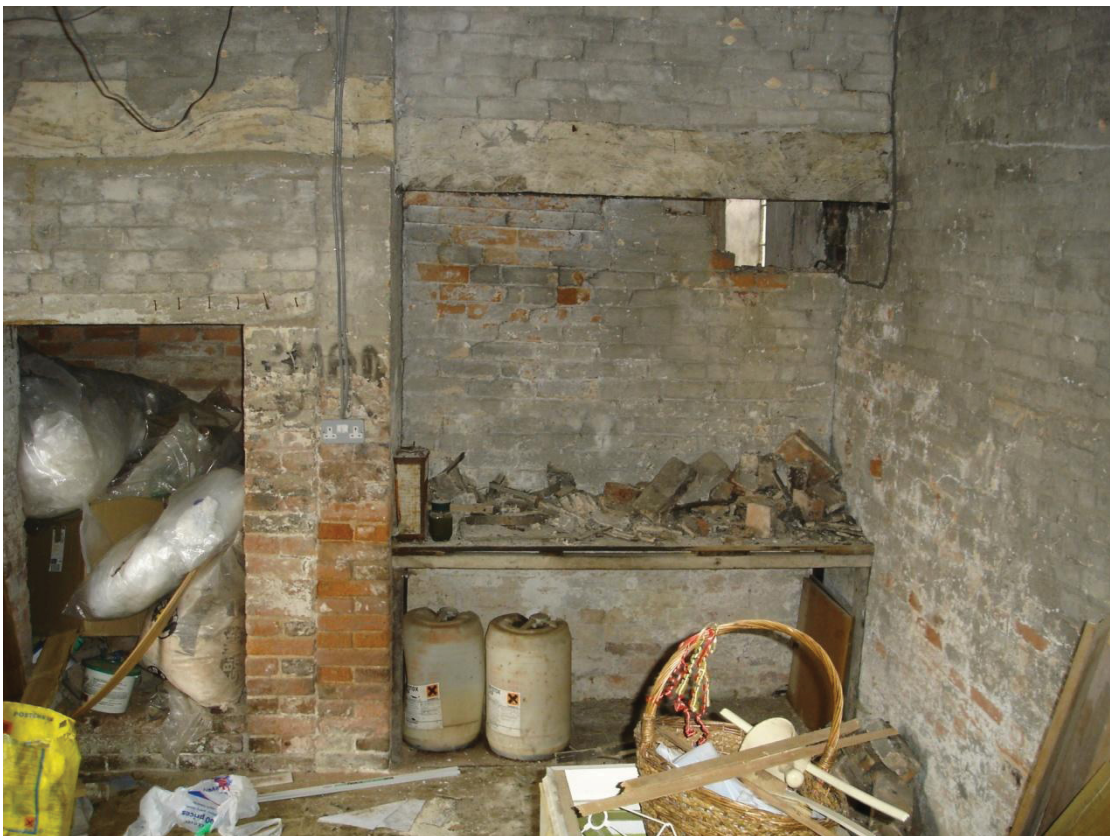
Figure 22 Stable fireplace, note reused lintel on left of picture
Looking west

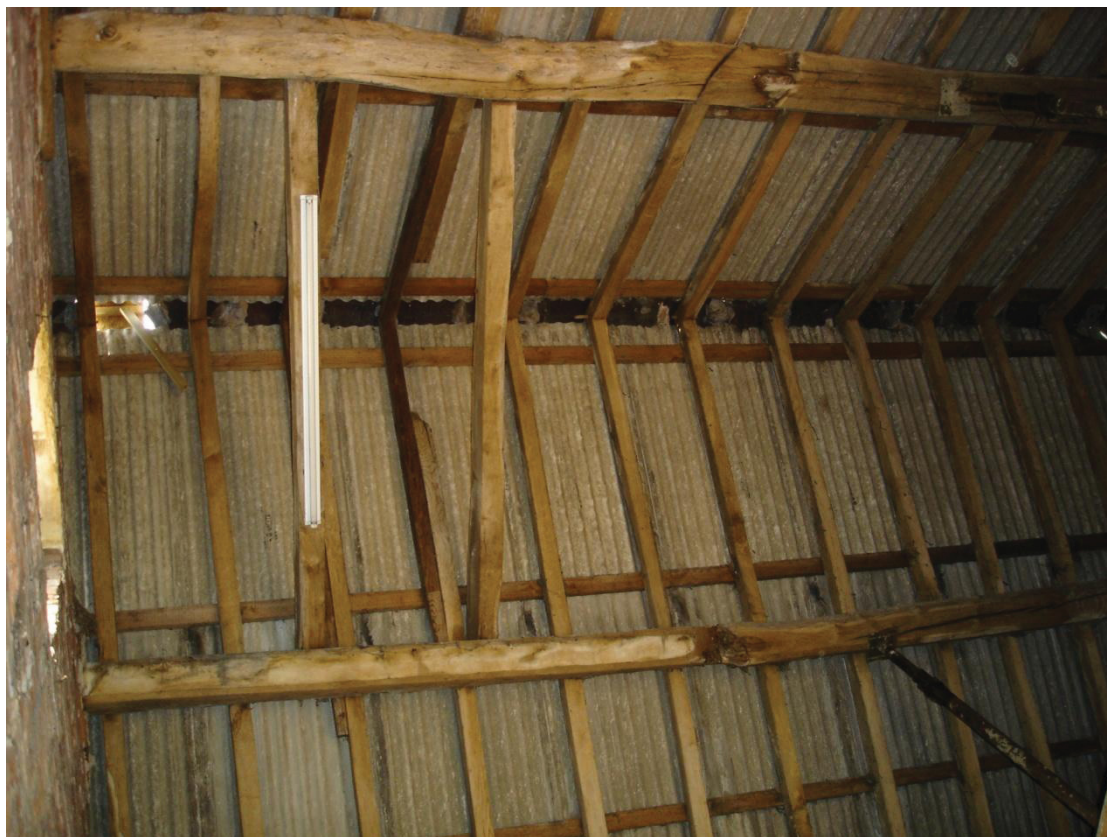
Figure 23 Roof detail of Room 1

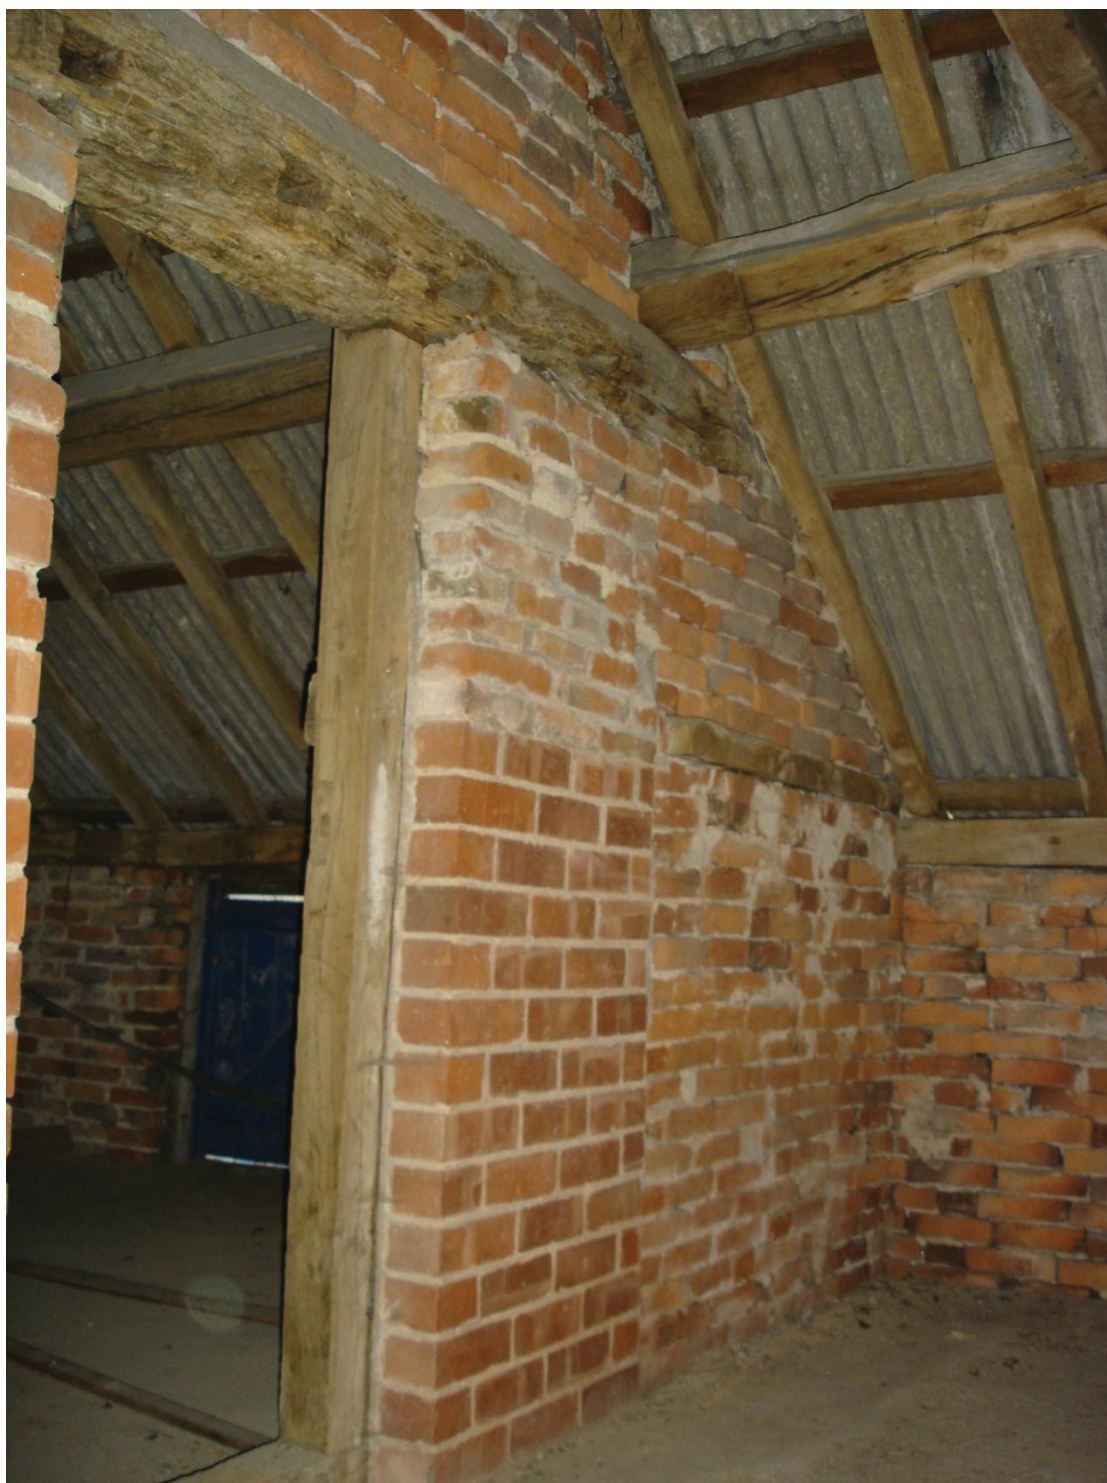
The first floor has six rooms which, although there is no clear evidence of their former use, would presumably have served as storage for fodder and basic accommodation. For the purpose of this survey the rooms were numbered 1 to 6 starting at the southern end of the north to south wing and going to number 6 over the coach store. Room 1, at the southern end of the north to south wing, has two parallel timbers set into the tops of the purlins and sawn off pegs suggesting that they were used as a support or lifting structure (fig. 23). Of the roof structure, only the tenoned and pegged principal rafters set onto the upper face of the purlins remained in place supporting the asbestos sheet roof. The principals were attached to the wall plate timbers by mortice and tenon joints and were pegged at their top ends. A timber lintel with a number of mortice holes had been reused over the doorway into Room 2 (fig. 24). From the poor quality

of the brickwork this doorway had the appearance of undergoing many episodes of rebuilding and patching.

Figure 24 Room 1 dividing wall into Room 2
Looking north-east

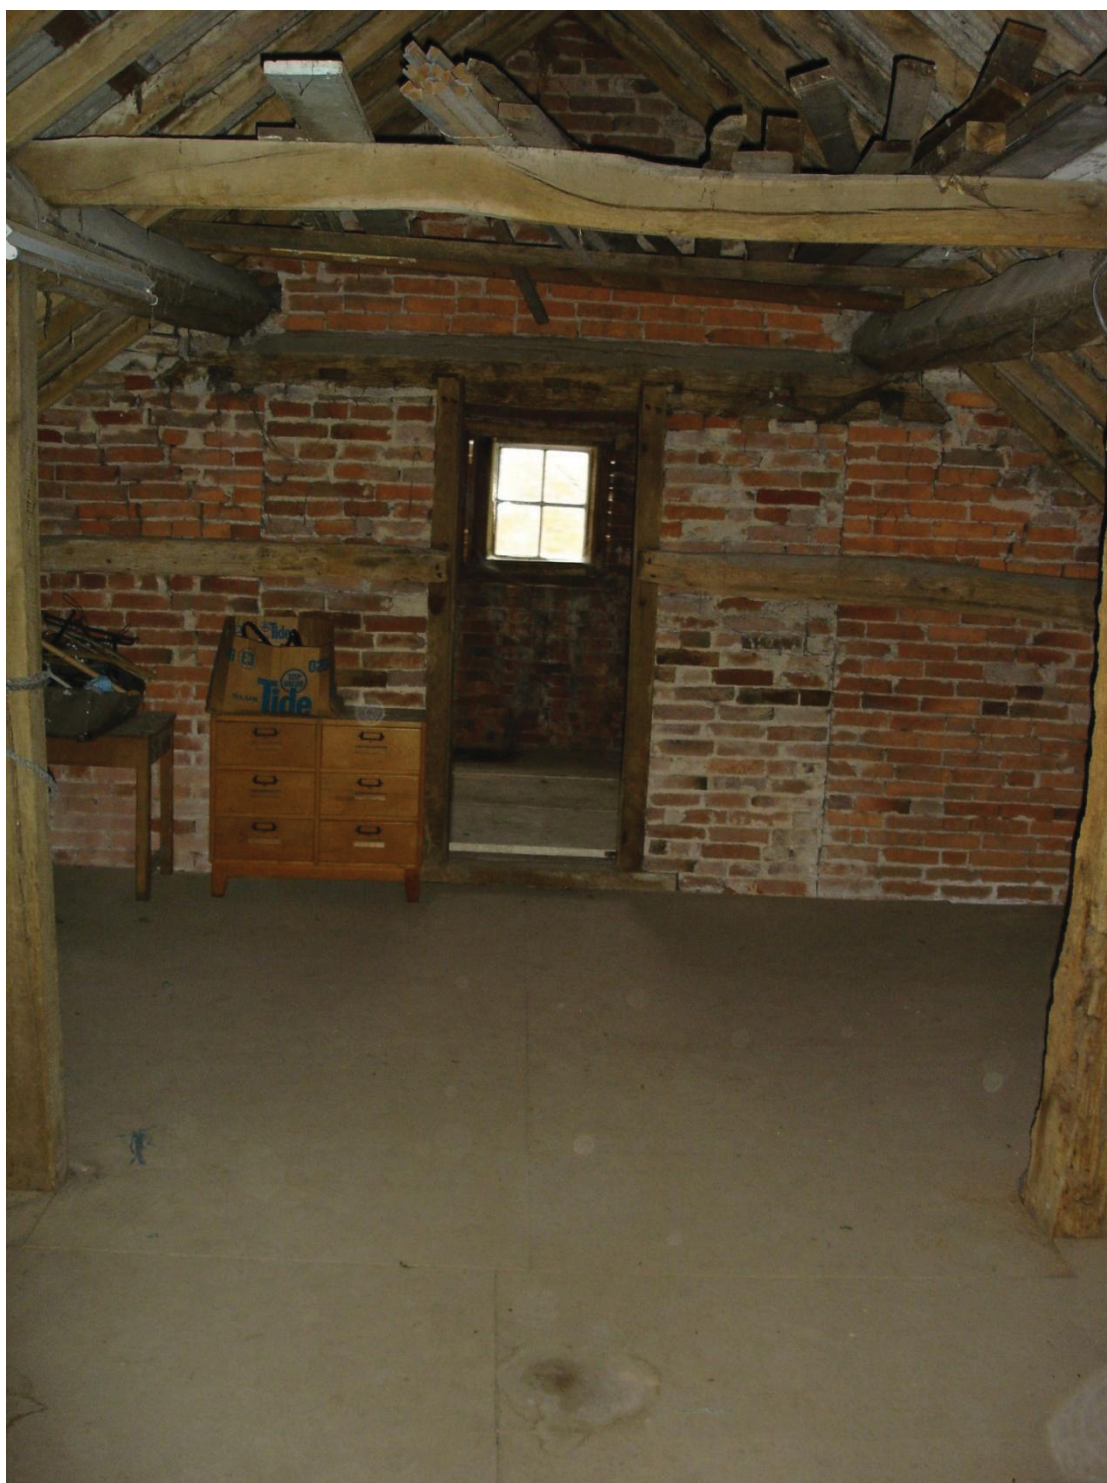
Figure 25 Room 2 dividing wall to Room 1, note purlin supports
Looking south

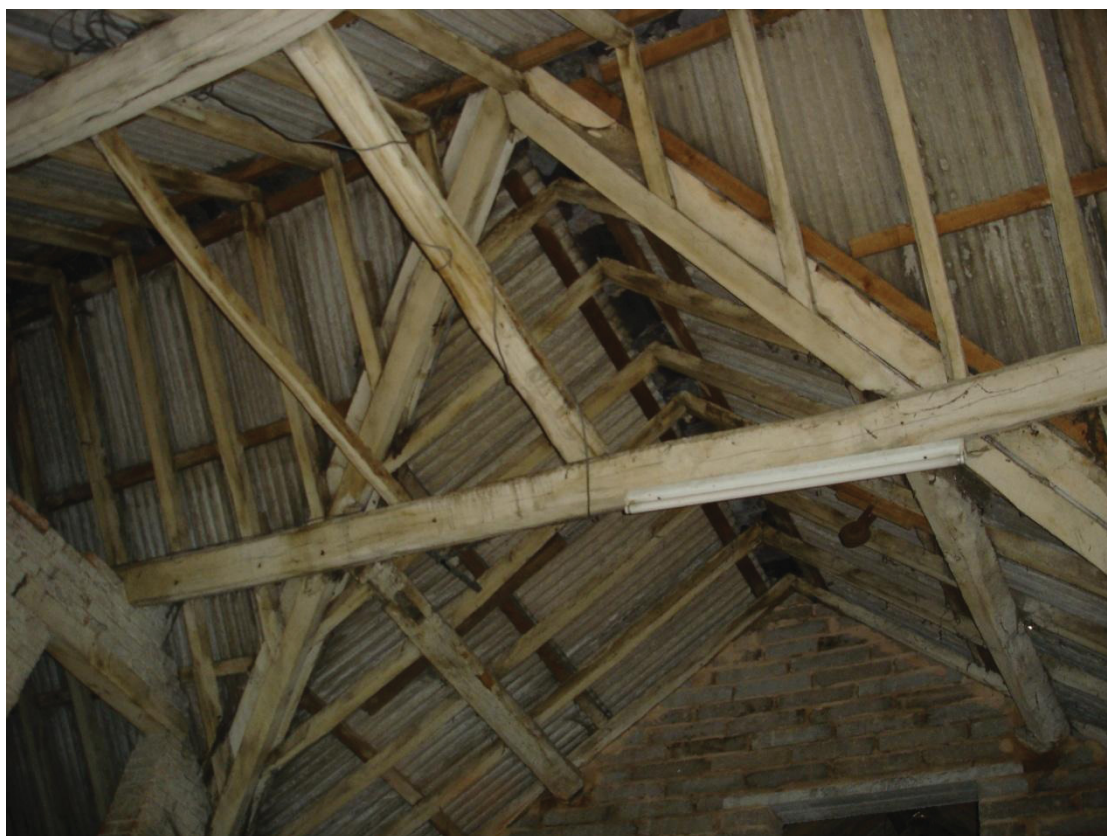
Figure 26 Room 4 roof detail at junction of the two wings
Looking south-east

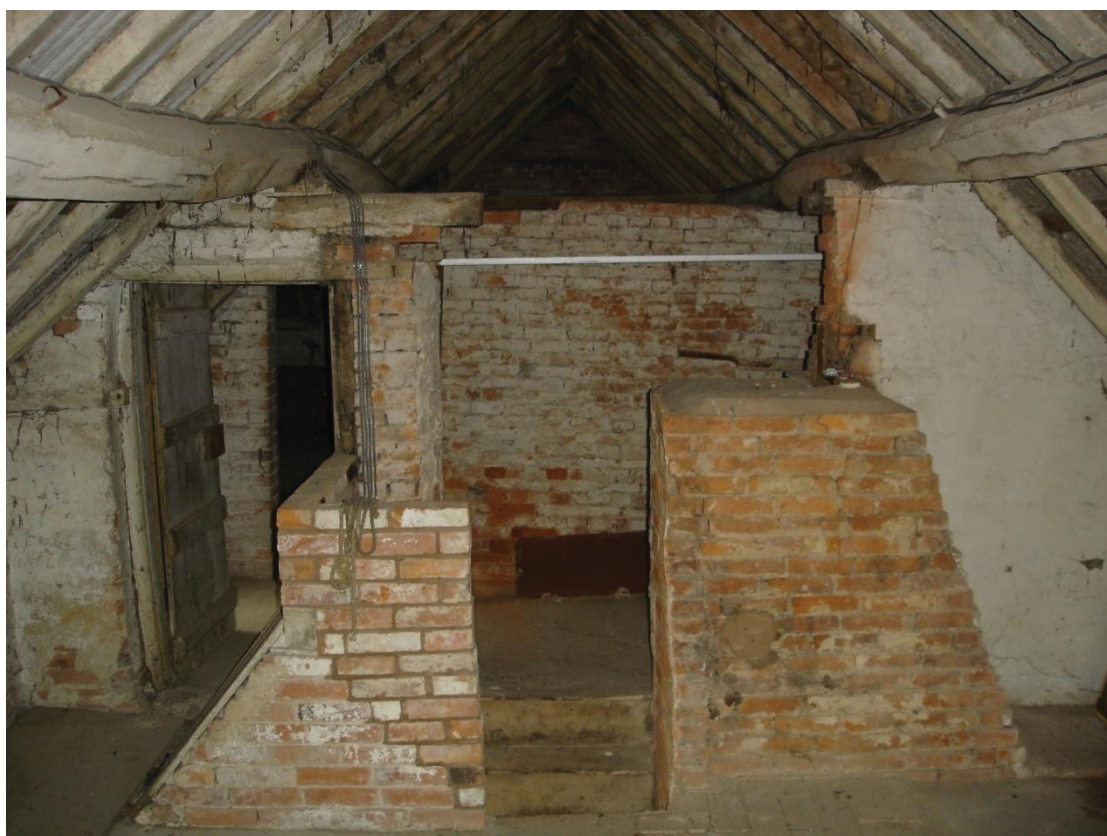
Figure 27 Room 6, top of stairs and capped chimney
Looking west

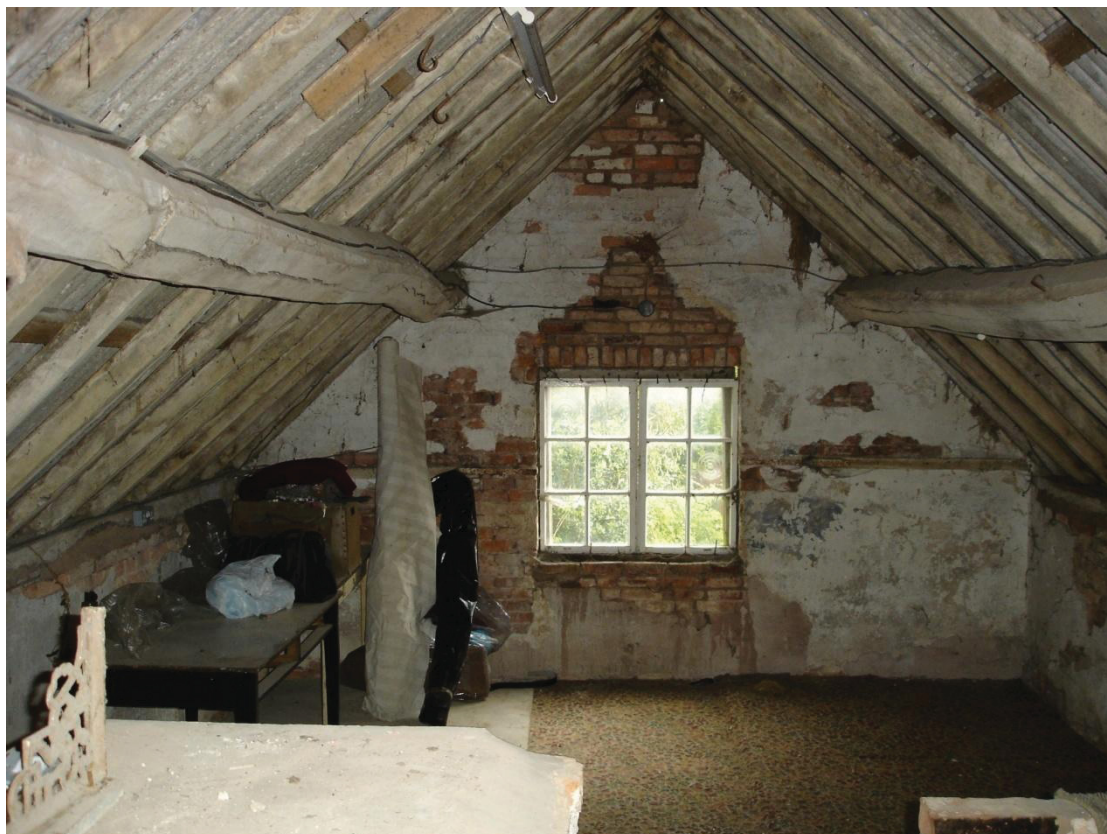
Room 2, as with the other rooms, had a plaster floor but also had a boarded area on the western side. The hayloft door opened into this room but otherwise the room was bare (fig. 25). A partial brick partition led into Room 3 which had reused timbers supporting the purlins. Rooms 3 and 4 were similarly devoid of fittings to suggest their former usage (fig. 26). Room 5 housed the small staircase leading from the courtyard and opened to the east and west into Rooms 4 and 6. Room 6, over the coach store, had the base of the chimney which had been reduced in height and capped when the old roof covering was changed to asbestos sheets (fig. 27). A small fireplace in this room suggested its use as a dwelling space (fig. 28).

Figure 28 Room 6 gable end wall
Looking east
