**An Historic Building Analytical Survey (Level 3),
Huskissons Lodge Farm Buildings,
Wansford Road, Kings Cliffe,
Northamptonshire.
NGR: TL 013 978**

ULAS Report No. 2009-137
©2009

For: Mrs D Coleman

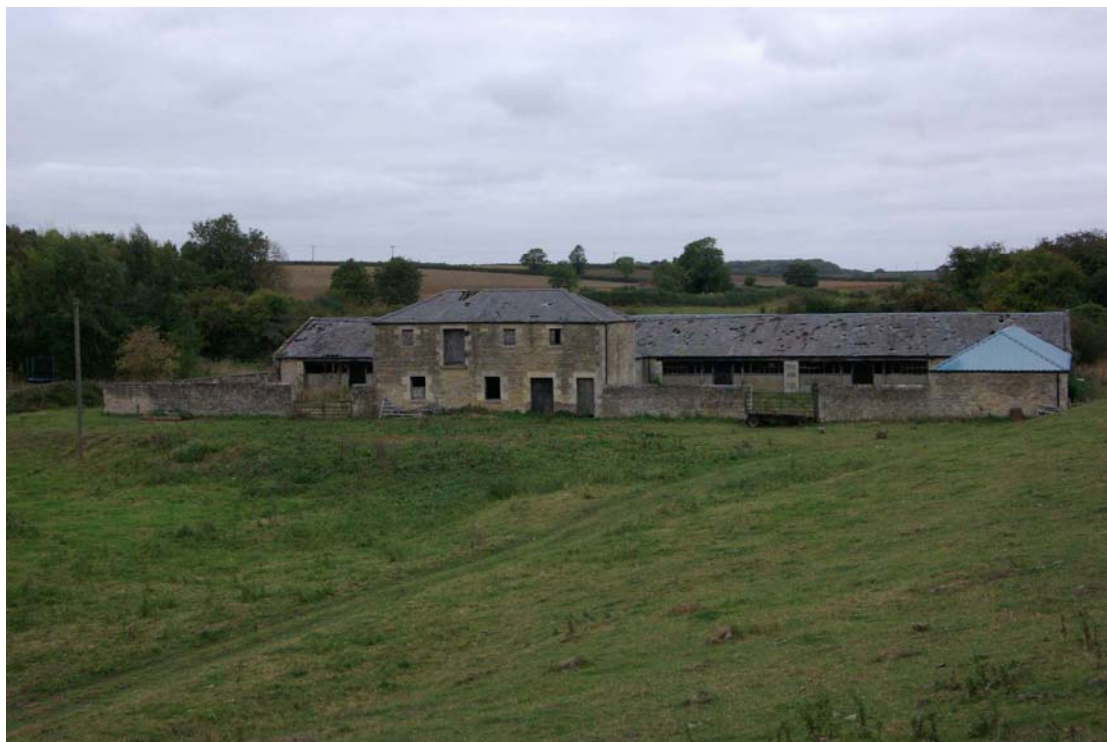
Figure 9 Huskissons Lodge farm buildings
Looking north west

The southern elevation is the main aspect of the range of buildings and looks down the slope towards open countryside. A central two-storey building is flanked by the two southern boundary walls of both courtyards (fig. 9).

The western courtyard (courtyard 2) wall has a blocked opening 3.5m wide in the centre of the wall with quoins either side. Coursed limestone rubble fills in the original gap which has been superseded by a similar width opening further east closer to the central building. The wall is capped by semi-circular stone and blue brick copings except for the extreme western end where flat copings are used. This change corresponds with the demolished building in courtyard 2 discussed in section 2 above.

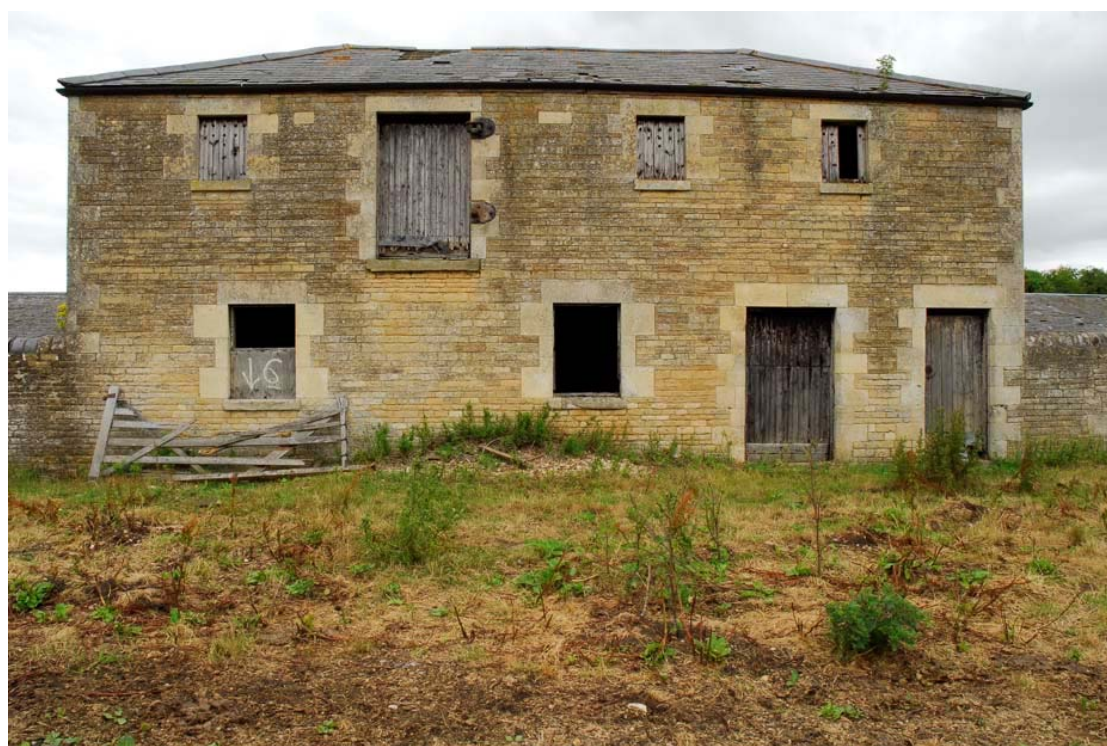
Figure 10 south elevation of central building
Looking north

The central range has a hipped slate roof and dressed limestone quoins (fig. 10). The stone sills project slightly on all windows on both floors as also seen on the north face of this building but not elsewhere in the complex. A single width plank and batten door with stop chamfered jambs leads to a set of stairs discussed later in this report. The ornate cast iron back plate to a latch survives but the handle is missing. All evidence of the latch is missing from the wider stable type door to the west which also has chamfered jambs. The frames are missing from the two ground floor windows. The first floor has plank and batten covered windows with a regular pattern of ventilation holes drilled in them. To the left of a full height rectangular loading door are two cast iron fittings that once held what appears to be a substantial hinged loading jib.

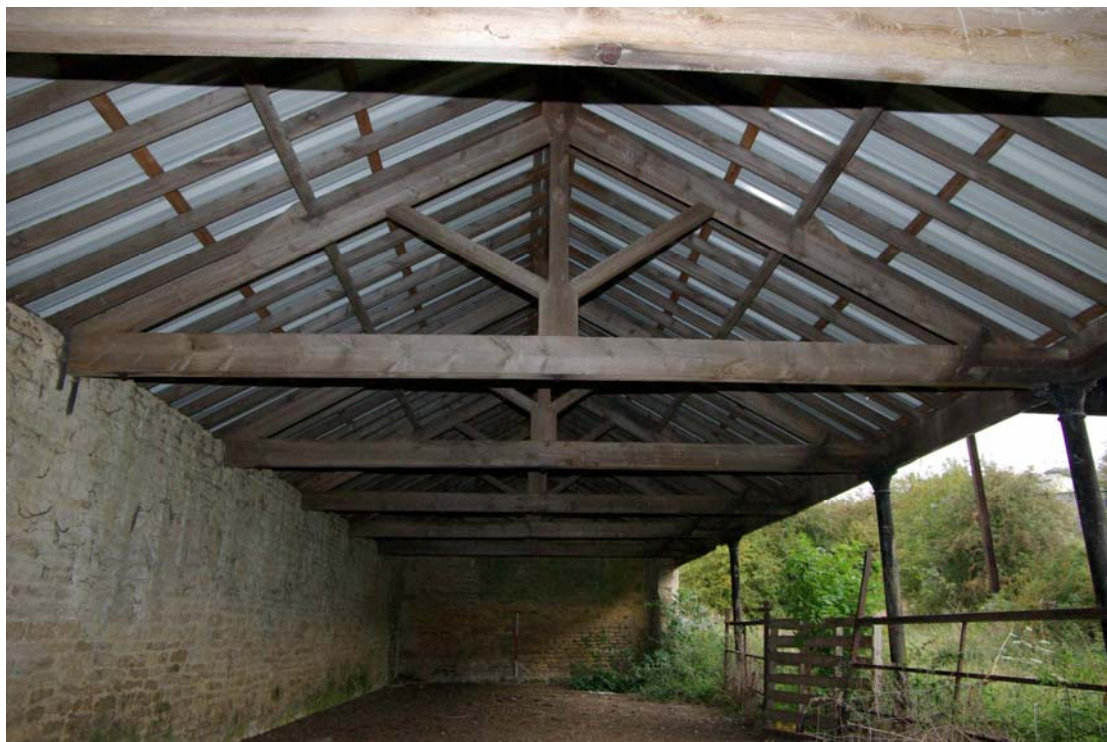
Figure 11 Internal details of cart shed
Looking north

This elevation consists of the open cart shed (room 14) and the gable end of the long northern range. The cart shed is open to the east away from the courtyard onto the track outside the buildings (figs. 11 and 12). It has cast iron columns of probable late 19th century date dividing each bay and which support a stop chamfered beam that acts as a wall plate. The roof trusses are strapped to the western face of the wall plate and also sit in a cast slot on top of each column. It appears that two columns may be missing as there are two unsupported trusses. The roof structure is of a common king-post truss type with raking struts supporting the principals. There are rather complicated iron bridle straps connecting the principals to the trusses and the outer wall plate. The reason for this complicated arrangement is due to the minimal area of support given by the iron columns. Despite this slightly unusual design, the date of strapped principals and trusses is normally no earlier than the mid 19th century. The purlins are cleated to the upper face of the principals. The king posts are bolted through the truss which is a feature not seen in agricultural buildings any earlier than the 1820s.

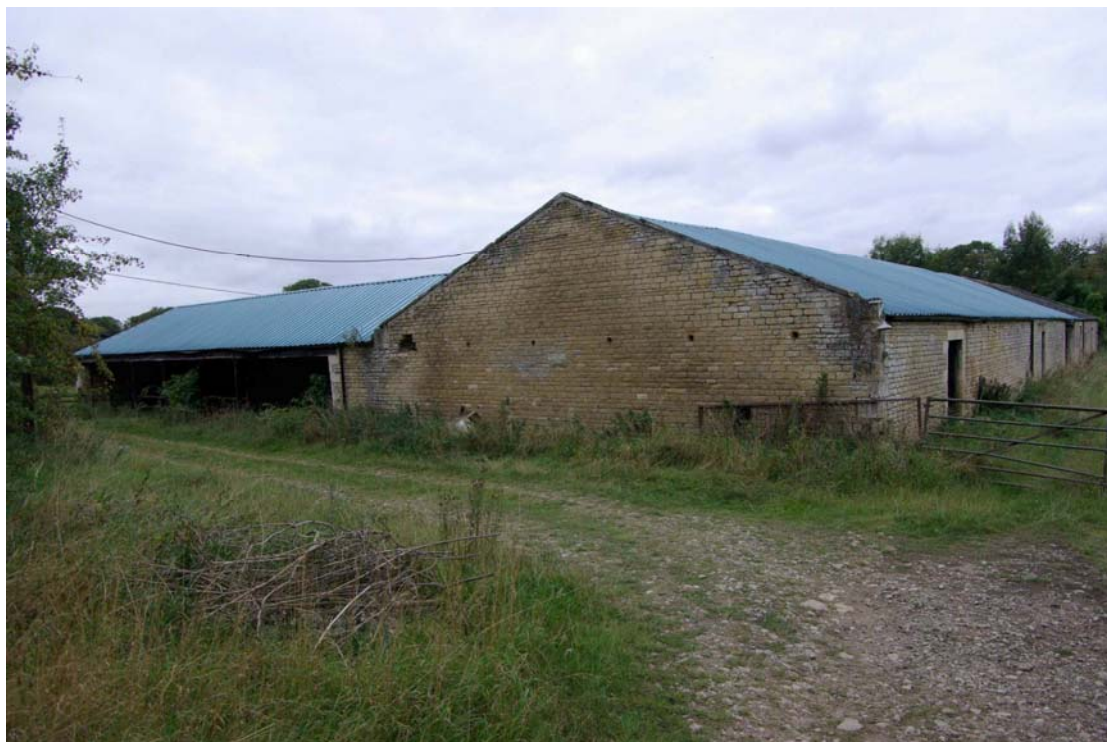
Figure 13 East elevation of north range
Looking south west

The eastern gable end of the north range is a blank stone wall pierced only by 6 small circular air vents approximately 2m from the ground (fig.13). A ragged hole has been made lower north corner and also at the south corner at vent height. Little care seems to have been taken making these holes which look quite recent.

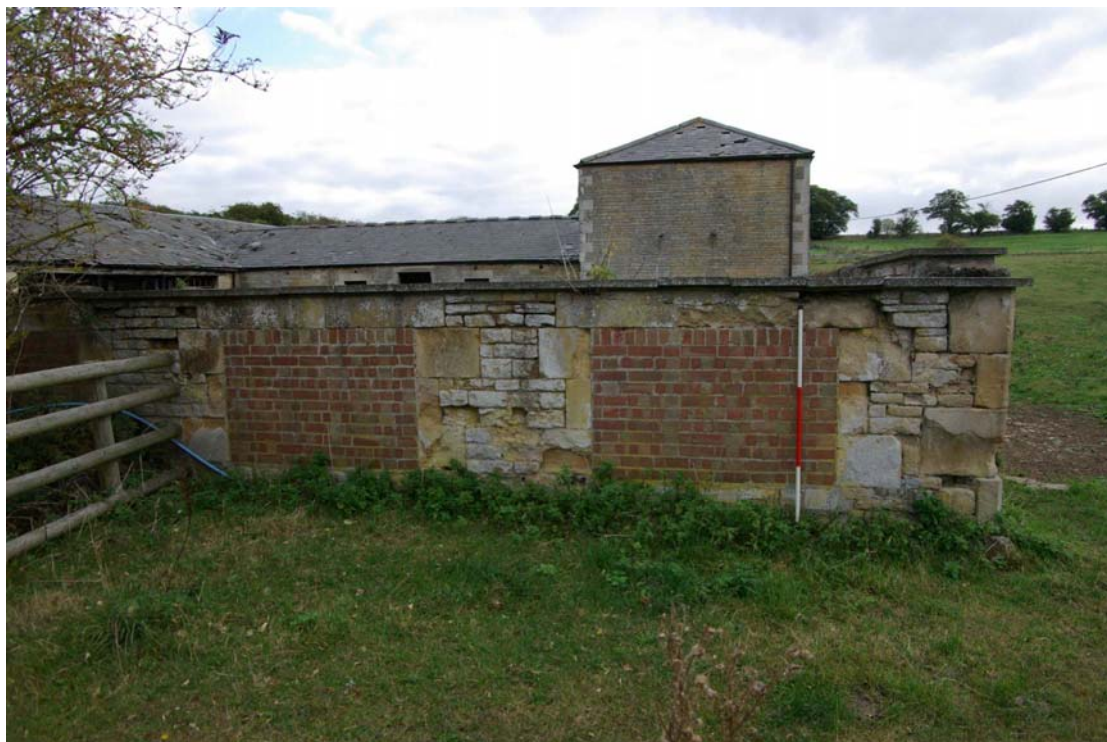
Figure 17 Western courtyard wall and blocked openings
Looking east. 1.5m scale

mid- to late 19th-century design. Two large circular air vents are located in the south side of the gable end. Otherwise there have been no visible alterations to this gable. The single gateway through the northern end of the western courtyard wall appears to have been inserted as the quoins stop at the top of the wall height on the range gable end and there are no quoins on the wall either side of the gateway. A row of four openings with dressed quoins are located towards the southern end of the courtyard wall. They have all been blocked with modern bricks and correspond with the demolished rectangular building within courtyard 2 (fig. 17).

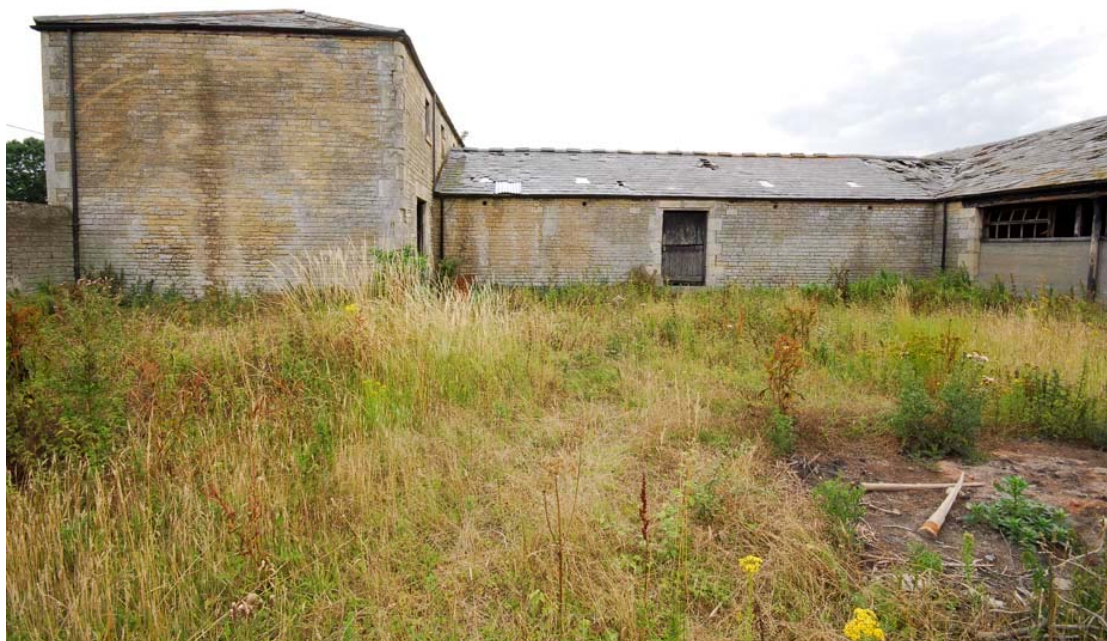
Figure 19 Courtyard 1 east elevation
Looking west

The east elevation of the courtyard consists of the central range and the two-storey building on the south side of the complex (fig.19). A single stable type door breaks the otherwise blank wall of the central range and has the same decorative quoins as seen elsewhere in the complex. Circular vents at eaves height are also in common with those seen on the other elevations. The two storey block has no evidence of any alterations or blockings and is keyed into the central range indicating a contemporary date of construction.

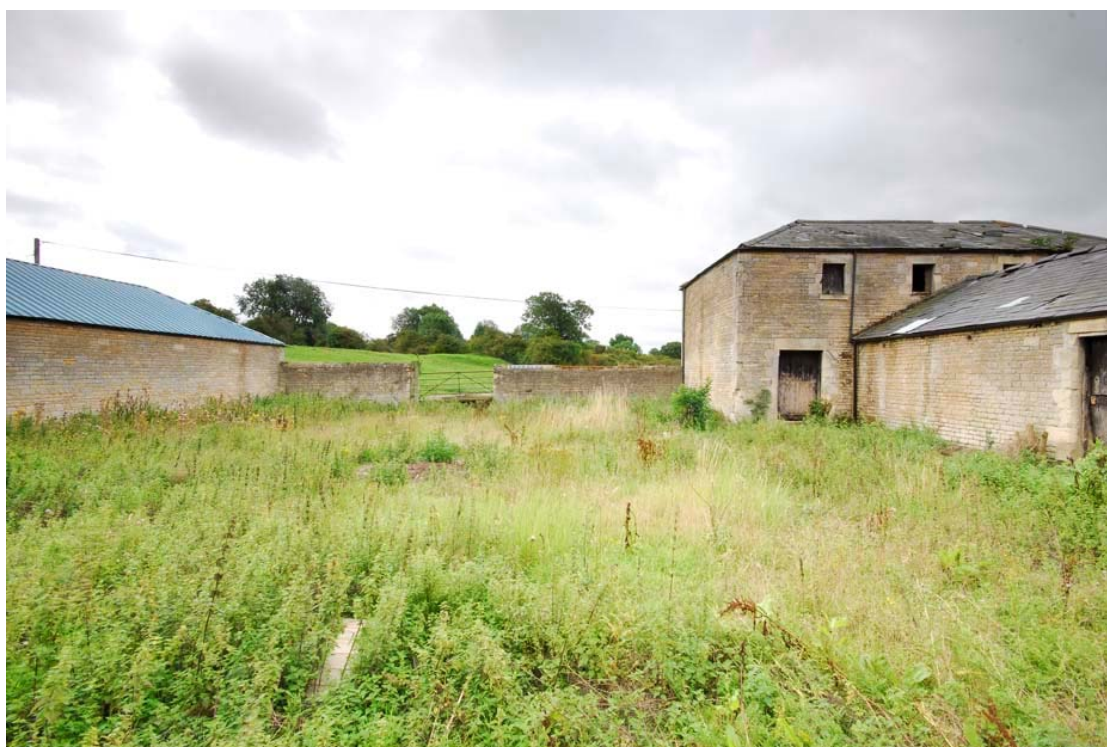
Figure 20 Courtyard 1 north elevation
Looking south

The outer courtyard wall shows the same signs of rebuilding as noted on its northern side. The two storey building has a single stable type door at ground floor level and two windows, matched by two more in courtyard 2 (fig. 20). The door has stop chamfered jambs and a decorative latch plate of the same design as on the front of the building (fig.21).

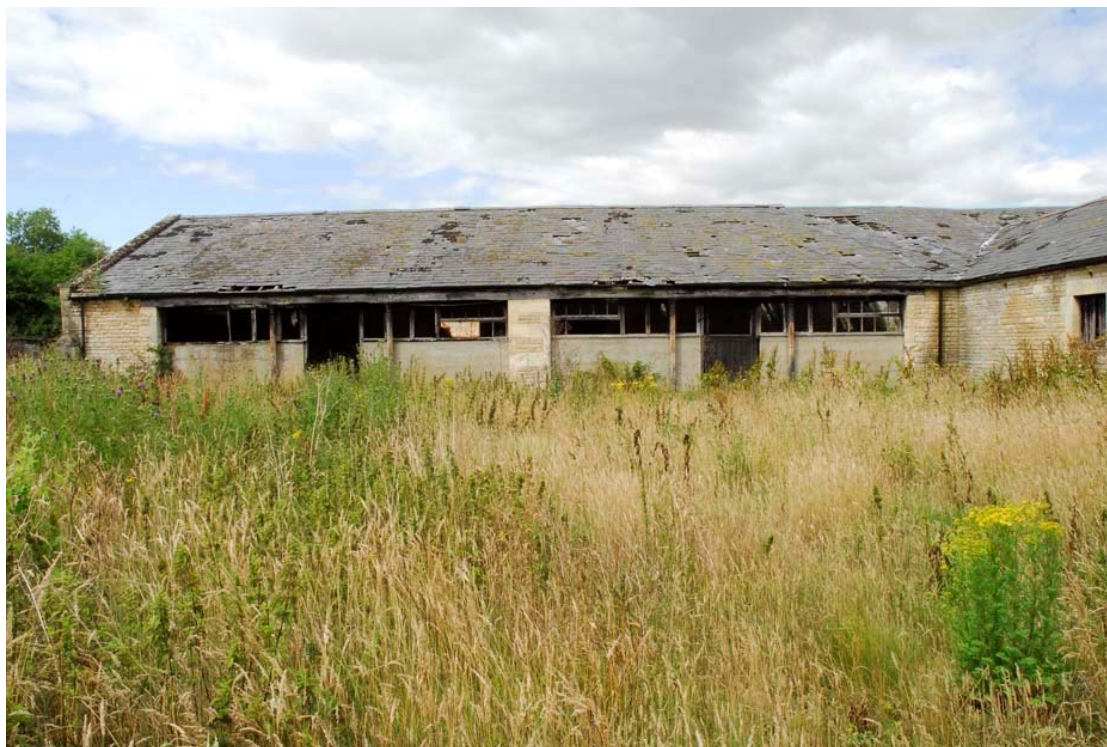
Figure 22 Courtyard 2 south elevation
Looking north

The south elevation of the courtyard is virtually the same as in courtyard 1 with an open fronted shed divided into six bays by cast iron columns. The same concrete block work and wooden windows have been used to enclose the room inside (fig. 22).

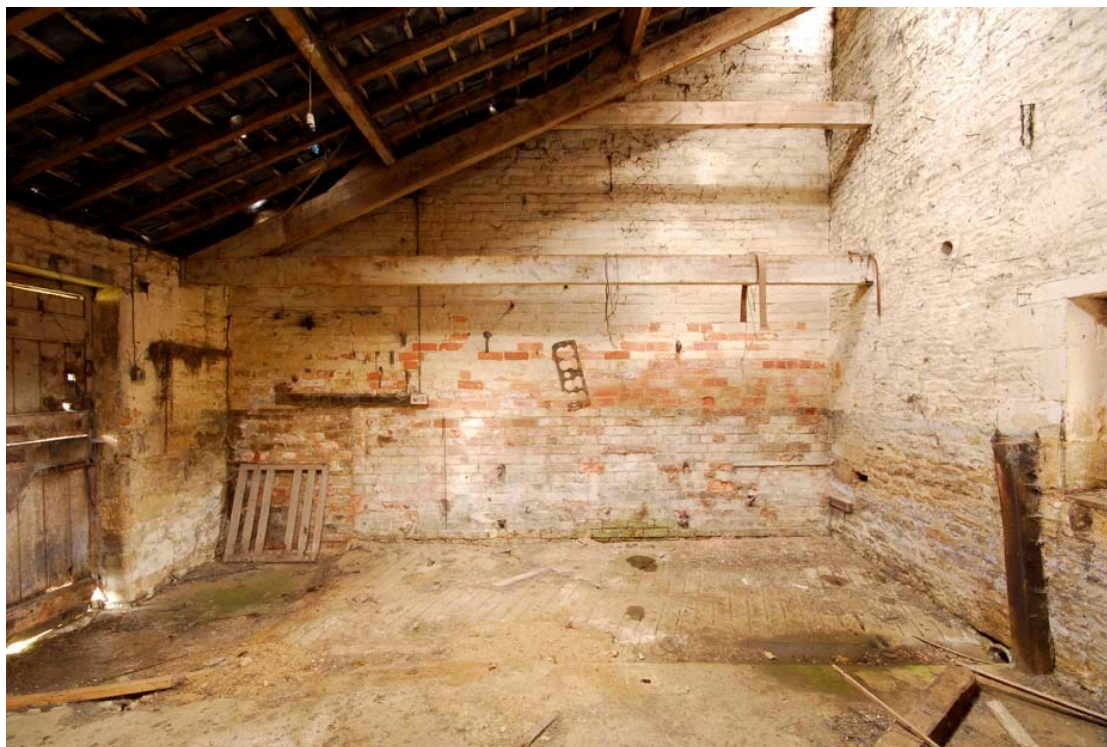
Figure 28 Room 3 with blocked door
Facing east

Room 3 is a small rectangular room with a single stable door on the northern wall (fig. 28). A square headed window with the remains of a wooden frame is on the southern wall and looks out into room 8. Above the window is a relieving arch made of stone rubble. This is a feature seen in all doors and windows cutting through the central spine wall. Fragments of board in the broken frame suggest the window had ventilation slats over it rather than being glazed. A single door with a wooden lintel leading east into room 4 has been blocked using 215mm x 65mm x 105mm high bricks. A small short wooden trough survives in the north-west corner.

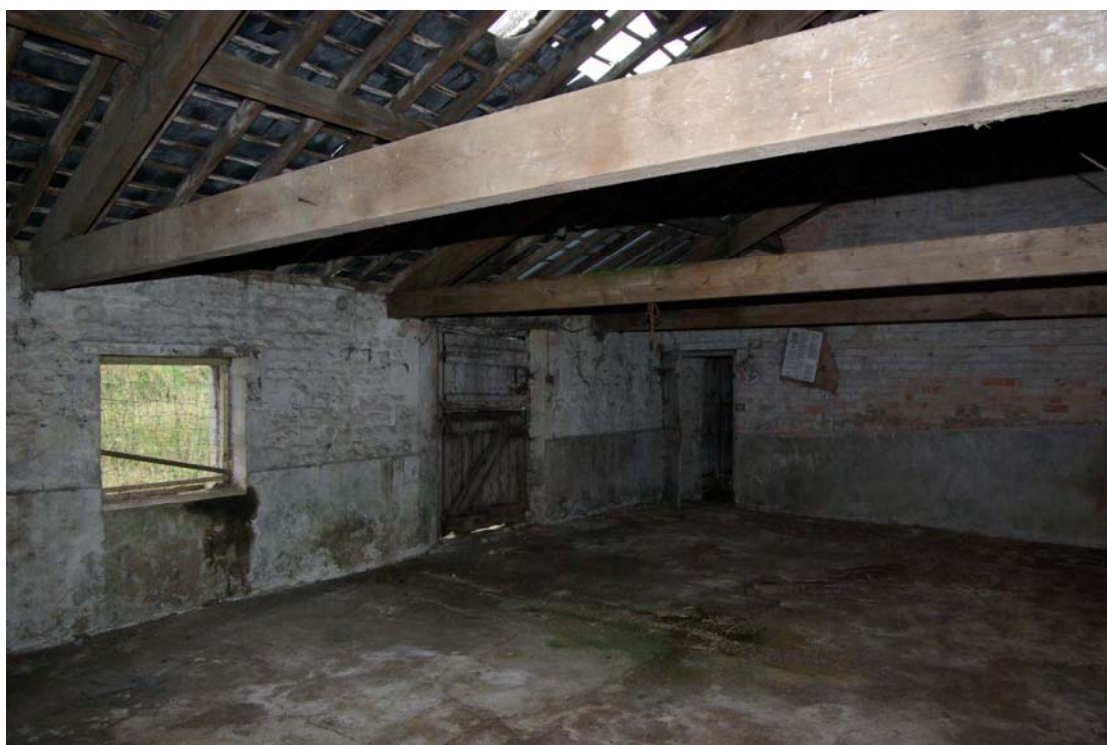
Figure 29 Room 4
Looking north east

Room 4 is roughly twice the size of room 3 and, when first built, had doors on each wall (fig. 29). The main entrance is a wide door to the north which has a deep chamfer on the west to allow the door to swing open to a wider angle than would normally be possible. A thin plank and batten doorway leading to room 5 gives an indication of what the blocked doorway from room 3 would have looked like. A better quality stable door leads from room 8, to the south, and is made from beaded vertical planks. The door has a metal latch and thin strap hinges of the same style as noted in other doors within this building (fig. 30).

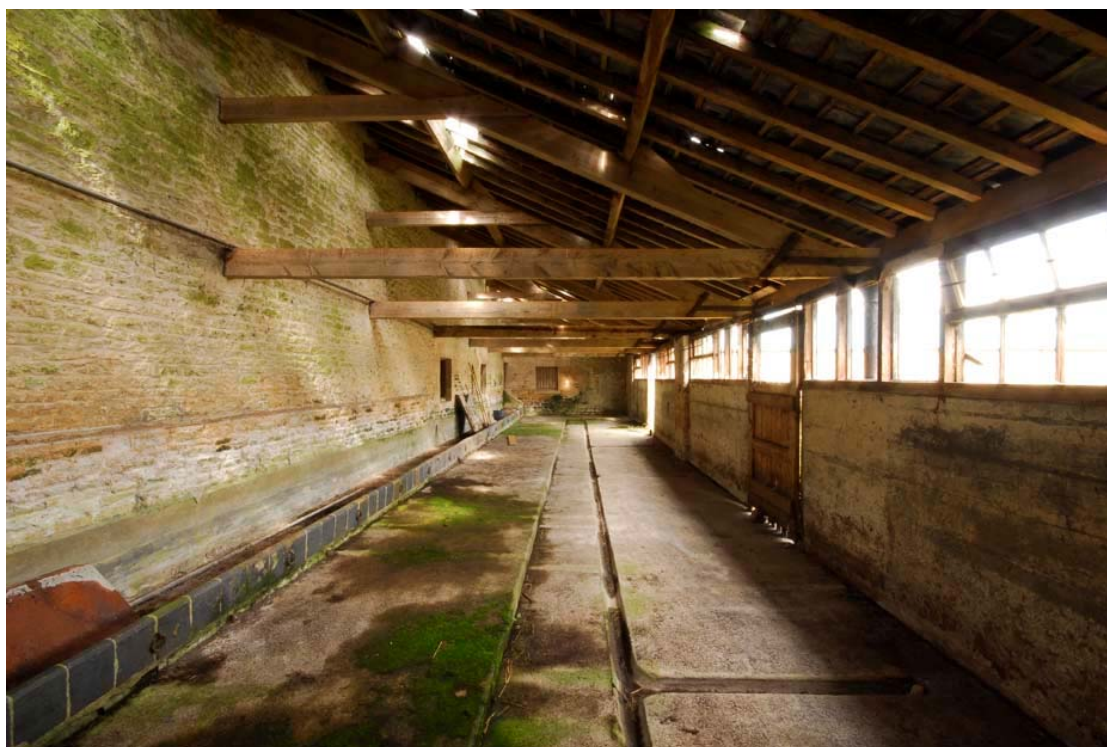
Figure 36 Room 9
Looking east

This room is virtually the same as room 8 except that the trough extends the full length of the room up to the doorway at the east end (fig. 36). The windows also have filled in holes each side to hold bars and the trusses have rusty marks where equipment has been removed. As with room 8 a single sliding door leads into the large central room 5. A wide doorway with a folding plank and batten door leading through into room 7 is located in the north east corner of the room. The door has long strap hinges and a metal latch with a recessed handle on the outer side (fig. 37).

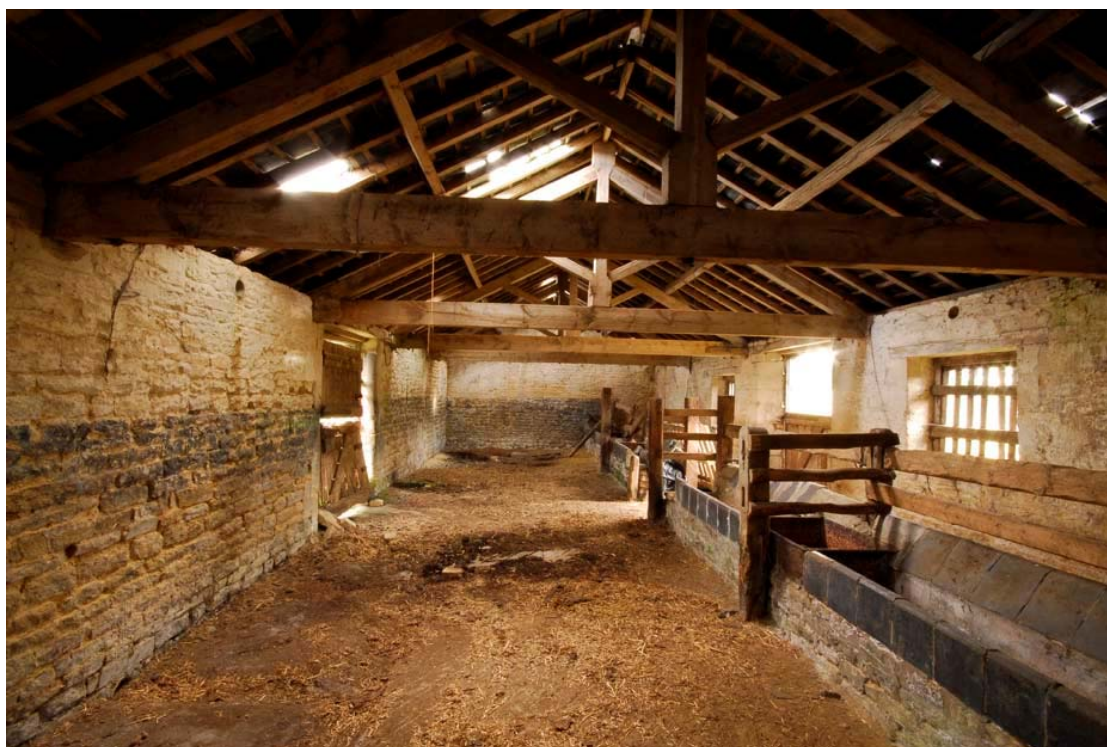
Figure 38 Room 11 north to south range
Looking north

Room 11 forms the only room of the north to south central range. It has a stone and brick built trough running down the western half of the room with metal bins breaking the trough into six bays (fig. 38). The troughs are in a relatively poor state of repair and do not look to be of the same quality as the rest of the building. The roof structure is the same design as the cart shed although there is no metal strapping and the principals are bolted to the trusses. Both doors leading out to the courtyards have wide chamfers on one side to allow the doors to be opened wider than would normally be possible.

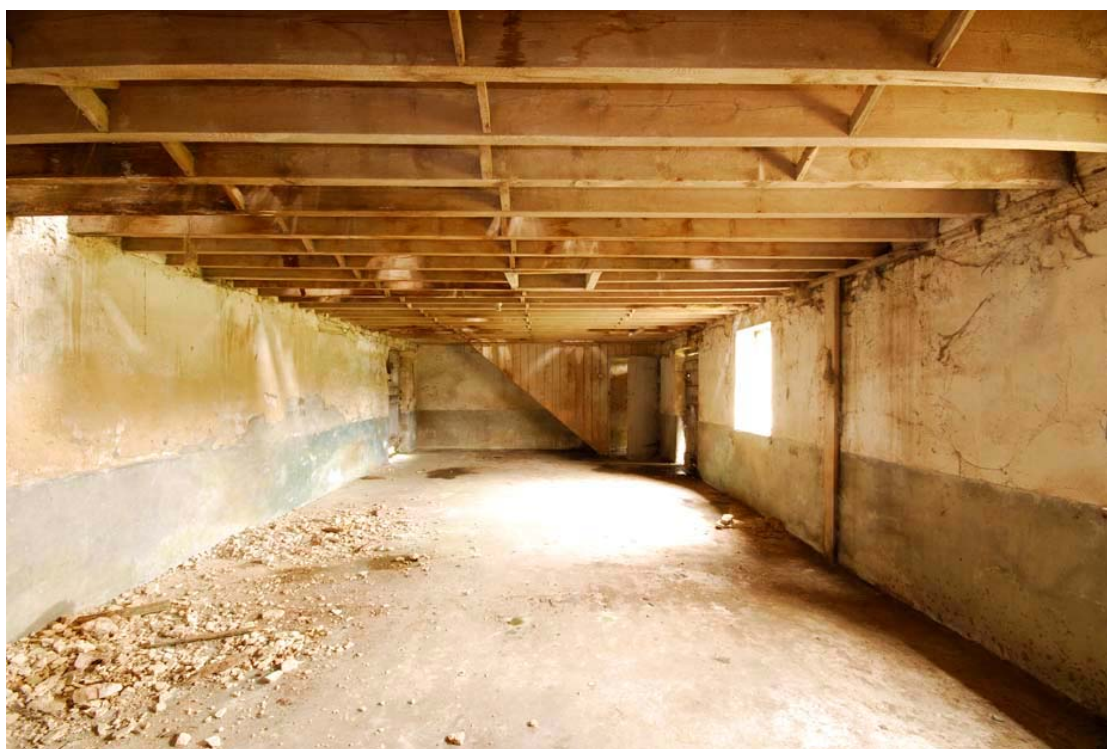
Figure 39 Room 12 central building, ground floor
Looking east

Room 12 forms the ground floor room of the two storey southern building. The room is fully plastered with lime plaster from window sill height to ceiling and with more recent plaster from sill to floor (fig. 39). The stable door from courtyard 1 has strap hinges and a metal latch matching the stable door leading out to the front of the range and others noted around the complex. No windows are left in the frames and the room appears to have been vandalised to a certain degree.

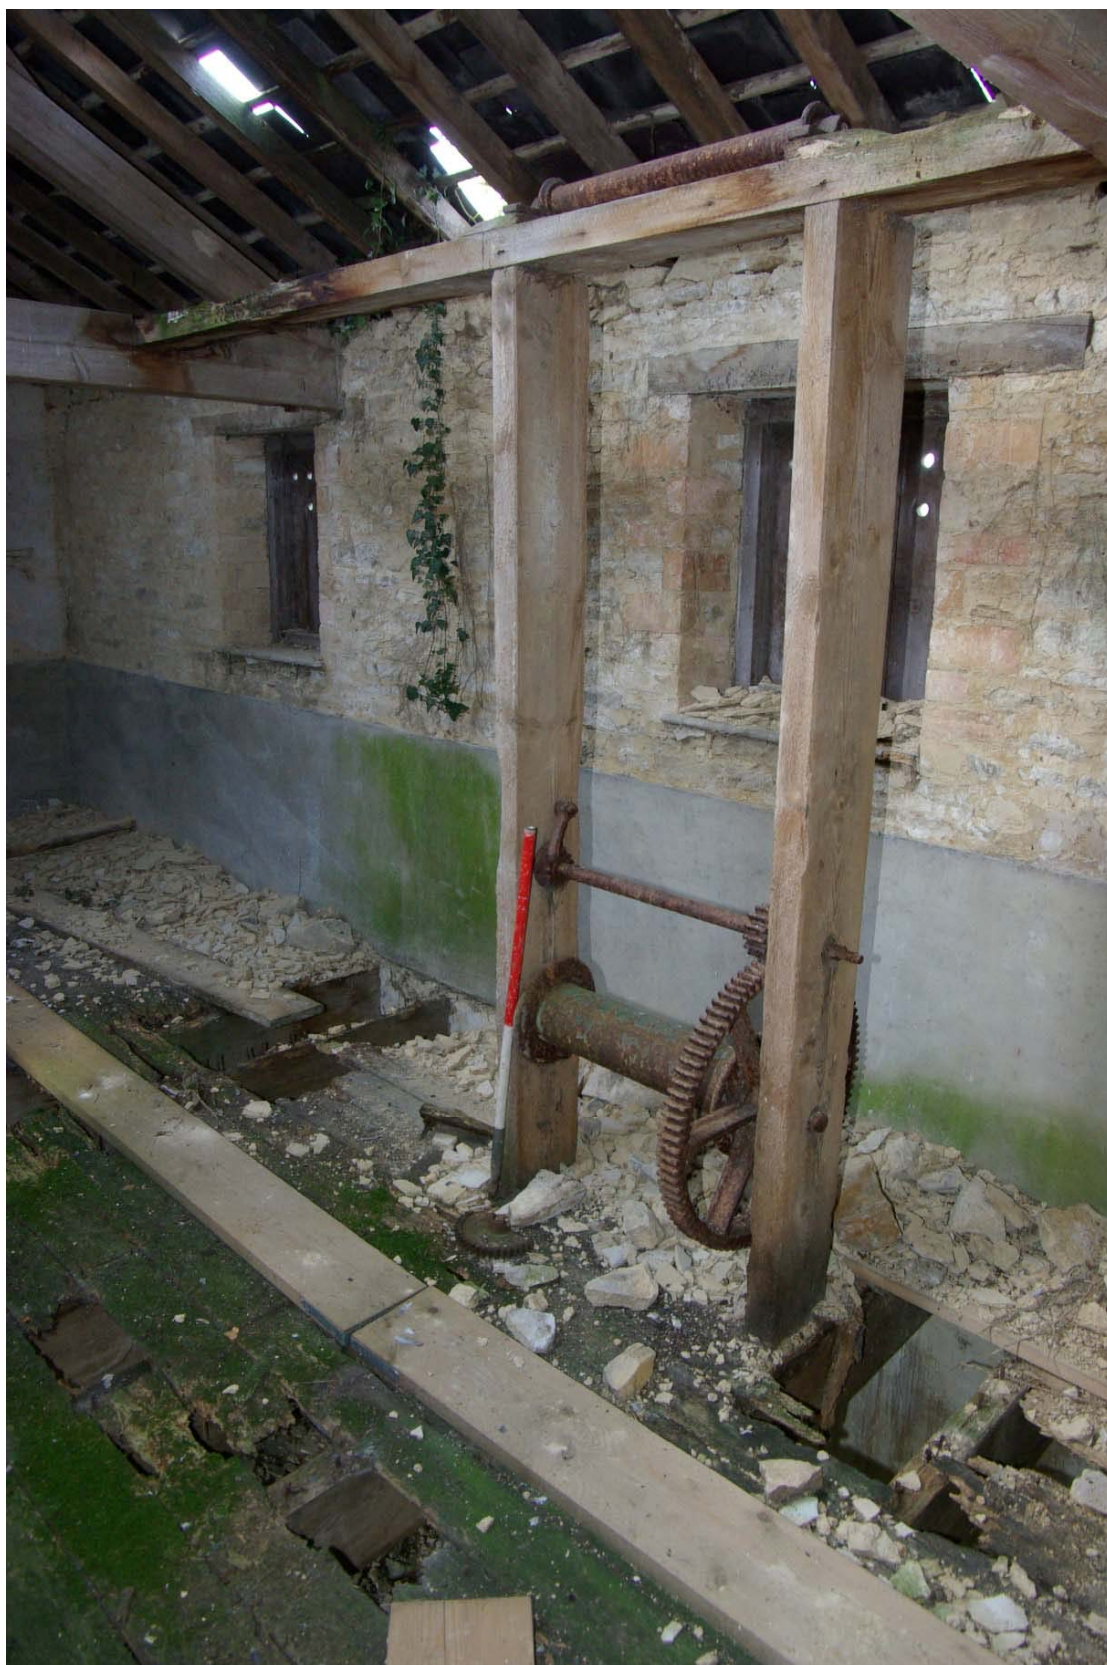
Figure 41 Room 13 winding gear
Looking north west. 1m scale

The first floor room floorboards are in a very poor state of repair due to the number of holes in the slate roof. It has an enclosed banister around the top of the stairs which lead up into the room which appears to have been plastered relatively recently up to sill height (fig. 40). To the east of the main loading door can be seen the bolts attached to the loading jib noted on the southern elevation. Opposite this are the remains of a hand-powered winch supported between two large timbers (fig. 41). The roof structure is the same as in room 11 and the cart shed.
