**An Archaeological watching Brief
At the Goddard and Paget Building,
The Atkins Factory, Lower Bond Street,
Hinckley, Leicestershire**

An Archaeological Watching Brief at the Goddard and Paget Building, The Atkins Factory, Lower Bond Street, Hinckley, Leicestershire. NGR: SP 426 941

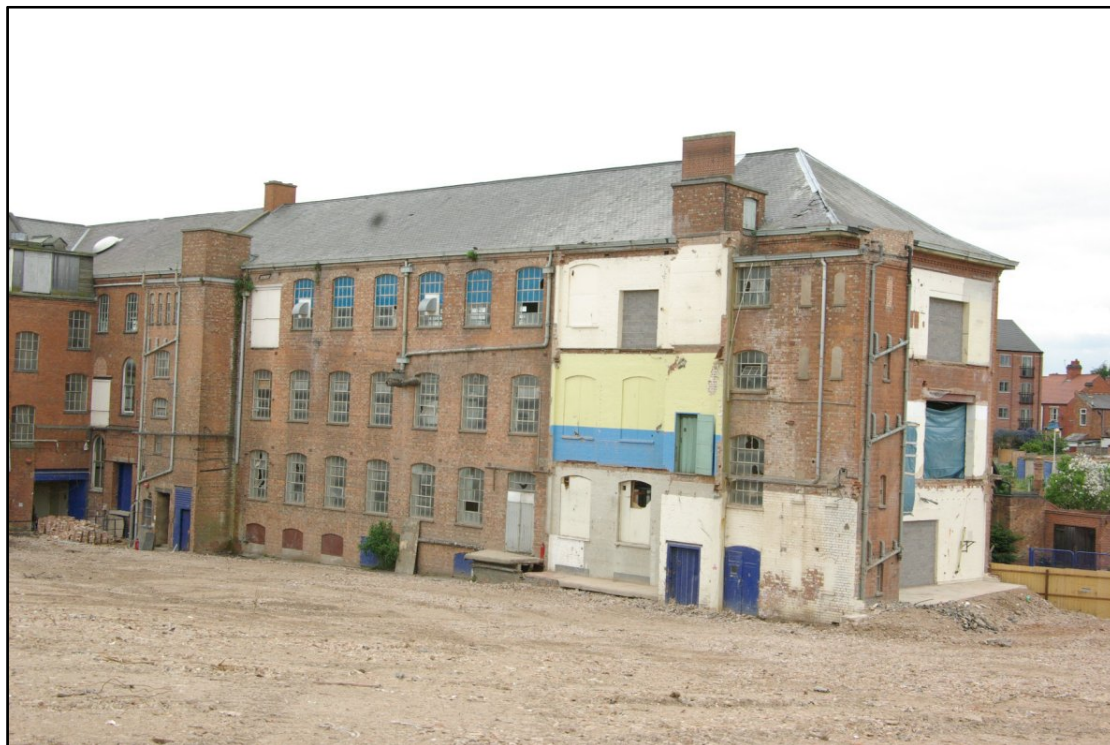
As the building has stood empty for a number of years, the effects of lack of maintenance and removal of vents and other outlets piercing the roof have begun to take their toll (fig. 3). Water is entering the building at a number of points and would, if not addressed, begin to cause serious damage to the structure. The roof renovation removed the existing slates, battens and all of the underlying fibrous material plus the replacement and repair of any damaged or missing sarking boards. Any vents and holes created by earlier extraction and venting equipment were also filled and covered. A breathable membrane and new battens were then attached before relaying the slates. The roofing slates and battens were removed in relatively small sections from north to south along the length of the building to ensure that only minimal areas of the underlying woodwork were exposed at any one time. Once any repairs to the sarking boards had been made a breathable membrane and insulating material were added and new battens nailed through onto the boards. Wherever possible the original slates were re-used and new, matching slates used for the remainder. The gutters and other rainwater goods were also repaired.

Figure 3. Rear of Lower Bond Street range showing poor state of roof prior to repairs.
Looking south west.

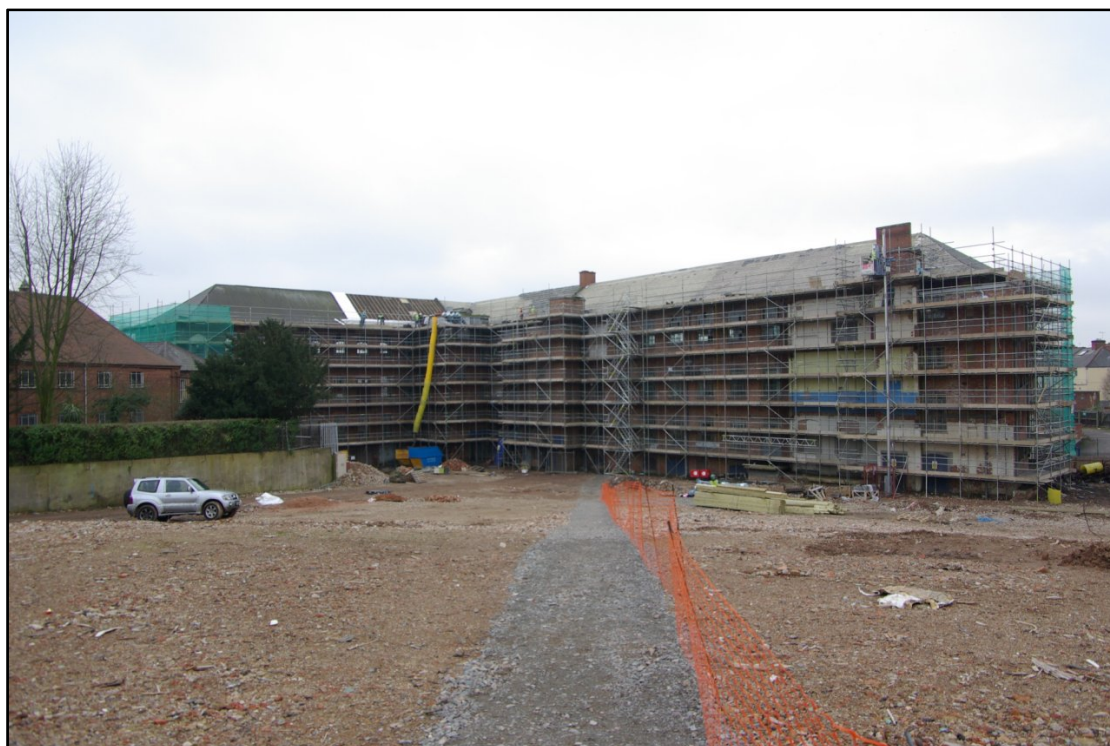
Most of the 1910 range on both east and west sides had been stripped and the membrane and insulation attached to the boards (fig. 4). The majority of the slates had also been replaced on the Lower Bond Street frontage so that the junction between the 1870s and 1910 ranges was effectively covered (fig. 5). It was however clear that the sarking boards, which were laid on top of the rafters, were originally covered with a fibrous sheeting material onto which the battens for the slates had been laid. Because of this construction method it could be seen that in most places the boards were not masking any hidden features between the outer and internal roof structure. The northern side of the Baine's Lane roof was also exposed at this time and had not yet had any insulation or waterproof membrane attached. Only the new boards covering the holes left by two modern ventilator fans could be seen over an otherwise featureless roof (fig. 6). Unfortunately because sarking boards had been attached to the rafters supporting both the roof and the internal gable at the Bond Street and Baine's Lane junction it was not possible to inspect the hidden gable in order to investigate the building sequence (fig. 7).

Figure 4. Courtyard of Baine's Lane and Lower Bond Street ranges.

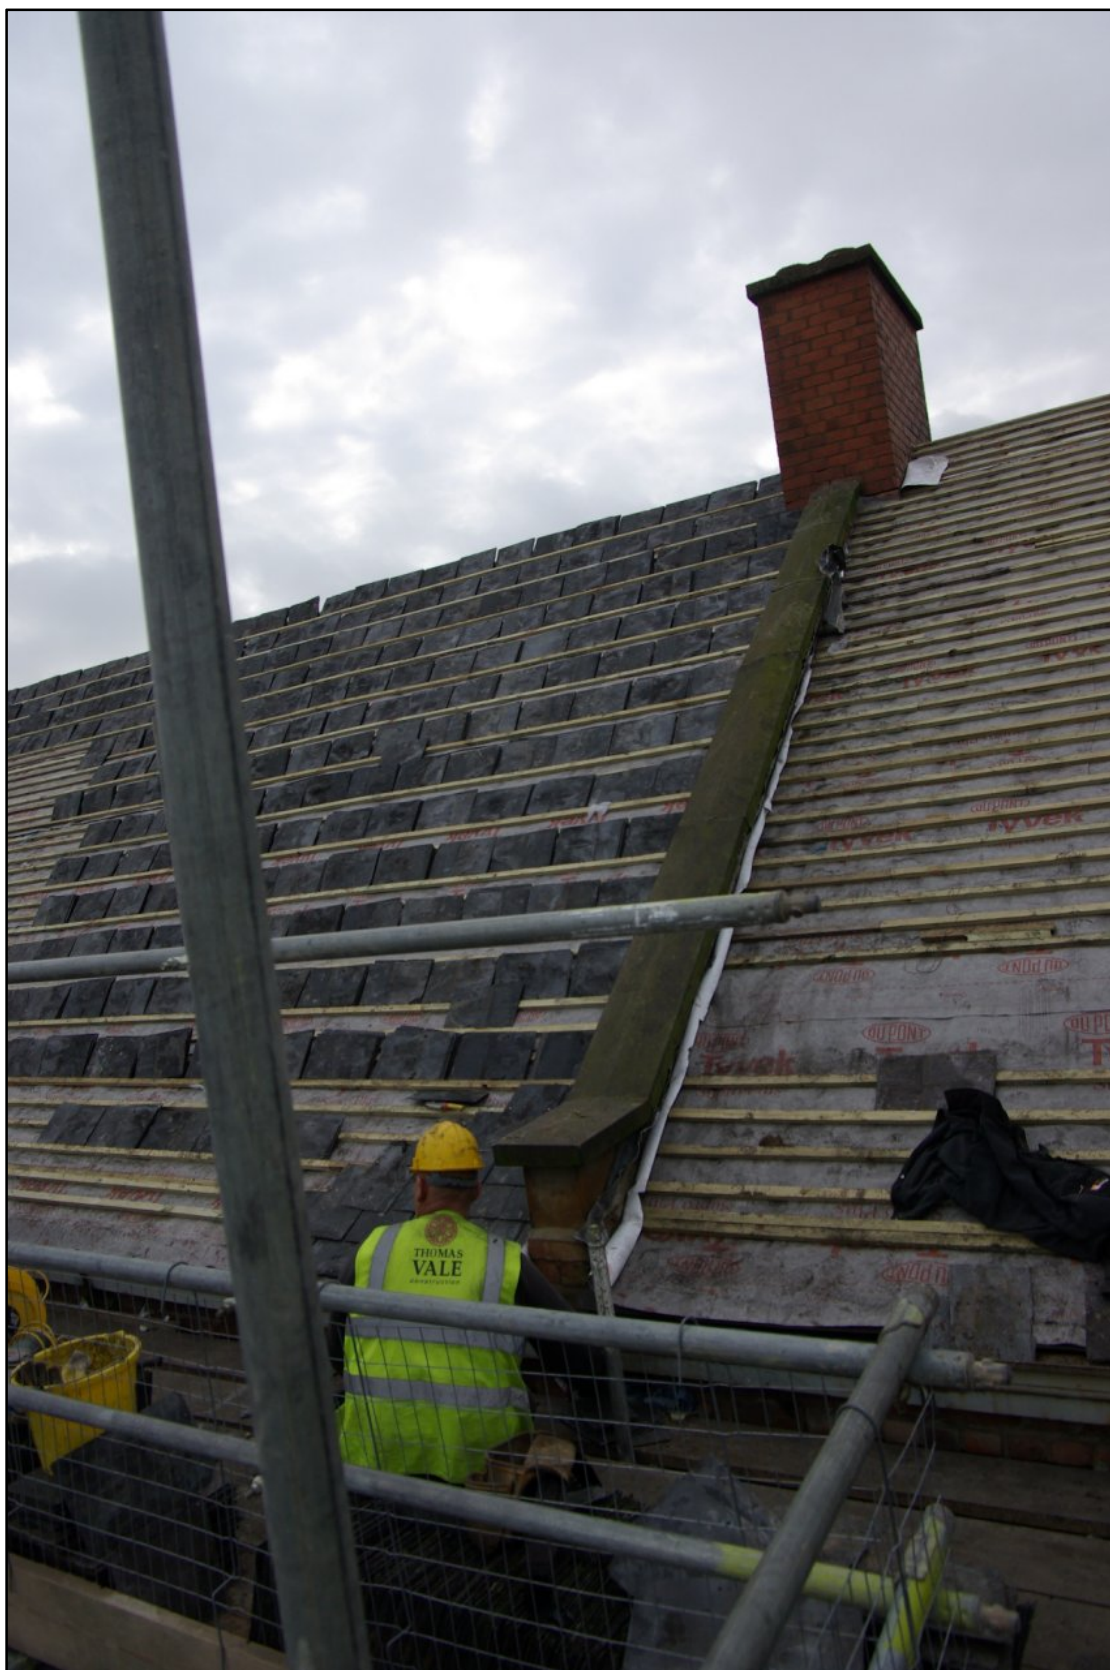
Figure 5 Junction of 1870s and 1910 ranges, courtyard side.
Looking south west.

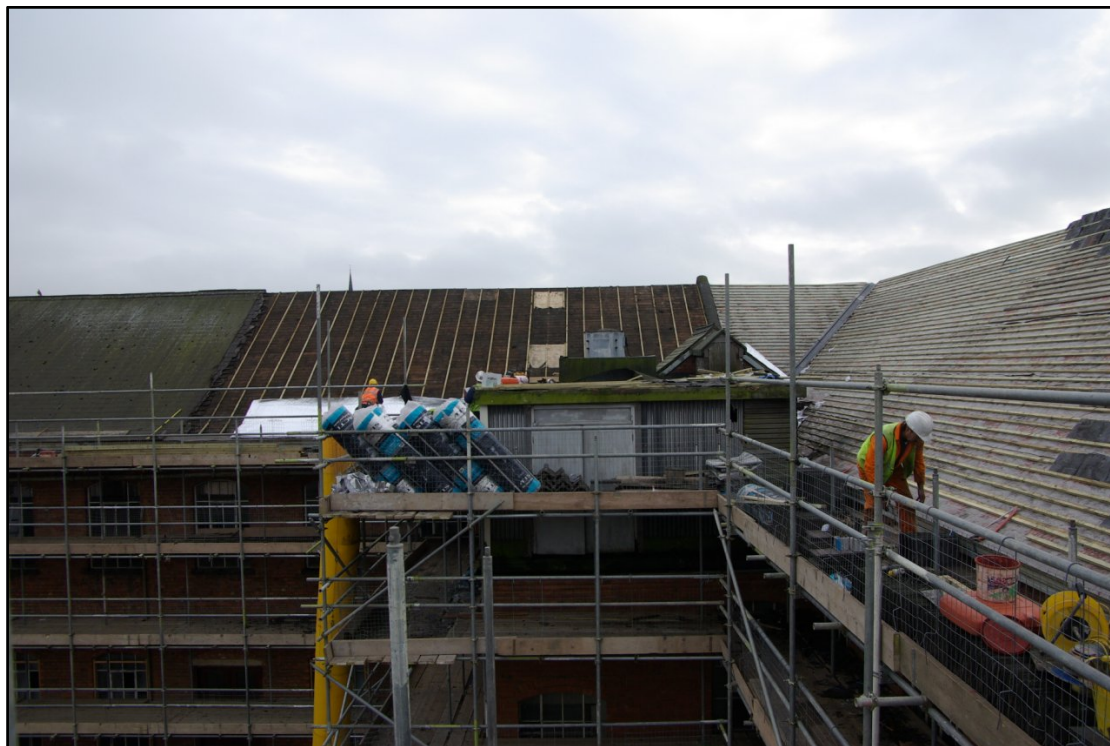
Figure 6 Baine's Lane and Lower Bond Street roof junction.
Looking south.

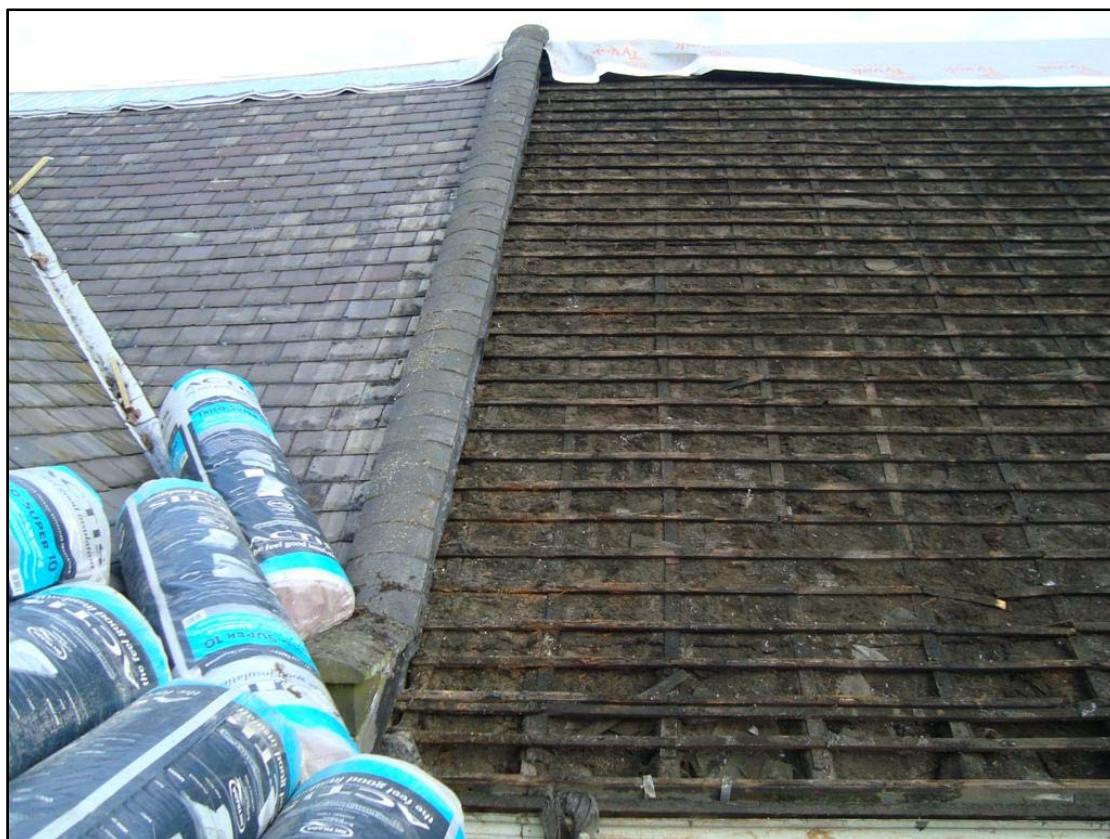
Figure 7 Junction of Baine's Lane and 1870s range
Facing north.

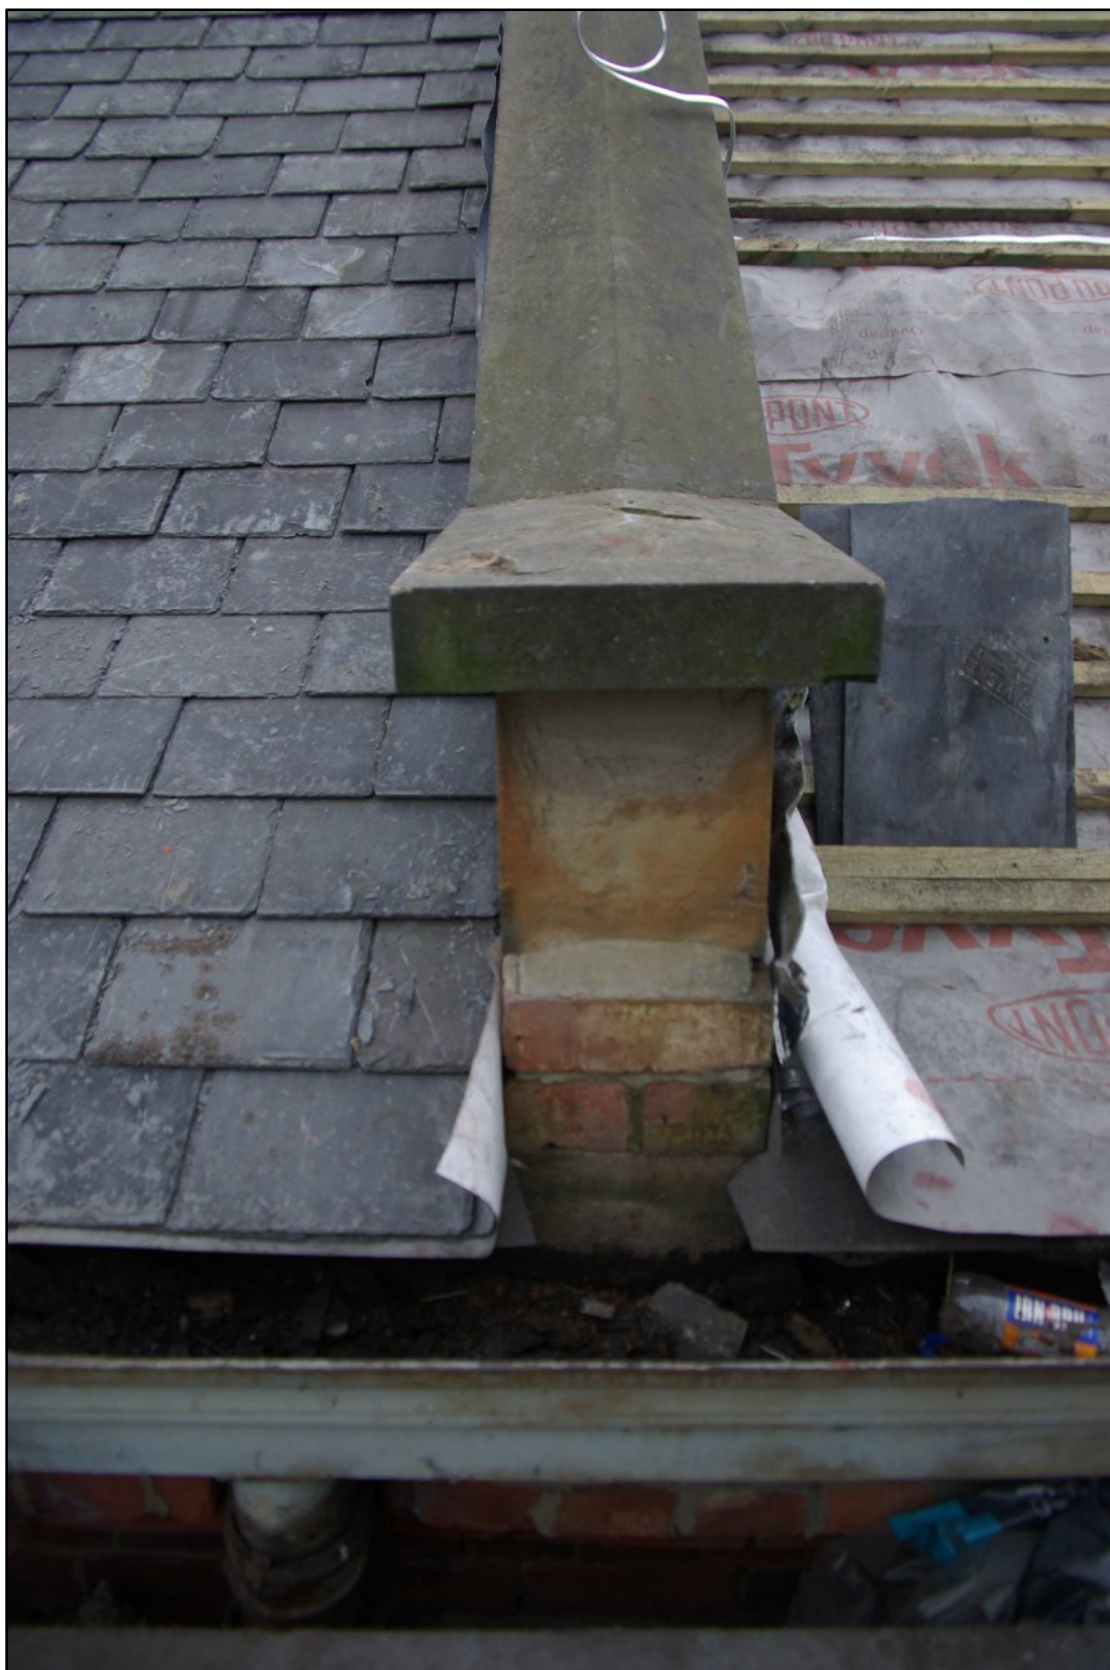
Most of the slates on the south side of the Baine's Lane range had been relaid by the time of the second visit leaving the southern end of the Lower Bond Street range and part of the courtyard side still to be completed. A record was made of the parapet junction between the 1870's and 1910 ranges, the rainwater goods and guttering details (figs. 8 and 9).

Figure 8 Parapet at junction of 1870s and 1910 ranges
Looking west

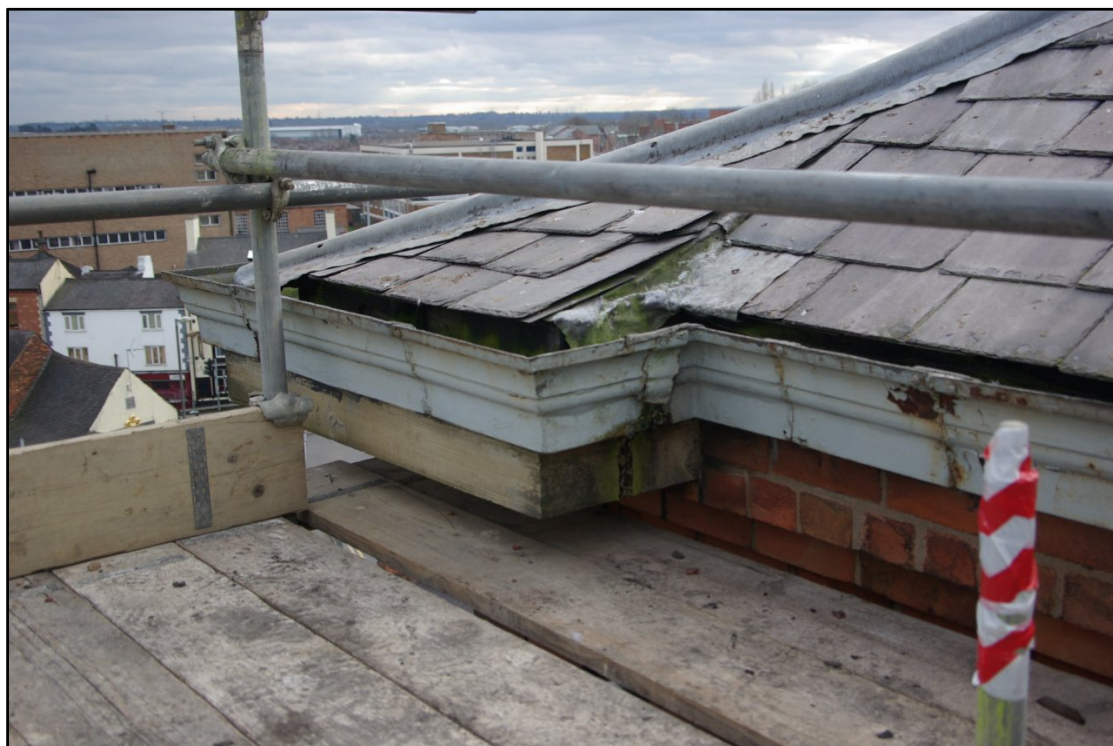
Figure 9 Baine's Lane guttering at southern end
Looking south west
