**A Photographic Survey of An Outbuilding
To the Rear of View Farmhouse
Sharnford, Leicestershire
(NGR SP 480 916)**

ULAS Report Number 2009-062

**A Photographic Survey of an Outbuilding to the Rear of View Farmhouse
Coventry Road, Sharnford, Leicestershire, (NGR SP 480 916).**

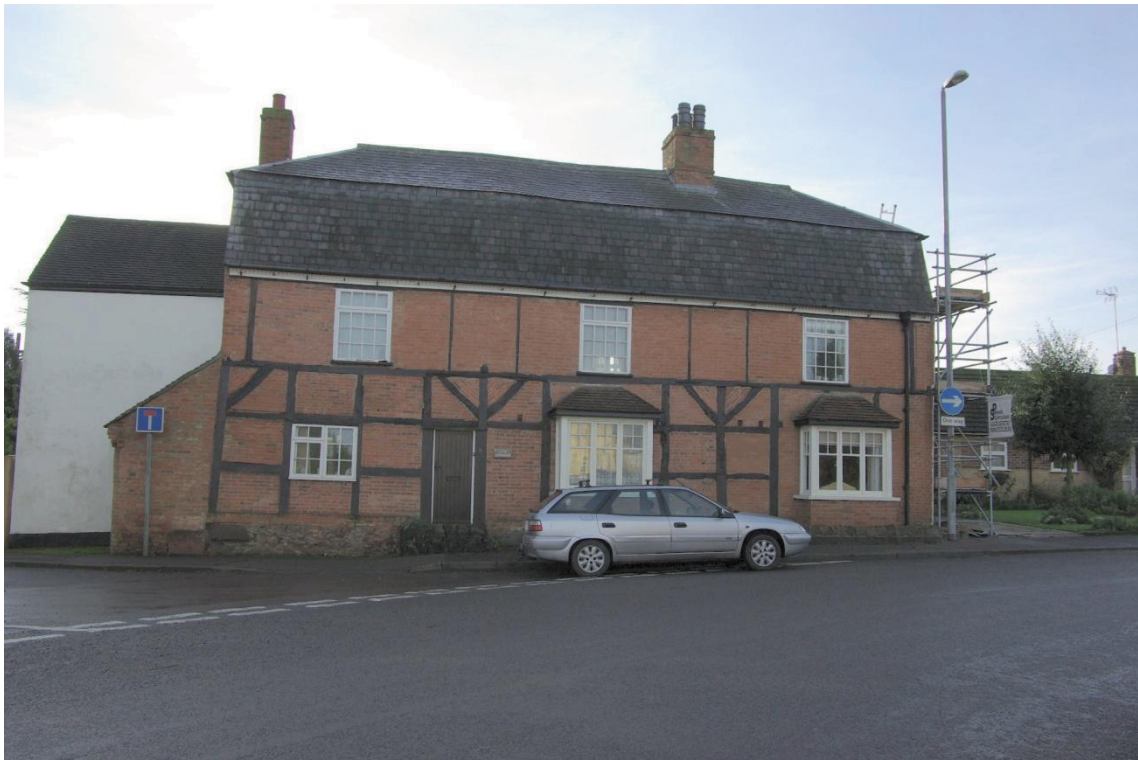
View Farmhouse is a Grade II listed building consisting of a three-bay timber box frame with brick nogging (*Figure 2*) with stables and outbuildings to the rear forming an L plan. It is the larger of these rear outbuildings, adjoining the house, which was recorded during this phase of work.

Figure 2 View Farmhouse, Front Elevation (Looking Southeast).

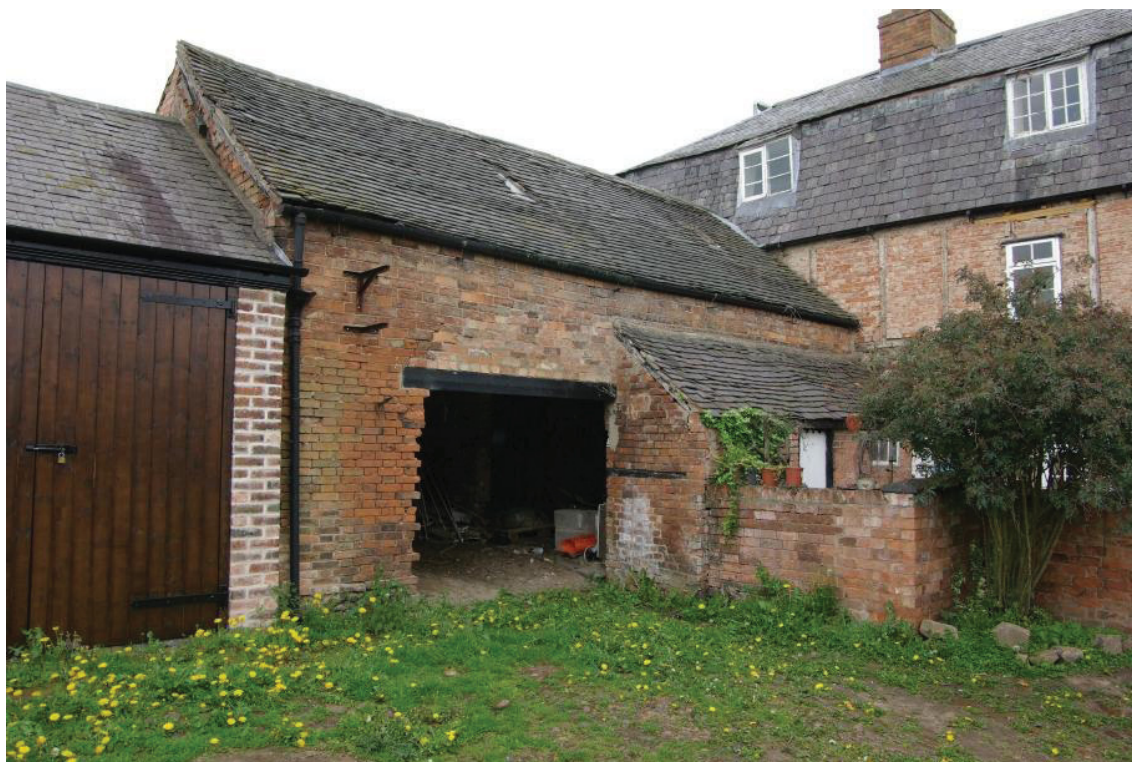
The surveyed building is constructed in red brick of several phases with a plain tile roof. There is a small lean-to on the northern side of the front elevation (*Figure 3*), to the south of which there is a recently-inserted opening. The lower courses of brickwork consist of 2 ½ inch hand made red bricks, probably late eighteenth or early nineteenth century in date. The upper ten courses of the east and west walls are 3 inch machine made bricks, indicating the eaves height has been raised by approximately 2' 6" (750mm), probably in the late nineteenth century. The bricks used in the lean-to are the same eighteenth/early nineteenth century bricks as the lower courses of the main building.

Figure 3 Front Elevation of Outbuilding (Looking North West).

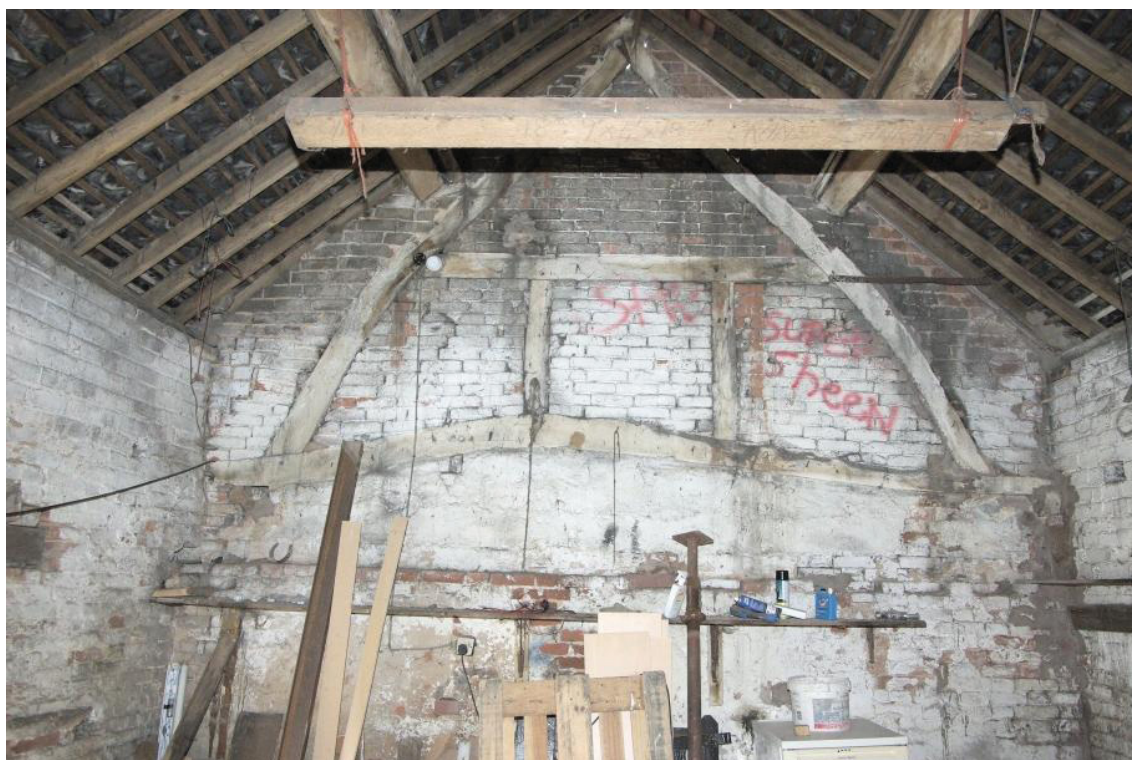
The most significant structural remains are the two timber roof trusses (*Figures 4 & 5*), one trapped within the southern gable wall, and the other within a partition wall. Both are similar in design, they are principal roof trusses of collar and tie beam form, the principals are ogee shaped and halved together at the apex. The feet of the principals, tenoned into the tie beam, are inset some distance from the tie beam ends. Both tiebeams are cambered. There are queen struts framed between the tie beam and the collar in each truss. Notches in the principals above the collar indicate original purlin positions, now infilled with brick. There are carpenters marks on the joint between the collar and principal (*Figure 6*). The roof has subsequently been raised in height and the existing purlins may be those removed from the frame and reset at a higher level. This design of roof truss was common in Leicestershire throughout the seventeenth century and into the first half of eighteenth century. The lowest courses of brickwork in the

Figure 4 Southern (Left Hand) Roof Truss.

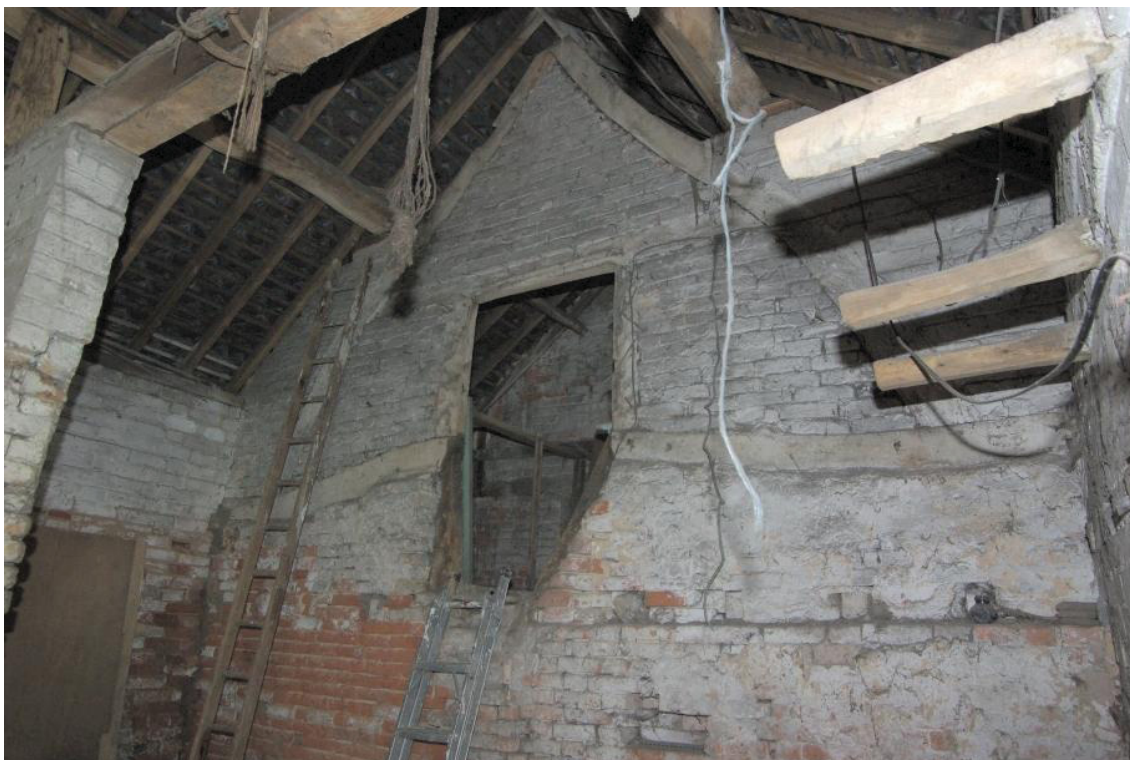
Figure 5 Northern (Right Hand) Roof Truss.

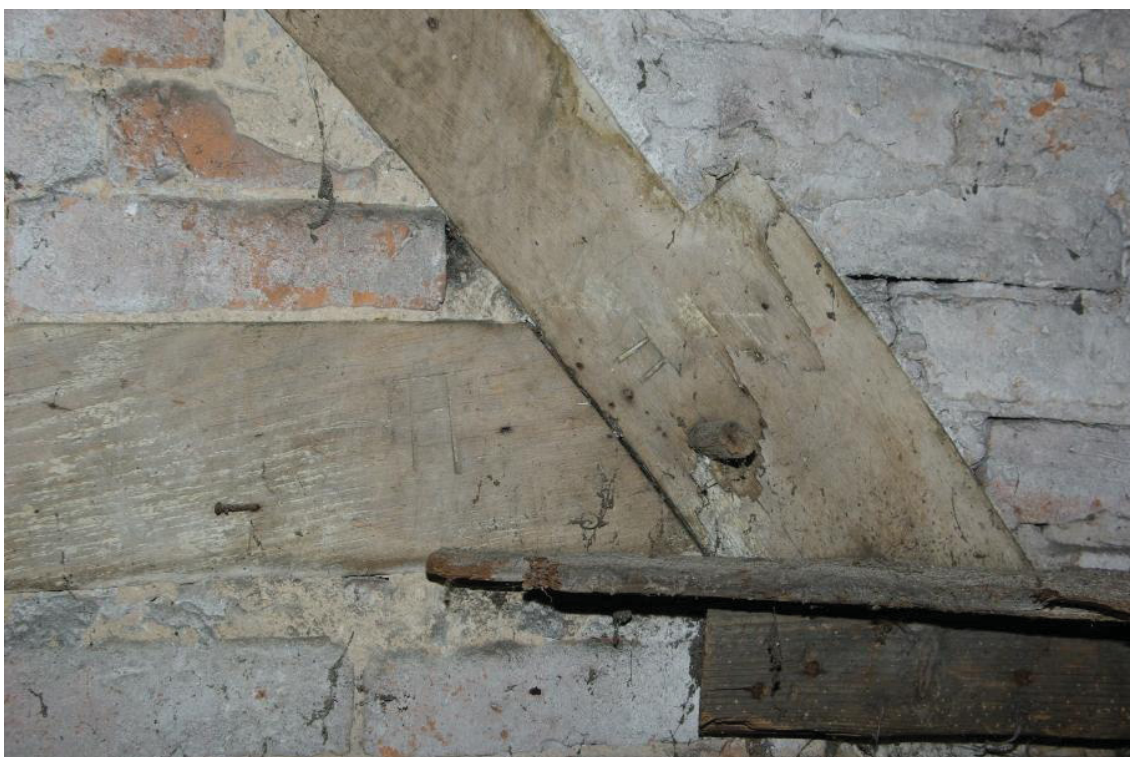
Figure 6 Detailed View of Carpenters Marks on Northern Roof Truss.

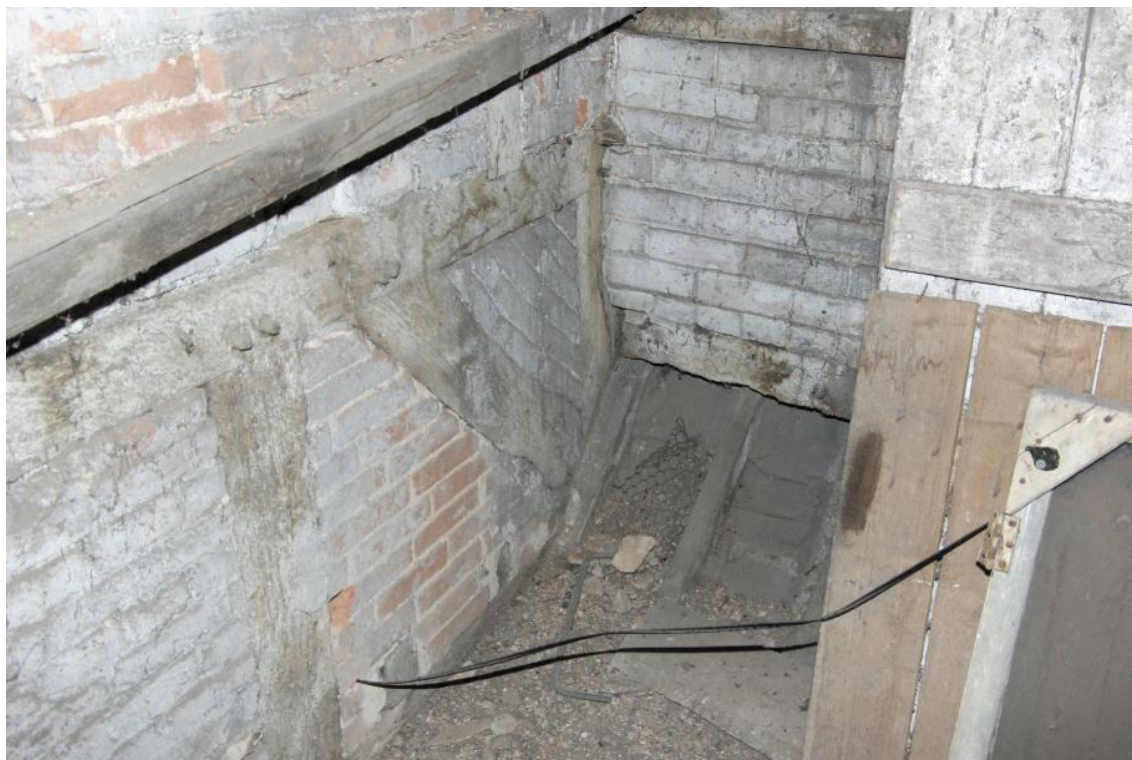
The building was originally of three bays, a stub wall projecting from the rear wall indicating the division of two of the bays. The third bay is still intact, abutting the rear of the house and is rather complicated. A limited view of some rafters (*Figure 7*) within the first floor loft space suggests the lean-to against the front wall is, in fact an earlier building onto which the larger building has been constructed. Further evidence of this can be seen in a straight joint within the brickwork on front wall and a possible scar of a removed wall visible in the floor.

Figure 7 Limited View of Roof Trusses from Possible Earlier Building.

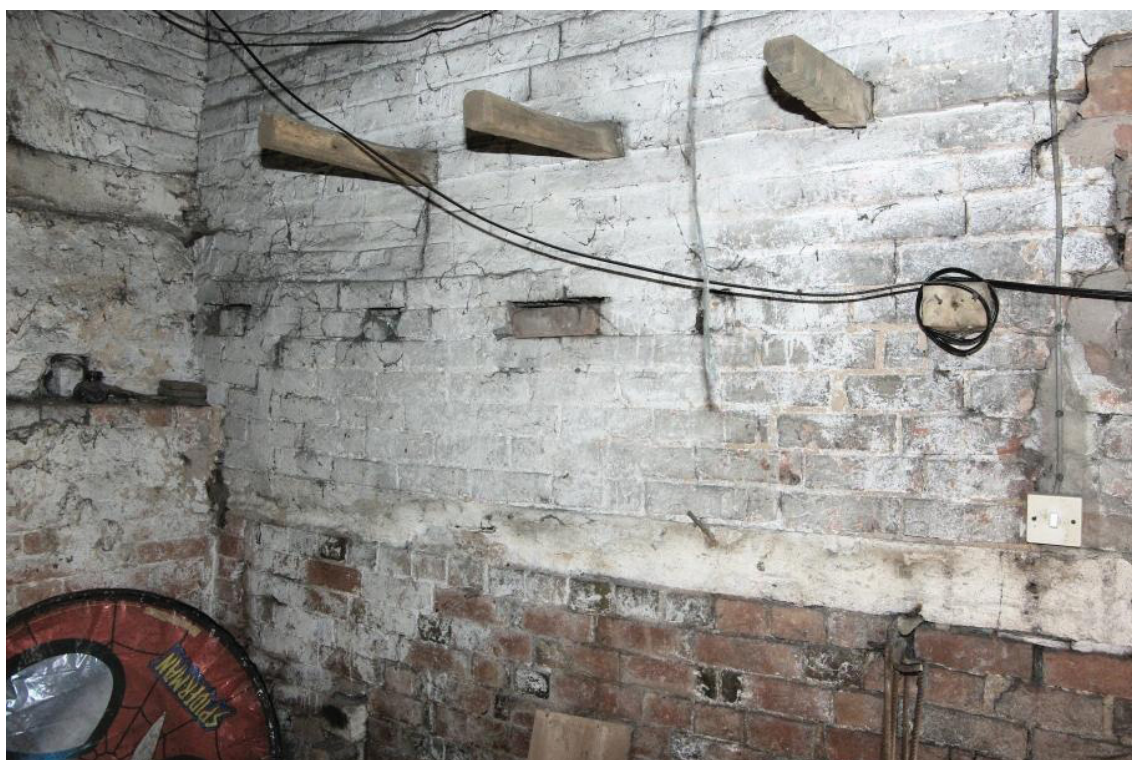
Internally, few historic architectural details remain. The only evidence for the former use of the main part of the building is three projecting timbers on the inside face of the front wall, wear on two of which suggest they were originally saddle trees (*Figure 8*). These suggest that this part of the building was in use as a tack room at some stage.

Figure 8 Possible Saddle Tree on Front Wall.

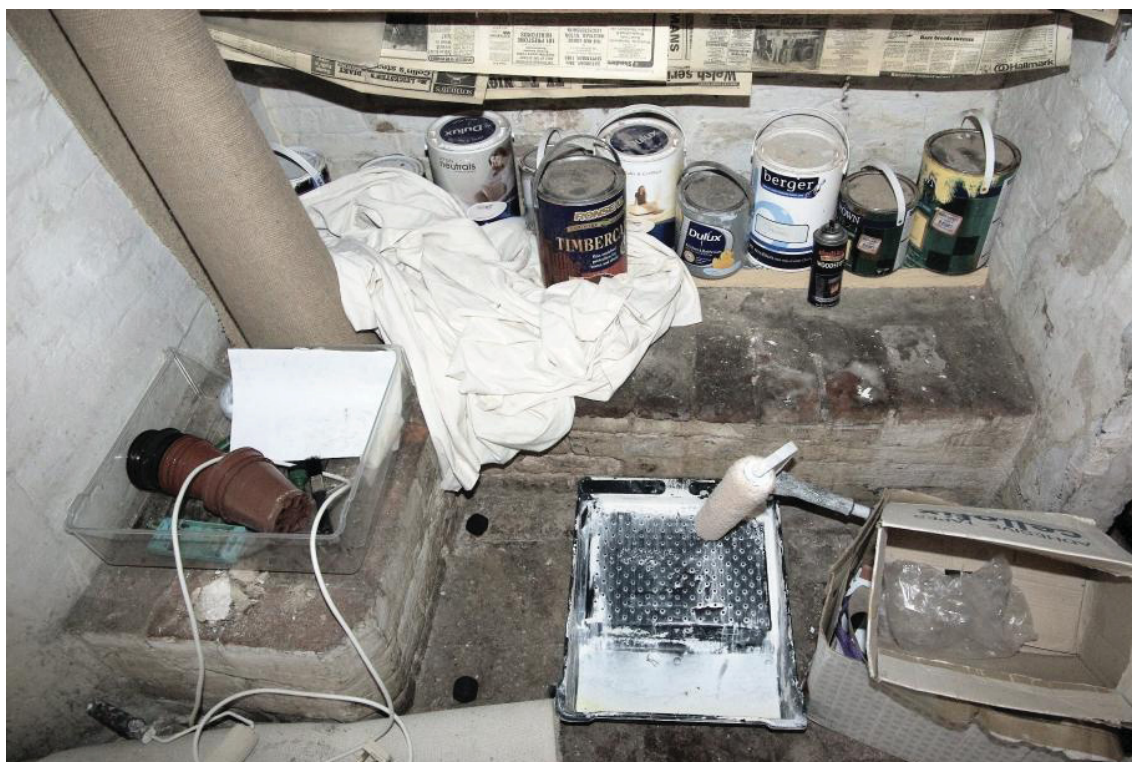
Immediately adjacent to the house, this third bay appears to have served a domestic function, there are thralls within two of the rooms (*Figure 9*) and there is a doorway into the main house. It is possible, therefore that this space was originally a dairy or pantry/scullery and was accessed from either the house or the door on the front elevation and isolated from the agricultural main building.

Figure 9 Thrall.
