**A Photographic Survey
of Cedars Farm, High Street,
Fleckney, Leicestershire
(NGR SP 649 935)**

For Glebe Contractors

Report 2004/179 ©2004

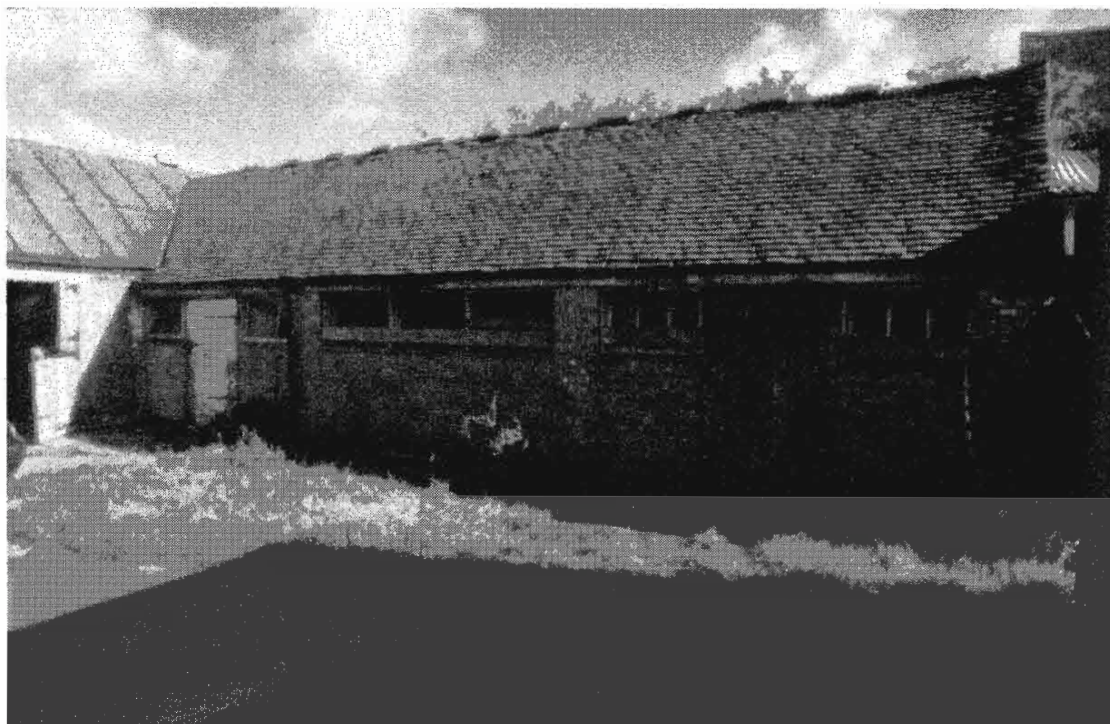
Outbuilding C2

Single-storey brick-built structure with flat clay tile roof (nib tiles) with stepped ridge tile ventilators (c/f B1). 3 bays. Late 19th century in date. This appears originally to have been open-fronted, the brickwork of the courtyard elevation being later than the rest of the structure. At the bay intervals originally brick piers with bull-nose brickwork, these supporting king post roof trusses. Same dentilated eaves course to B1 and same angled vent pipes in rear wall; various other similar details to that range but not identical and not certainly of the same date.

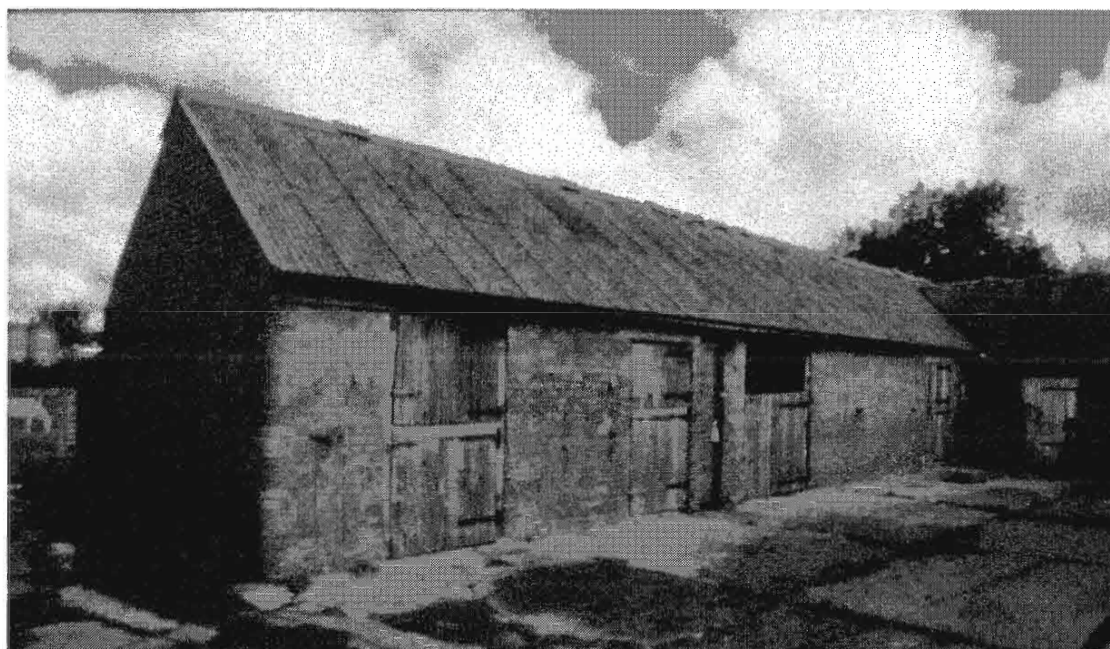
Outbuilding C1

Single-storey brick-built stable block (still in use as such at time of survey), with corrugated asbestos-covered roof. Late 19th century in date. Farmyard facing (front) elevation: bricks measure 9½ - 9⅝ x 4½ - 4⅝ x 3 inches. Crudely moulded bull-nose bricks to left hand corner, the left hand end of the building forming one side of the

farmyard entrance. Bricks vary in colour from buff to orange-red. There is a dentilated eaves course to the front elevation identical to that of B1 & C2. Internally floors are composed of large water-worn pebbles and incorporate drains. The roof structure is supported by two suspended king post trusses of rather crude form. The king posts, bolted to the tiebeams, are straight and do not support the ridge. Purlins are carried on cleats nailed to the backs of the principals. There is an inserted brick wall between the two stalls at the left hand end. The building is described as a 'six-horse stable' in the sales catalogue of 1917. To the rear of C1 at the left hand end is a later brick-built lean to loosebox.

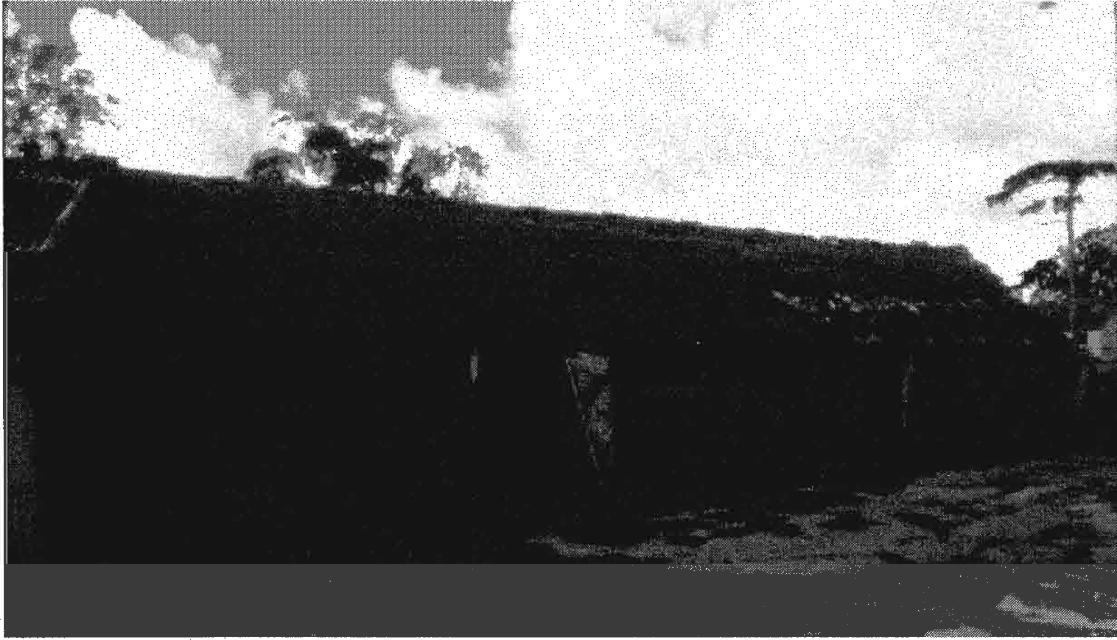
Outbuilding B1

B1: Milking Parlour. Internal dimensions: 15.23m x 4.18m.

4 bay brick-built structure open to the rafters. Courtyard-facing (front) elevation has a 3-light bottom-hinged timber window to each bay and a ledged and braced timber door to both of the centre bays.

Brickwork is Flemish garden wall bond, dimensions: $9\frac{1}{4} \times 4\frac{1}{2} \times 2\frac{3}{4}$ inches. Windowsills are in over-fired brick. An eaves course (on the front elevation only) consists of a projecting brick course with a course of dentilated brickwork above this. Rear elevation has inserted doorway in the second bay from the left. Internally there are paired stalls with tethering bars and feeding troughs, in concrete, ranged along the rear wall. Central to each pair of stalls a downward angled ceramic vent pipe is set into the rear wall. A drain runs the length of the floor and empties through an opening in the front wall.

The roof structure comprises 3 suspended king post trusses with angled struts. The kingpost is straight (ie lacking joggles, shaped head etc. see Campbell 2000 for the terminology used in describing post-medieval roof structures) and is bolted to the tiebeam. Purlins are carried on cleats across the backs of the principals. The tiebeams are low set, with less than 2m clearance above the floor. Presumably the floor level has been raised, possibly on a number of occasions. The roof covering is flat clay tiles (nib tiles), partly replaced with corrugated asbestos, stepped ridge tiles provide additional ventilation.

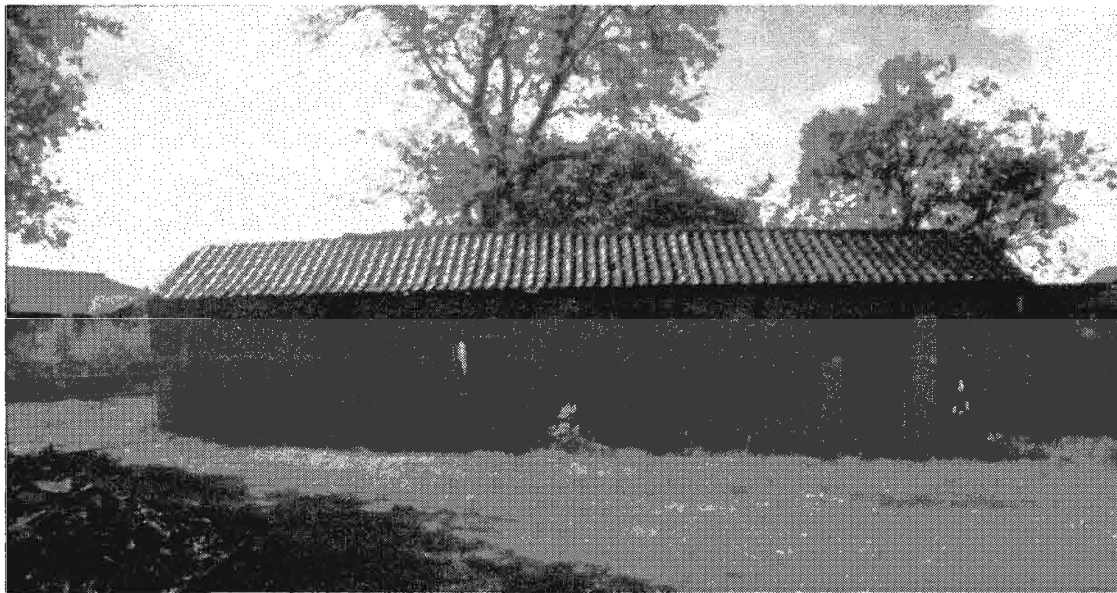
Outbuilding A

4 bay, single storey brick-built cart shed, roofed in black-glazed pantiles. Date: late 18th century?

On the front (farmyard-facing) elevation 4 wide depressed three-centred arch openings, all but the right hand one now blocked. Elevation is slightly asymmetrical with a wider brick pier between the two archways on the right hand side. Inserted doorway in second archway from left. Three inserted tie bars with tie plates occur at the bay intervals. The tie plate on the left is circular with pierced decoration; the other two are plain flat bars.

The roof structure is based on a series of tiebeams, at the bay intervals and inside the end walls. These are substantial squared oak timbers; a variety of empty mortises and lap joint matrices indicate that these are reused from an earlier, timber-framed building. At the interval between the first and second and second and third bays from the left the tie-beams carry later, small king post trusses. The roof covering is black-glazed pantiles with black-glazed semi-circular ridge tiles. There is evidence of some relatively recent repair, but the roof is presently in a poor state.

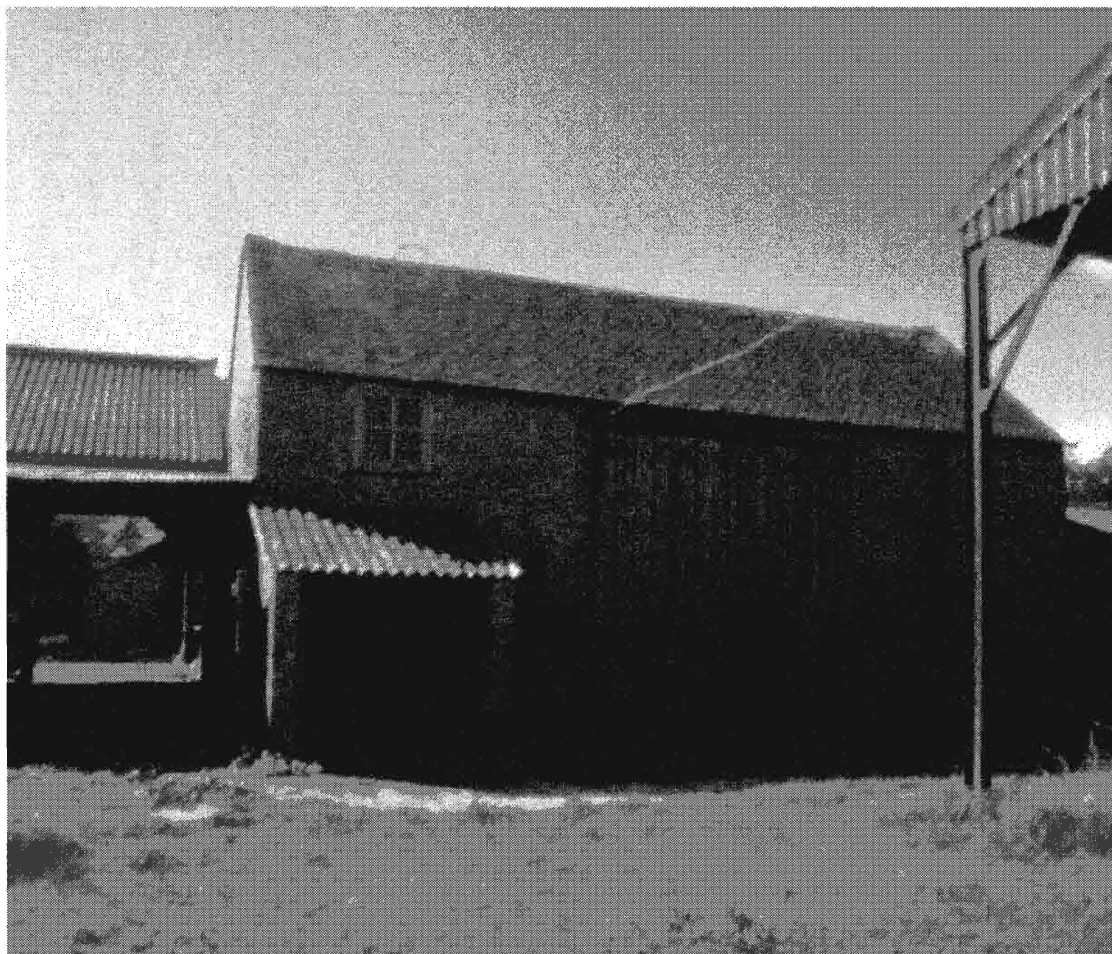
Outbuilding D

Barn. Internal dimensions: 11.05m x 5.54m.

3 bay brick built barn with flat clay tile (nib tile) covered roof. 18th century. Brickwork: orange-red brick laid in Flemish garden wall bond. Brick dimensions: 9 - 9⁵/₈ x 4³/₈ - 4⁵/₈ x 2³/₈ inches.

North-east elevation (facing away from the courtyard) has large ledged and braced timber barn doors to the central bay with iron T hinges at the top and L hinges at the bottom. There is a smaller opening section in the right hand door. In the left hand bay there is a wooden framed fixed 4-light window set high in the wall. There is a blocked window opening at the same level in the left hand gable end wall. On the courtyard-facing elevation the central bay has a winnowing door, opposite the main doors, with segmental arched head and pegged timber door frame with simple beaded detailing to the lintel. The door itself is a recent ply sheet. Adjacent to the doorway, inside, is a candle niche. Internally, brick piers at the bay intervals support the roof trusses. Joist sockets in the front and rear walls of the left hand bay indicate the position of a removed loft floor, lit by the window described above. The small size of the joist sockets tend to suggest that this upper floor structure was not very substantial, it was also relatively low at only 1.7m above the present floor level. The floor in this bay is concrete and there is a relatively recently inserted brick-built structure against the left hand gable end wall. This looks to be some kind of ?heating duct or vent and opens into a small, brick-built lean-to addition at the east corner of the building. The centre bay is floored in brick. The brick piers between this and the left hand bay, supporting the roof truss, have both been cut back at some stage by about 250mm (10 inches), for reasons which are not now apparent. The right hand bay has an inserted upper floor with 9 x 3 inch joists running between the front and rear walls, supporting deal boards up to 11 inches wide. Galvanised sheeting on timber studs forms a grain storage bin which rises to the height of the roof truss tiebeam. The 1917 sales catalogue notes a 'Barn with Granary'.

The roof structure is based on 2 queen post trusses. The queen posts are straight timbers bolted to the tiebeam and joined near the top by a strainer beam. Purlins are carried across the backs of the principals, supported on cleats. In both end bays windbraces run from the outer ends of the wall plate to the underside of the purlin, and from the top of the purlin up to the ridge.

There are large lean-to additions of 20th century date on three sides of the barn; that on the farmyard side consists of corrugated iron sheeting fixed to substantial roundwood and half round poles.

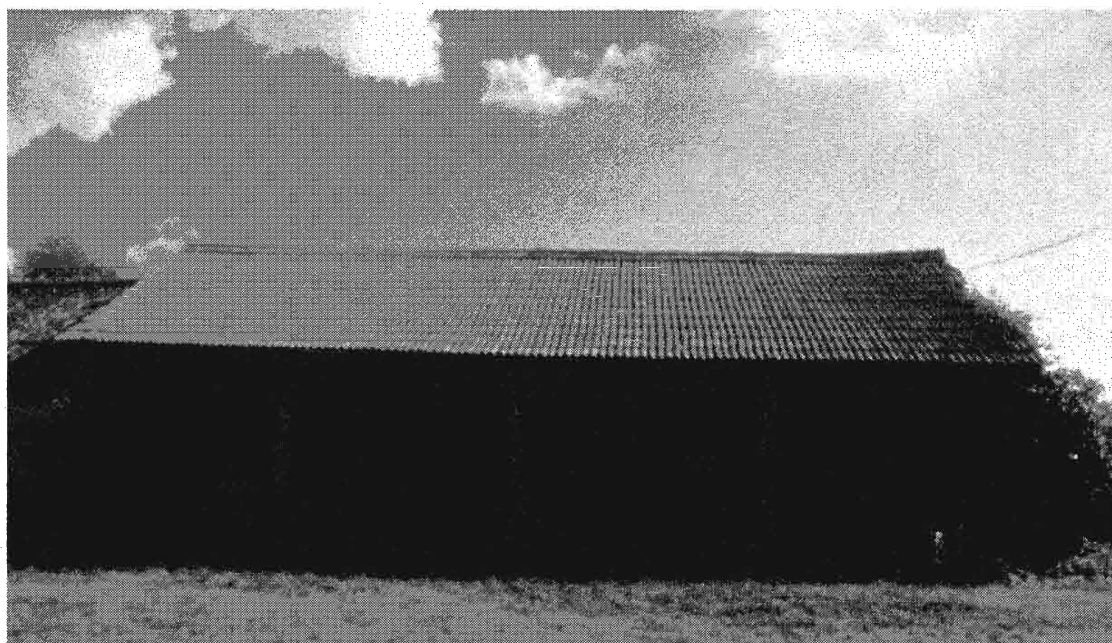
Outbuilding E

Implement shed: Internal dimensions 11.75m x 5.62m.

Brick-built implement shed with tiled roof. Late 19th century. An open fronted 4 bay structure located to the east of the farmyard. Brickwork is in Flemish garden wall bond; brick dimensions: $9\frac{1}{4} \times 4\frac{3}{8} - 4\frac{1}{2} \times 2\frac{3}{4} - 2\frac{7}{8}$ inches. Internal brick piers at the bay intervals along the back wall. On the front wall line at the outer corners chamfered brick piers support the wall plate; at the bay intervals timber posts carry the wall plate. At the base of these large concrete blocks appear to have been formed around the posts, presumably to as the timbers rotted. The roof structure is based on 3 king post trusses, with king posts and principals bolted through the tiebeam. The king posts have notched and splayed heads and the ridge plate is housed. Purlins are carried on cleats and are joined across the central truss with a simple splayed scarf. The roof covering is unusual zig-zag shaped tiles with matching ridge tiles, these are stamped: MAJOR-BRIDGEWATER. REGISTERED.

The floor of the right hand bay is paved in brick; the others are earth.

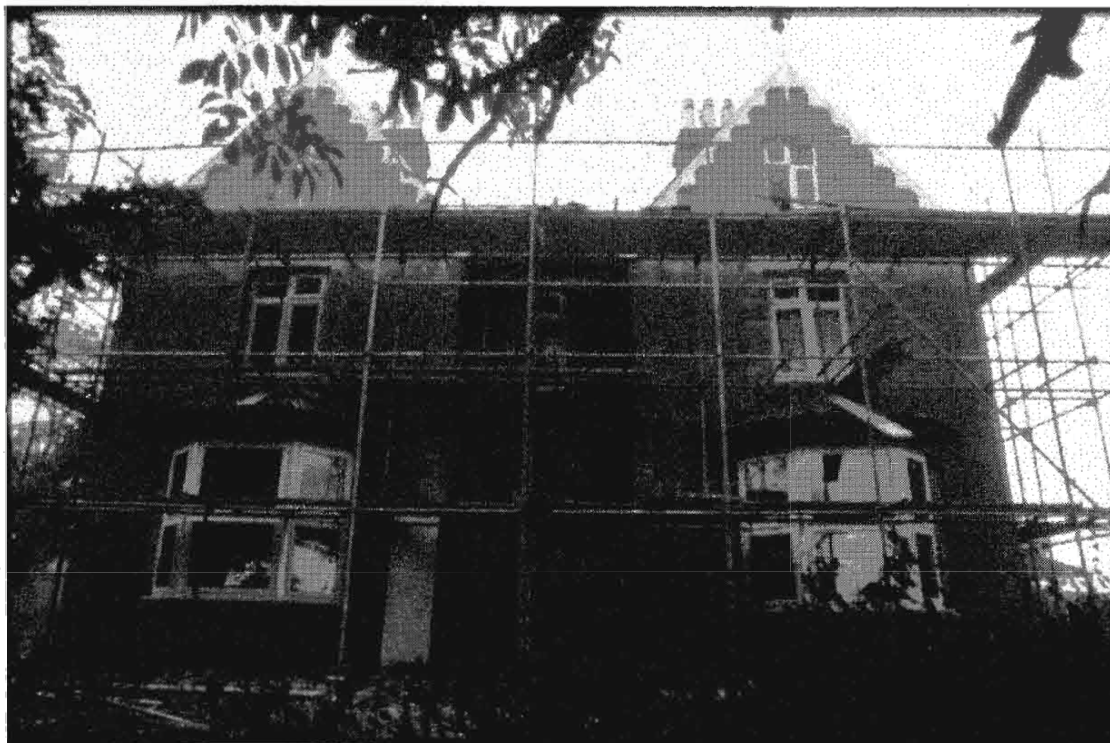
Farmhouse

A brief inspection of the farmhouse was made; building work was in progress at the time. This is a three-storey double pile brick building with slated roof and decorative bargeboards. The principal elevation faces south-east with the rear elevation overlooking the farmyard. Badcock (1980, 39) states that the house was built in 1868. All internal wall coverings had been stripped back to bare brick and all windows replaced with uPVC at the time of the site visit. Original skirting and doorframes remained in some rooms. Of particular note is the decorative newel post to the principal staircase; all of the balusters have been removed from this stair, however. There is a small brick-vaulted cellar the entrance to which is below the service staircase.
