**A Photographic Survey of Outbuildings
At Groby Old Hall Farm, Markfield Road,
Groby, Leicestershire
(NGR SK 5241 0757)**

ULAS Report No 2011-009
©2011

Planning Application No's: 10/00267/LBC

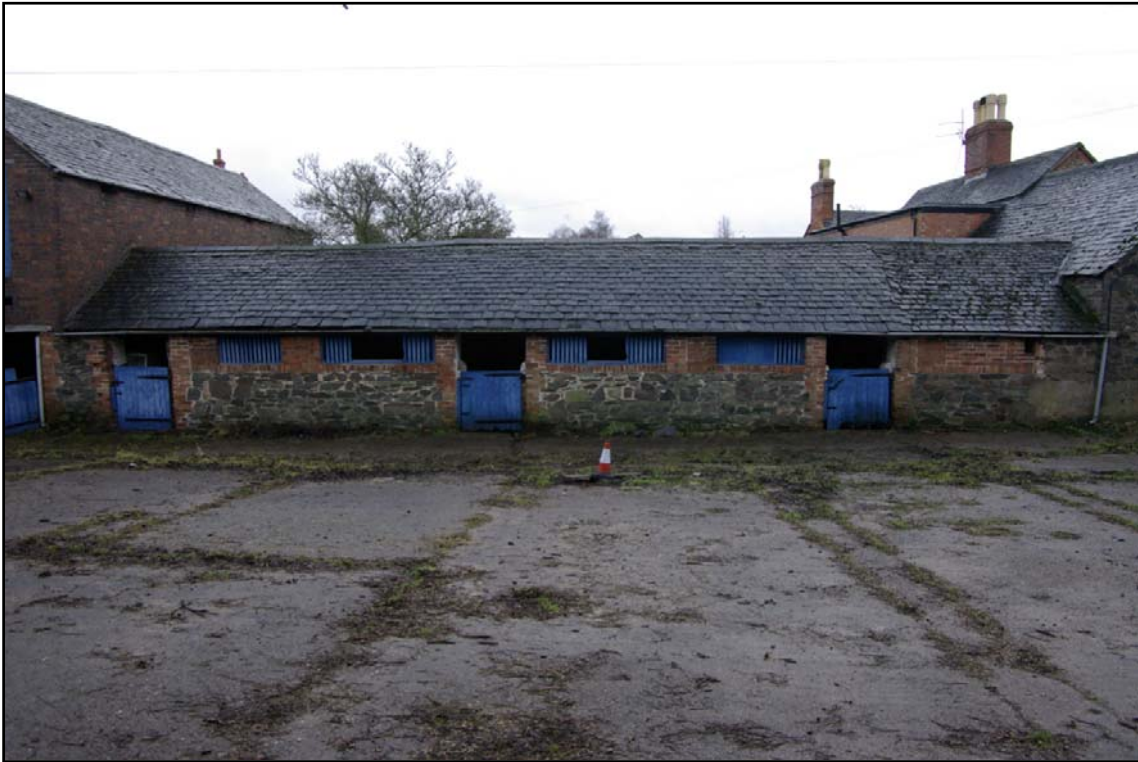
Figure 7 Building A1, principal elevation, looking south east (001-002).

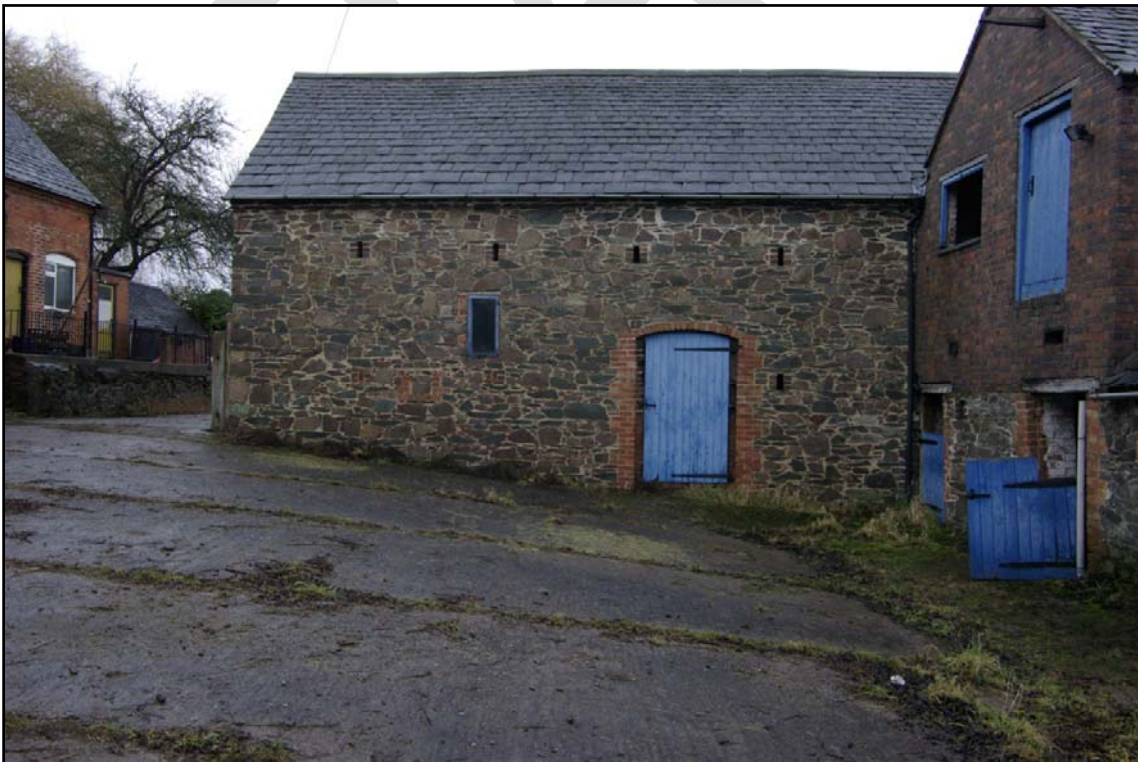
The final element of Building A is A3, a large three bay barn (*Figure 8*). Although being identical in appearance its alignment does not exactly match that of the other buildings suggesting it may not be contemporary. It is possible that the footings of an

Figure 8 Building A3, principal elevation, looking north east (003-004).

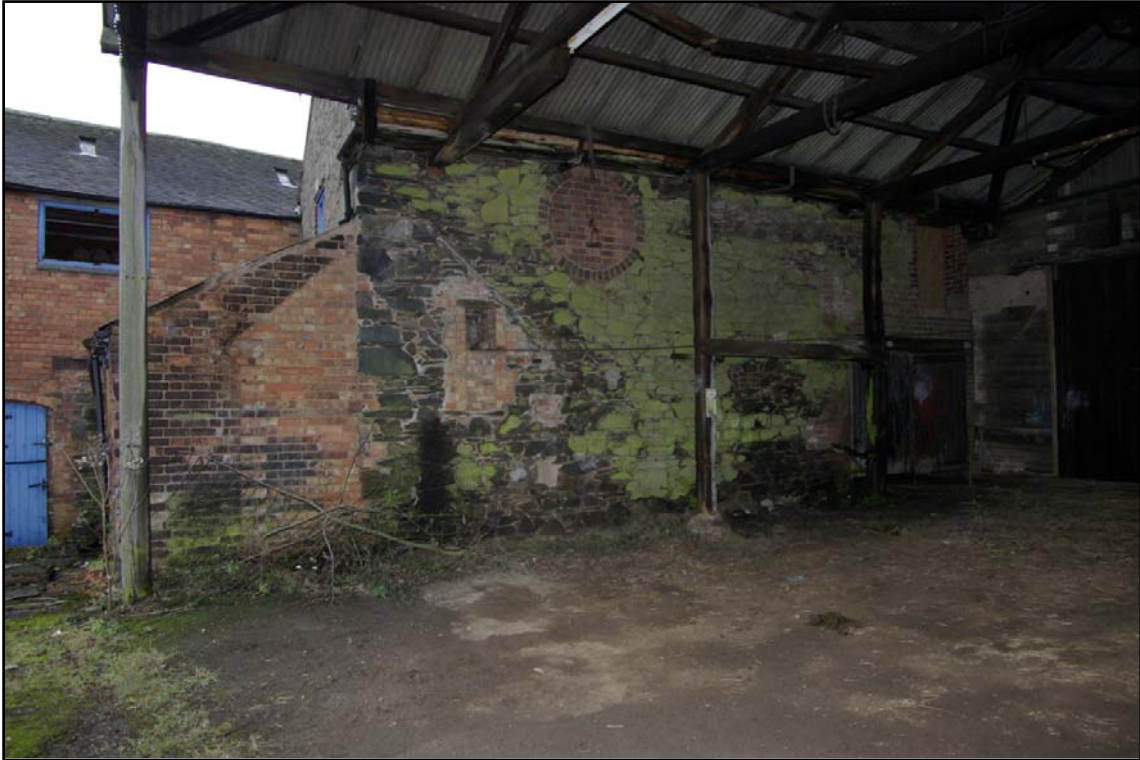
existing barn were re-used for its construction. Internally, there are three ground floor bays as well as a mid twentieth century brick-built lean to on the east gable. There are pitching holes on the west gable and the eastern end of the north wall, the northern example having been recently brick up (*Figure 9*). The western bay is used as stabling; the central bay has a well laid blue tile floor, which along with the large double cart doors on the north wall suggests it may have been a small threshing floor. First floor access is via a stair in the east bay.

Figure 9 Building A3 north east facing elevation (049-050).

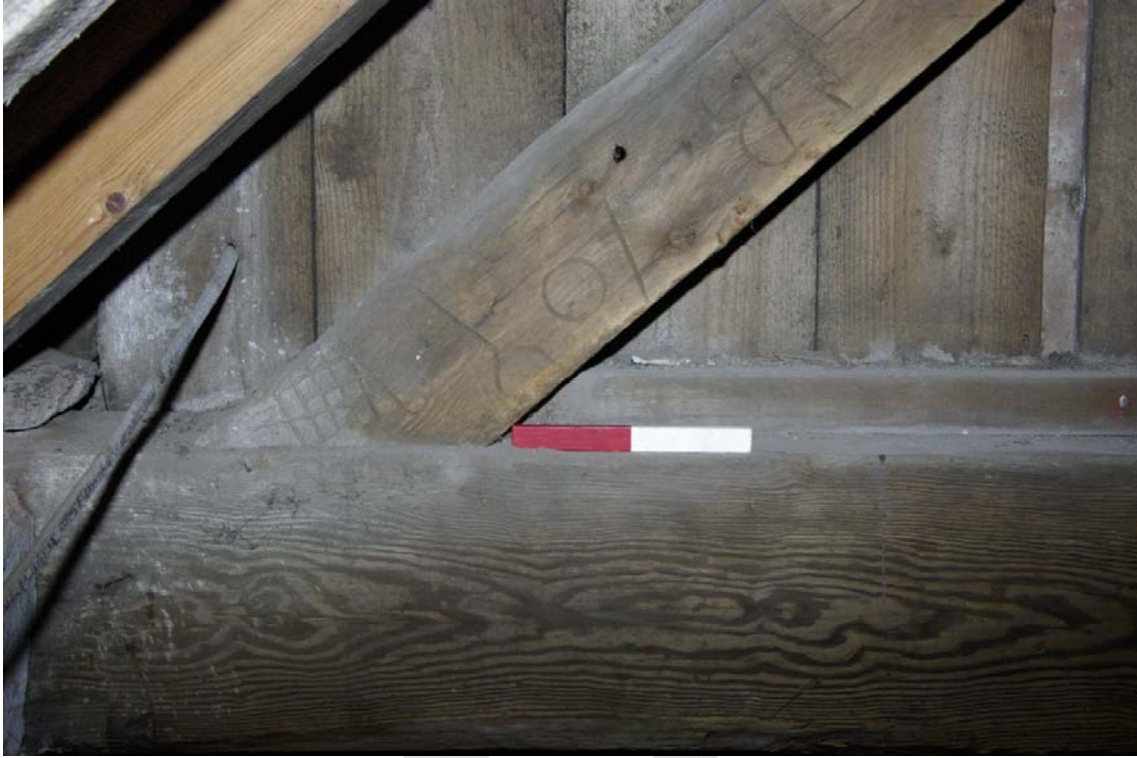
Figure 11 Rase or shipping marks on truss within A3 (059-060).

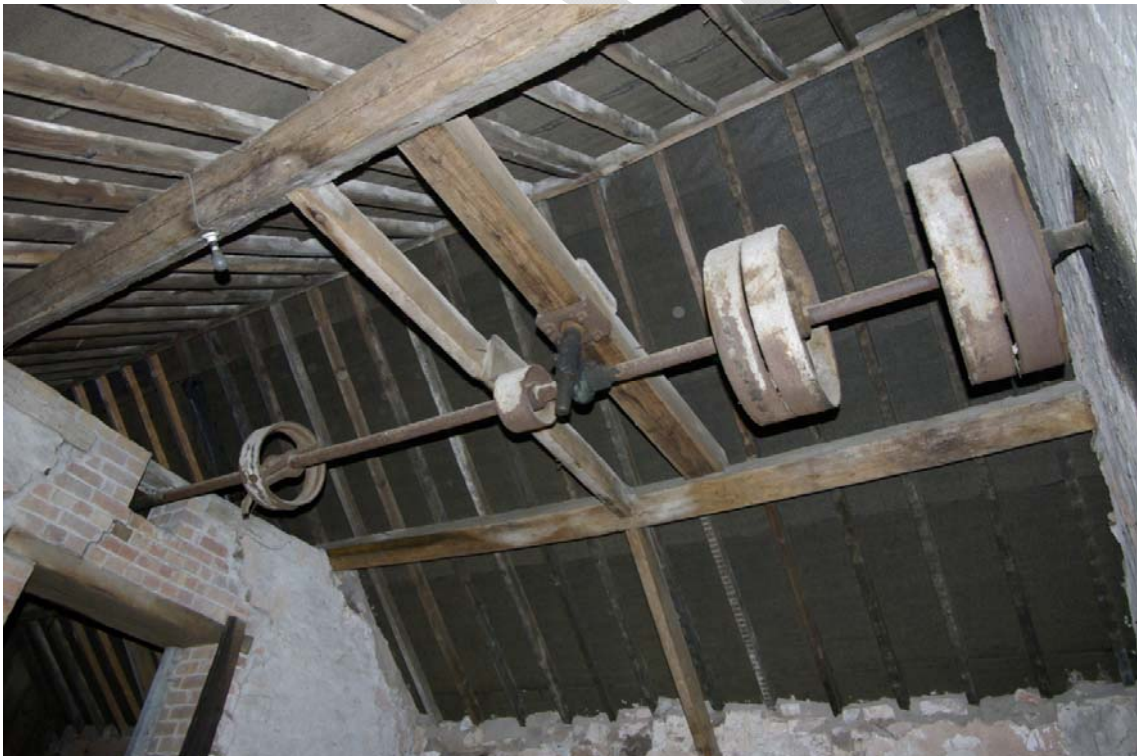
The first floor has a number of interesting features, most significantly a line shaft within the east bay (*Figure 12*), and a belt trap in the floor, there is a further single drive wheel in the central bay. The western bay has a raised floor and small access door, adjacent to which is a cat hole, suggesting it was originally a granary. There is a single bolted king-post truss with raking struts within the bay, once again there are shipping marks incised into the principal rafter (*Figure 11*), again the letter B is clearly identifiable as well as a perfect circle, this circle is made with a scribing iron and again is part of the marking process. As well as the usual strokes there is an area of strokes creating a grid pattern, the exact purpose and origin of which is unknown. A second group of rase marks can be seen on the northern purlin; once again the letter B is clearly identifiable along with other strokes.

Figure 12 Line shaft within A3 (069-070).

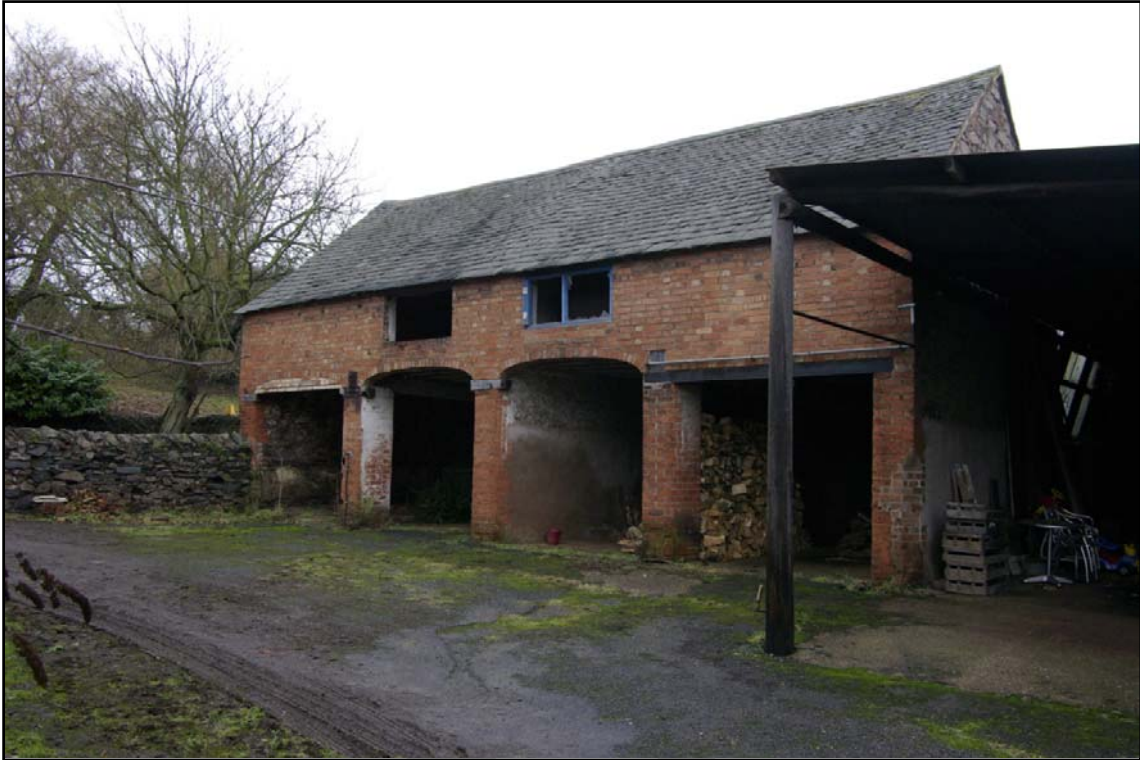
Building B is a detached building to the north of Building A, it is aligned east west with its principal elevation facing to the south (*Figures 2, 5 & 13*). The building itself is a two bay cart shed the southern wall is in red brick (brick dimensions 9 ½ x 3inch), the other walls are granite rubble and the roof is Swithland Slate. The southern elevation consists of three brick-arched entrances and a fourth, the easternmost, being a simpler timber lintel with no evidence for an arch.

Figure 13 Building B, principal elevation, looking north-north west (091-092).

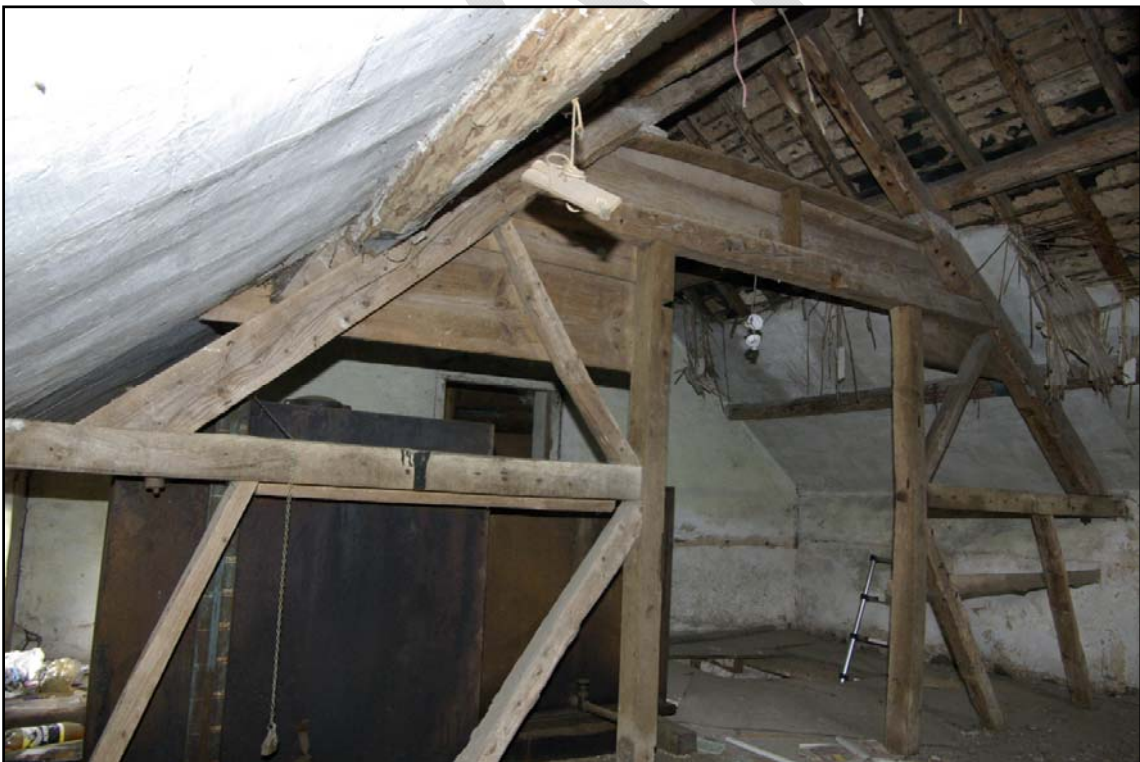
The roof structure is by far the most significant feature of the building, it is carried on two interrupted tie beam trusses (*Figure 14*). Both are softwood and some of the struts and the purlins are only roughly squared, with some still carrying bark. The principals are pegged at the apex, while the tie beam has been bolted to the principals and to the queen posts. There are struts from the tie beam which pass through the floor and abut the axial beam seen within the ground floor. The trusses have the appearance of having been locally built, possibly even using local timber as there are none of the rase marks

as seen within the other buildings. It is possible that a carpenter within the employ of the Groby Estate constructed the roof. Also of interest are the very wide planks attached to the trusses, only a few of which remain, it appears these were used to further partition the two bays into four.

Figure 14 Interrupted tie beam truss, building B (116-117).
