CRAIGLOCKHART CASTLE, EDINBURGH

Photographic Survey & Monitoring

for Addison Conservation + Design

May 2012

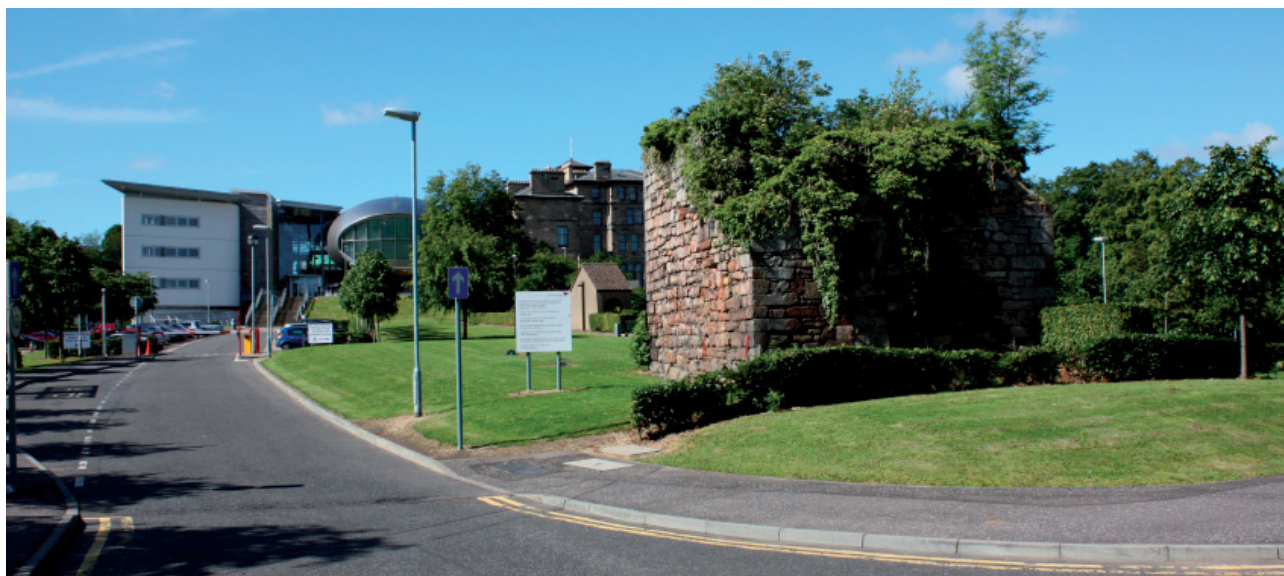
Illus 2

View of Craiglockhart Castle facing S

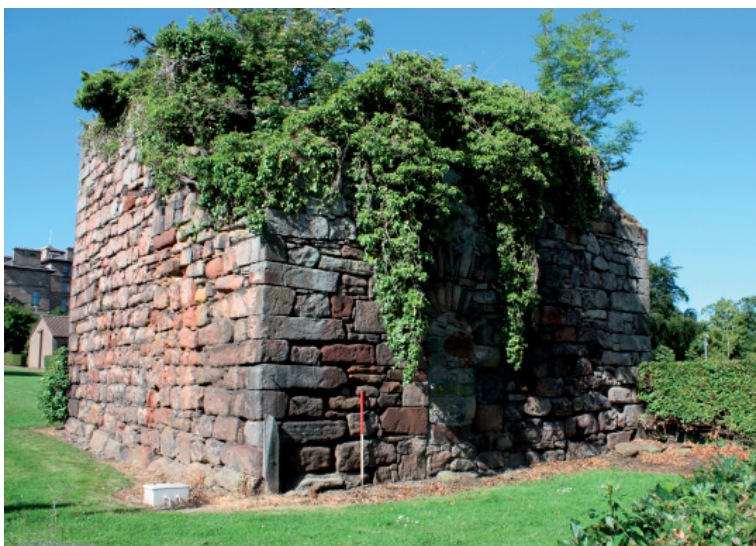
Illus 3

Detail of the castle prior to consolidation works, facing S

The castle stands within the grounds of Edinburgh Napier University on a manicured lawn opposite Glenlockhart Road. The castle is a small rectangular 15th century tower that is roofless and in a ruinous state (Illus 2 – photo 026). An initial visit to the structure prior to the commencement of the consolidation works recorded that the tops of all the walls were covered in heavy vegetation masking a number of features (Illus 3 – photo 015). A photographic record was taken of the castle in this state.

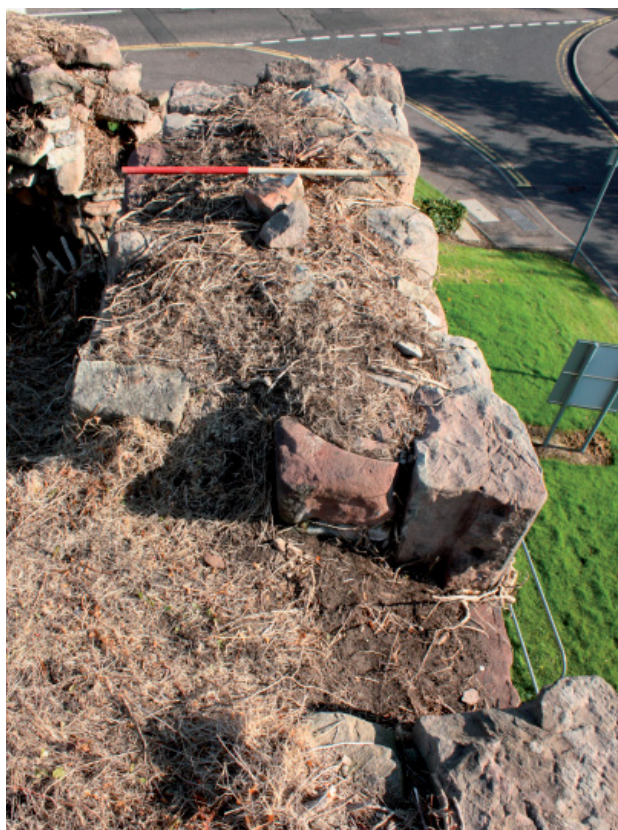
Illus 4

Top of the SE wall, facing NE

A second visit during the removal of the vegetation allowed access to the top of the wall heads. A photographic record of the tops of the walls was taken although this was limited in scope due to health and safety concerns and limited access due to the small size of the building (Illus 4 & 5 – photo 041 & 044). Access to the wall head also allowed a limited view of the internal aspects of the castle although again this access was limited. A photographic record was taken of as many of the internal features as possible although it was not possible to capture all of the internal arrangements.

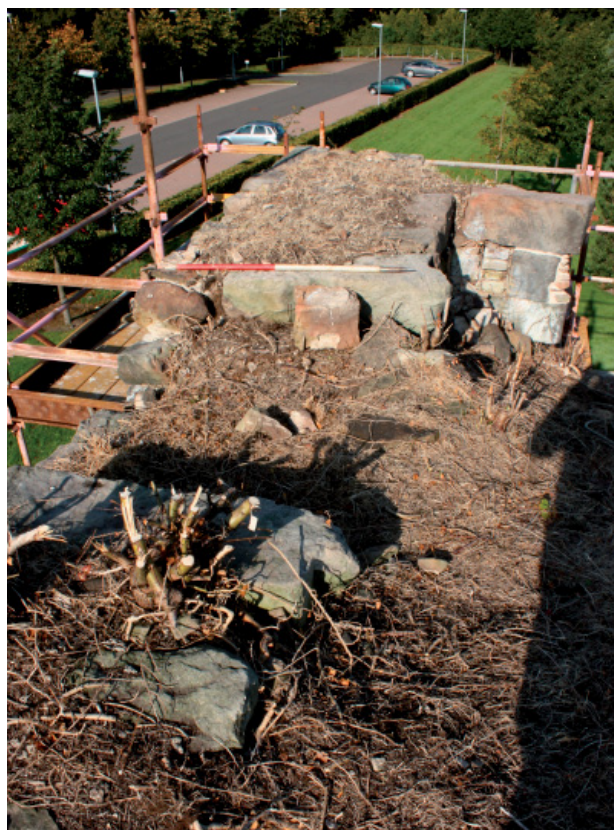
Illus 5

Top of the SE wall facing SW

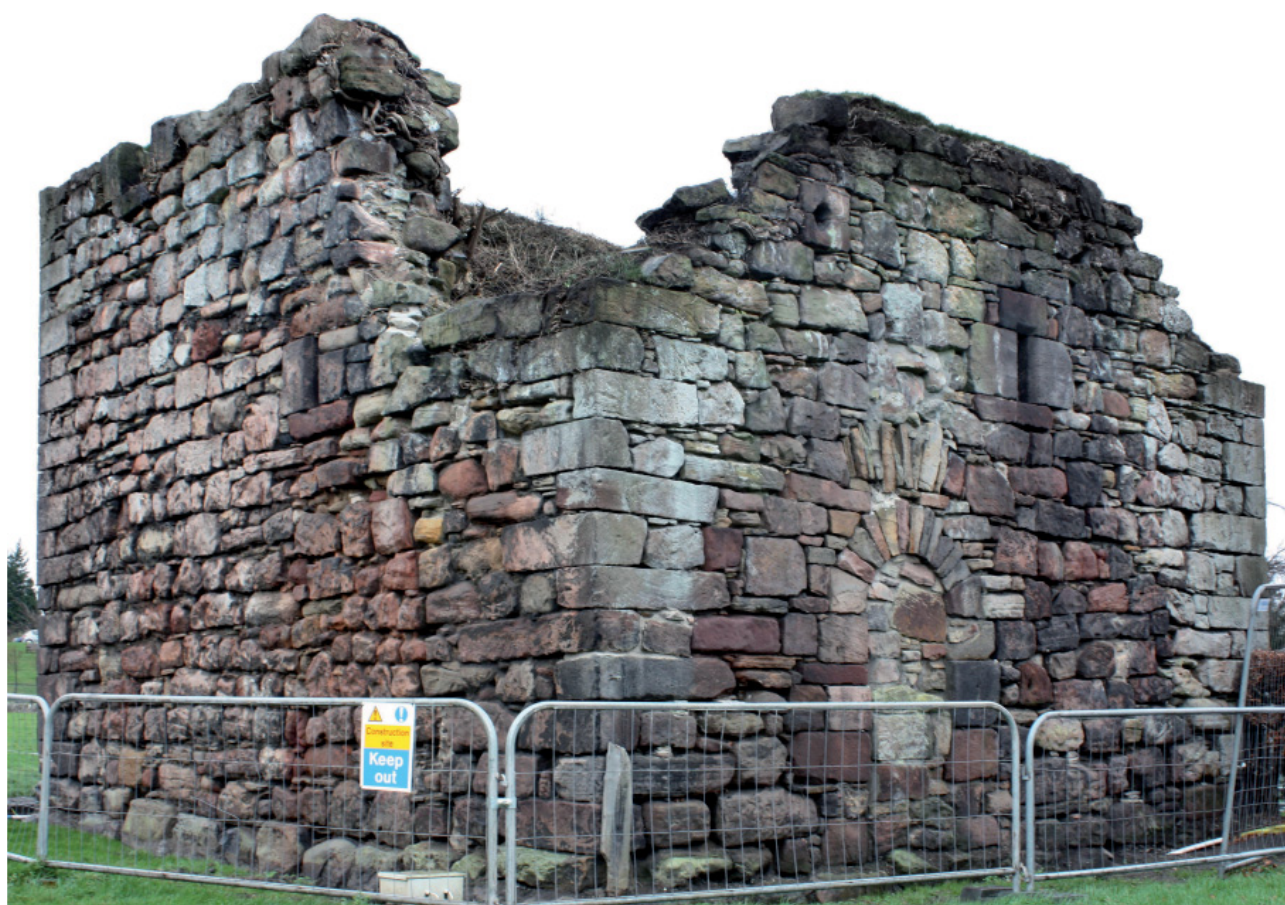
Illus 6

Detail of the castle with vegetation removed, facing S

A final visit once the scaffolding had been removed was undertaken in order to photograph the external elevations with all the vegetation removed and walls consolidated (Illus 6 – photo 088).

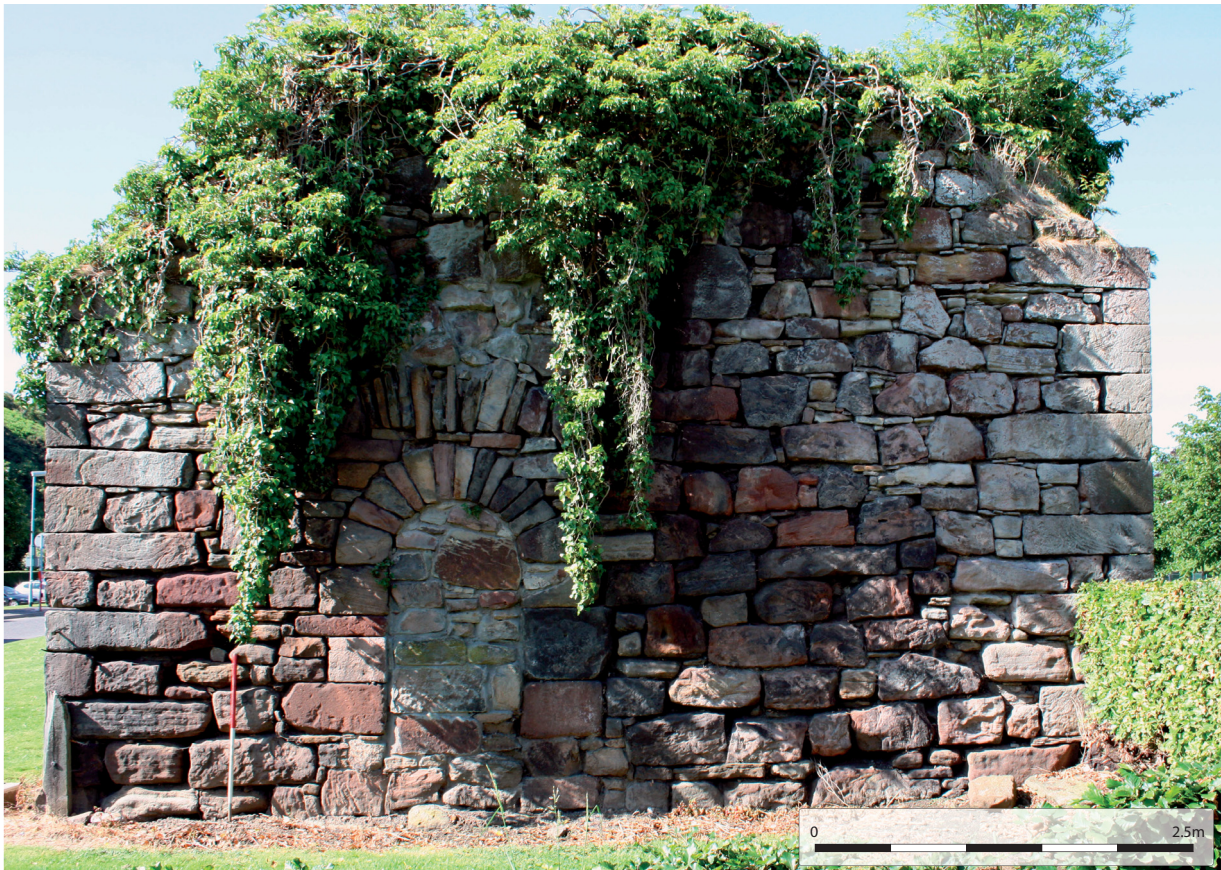
Illus 7

View of the NE elevation prior to vegetation removal

NE elevation (Illus 7 & 8 – photo 014 & 063) – a stone blocked round arched door with a basic relieving arch above, a narrow window slot with heavy stone surround and a small indented gun-hole close to the wall head.

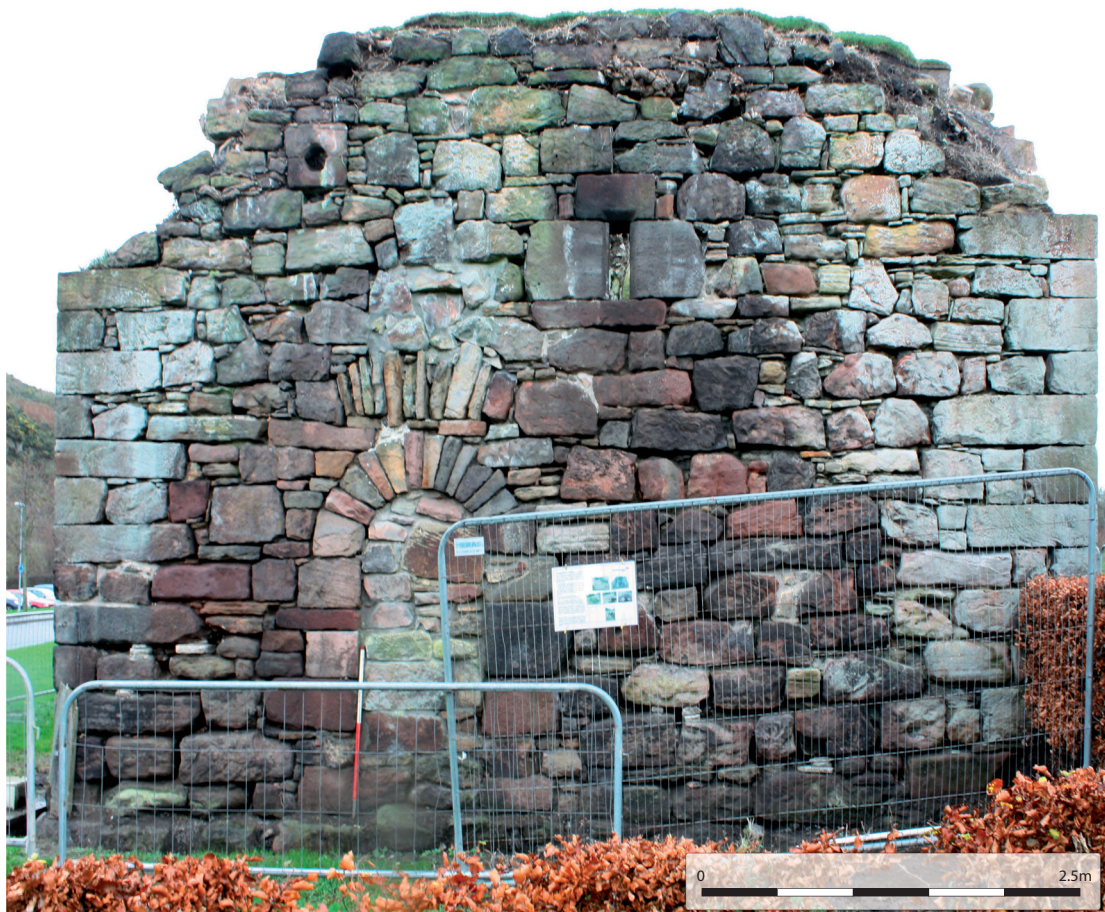
◀ **Illus 8**

View of the NE elevation with vegetation removed

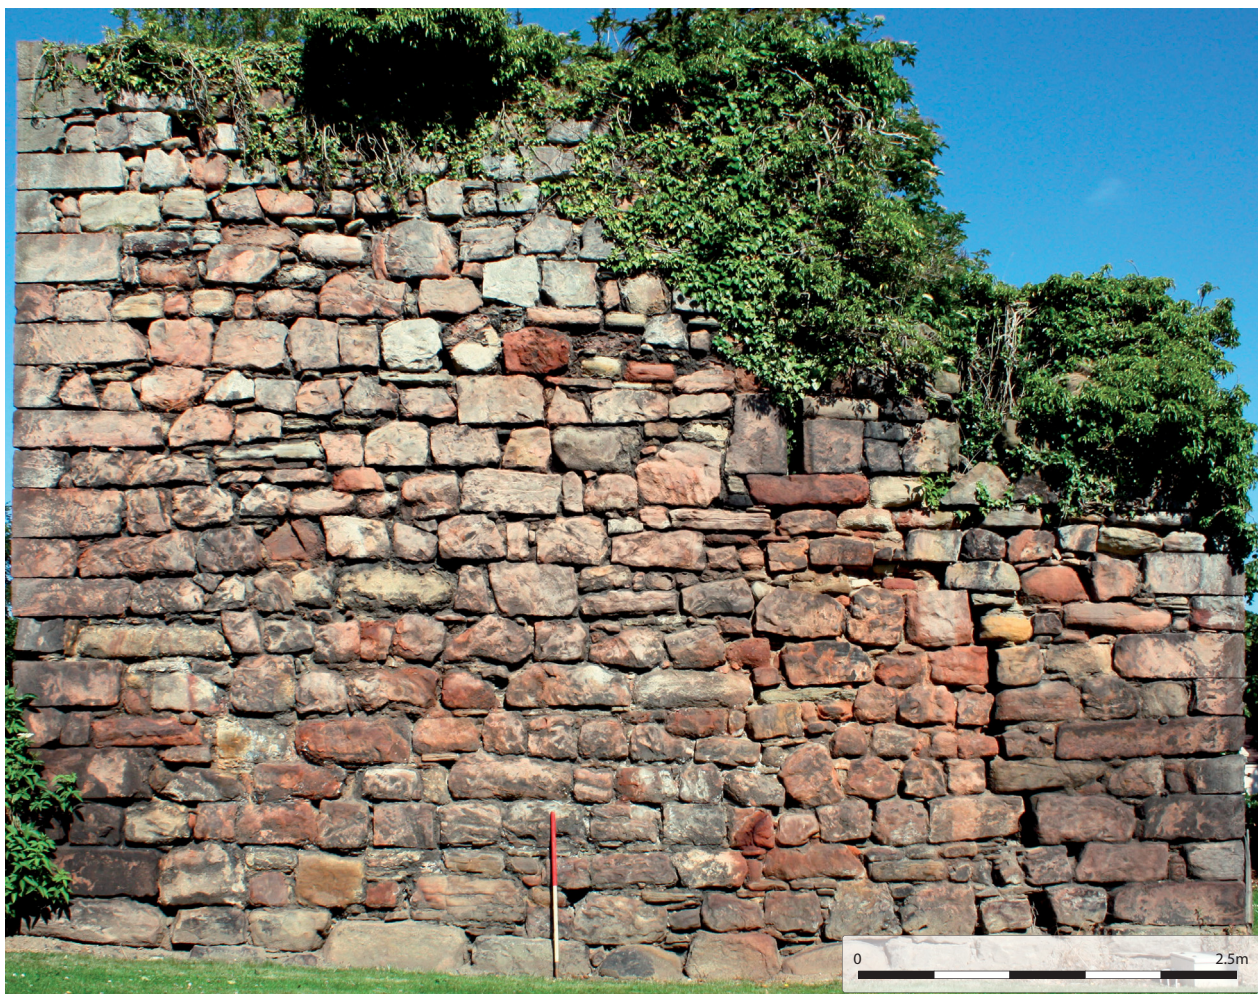
**Illus 9***Pre-consolidation view of the SE elevation*

SE elevation (Illus 09 & 10 – photo 007 & 068) – a narrow window slot with a chamfered heavy stone surround half-way up the wall and the remains of a larger window with squared stone surround at the wall head (Illus 12 – photo 036).

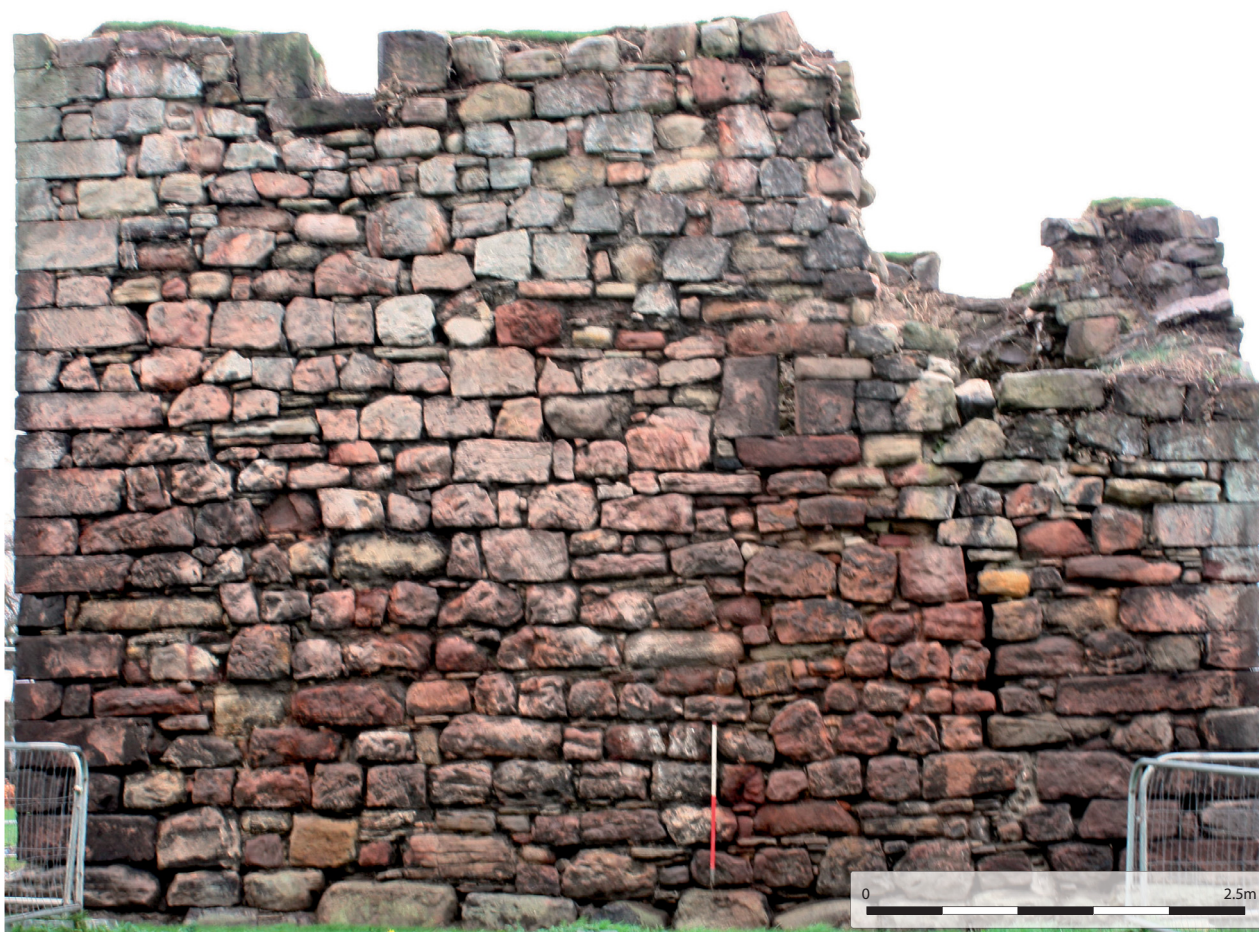
Illus 10

SE elevation after the removal of vegetation

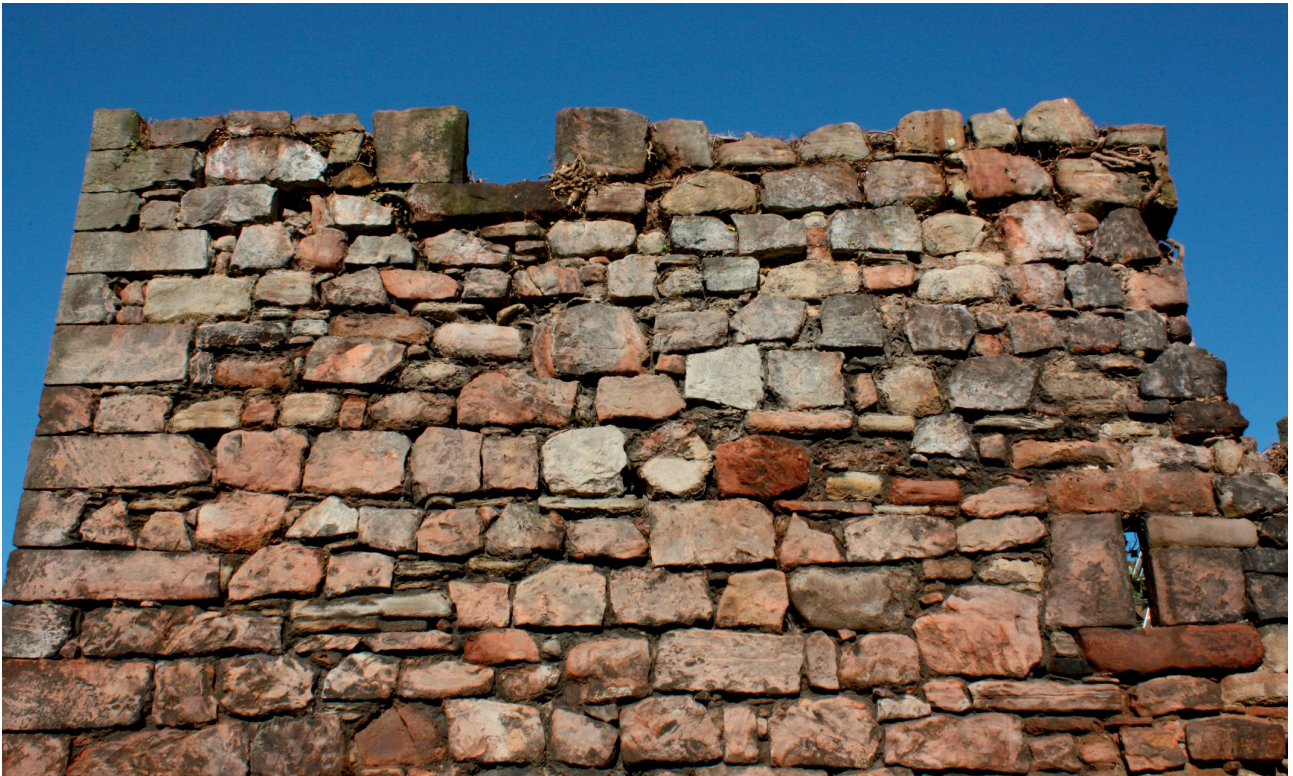
Illus 11

Detail of the wall head of the SE elevation

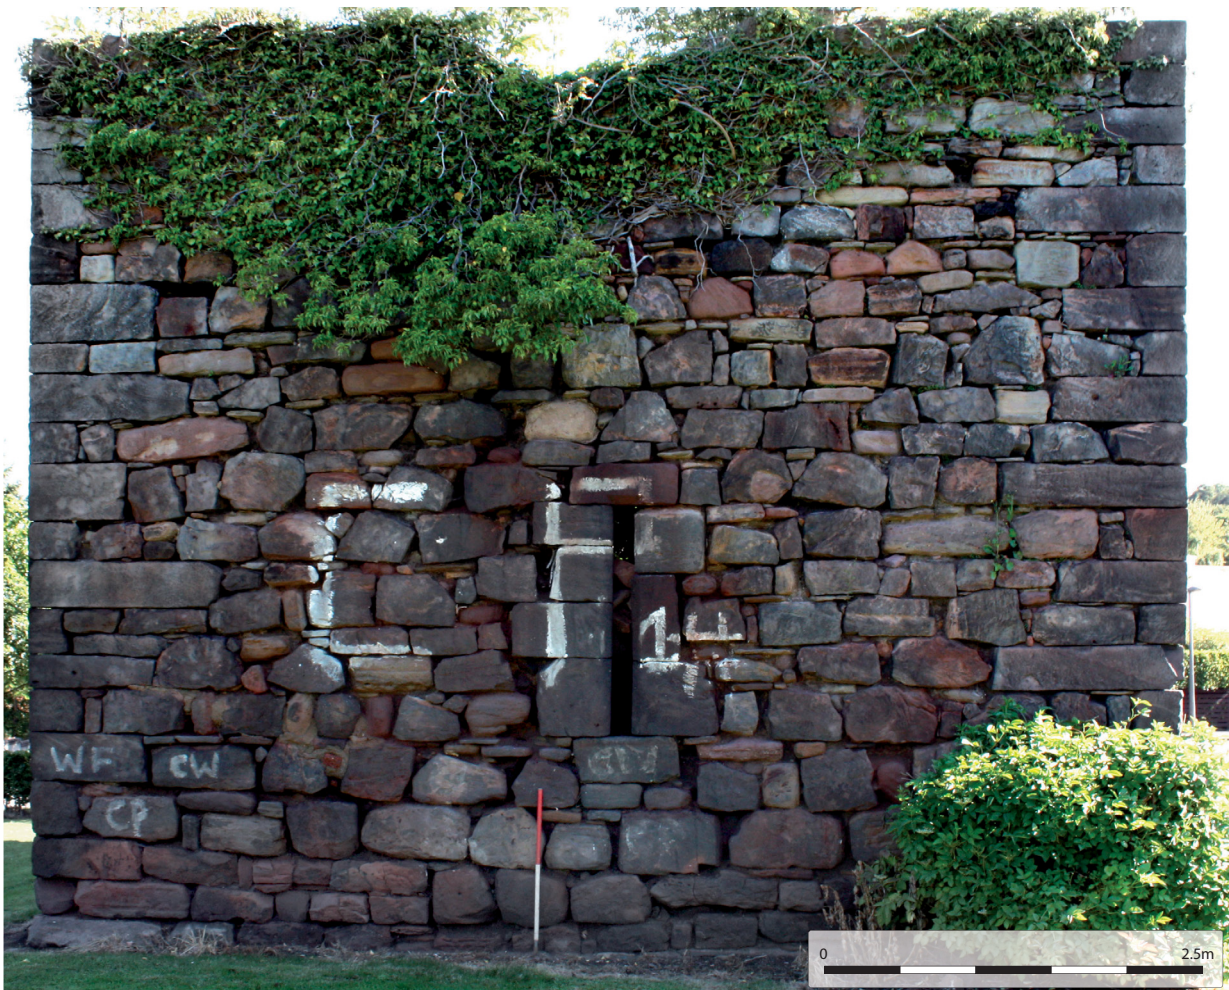
Illus 12 ►

SW elevation (Illus 12 & 13 – photos 020 & 073) – a single tall and narrow window slot with chamfered stone surround located in the centre of the wall (Illus 14 – photo 076).

SW elevation prior to vegetation removal

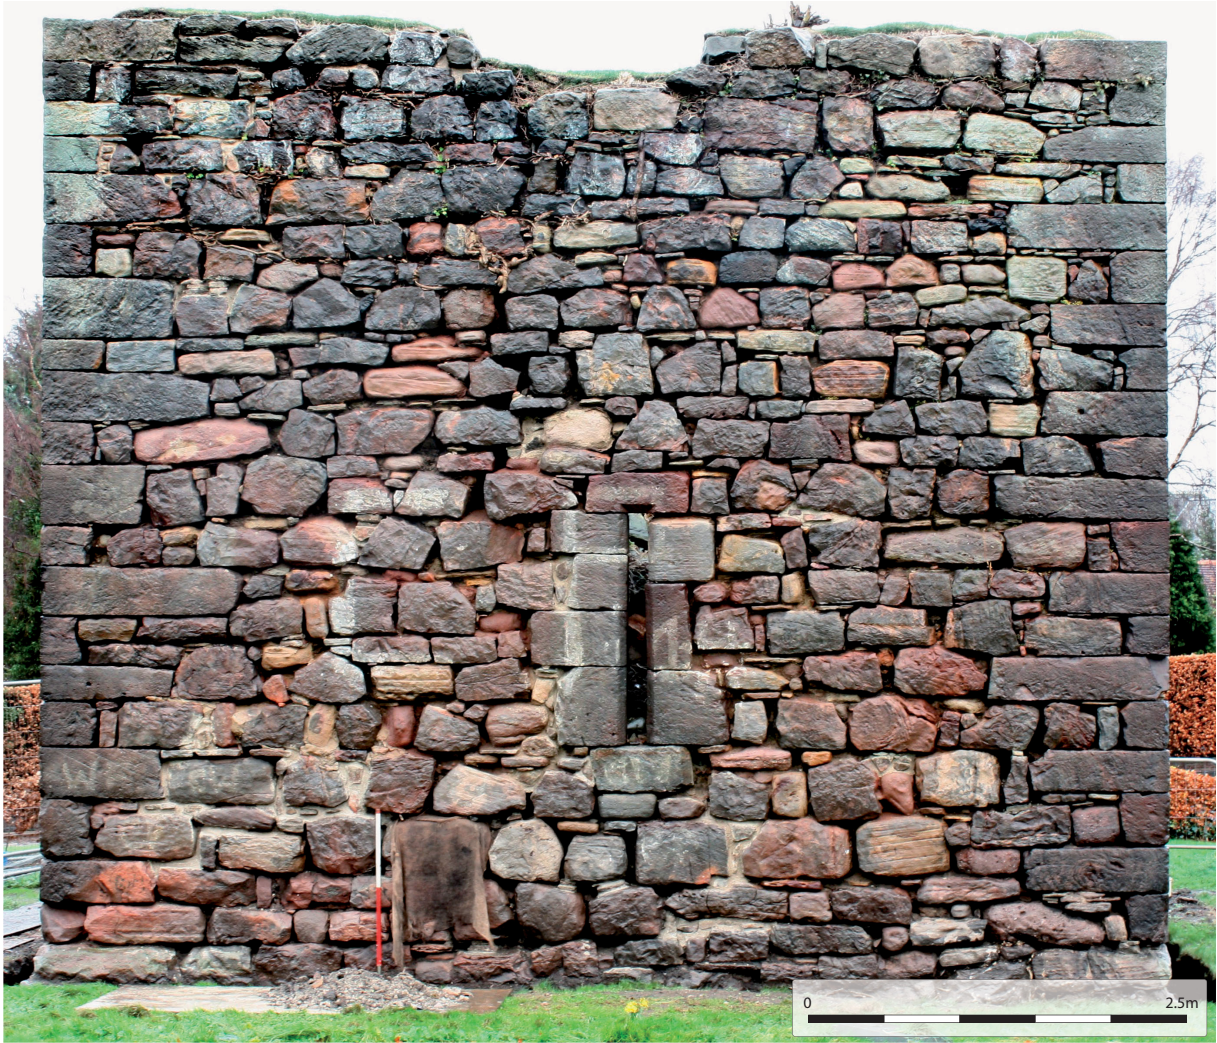
Illus 13

SW elevation with vegetation removed

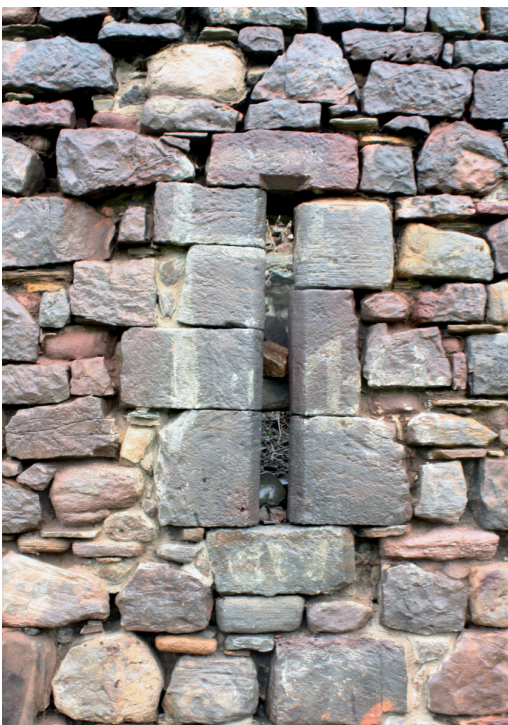
◀ **Illus 14**

Detail of the window slot on the SW elevation

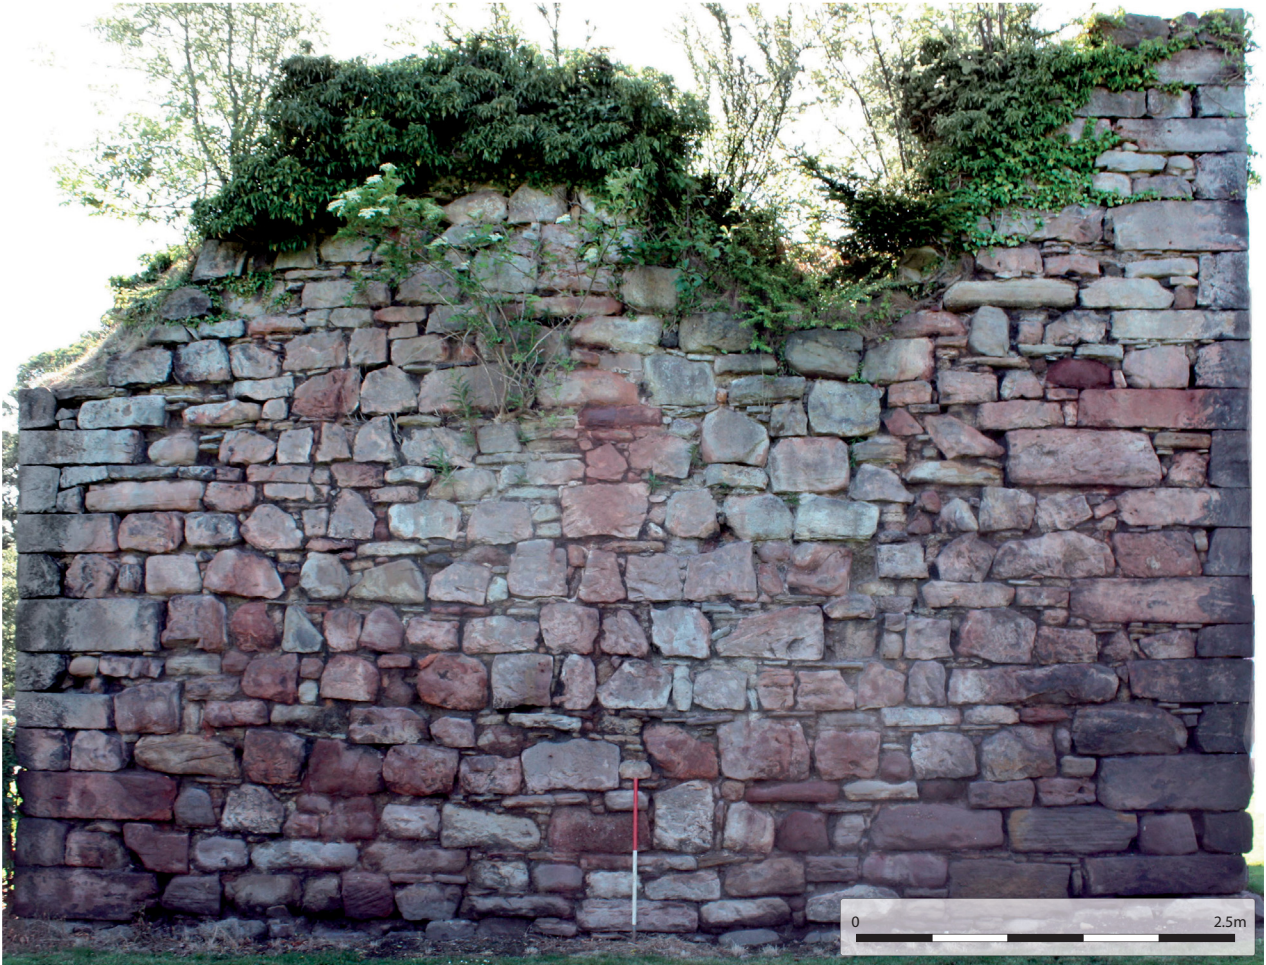
Illus 15

NW elevation (Illus 15 & 16 – photos 020 & 079) – no features were recorded on this elevation; the wall heads were in a poor state of repair.

View of the NW elevation with vegetation

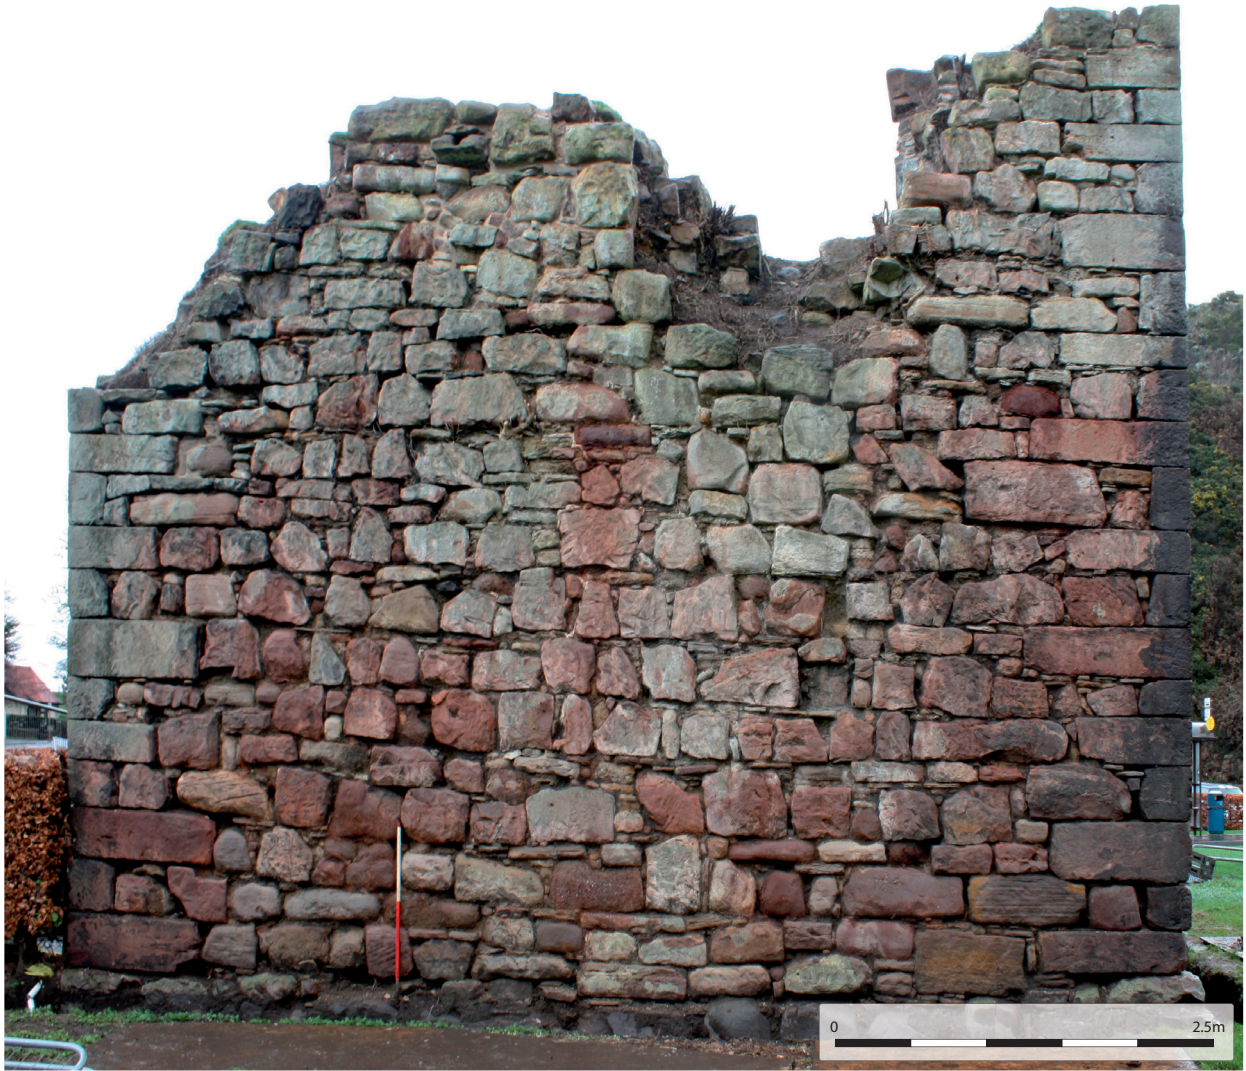
Illus 16

NW elevation with vegetation removed

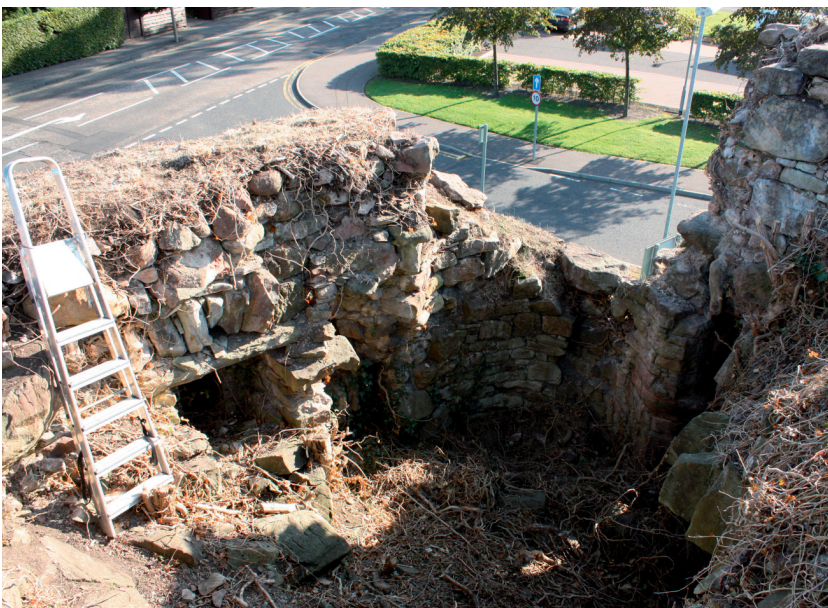
◀ **Illus 17**

The internal arrangements included: rounded walls on the E corner suggesting the location of a spiral staircase, a small alcove leading to the narrow window on the SE elevation and the remains of a vaulted ceiling between the ground and first floors over the SW half of the building (Illus 17 & 18 – photos 048 & 049).

*View of the internal arrangements facing the
W corner*

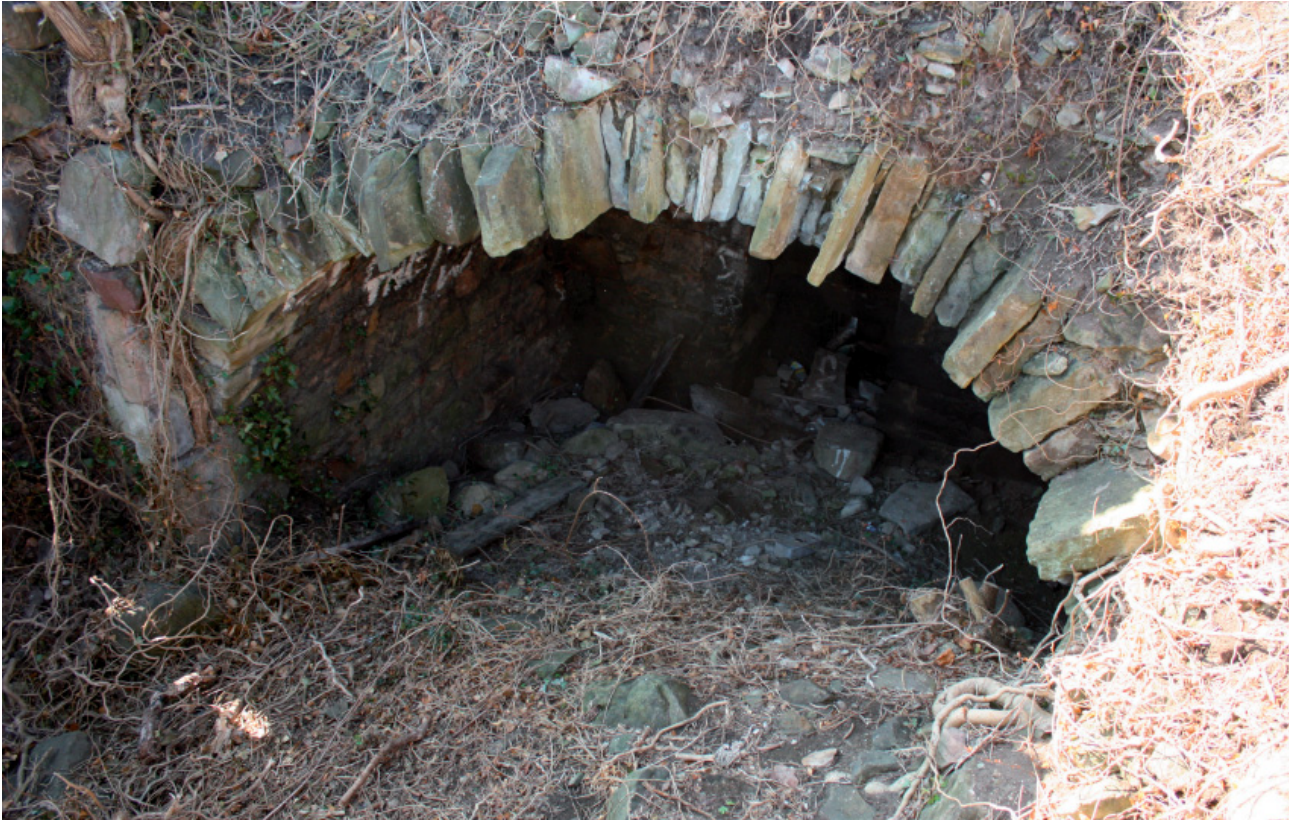
Illus 18

Internal view of the vaulted ceiling of the ground floor, facing S

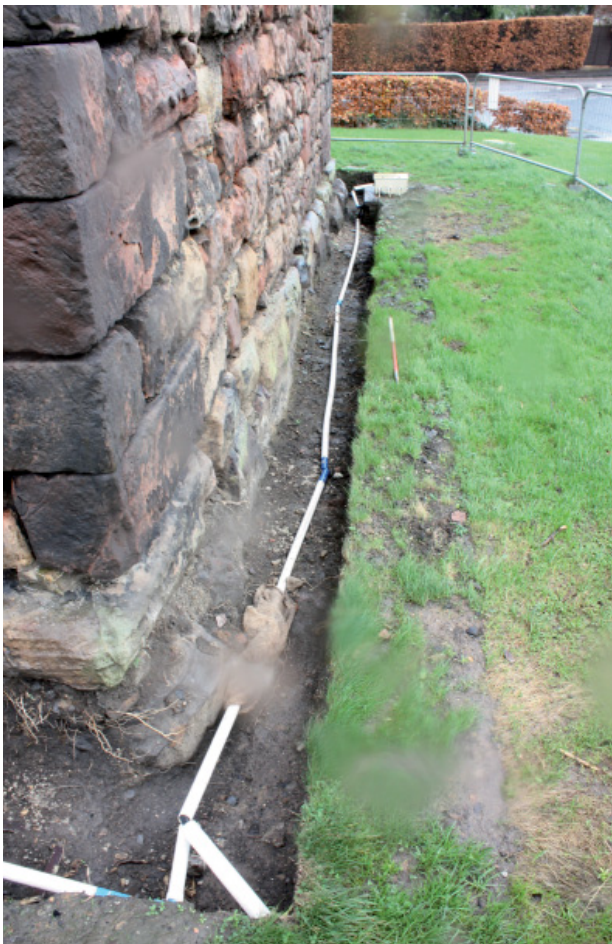
◀ **Illus 19**

The removal of the gravel fill in a drainage trench at the base of the castle walls (Illus 19 – photo 060) revealed an existing trench 0.5m wide and 0.25m deep around the base. Inspection of these trenches did not reveal any further features. The base of the trench comprised brown loam topsoil and did not extend to either geological deposits or significant archaeology. The trench did reveal the top of the stone foundations of the castle walls. These foundations projected slightly from the face of the wall at the same level as the surface of topsoil and this suggests that the existing ground level corresponds with that of the 15th century.

View of the trench at the base of the castle walls facing SE
