Non-Invasive Archaeological Investigations for the Aberdeen Western Peripheral Route (AWPR Package)

Danestone Walled Garden (Site L1)

Building Recording Survey

Report Reference No.: AWPR-TDC-004

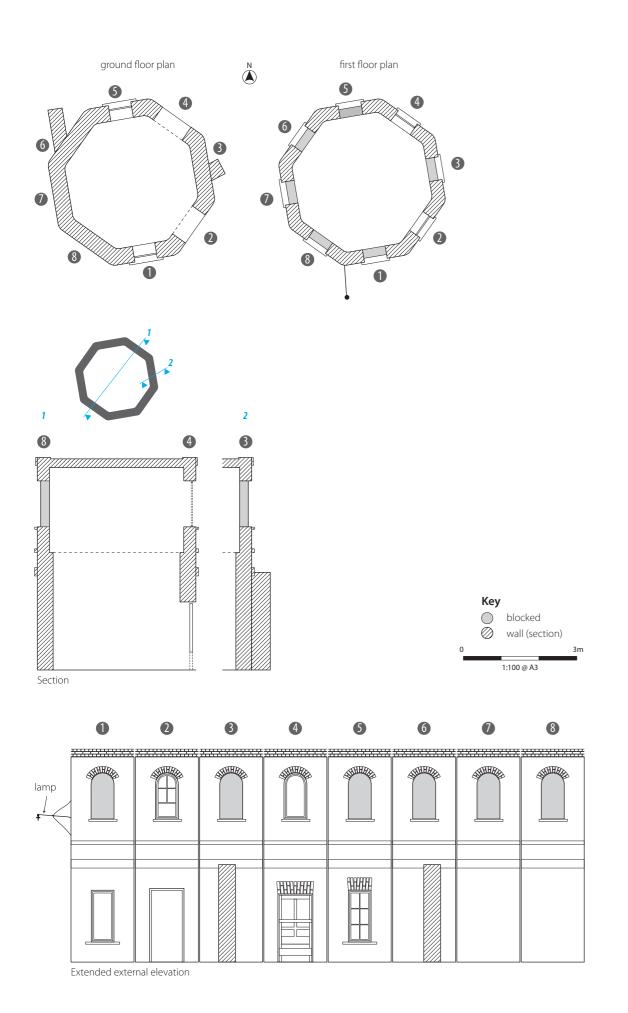
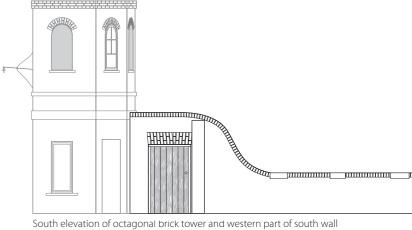
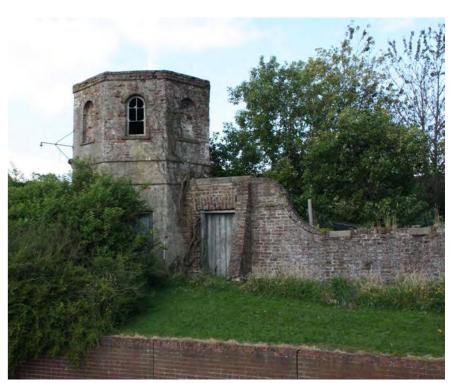
Illus 6Plans, sections, photographs and external elevation of octagonal brick tower

- 3.2.1.1 The two storey octagonal brick tower is located in the south-west corner of the walled garden and stands to a height of 5.7m and is 4.4m in diameter (Illus 2). The walls are 0.4m thick and it has a flat roof. It was constructed of hand-made bricks (averaging 220mm x 60mm x 100mm) using a lime mortared English Garden Wall bond (Curl 1993, p.56). The exterior has been harled using a grey render though this has fallen off in places exposing the underlying bricks. It seems unlikely that the harl is an original feature. Two ornamental string courses one narrow and one wider, project from the wall at approximately first floor height and the wall head is capped by two courses of projecting headers and one of stretchers. An iron fixing for an electric lamp (probably early 20th century) was fixed to the south-facing wall of the structure.

- 3.2.1.2 The ground floor can be accessed by either of two doors, one from the garden itself and the other from the exterior of the garden to the west. Like the upper storey windows, the doors have brick voussoirs rather than lintels (Illus 7b). Two windows are present on the ground floor in the walls adjacent to the doors (Illus 6). The window looking into the garden retains a six-panel metal frame and the window looking to the west has a single pane.

- 3.2.1.3 The eight first floor elevations have central 'windows' with brick margins and an arched head. It is uncertain whether six of these were ever anything more than blind decorative features but the brick is of the same type and the courses do follow through from the adjacent wall. The two serviceable windows are on the south-east and north-east facing elevations (Illus 6). A frame is still present in the south-east facing window only, and this comprises a single lower pane and four panes above. Although access was restricted the roof appears to be flat and constructed using iron beams supporting iron sheets (Illus 7a). It seems unlikely that this arrangement was totally original although beams of this type would have been available in the 18th century.

comm). A doorway measuring 1.8m high and 1.2m wide is present in this wall, adjacent to the octagonal structure, and may have provided access to the now-demolished building (Illus 6 - east facing), depicted on the 1869 first edition Ordnance Survey map (Illus 3). It is possible that this door may be a secondary feature but in any event there has been some significant modification at the door head with the insertion of a crude stone lintel possibly associated with the replacement of an earlier timber one. Restricted access to this area (private gardens on the exterior and thick vegetation on the interior) precluded inspection of the west elevation that would undoubtedly have provided evidence for the character of the demolished structures.

Doorway in the south end of the west wall

Octagonal tower, doorway and wall from the south-east

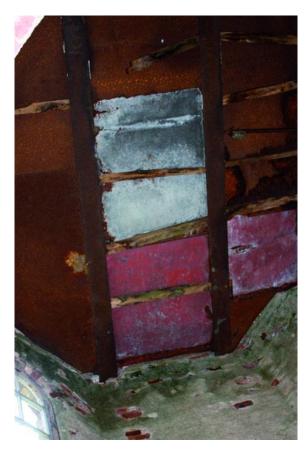
Illus 7aDetail of the octagonal tower – the iron roof

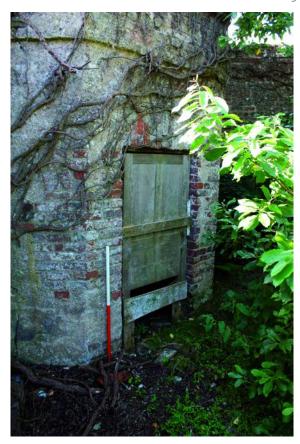
Illus 7bDetail of the octagonal tower – detail of doorway in the octagonal tower (no. 4 on plan, Illus 6) from the north-east

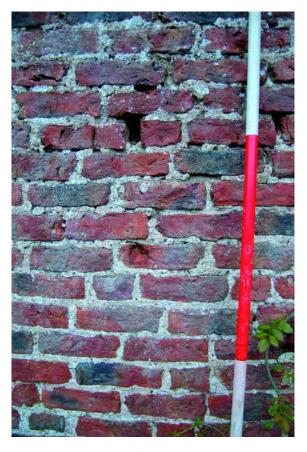
- 3.2.2.2 The garden wall was largely constructed of hand-made bricks (Illus 7c) and its height varies around the circumference. The south wall, closest to the road, stands to a height of between 1 and 1.5m (highest in the west, external elevation) and 0.37m thick (Illus 6a & 8a). As in the tower, it was constructed of brick using a characteristic English garden-wall bond, with one course of headers (bricks laid end on) separated by three to five courses of stretchers (bricks laid side on) (Curl 1993, 56). This pattern is, however, broken in limited areas through the introduction of additional headers. The coping comprises brick headers and regularly spaced squared granite blocks between 0.4 and 0.5m wide and 0.15m deep. These blocks were placed at intervals of 1.2 to 1.4m. They may have been purely decorative but may also have supported ornamental features such as statues or pot plants.

Illus 7cClose up of brickwork of north wall showing Flemish bond and hand made bricks

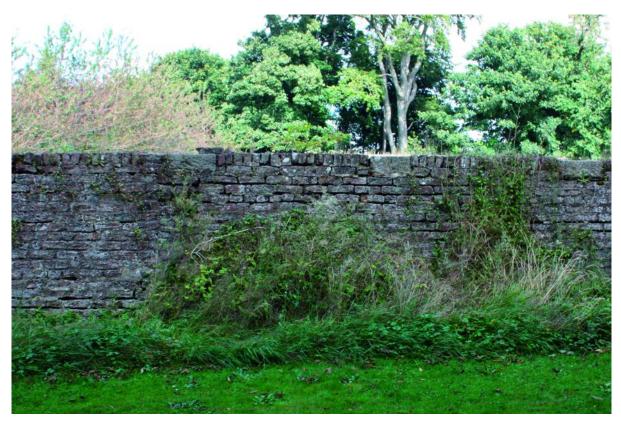
Illus 8aSouth wall showing fabric and stone blocks incorporated into the wall, from the north

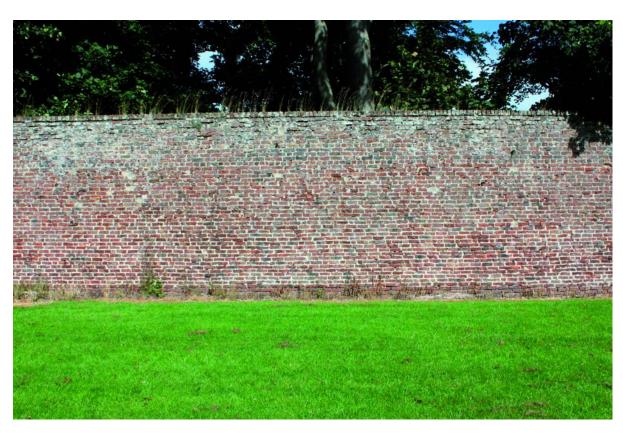
Illus 8b *North wall showing the fabric in detail, from the south*

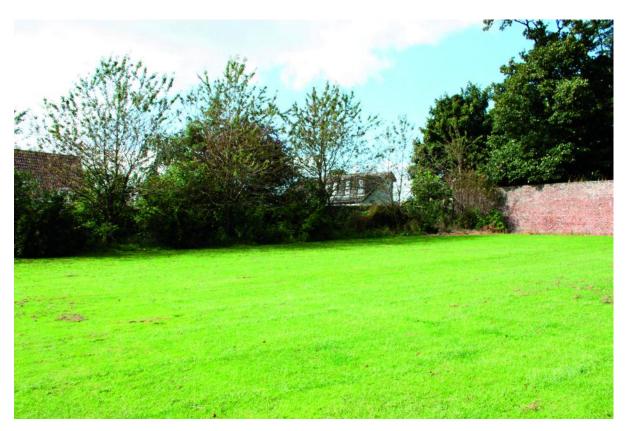
Illus 9aNorth-west corner of the garden showing addional lengths of the west and north walls

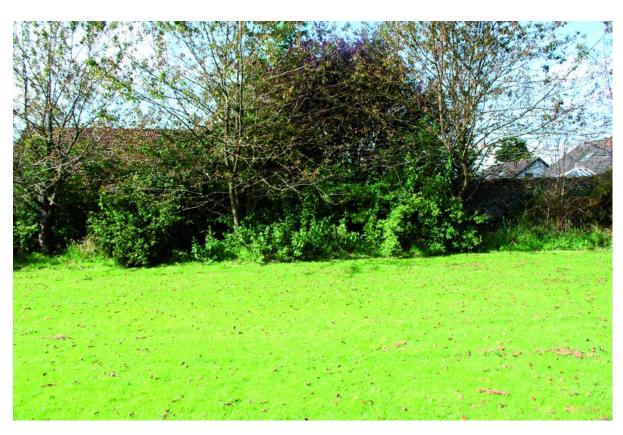
- 3.2.2.4 The height of the west wall has been reduced from c. 3.5m to 2m along the majority of its length. The downtaking occurred during the construction of the 1980s' housing development to the west of the walled garden (Mr S. Gordon, local resident, pers

Illus 9bWest wall

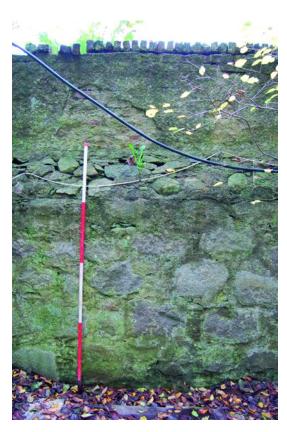
Illus 10aDetails of north wall construction, from the north

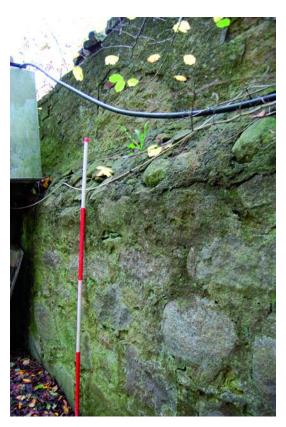
Illus 10bDetails of north wall construction, from the north

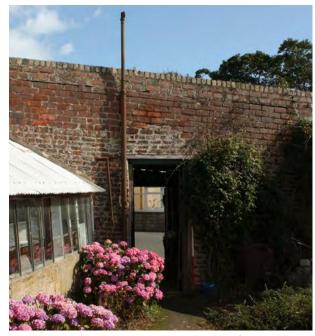
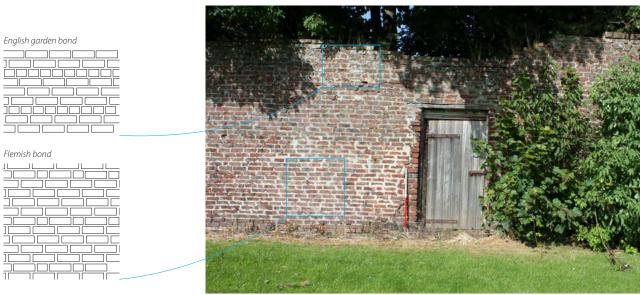
Illus 11 *Elevations of doorways in the north and east walls*

- 3.2.2.5 The north wall stands to a height of up to 3.6m with some parts slightly damaged by trees. A doorway (Illus 11) is present in this wall towards the west end and has clearly been inserted after construction. The doorway is 2.2m high and 1.2m wide, the margins are largely of later machine-made bricks and it has a wooden lintel and a simple wooden door. The wall has been extensively re-pointed except for the 2-3 footer courses which were presumably obscured by vegetation or have been affected by rain splash-back.

- 3.2.2.6 The east wall is constructed of the same hand-made bricks used elsewhere and using an English garden bond up to a height of c. 2m. (Illus 11) Above this the wall has been brought to the same height as elsewhere through the use of machine-made bricks (240mm x 90mmx 110mm, header bond), presumed to be late 19th early 20th century (see also 3.2.2.8).

West elevation of door in east wall

South elevation of door in north wall

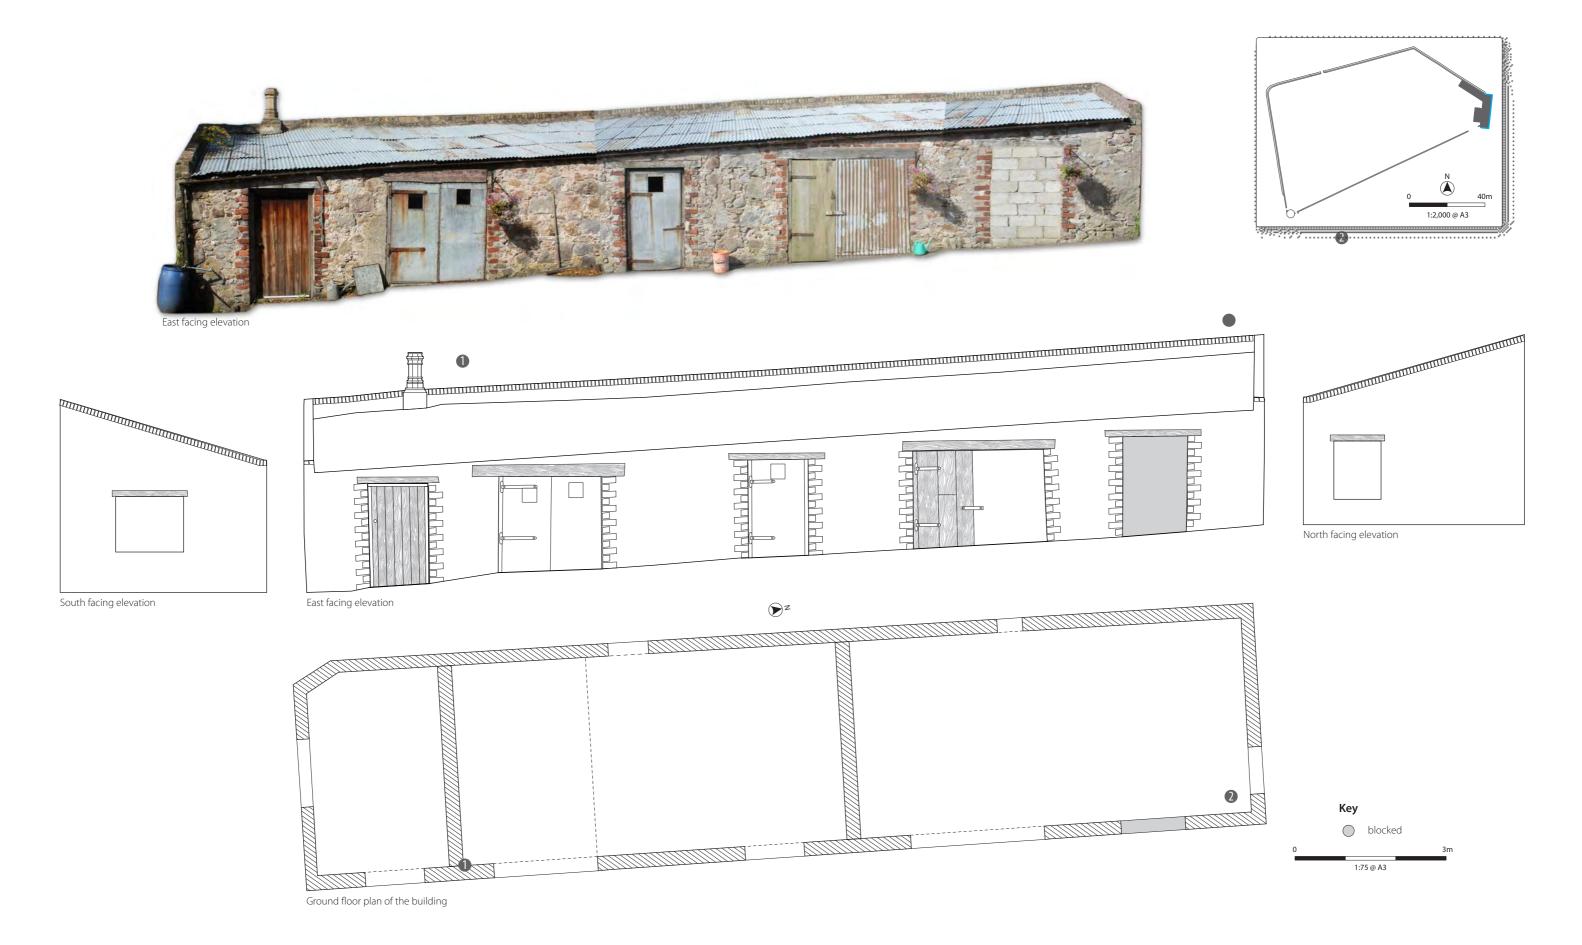
Illus 12 *Elevations and plan of outbuilding outside the east end of walled garden*

- 3.2.2.7 A small range of outbuildings was added to the outside of the east garden wall sometime after the 1869 Ordnance Survey and before the 1901 Ordnance Survey (Illus 11 & 12). The construction of this range saw the garden wall rebuilt or raised by 1.1m to accommodate both the sheds and the glasshouse (see 3.2.2.8). The range was a leanto structure built of random stone bonded with lime mortar. The front of the building has been modified significantly. The current doorways have brick margins suggesting they are later insertions, as is the corrugated iron roof. The two windows at either end of the range, having no brick margins, appear to be original. A door has been added to provide access to these buildings from the interior of the garden. Other details include a grepe (water channel) in the concrete floor of the north room which was used for cattle in 1930 when the current occupier, Mr Gordon, moved in. The middle room was for horses and there are surviving stalls to support this. Access was not possible to the south room in this range but the presence of a chimney suggests that this was the location for a boiler that provided heat for the glasshouses to the west. This boiler house, the only room that has water now, was fed by the well.

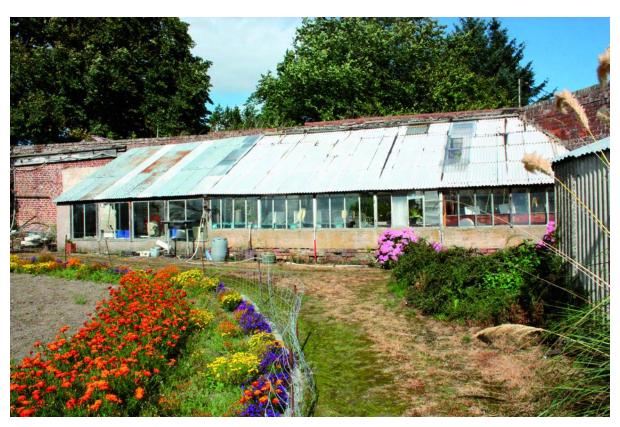
Illus 14

- 3.2.2.8 A lean-to glasshouse measuring 15m by 3.4m was present along the north-west wall (Illus 13, 14). It had a roughly built brick (header bond & machine-made, 240mm x 90mmx 110mm) and concrete plinth onto which the glasshouse frame and windows had been set. This building is not depicted on the 1901 Ordnance Survey map but it is on the 1926 edition (Illus 5) so it was clearly constructed in the early 20th century. It may once actually have been somewhat longer as evidenced by some exposed plasterwork (Illus 15) on the adjacent areas of brickwork to the north-west. A board has been fixed to the wall at this point to facilitate the attachment of 20th century services (Illus 15). Further

The greenhouse at the east end from the south-west

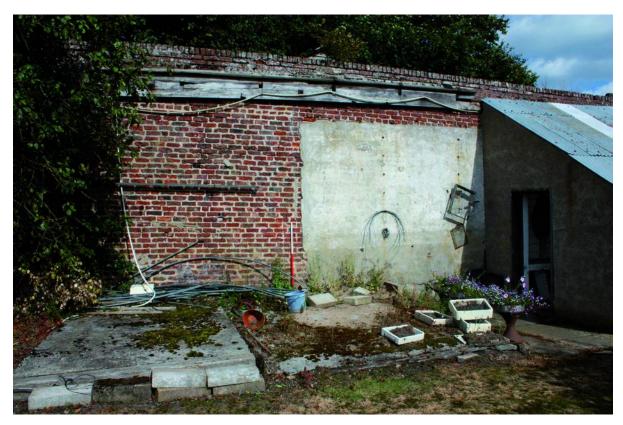
Illus 15East wall showing the fabric of the wall and residual render from a now-demolished glasshouse, from the west

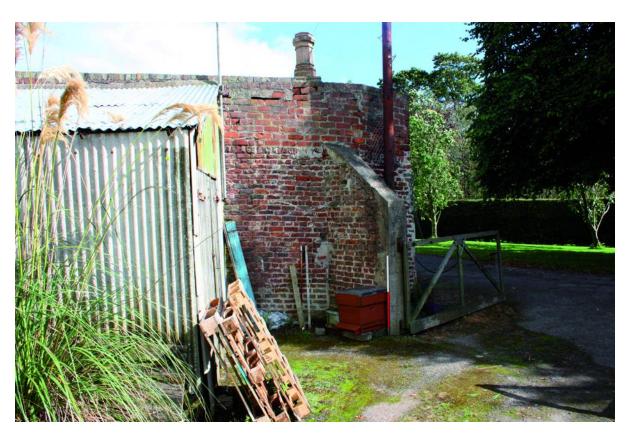
3.2.2.9 The main entrance to the garden is 6m wide and located along at the east end of the south wall (Illus 13 & 16). Although the map evidence implies that this was always an entrance, the terminal of the adjacent wall to the west shows a degree of modification, so the entrance has probably been widened at some point in the past. The east jamb of the gate is formed by a small stub of wall which is tied into and coursed with the main east wall. The southern terminal of the east wall has been modified by the construction of the sheds to the east but the Ordnance Survey maps suggest that this could have continued across the service road to the south (Illus 3-5). A smaller doorway is present at the west end of the wall, where the wall raises to a height of 2.8m with a gentle upwards curve and meets the octagonal tower (Illus 6). This doorway is 1.4m wide and 2.6m high with brick 'soldiers' (brick lintel) above and with a supporting buttress to the E. It has a wooden frame and a simple board door (Illus 6).

Illus 16East wall, showing detail of east gate terminal and modifications to the height of the wall

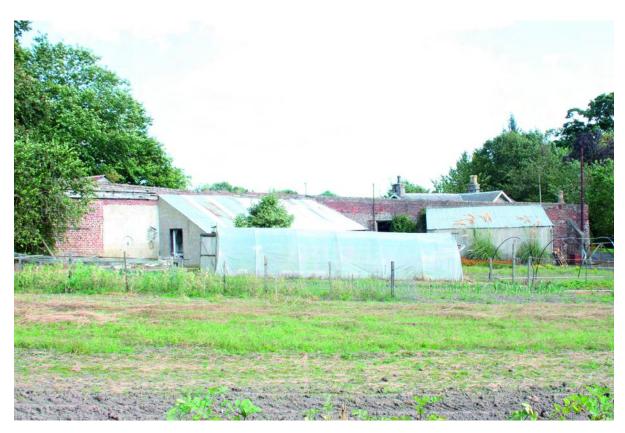
Illus 17 *East glasshouses, from the west*

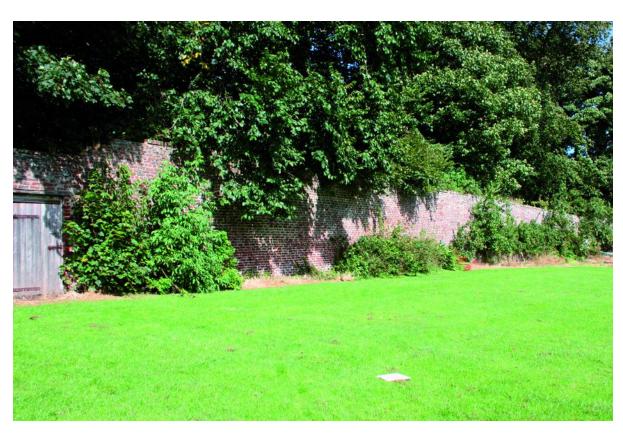
Illus 18North wall and fruit trees, from the south-west

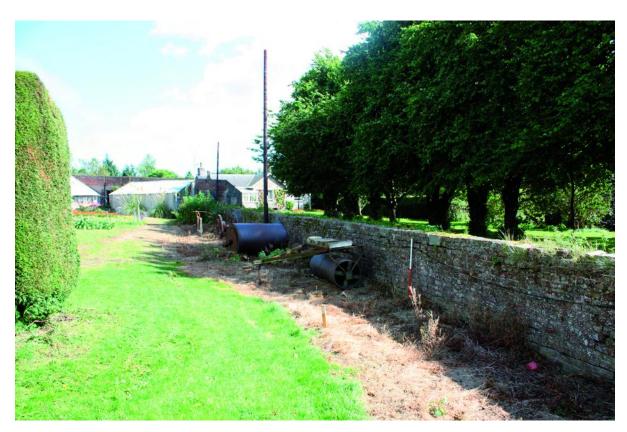
Illus 19South wall and garden from the west

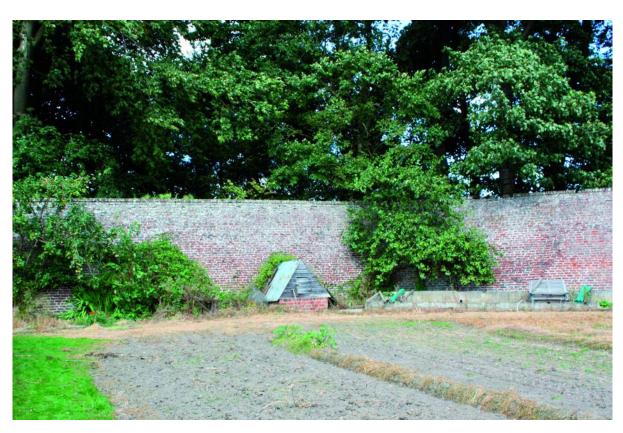
Illus 20 *North-east corner of the garden including the well from the south-west*
