DALKEITH CORN EXCHANGE

Historic Building Recording

for Melville Housing Association

May 2013

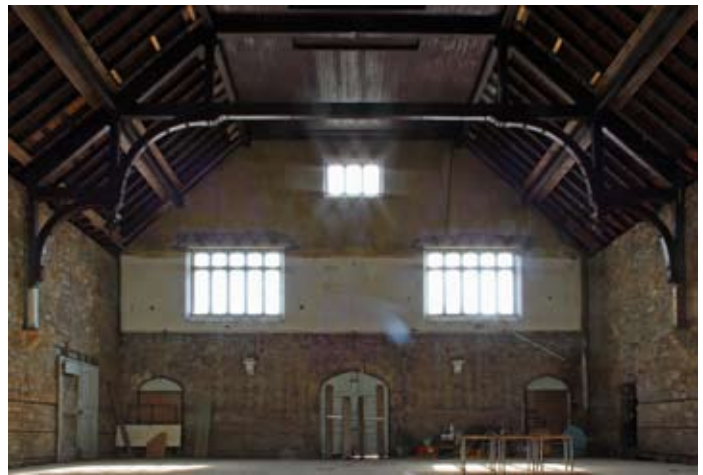
Photo 003

East elevation (Photo 003) Lathe and plaster removed on lower part of wall, exposing original random rubble stonework. Slots for timber batons that would have supported the original wooden panelling to dado height still evident. Main entrance is a double leaf wooden door hung in a wide tudor arch, currently out of use. Two smaller flanking doorways in similar style are presently boarded up. Two springers in wood mimic the stone ones on the long elevations but are unlikely to be structural. Two substantial rectangular 15-pane transomed windows appear to have had their lintels replaced with concrete. A further central 9-pane window appears to retain its original lintel.

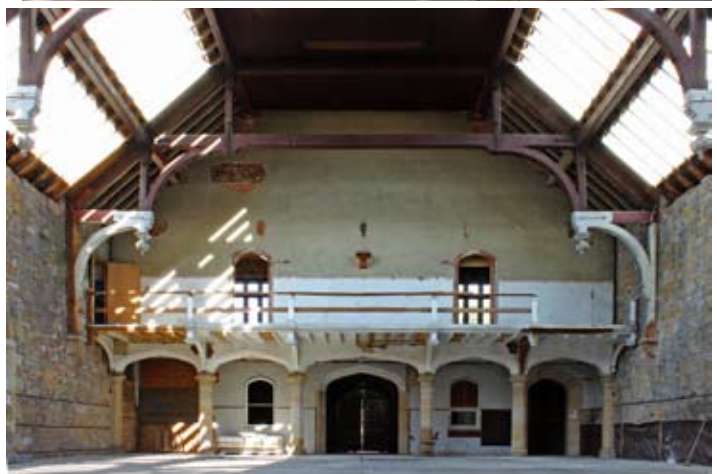
Photo 004

West elevation (Photo 004) Tudor-arched colonnade supported on octagonal stone columns with plain capitals and bases. Wide central bay with two narrower ones on either side. Arches formed of timber and plaster. Wall behind retains wooden panelling to dado and most of lathe and plaster above, although some brickwork revealed. Openings to western rooms described below. Colonnade supports wall for upper storeys and projecting balcony. Upper wall plaster mostly intact. Two tudor-arched doorways leading to upper rooms and one central wooden decorative corbel as per east elevation. Floor of balcony recently replaced, only main posts of the banister survive.

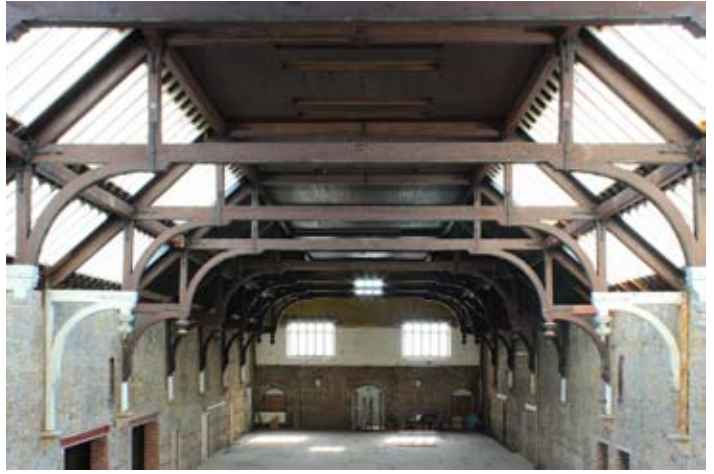
Photo 005

Roof Pitched timber clad roof supported by double hammer beam truss structure sprung from protruding stone corbels (Photo 005). These correspond with the substantial buttresses on the exterior and form nine internal bays. Some original hammer beam decorations are missing. Some lean can be seen in this structure when viewed from the balcony. Metal strapping has been installed on several beams. The collar ties support a timber-clad ceiling with space above; a series of long rectangular slots run transversely at intervals in this ceiling. The timber cladding may once have continued onto the pitched part of the ceiling. The four western bays have retain their substantial rooflights – they appear in good order and may have been replaced.

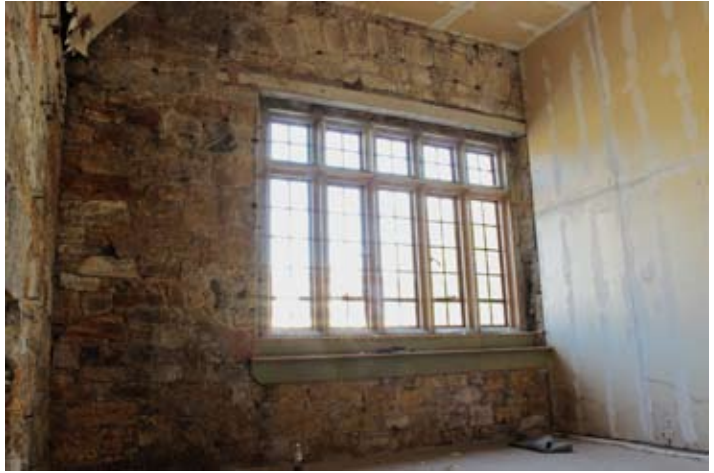
Photo 010

West elevation Plaster finish removed exposing uncoursed random squared stonework. Two large rectangular 70-pane casement windows with transoms (Photos 010 and 018). Original lintels replaced with concrete. Sills recently repaired with neatly finished MDF.

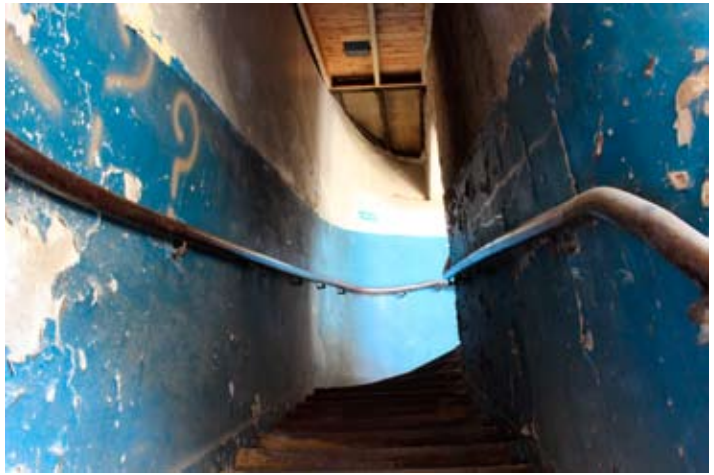
Photo 011

First floor accessed by external projecting stone stair on south elevation of main hall. This has been constructed in place of the westernmost buttress on this side. These stairs would have been open to the close to the east but has been subsequently been blocked (Photo 026). Plaster mostly survives. Curved wooden handrail (Photo 011). Exposed ceiling timbers look recently replaced.

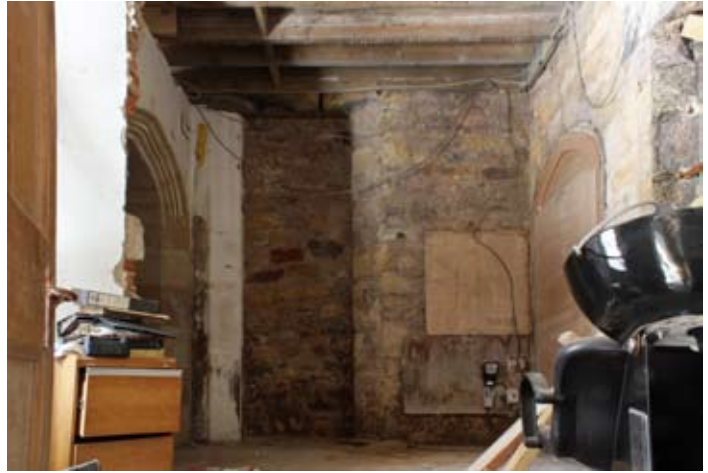
Photo 014

North and south elevations External stone wall of squared stones built to courses. No evidence for plaster finish. Chamfered recess below upstairs fireplaces – hearth stones visible from below. Electricity panel on south elevation (Photo 014).

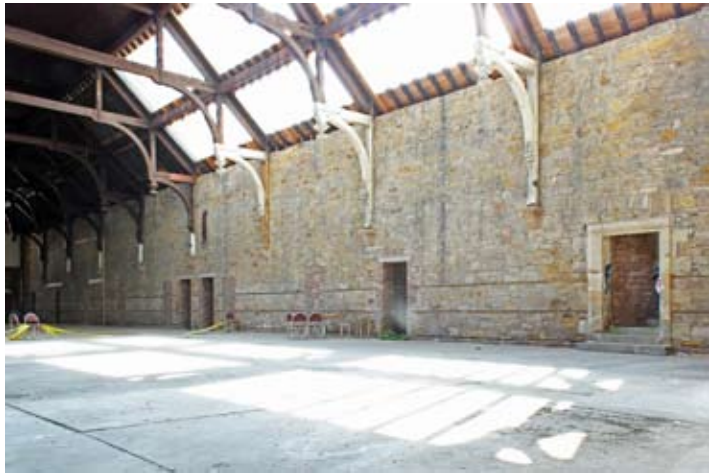
Photo 018

North elevation (Photos 018 and 021) Lathe and plaster removed completely, slots for wooden panelling to dado still evident. There are 8 openings in this elevation, of which only the eastern two appear to be original. These comprise a large double door with a replaced iron H beam lintel, and a narrow blocked doorway with stone relieving arch. The remaining openings are later insertions with steel or concrete lintels and brick frames. An iron slot can be seen half-way down the hall which would have held a spanning beam as part of the ballroom partition wall.

North and south elevations Plaster finish removed exposing uncoursed random squared stonework. Western side projected to house large fireplaces with tall stone lintels (Photos 018 and 019). Slots adjacent to west elevation above head height – purpose unclear. Ladder mounted to south elevation for access to loft space above.

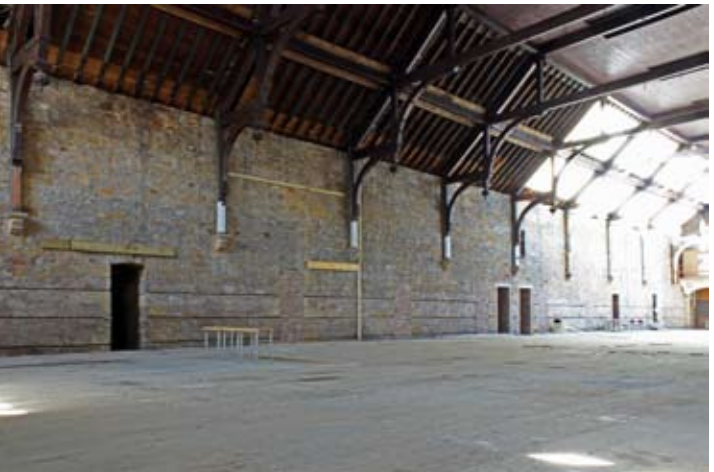
Photo 019

South elevation (Photos 019 and 020) Lathe and plaster removed completely, slots for wooden panelling to dado still evident. There are eleven openings in this elevation, of which eight appear to be original. Each bay bar the two westernmost has an original doorway at its centre, although five of these have been blocked. The easternmost doorway has a stone lintel as well as a relieving arch, and has ashlar jambs of higher quality than the others. At the western end, a chamfered ashlar doorway (Photo 012) leads to the external stairwell. The remaining three openings are later insertions with concrete lintels and brick frames. An iron slot (Photo 031) can be seen half-way down the hall which would have held a spanning beam as part of the ballroom partition wall.

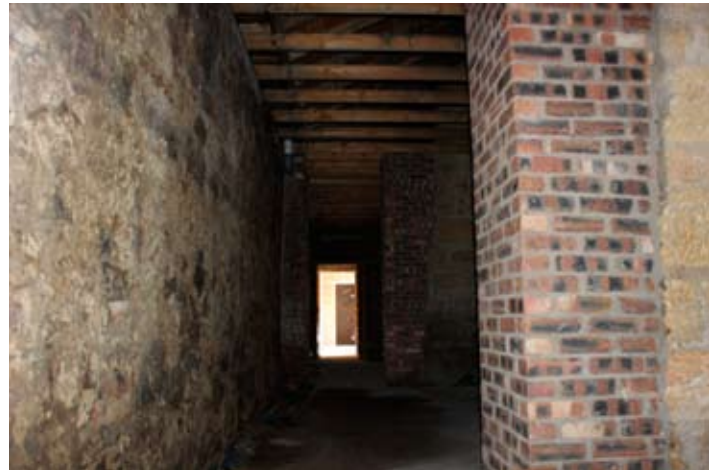
Photo 023

close wall, the top of which has been somewhat consolidated. The internal space is built around the original stone buttresses, some of which have been squared off with brick. Further brick walls divide the space into a series of smaller rooms (Photo 024). A number of original entrances to the main hall have been blocked during construction of the lean-to (Photo 025), and several new ones have been broken through (see description of main hall for details). At the western end, a series of steps (Photo 026) join the projecting stone stair to the original close level (the connection has been subsequently bricked up). An external window at the eastern end has been blocked. A large steel H beam has been inserted near the eastern elevation, possibly related to some repair of the close wall at this point (Photo 023).
