32 – 38 MILLHILL, MUSSELBURGH, EAST LoTHIAN

HISTORIC BUILDING SURVEY

commissioned by Loretto School

January 2017

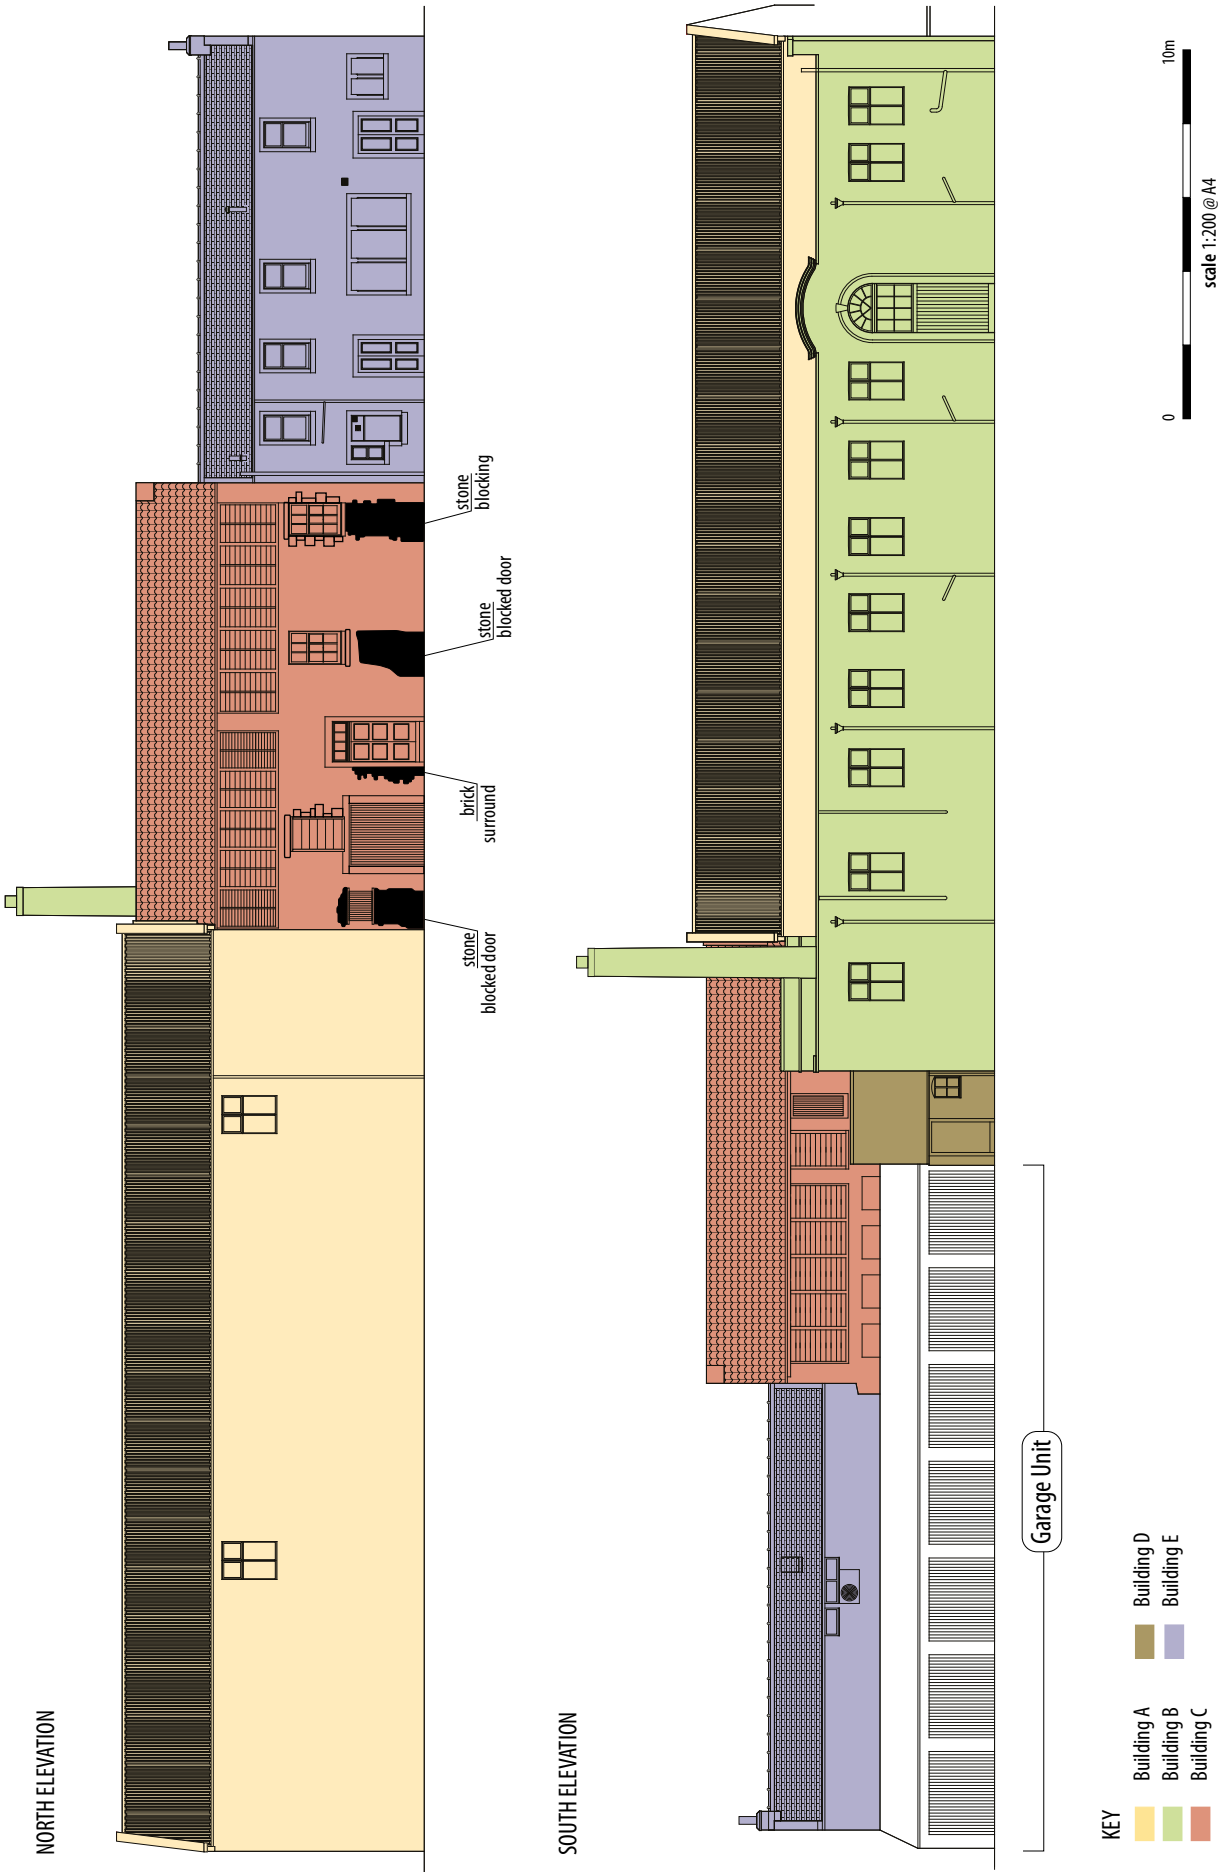
ILLUS 5
North and south external elevations of Buildings A – E

This was a long tall rectangular building with a pitched corrugated roof that abutted Building C to the west and a row of Victorian houses to the east. The external appearance of this building gave little impression as to its present day use. The rendered north wall facing onto Millhill presented a long tall wall with no features or openings. The east and west gables were mostly masked by attached buildings although the tops of the gables were partially exposed. The south elevation was formed by the south wall of Building B that formed the main entrance to the swimming pool. The original south wall of Building A had presumably been demolished (probably during the construction of the swimming baths in 1919). Only the lower courses of the line of the original wall were still present, being recorded in the basement below the pool (Illus 5).

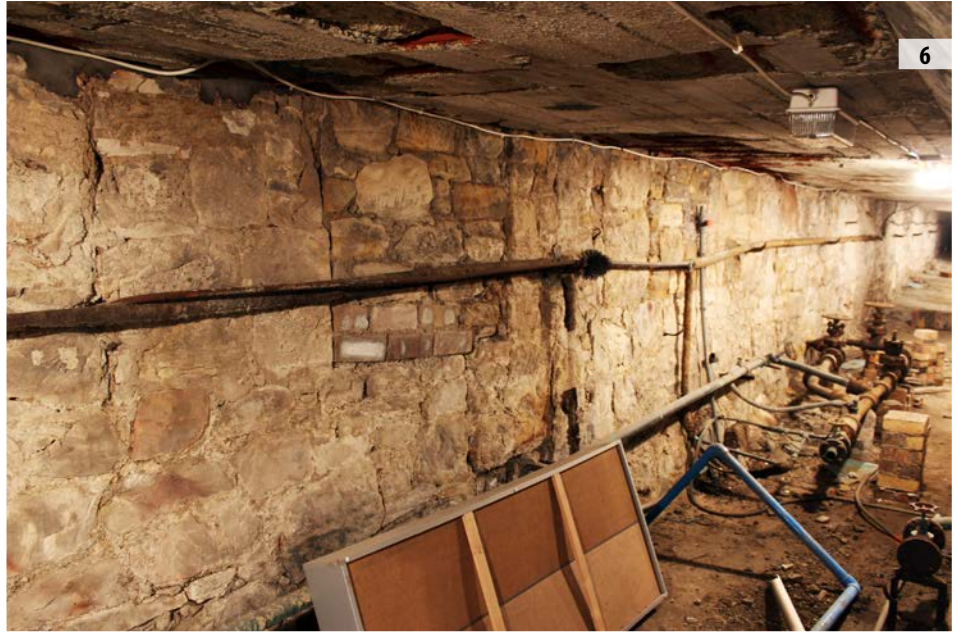
ILLUS 6

Although access to the basement area was limited the rubble stone walls recorded below the pool presented a number of features. On the north wall three stone-blocked windows were visible close to the west end. These would have been partially below the present street level. The west wall included a narrow brick-blocked doorway close to the north side. No openings were found on the south wall although in places the wall projected into the building that may present evidence of additional support for the location of heavy machinery (Illus 7).

View of the north foundation wall of Building A

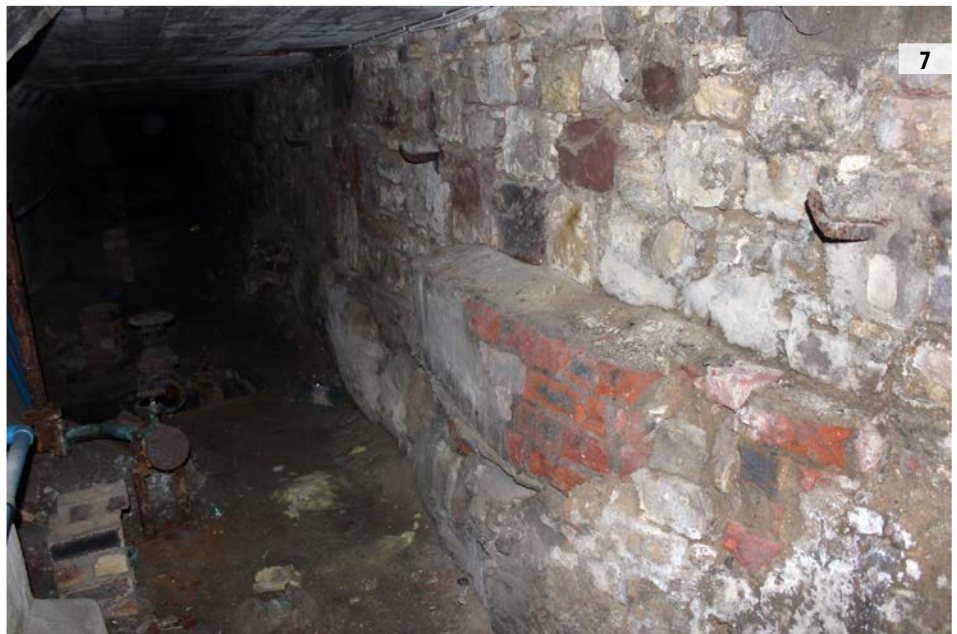
ILLUS 7

Detail of the projecting south foundation wall of Building A

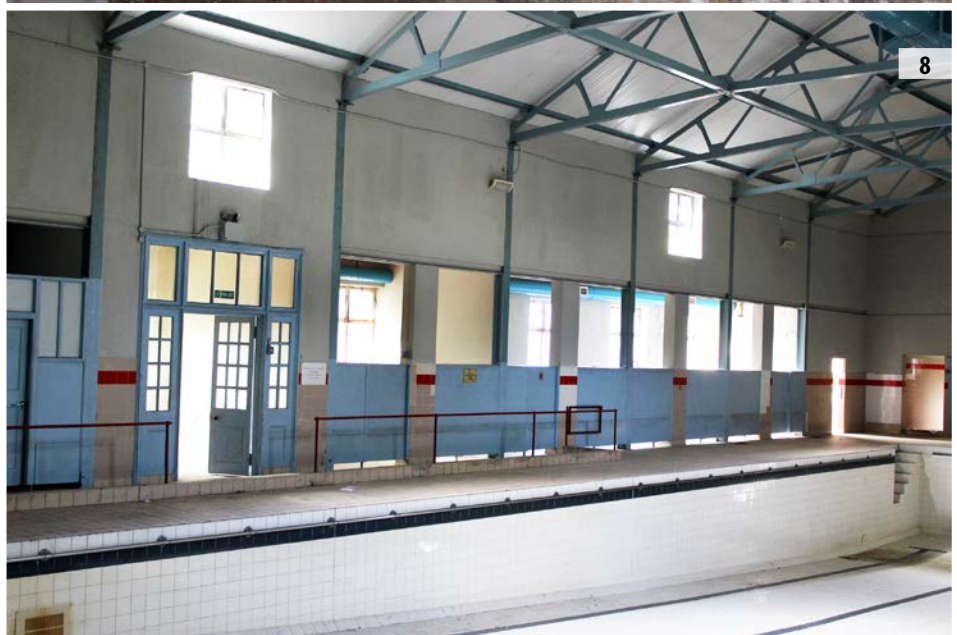
ILLUS 8

The internal division between Building A and Building B were marked by the painted timber walls of the changing rooms and shower blocks located to the south side of the swimming pool (Illus 8).

View of the changing room and shower partition walls in Building B

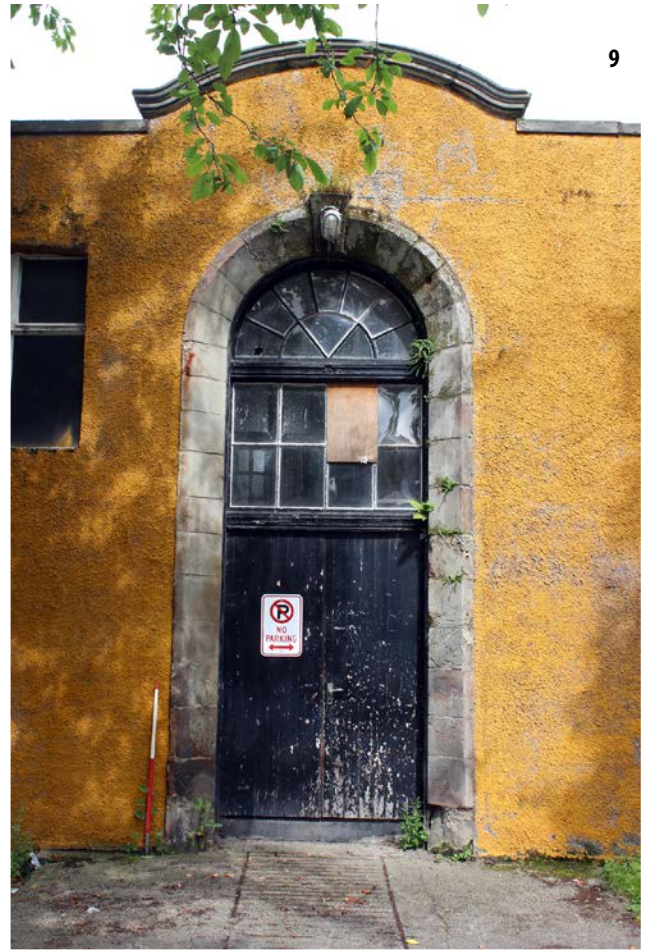
ILLUS 9

building into the swimming baths in 1919. The rendered external south wall of this building included a double swing door with an elaborate arched stone surround flanked on both sides by plain casement windows which also continued along its length. The stone surround to the door had a decorated bevelled edge and a projecting key stone with the door itself including a rounded skylight. The top of the wall above the door included an arched pediment topped with a projecting cap stone (Illus 9). The roof of this building was flat and as it wrapped around the west side of Building A it stepped up in height. This part of the building also included a tall square chimney that was thought to be part of the same phase of construction.

Detail of the pool entrance on the external south wall of Building B

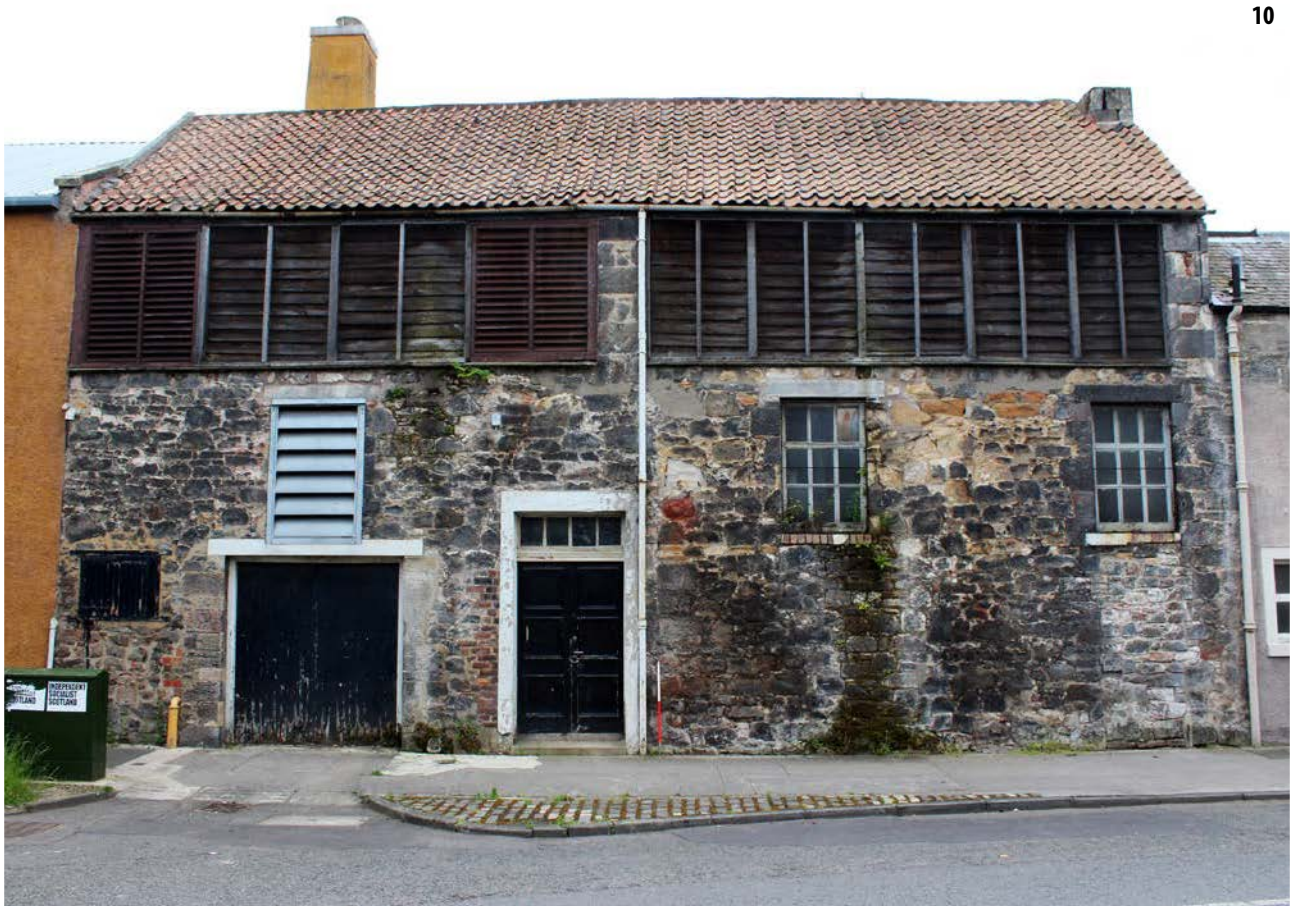
ILLUS 10

The external rubble stone north wall displayed a number of features and alterations although the addition of later openings and the application of new cement in places made the interpretation of this wall difficult. In its present state the elevation included a main entrance door, a wider garage door and a timber hatch along with two windows and a steel vent high up on the ground floor level. Above this was a series of timber slatted vents forming the first floor wall. These vents occurred on both main elevations of the building.

View of the north external wall of Building C

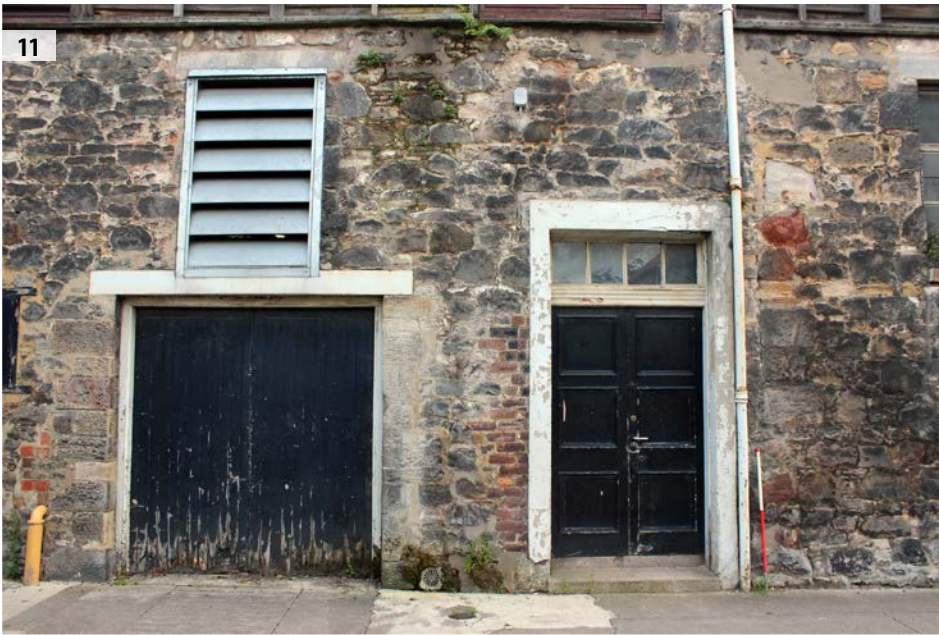
It was clear that the two doors on the north wall were later phase alterations due to the occurrence of brickwork abutting the door surrounds (Illus 11). These features may relate to the conversion of the buildings into baths in 1919. The hatch to the east side of the doors was also probably part of this development. The brick cills and concrete lintels of the two windows indicate a level of alteration. The window to the east side was clearly a later addition, although the window to the west side included tool-marked in-out surround stones that continued below the level of the inserted window. This suggests that although this was the location of an original window a new shorter window had been inserted at a later date contemporary with the window to the east. Further in-out surround stones were present to the west side of the steel vent above the garage door

ILLUS 11
Detail of the doors on the external north wall of Building C

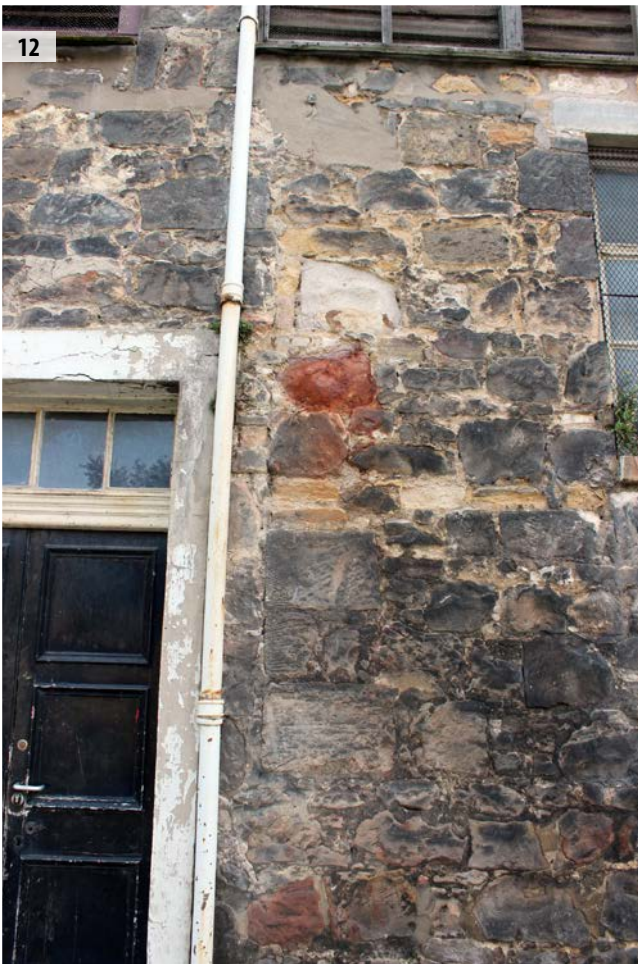
indicating that this too had probably been the location of an original window. To the west of the main entrance three further in-out surround stones were visible within the makeup of the wall indicating the possible location of a further original window (Illus 12). A construction line continued above these stones but it was unclear what this represented. Below the central window slight evidence of a stone-blocked door was visible. The evidence for this was much clearer on the internal face of the wall with clear construction lines and a timber lintel visible (Illus 13). Further construction lines were evident below both the window to the west side of the external elevation (Illus 14) and the hatch to the east. It was not clear what the lines below the window represented as they were fairly irregular. It is possible that they represent evidence of repair to the wall, possibly during the insertion of the new window. The construction lines below the hatch may represent evidence of a small door although no sign of the lines were visible on the internal face of the wall.

ILLUS 12
Detail of the in-out surround stones to the west of the door on Building C

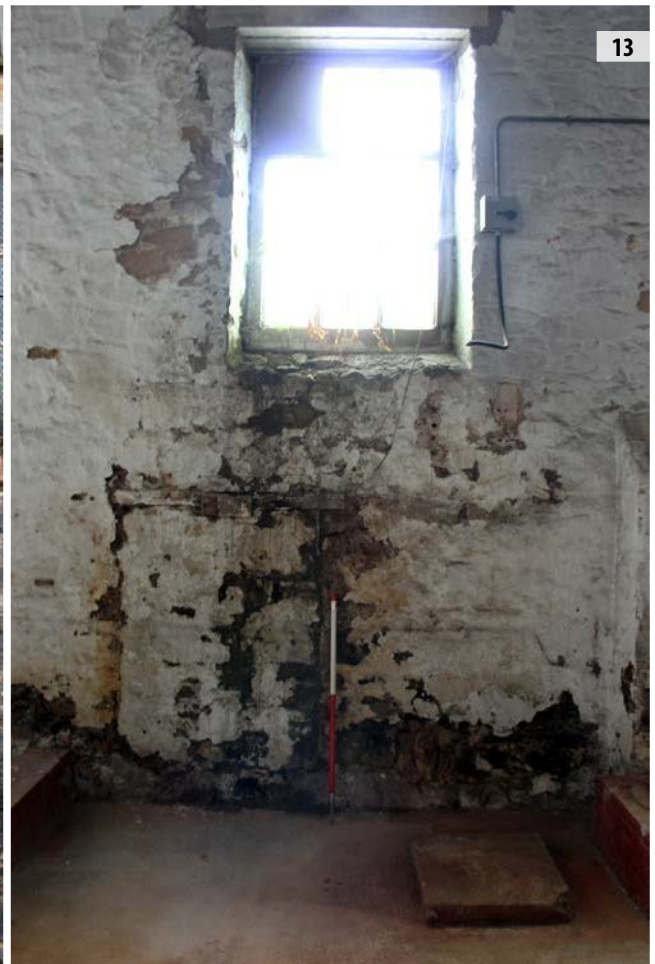
ILLUS 13
Internal view of the stone-blocked door on the north wall of Building C

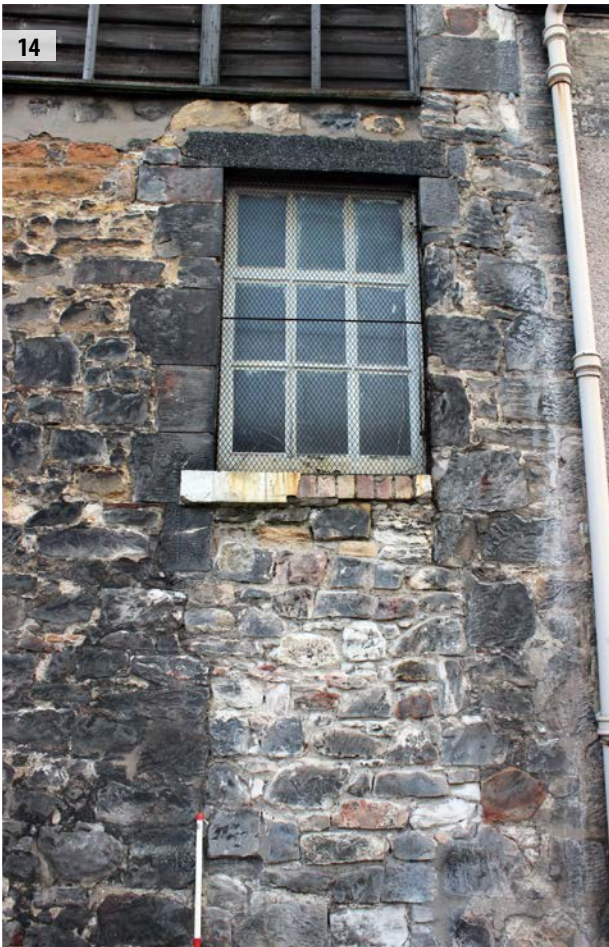
ILLUS 14
Detail of the construction lines on to the west side of Building C

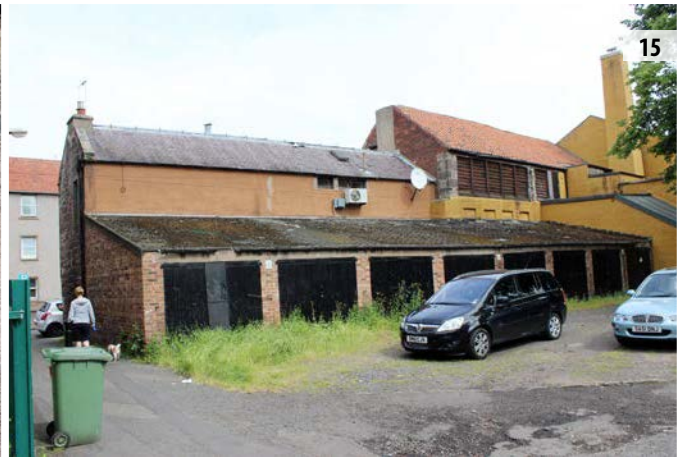
As mentioned above, much of the south external elevation was masked by other buildings including the modern garage unit (Illus 15). The walls on this side of the building had also been covered in the painted render masking the construction material. All that was visible was the top half of four blocked windows on the ground floor and the timber venting on the upper floor. One feature of note on the south wall was recorded at the west end of the wall. Here the wall at ground floor level extended further to the west than the first floor level forming a small step in the wall (Illus 16). This evidence indicated that the whole of the upper floor of the building may have been part of a later phase. The reasonable condition of the timber venting across the upper floor would indicate that it was not that old. Given the ground floor rooms would have held strong chemicals for the swimming pool the ventilation was probably associated with the pool, although a tannery would also have needed good ventilation. The brick gable end of Building C visible above the roofline of the public house (Building E) was further evidence of this later phase construction as it would be expected that the original construction would have been stone.

ILLUS 15
View of the south side of Buildings C, D and E

The only demolition work due to be carried out comprises the removal of the garage units to the rear of the buildings. This may reveal further features of the south elevations of both Building C and E. A photographic record of this once the garage has been removed and prior to any rendering work would be recommended.

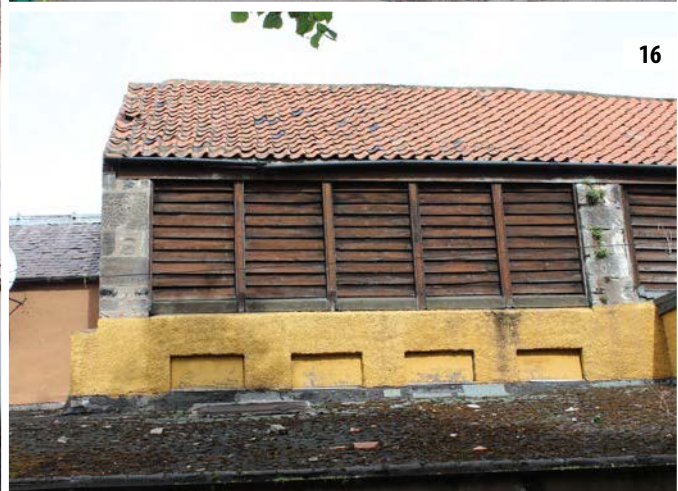
ILLUS 16
Detail of the ground floor north wall of Building C extending to the west

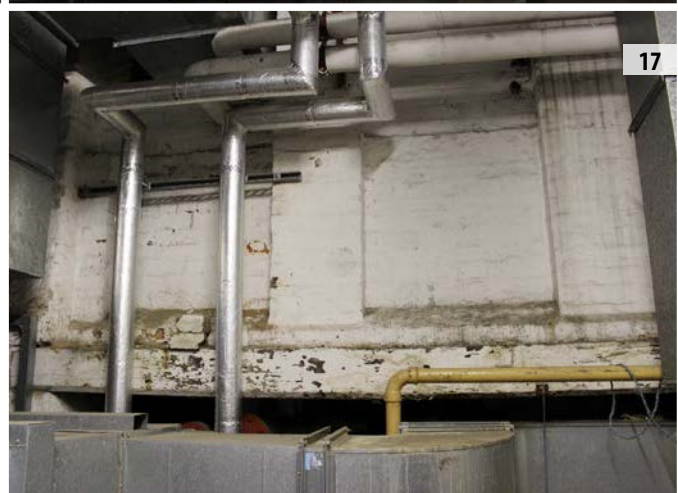
ILLUS 17
Internal view of the south wall of Building C (east side)

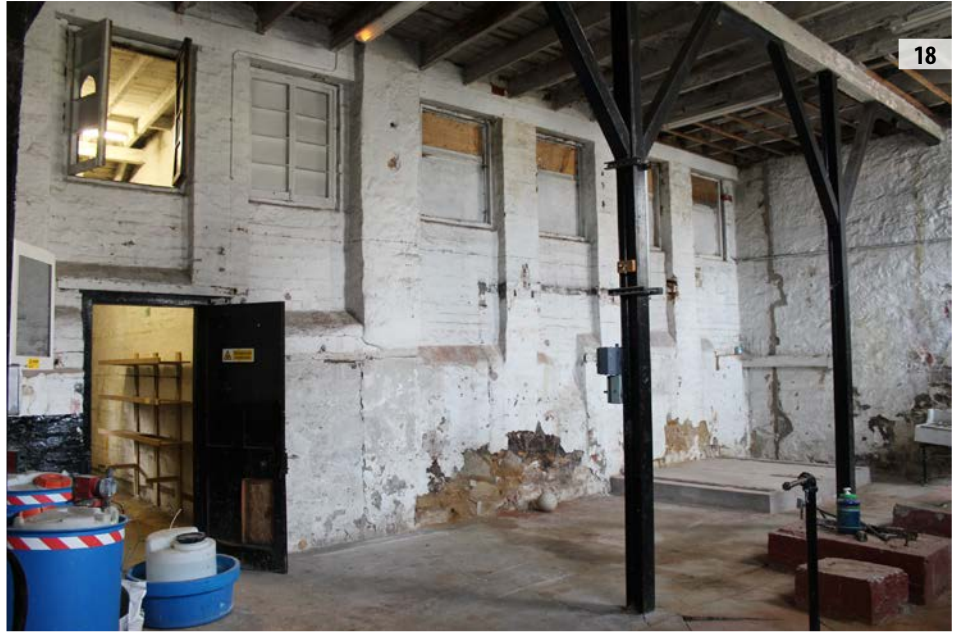
ILLUS 18

Internal view of the south wall of Building C (west side)

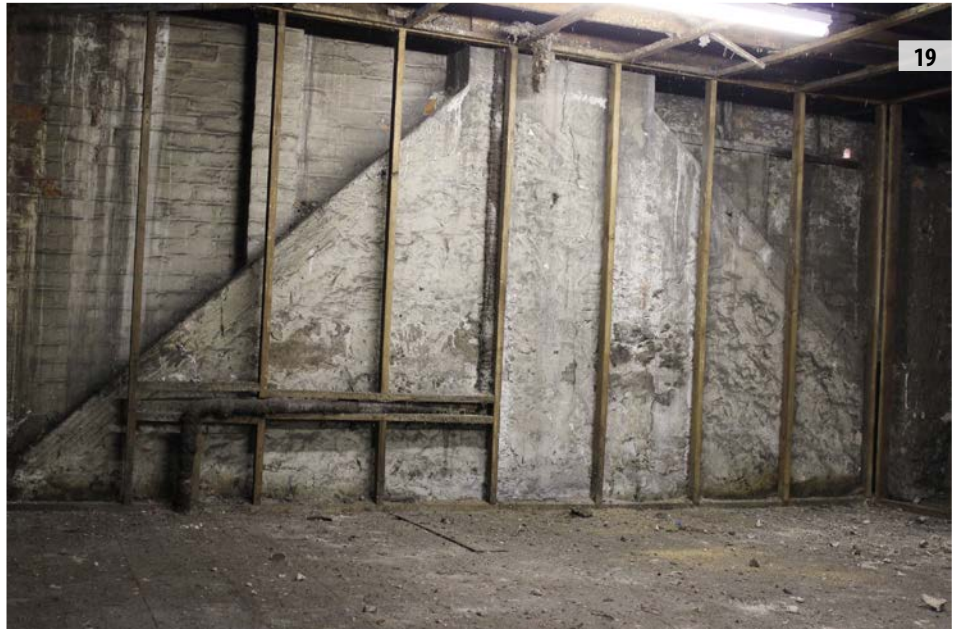
ILLUS 19

Access to the attic/upper floor space was gained by a timber stairway located in Building B. Within the attic area the stone gable of Building E extended slightly into the room (Illus 19) with the brick gable of Building C constructed over the top of it. This indicated that the gable of Building E had been constructed earlier than the roof and gable of Building C, providing further evidence for the assumption that the upper floor of building C was a later phase construction. The only other feature of note in this space was a large cast-iron water tank sat on the timber floor.

Detail of the Building E gable in the attic of Building C

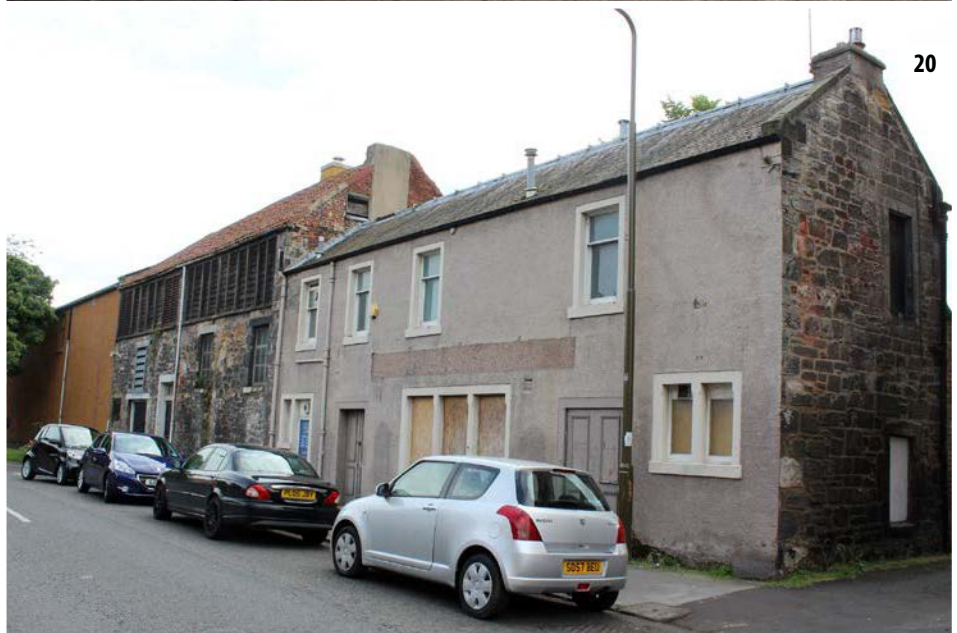
ILLUS 20

View of the Golf Tavern
