ABBNEYHILL, EDINBURGH

Historic Building Assessment and Excavation

commissioned by Watkin Jones

October 2014

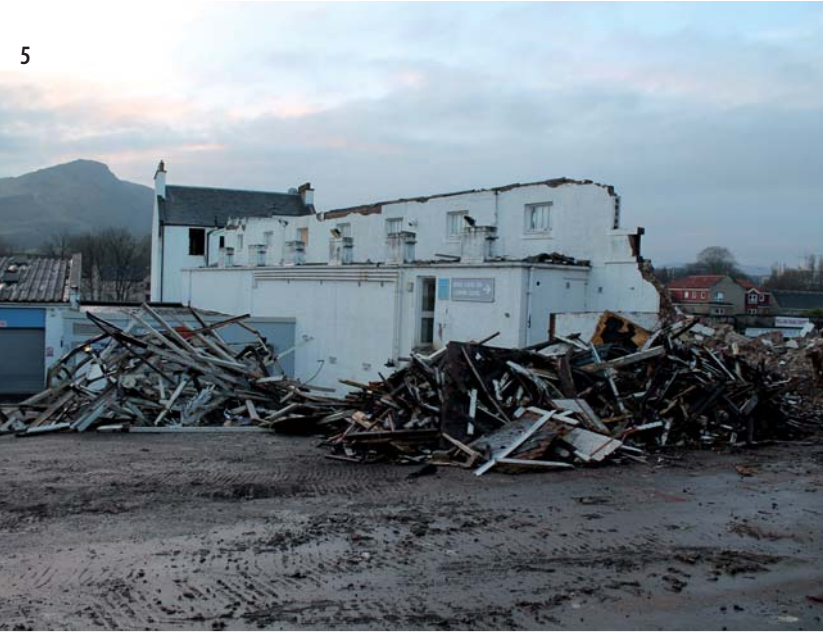
ILLUS 5

View of Building 1, facing SW

A large part of this building had been demolished at the time of the site visit including the roof and the north and west walls (illus 5). Only the south and east walls survived to any height. The building was a rectangular brick built two storey building aligned N-S. Due to the alignment of the building the first floor level at the north end was at ground level as the building cut into the bank. The upstanding east wall included a row of casement windows high up on the wall of the first floor level. Part of the east elevation was also masked by the stores building (Building 2) attached to the south end. No access was permitted to the ground floor level due to health and safety concerns. The first floor level included a tile floor with a series of small offices located on the east side

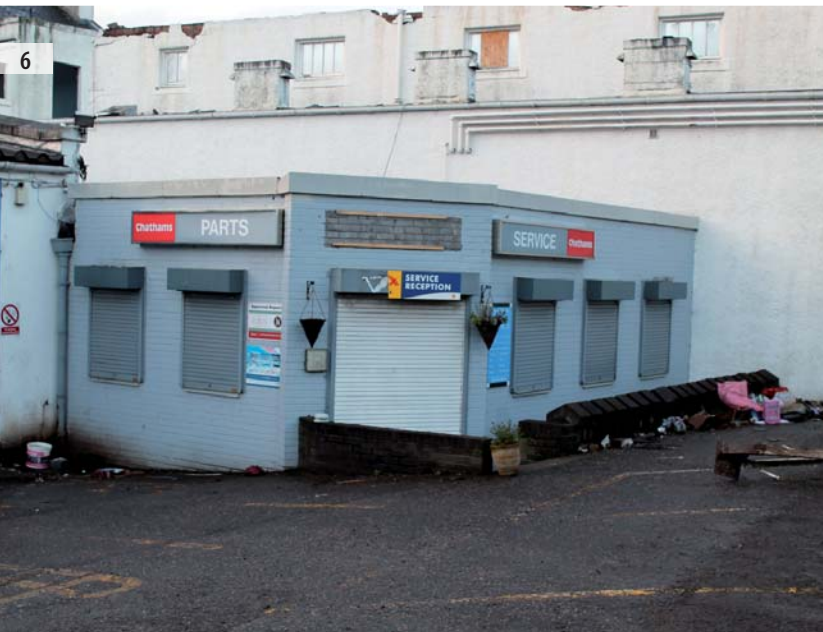
ILLUS 6

View of Building 2, facing SW

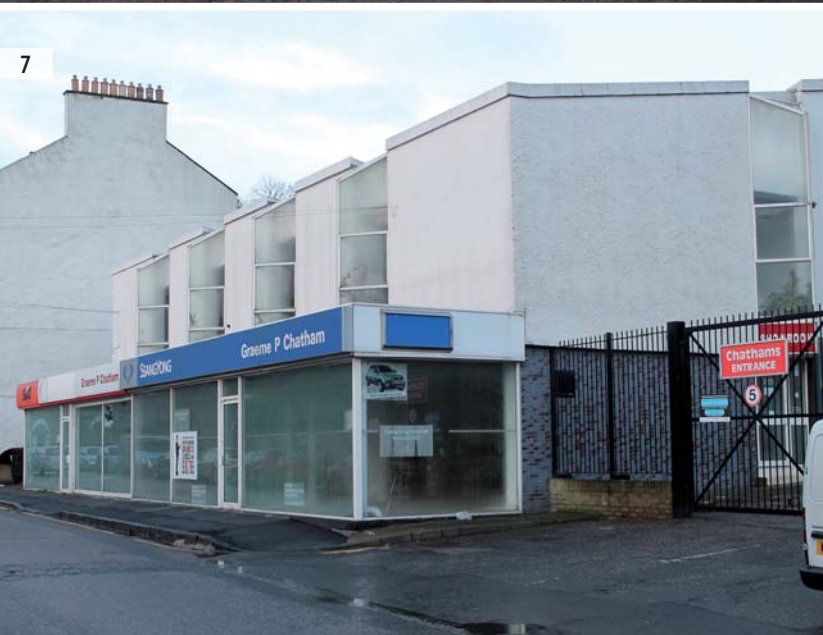
ILLUS 7

View of the front of Building 3 with the tenement in the background

The showroom and garage was a large square two storey structure (illus 7) constructed of breeze blocks covered in a pebble dash harl.

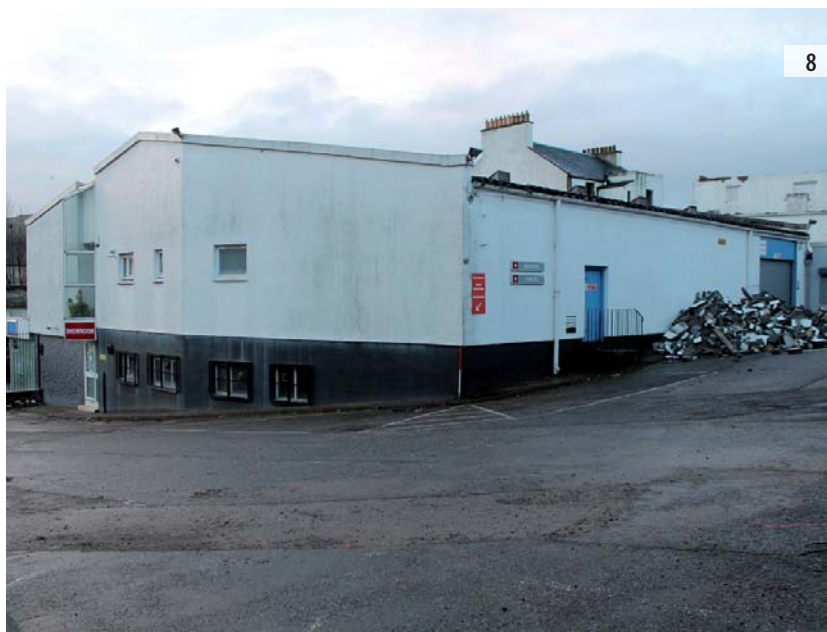
ILLUS 8

Detail the N and E elevations of Building 3

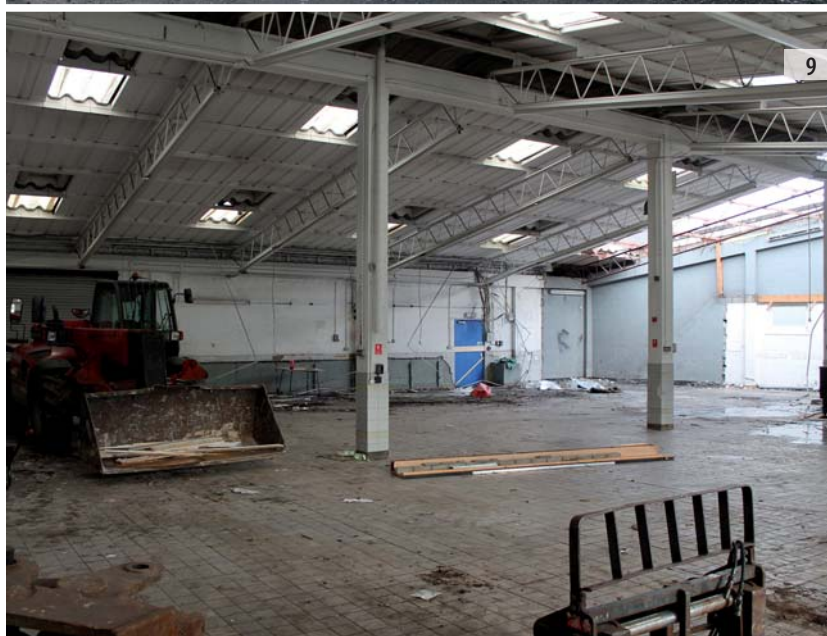
**ILLUS 9**

General internal view of the garage Building 3

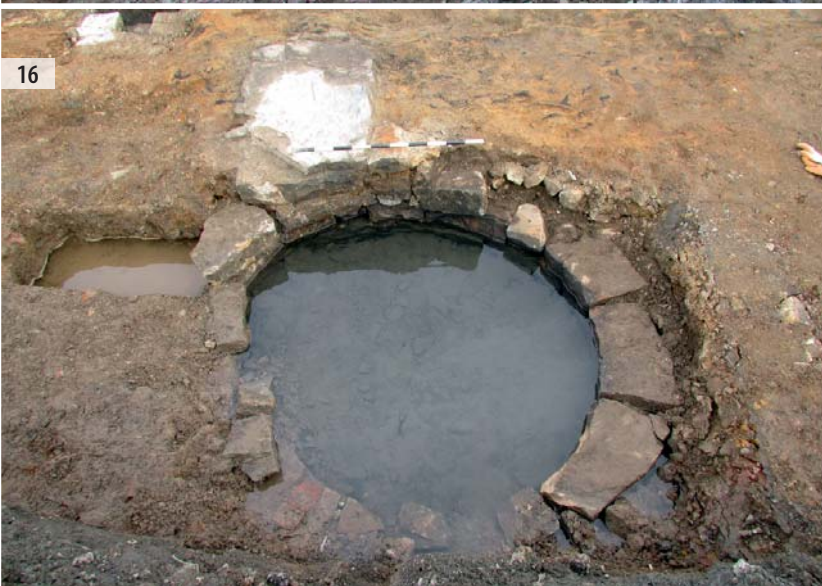
ILLUS 16

Detail of stone-lined well [020], facing N

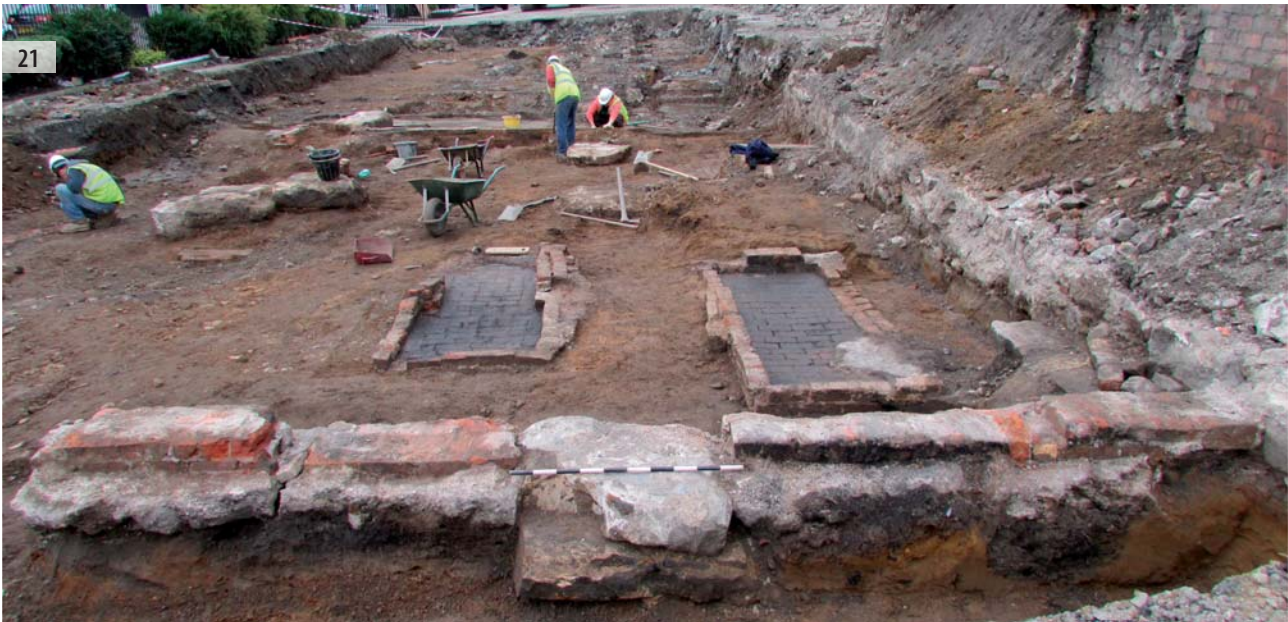
ILLUS 21

View of wall [061] along the base of N boundary of Area A, facing W

Wall [061] was a rubble stone wall that was 13m long and stood to a maximum height of 0.55m (illus 21). The east end of the wall continued into the edge of the excavation area and the west end was truncated by a modern revetment wall. The wall [061] may have formed part of a rear wall to one off the early buildings facing onto Abbeyhill although its phasing is unclear and no sign of a return wall was recorded. A later phase brick wall [026] abutted the south face of the stone wall close to the east end and a brick floor [050] with associated wall [051] truncated the wall close to the west end.

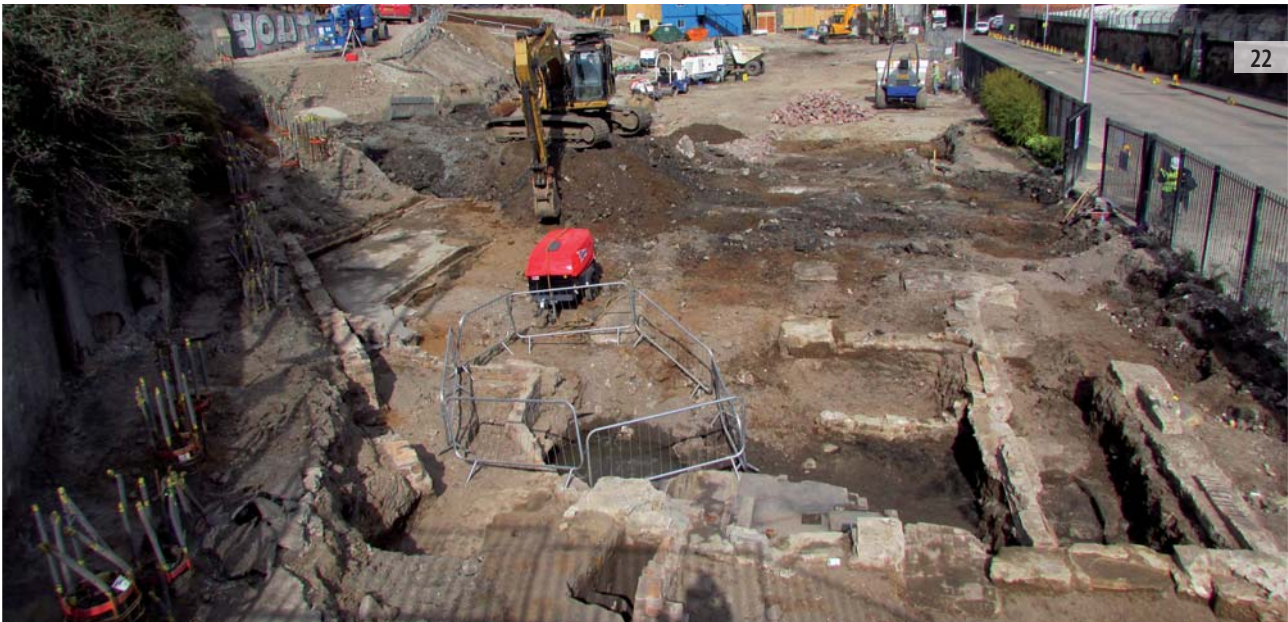
ILLUS 22

View of Area A showing the brick walls in the foreground, facing E

Slightly to the east two further stone walls [094] and [123] along with cobbles (147) may represent further evidence of the pre-brewery phase of development. These may also form part of the same structure represented by walls [081] and [088] or [134] (illus 22).

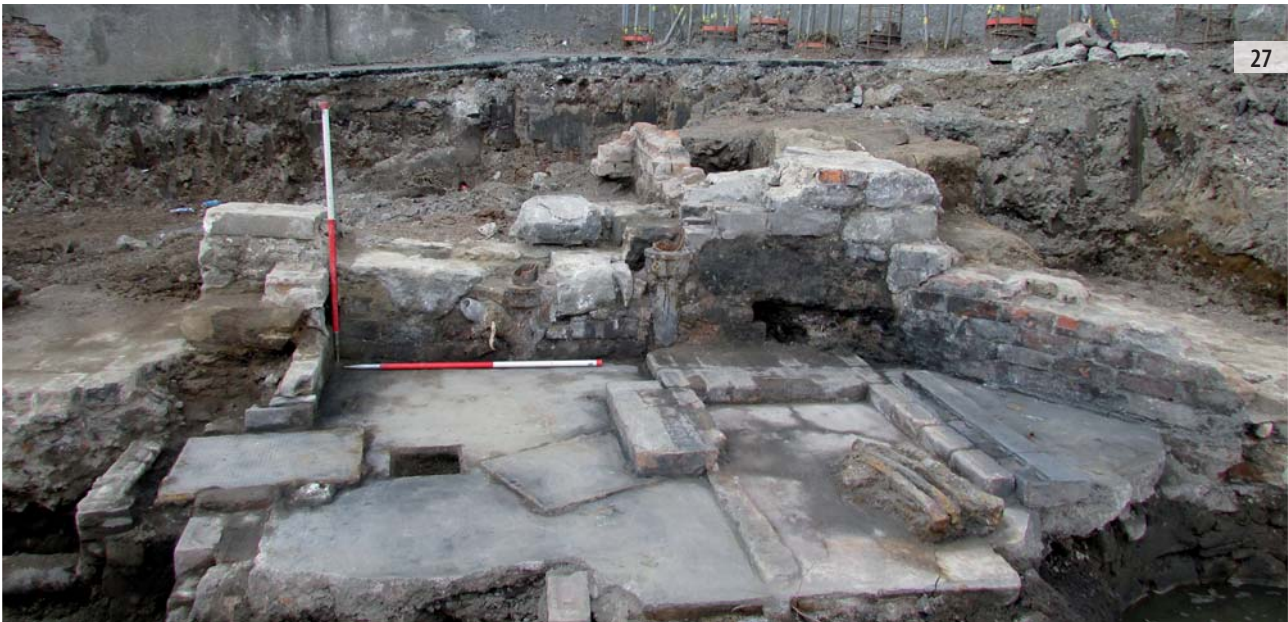
ILLUS 27
General view of the W side of Area A, facing NW

At the west end of the site a number of brick walls with concrete foundations were considered contemporary with the duct due to their location and alignment (**Illus 27**). Brick wall [084] was aligned on a NE-SW angle turning to the east at the north-east end. It had been constructed over the top of the stone-lined well [145]. This wall along with brick wall [102] seemed to respect the line of the heating duct. Wall [084] seemed to be lower at the point the duct floor would have crossed over the top of it had it survived here. The evidence for this was slightly circumspect as the area had been damaged by test pitting with much of wall [084] truncated by this damage. Wall [084] also abutted the west side of wall [102], the south end of which respected the line of the duct. Wall [102] included more bricks

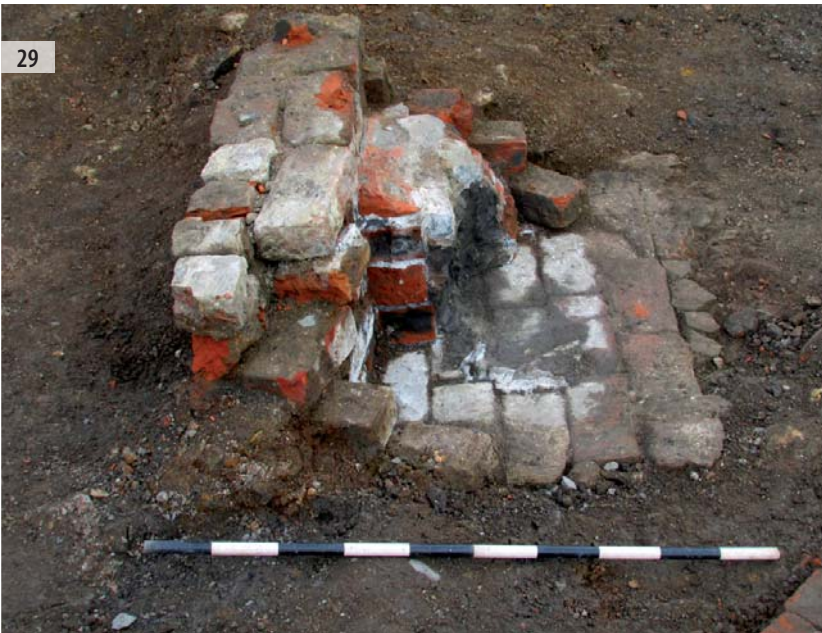
ILLUS 29

Detail of brick feature [057]

A number of features, either cutting or overlying the geological subsoil that proved difficult to phase included the remains of a small heat affected brick structure [057] (Illus 29) This formed a sump measuring 1.14x0.9m with a stone floor and a small raised shelf formed of slate to the south side. The bricks were handmade indicating an early phase and the sand bonding indicated the feature's possible use as a kiln base or fireplace. A much larger feature that probably represented the foundation for a chimney was

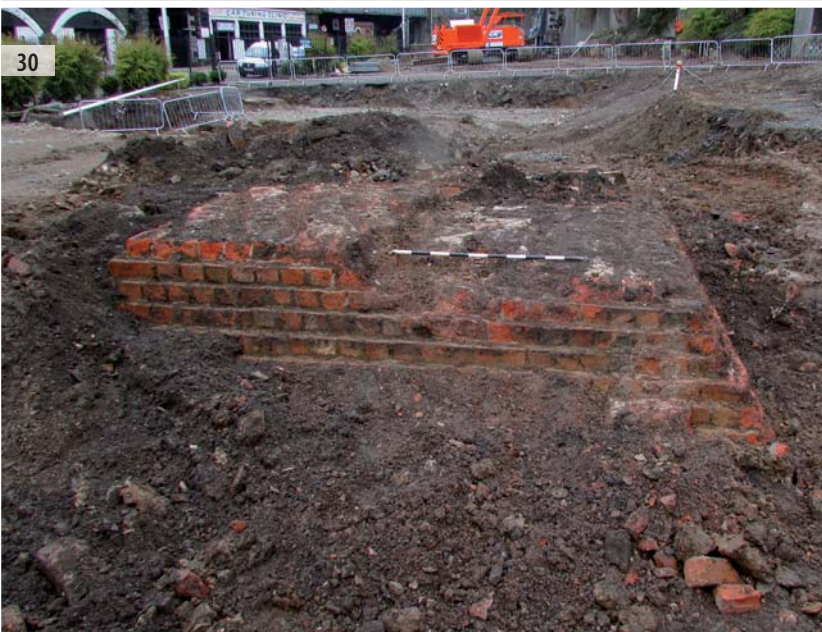
ILLUS 30

View of chimney base [078], facing S

recorded further to the north. The platform [078] was constructed of 11 stepped courses of brick 1.25m high sat on a concrete base forming a large rectangular foundation 3.2x2.8m cut into the geological subsoil (Illus 30). Given the foundations location north of the main brewery building it is possible that the chimney base was associated with the washhouse established in 1922.

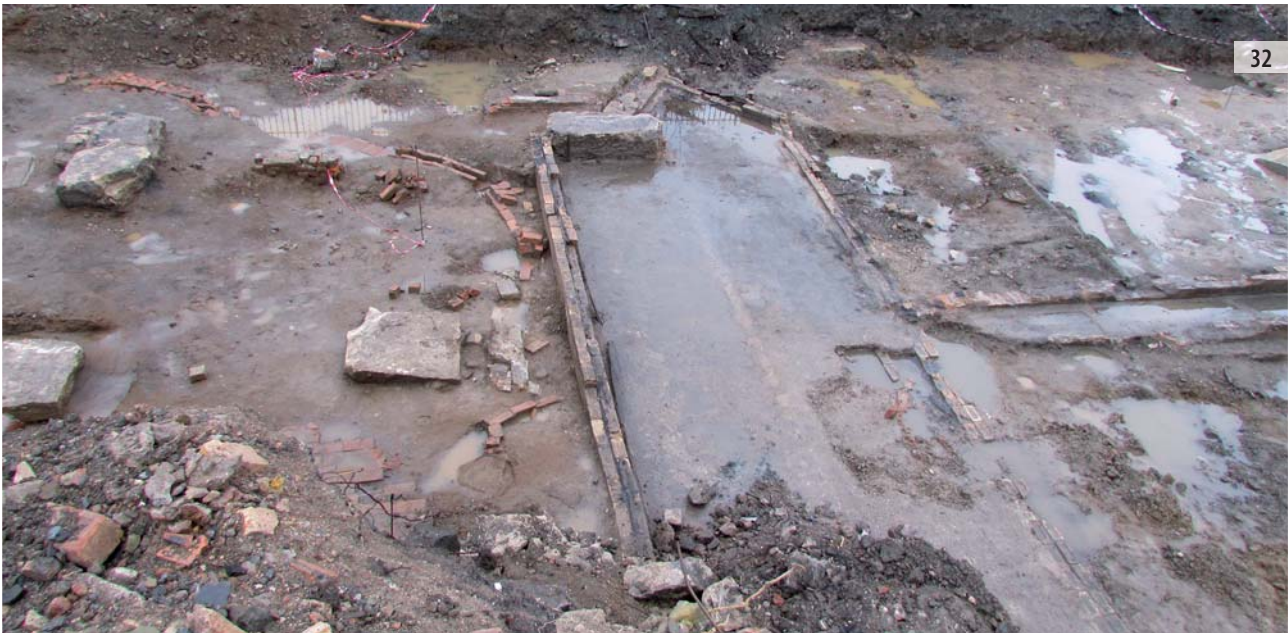
ILLUS 32

Floor surface [030] and associated features, facing S
