FURNESS ABBEY CAR PARK

Watching Brief

commissioned by English Heritage

October 2014

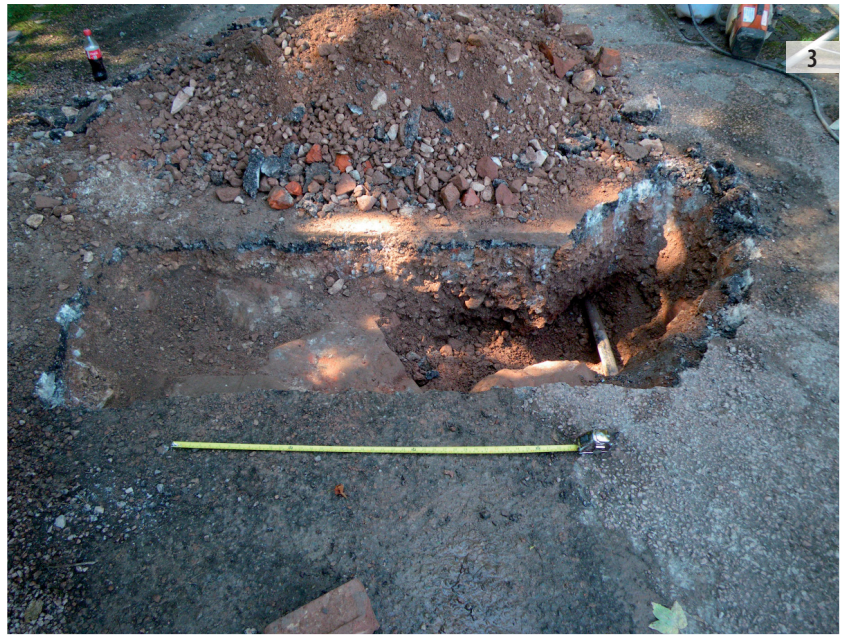
ILLUS 3

At the southern end of the trench a sandstone block [05] measuring 0.43m by 0.18m deep was observed. It appeared to form a possible wall foundation oriented north-east – south-west with another block to the south-west, joined by mortar containing brick and stone fragments. A 0.03m thin sandstone slab [04] 0.26m below ground level was observed joined by mortar to the first sandstone block [05]. Another similar sized sandstone block [06] was observed to the north-west which appeared to form a wall foundation oriented at right-angles to the first wall. A sandstone block was observed in the section of the trench opposite this block which may have been a continuation of the wall. The gap may have been caused by the excavation of the trench to contain the water pipe (which was observed at 0.5m depth between the two blocks).

W facing view of stone walls in Trench 1

orientation as the hotel. The fragments of brick within the mortar joining the sandstone blocks indicate a modern date. This points to a post-demolition phase of construction; possibly a boundary wall foundation.

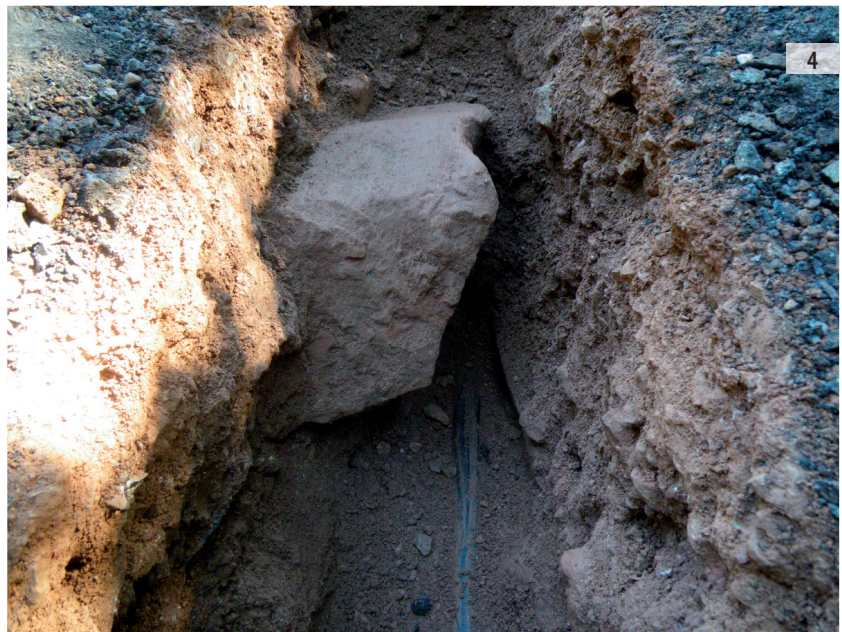
ILLUS 4

In the extension to trench one at 0.5m depth a shaped stone [07] was observed which measured 0.38m wide and 0.21m high. The shape of this decorative masonry indicates that it would have been part of a door / window surround. The location and depth of the stone suggest it was not in situ and had probably been disturbed by the excavation of the water pipe trench. The water pipe was observed at between 0.5m depth to the west and 0.8m to the east of the trench.

E facing view of shaped stone in Trench 1

The sandstone block identified in Trench 1 is interpreted as a door / window jamb or sill. Its abraded state and location within the compact red clay deposit is indicative of it having been considerably disturbed. It is most likely part of the fabric of the hotel structure but may have been reused from an earlier building or even from the remains of Furness Abbey. The wall remains are more difficult to interpret. According to the 1st Edition Ordnance Survey (**Illus 11**), Trench One is located on the approximate footprint of the hotel building, however the exposed walls are not on the same

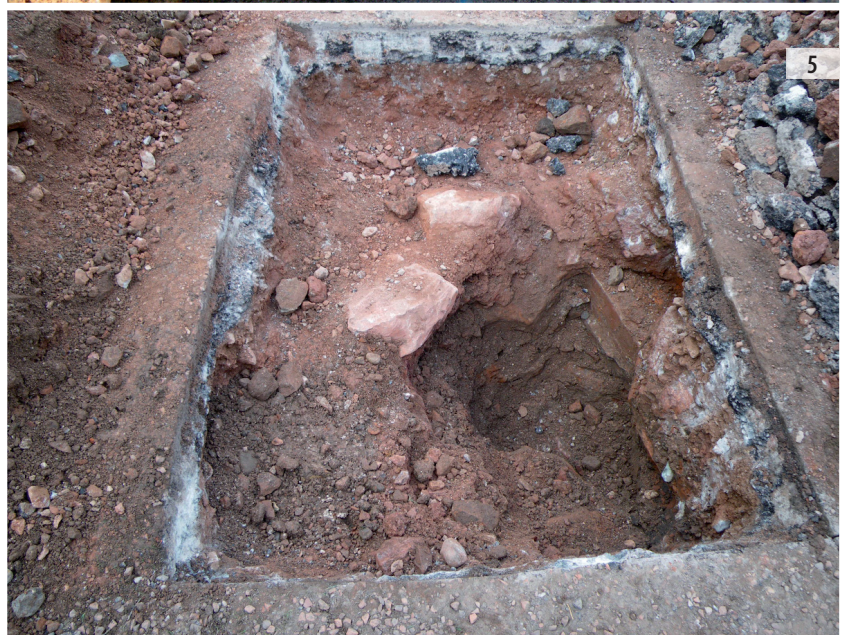
ILLUS 5

Trench 2 was located to the west of the museum building, immediately to the north-west of the pavement kerb, and was irregular in shape, measuring approximately 1.9m by 1.9m. A modern plastic gas pipe was observed in this trench, with the water pipe observed at 0.8m below ground surface. At 0.4m below ground level at the eastern edge of the trench the remains of a brick wall [11] were observed, oriented north-west – south-east. The wall consisted of two courses of brick, (the single measurable brick was 0.22m by 0.1m and 0.08m high) with evidence of pointed mortar on the south-west side (the opposite side was not observable). No sign of a cut for this wall was observed. In the north-west edge of the trench one face of a 0.22m high sandstone block was observed oriented east – west. Above this was a layer of mixed brick and slate fragments and sand and gravel with occasional glass fragments [10]. This was overlaid by a layer 0.28m deep of compact red clay and gravel [09] with some fragments of worked stone. Above this was a layer 0.1m deep of yellowish brown sand and gravel hard-core [08] which was overlaid by a layer 0.1m deep of tarmac.

View of Wall [11] in Trench 2

The brick wall in Trench 2 is clearly built on top of the demolition rubble layer which would indicate it is a disturbed fragment or part of a later conduit, culvert or inspection chamber associated with the visitor centre. The shaped sandstone blocks observed in the section of Trench Two and recovered from the demolition layer of Trench Three are most likely the remains of the walls of the Hotel.

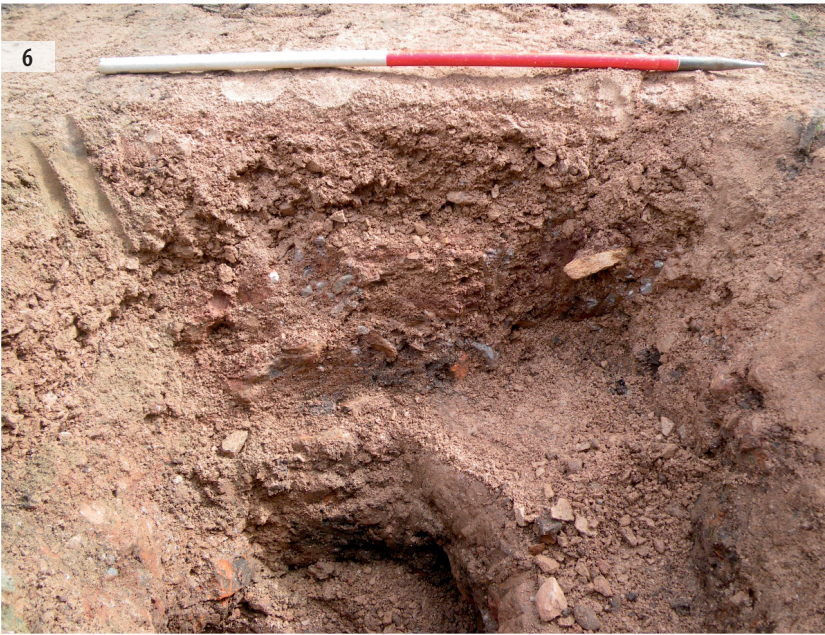
Trench 3 was located to the west of the museum building under the concrete slabs (0.62m square and 0.05m thick) that make up the pavement, immediately south-east of Trench Two. It measured 0.9m by 1.4m (with a 0.9m by 0.4m extension at its north-east corner) and was oriented north – south. The water pipe was observed at 0.9m depth, within a mix of tile, slate, brick, and ceramic sewer pipe fragments with grey sand and gravel [10]. Also included in this layer was a large shaped sandstone block 0.53m by 0.2m by 0.18m which may have been part of the walls of the hotel structure. This was overlaid by a layer 0.2m deep of compact red clay and gravel with large irregular stone fragments [09] which was covered by a layer 0.16m deep of yellow sand and gravel hard-core [08]. Above this was a layer 0.08m deep of yellow sand [12] underneath the paving slabs.

ILLUS 6
W facing section of Trench 3

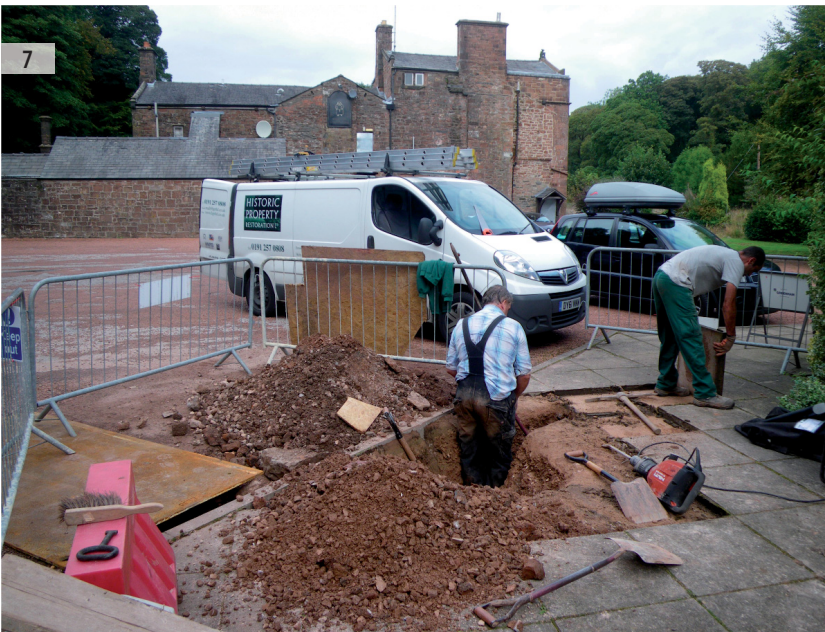
ILLUS 7
N facing view of Trench 3

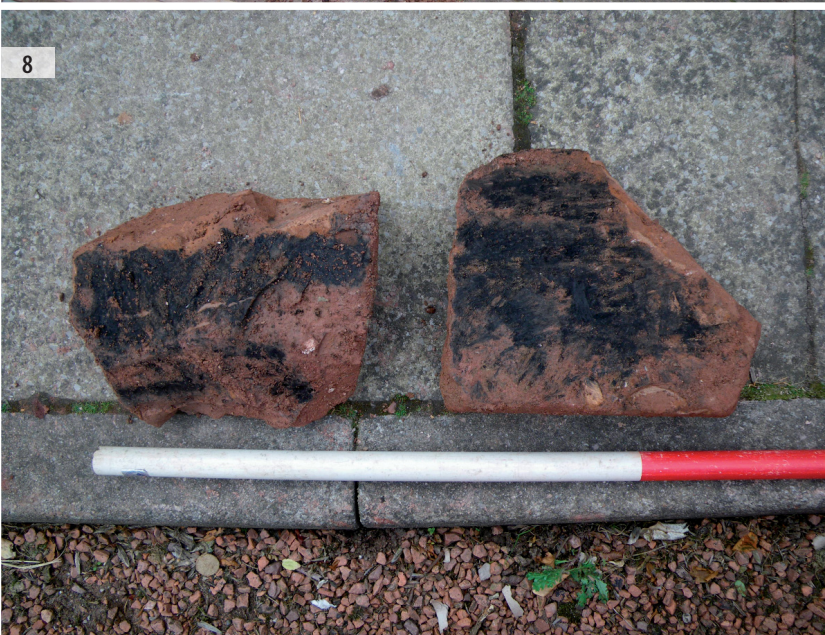
ILLUS 8
View of soot stained stone fragments from Trench 5

sterile approximately 0.8m below ground level. Within this layer two large stone fragments were observed which appeared to have charcoal dust deposits on one side indicating they were once part of a chimney (Illus 8). A fragment of tile with a cracked green glaze, identified as a Victorian hearth tile (see Finds Assessment below), was also observed. This layer was overlain by a deposit 0.38m deep of yellowish grey sand and gravel hard-core [08], which was overlain in turn by a layer 0.08m deep of yellow sand [12] underneath the paving slabs.

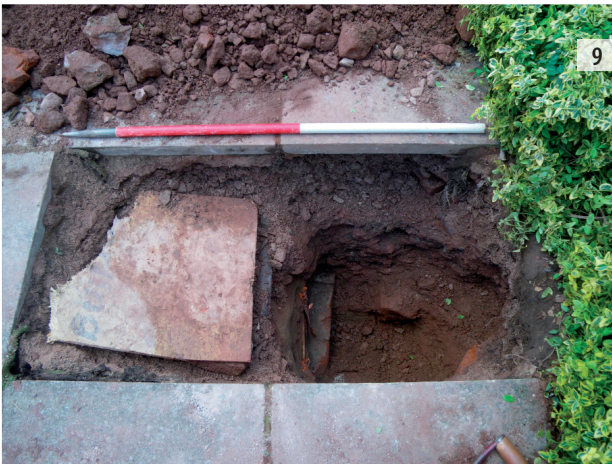
Trench 5 was located north of the museum's northern wall, measured 1.22m by 0.62m and was oriented north – south. The water pipe was located 1.1m below ground level. 0.2m north of the pipe a brick wall [13] was observed at 0.85m below ground level. It consisted of two courses of brick with lime mortar joints above a sandstone block, all oriented east – west. The bricks measured 0.22m by 0.1m and were 0.08m high.

ILLUS 9
E facing view of Wall [13] in Trench 5

The brick wall observed in Trench 5 is interpreted as part of the subsurface remains of the Hotel, possibly a conduit or culvert. Its east-west orientation matches the orientation of the walls of the hotel, although so little of the feature was exposed that definitive conclusions are problematical.

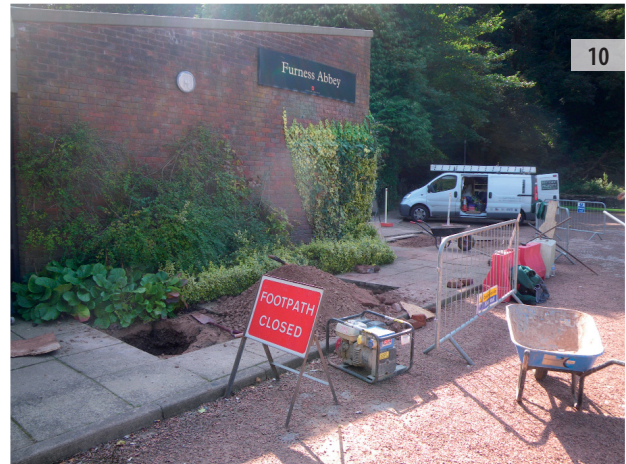
ILLUS 10
SW view of Trenches 5 and 6
