396–410 GORGIE ROAD, EDINBURGH

Historic Building Recording

commissioned by 3DReid Architects

November 2014

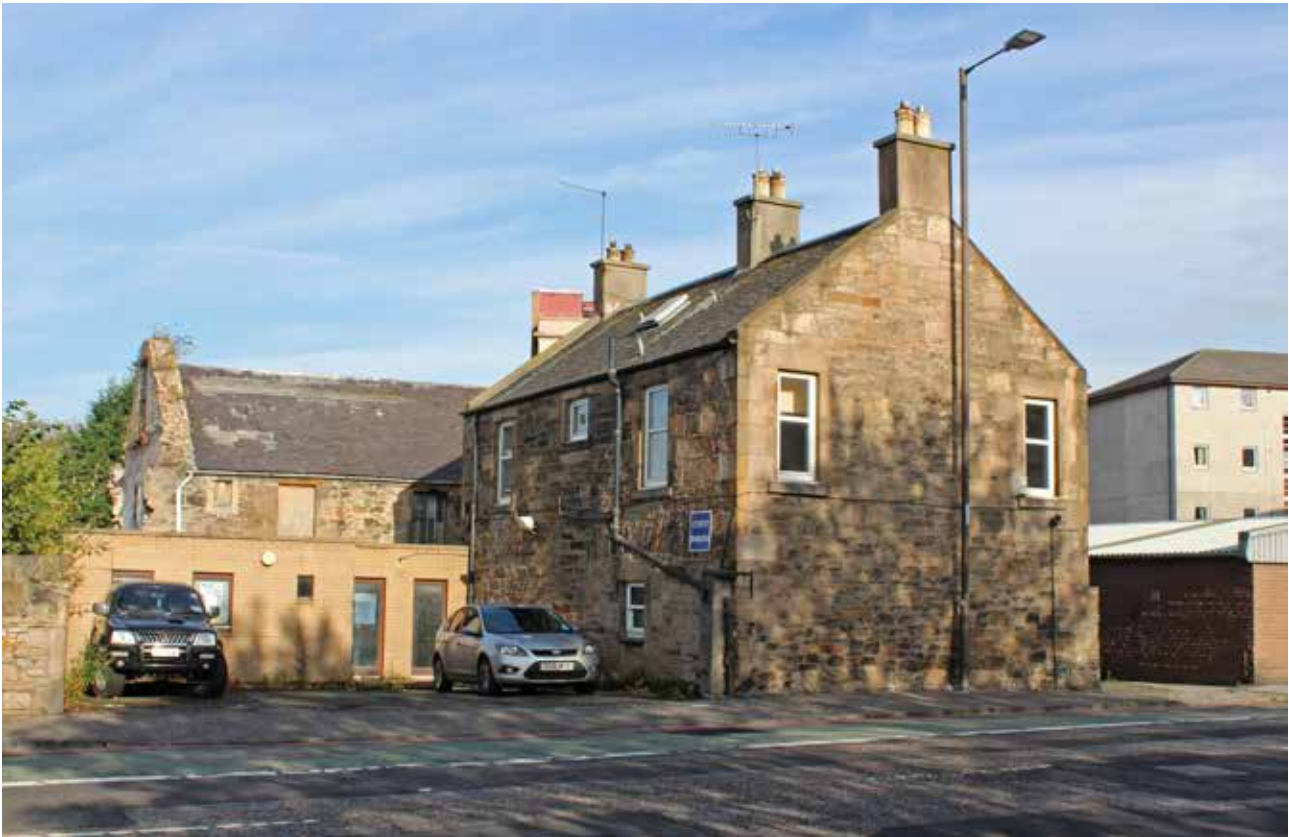
ILLUS 3

Gorgie Mill House (398 Gorgie Road), facing north

The building comprised a simple two-storey sandstone house (Illus 3 & 4), L-shaped in plan, measuring 10.9m x 7.2m, facing with gable end onto Gorgie Road. The first floor housed a self-contained dwelling accessed by a stairwell from a door on the north-eastern elevation (Photo 022). The ground floor layout was more in keeping with an office space or other non-domestic function, with two connected rooms at the front and a separate space behind. It was not clear to what extent the ground floor interior had been altered during conversion into a veterinary centre as all internal coverings were still in place.

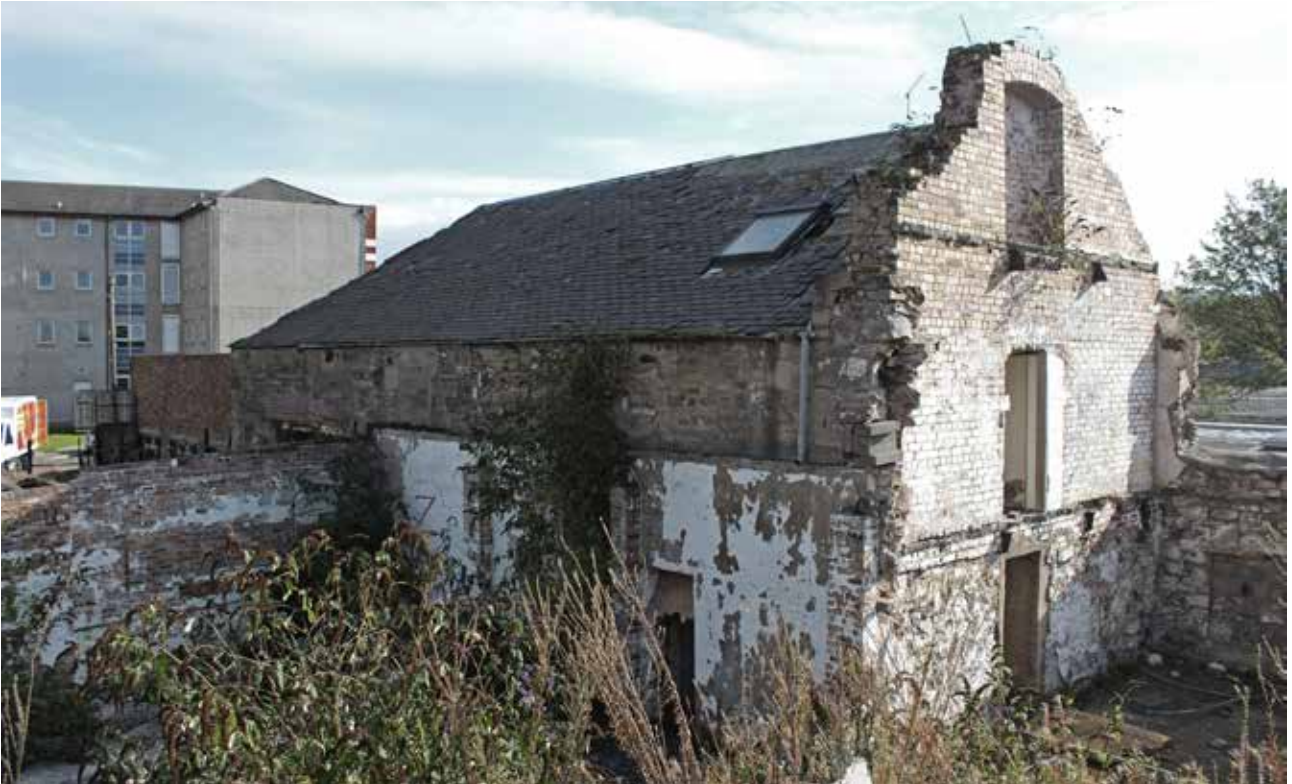
ILLUS 5

This structure (**Illus 5-7**) consisted the two-storey north-eastern section of an originally longer rectangular stone mill building. The three-storey south-western section (photographed during the 2007 desk-based assessment prior to demolition) appeared to be of very similar character in terms of construction suggesting contemporaneity either as a single build or a rapid expansion. The surviving section measured 15.6m x 6.8m, and appeared to have been central to the mill's operation, with single-storey brick extensions to the north-east and north-west, the mill lade below and easy access to Gorgie Road to the south-east via a cobbled yard.

Gorgie Mill, facing east

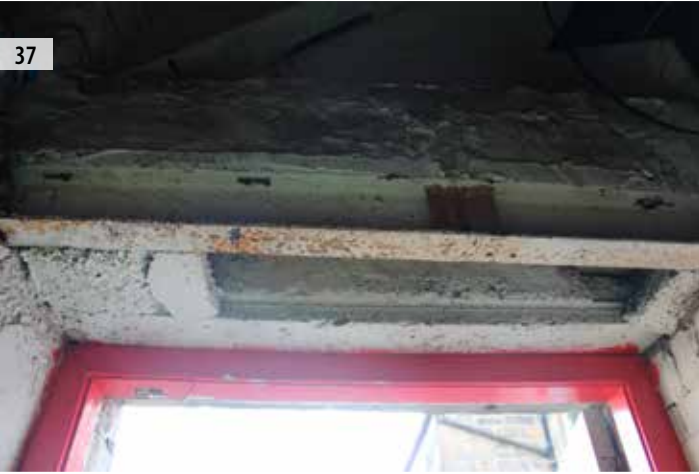
PHOTO 37

Gorgie Mill, detail view of store room interior – replaced lintels above door on south-east elevation

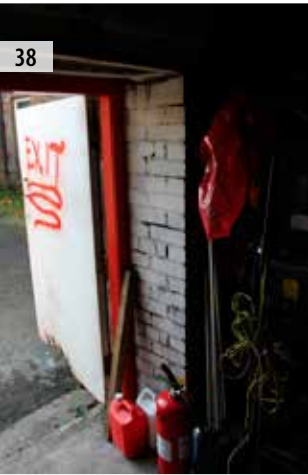
PHOTO 38

Gorgie Mill, detail view of store room interior – brick infill adjacent to door on south-east elevation

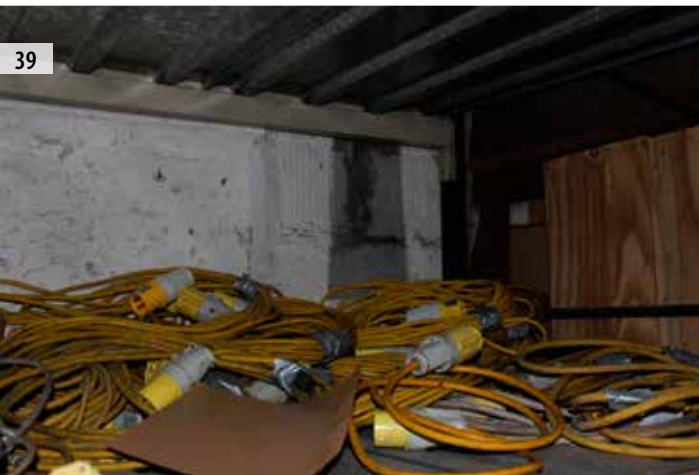
PHOTO 39

Gorgie Mill, detail view of store room interior – ground floor blocked window on south-east elevation

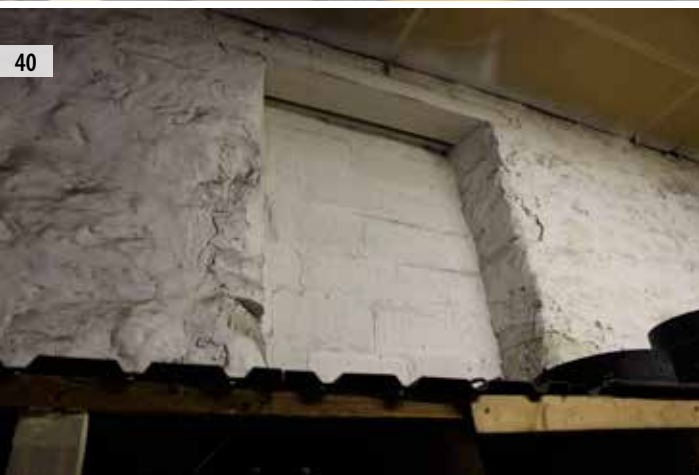
PHOTO 40

Gorgie Mill, detail view of store room interior – first floor blocked window on south-east elevation

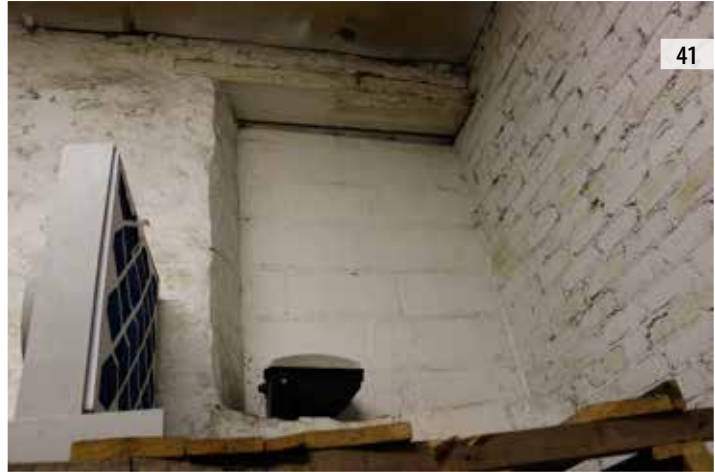
PHOTO 42

Gorgie Mill, detail view of store room interior – possible blocked door on south-west elevation

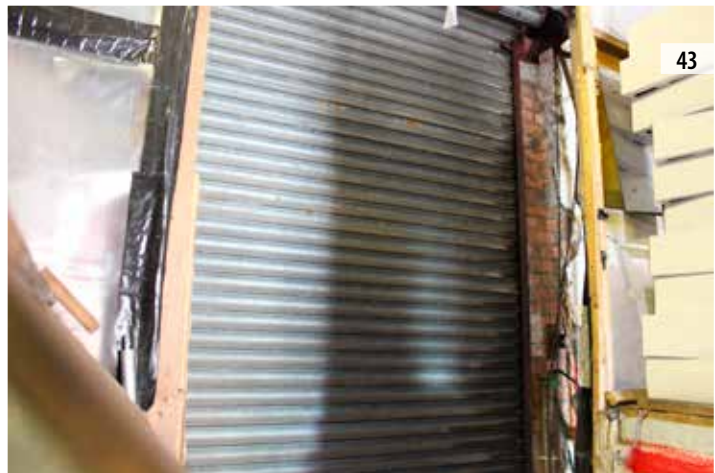
PHOTO 44

Gorgie Mill, detail view of store room interior – blocked first floor door/window on north-west elevation

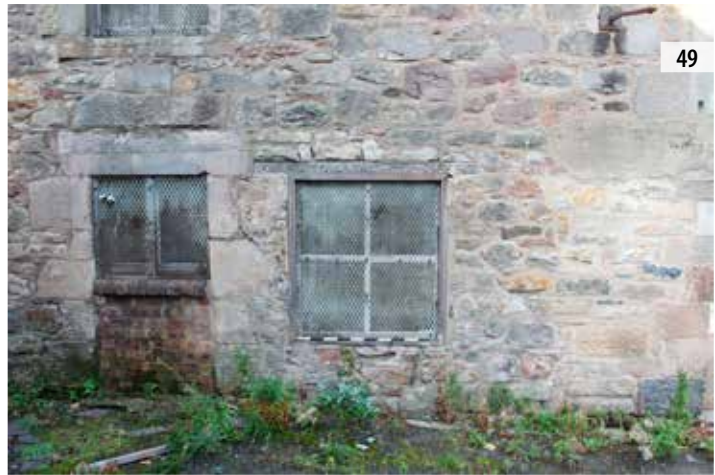
PHOTO 50

blocks. The first floor featured three large windows, a further small square one and a double wooden door positioned above the present ground floor doorway. An iron fixture adjacent (Photo 050) may have supported a ladder, hoist or other structure for accessing the first floor. This elevation could be accessed from Gorgie Road via a cobbled yard, some of which remained below tarmac. A 4m length of the outer wall of the three storey section of the building survived (shown on **Illus 7d**), albeit obscured from the outside by a modern brick structure and surviving only to just above first floor level. From the inside (Photo 073) it was of similar stone construction, featuring a single doorway and window, both blocked with concrete blocks. The doorway had an inserted iron lintel, which in turn supported a substantial double iron floor beam (Photo 074). The window had a thin timber lintel similar to the one further to the north-east and may have been a contemporary insertion.

Gorgie Mill, detail view of south-east external elevation – iron fitting
