CARBERRY MAINS, EAST LOTHIAN

Historic Building Recording

commissioned by Elayne Blackwood

January 2015

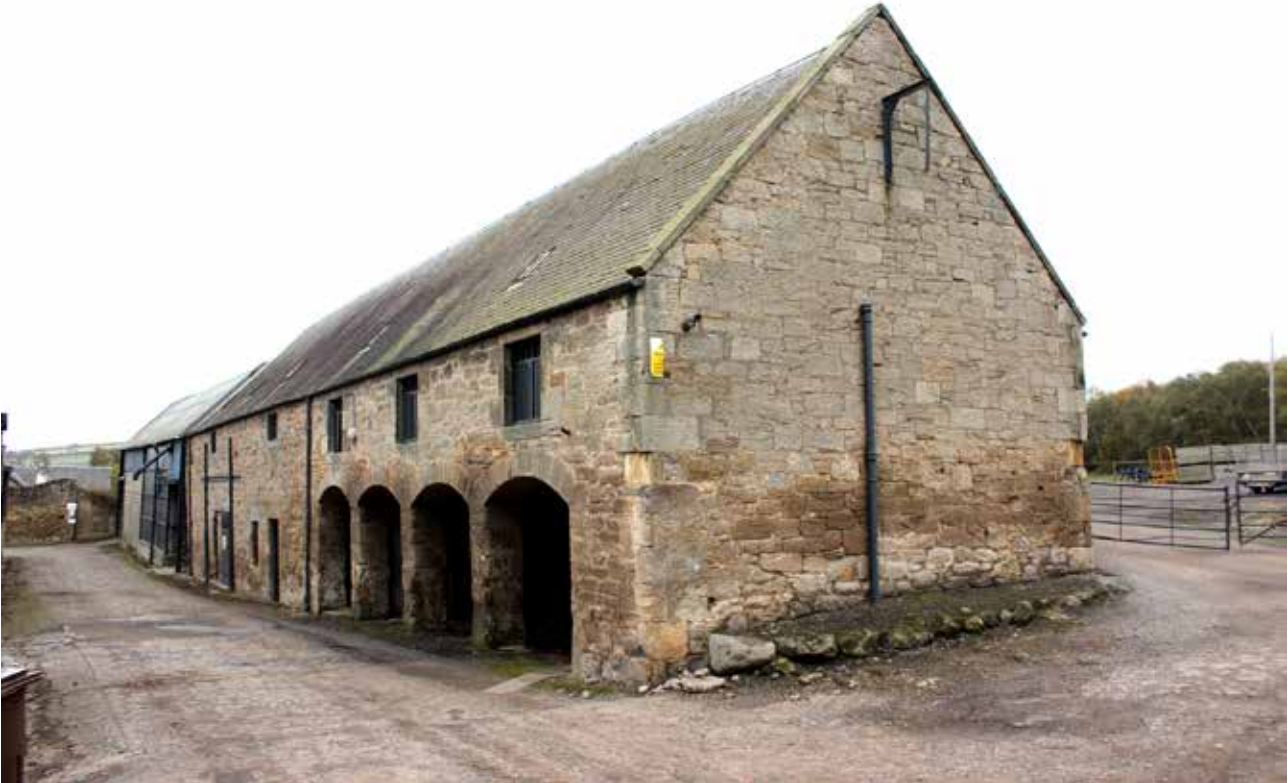
ILLUS 4

Carberry Mains – general view of South Range, facing E

The building comprised a rectangular two-storey stone-built steading (Illus 4 and Illus 5), aligned north-east to south-west and measuring 33m x 7.5m. The ground floor consisted of two main spaces. The north-eastern space was enclosed and the south-western open to the north-west by way of four large arched

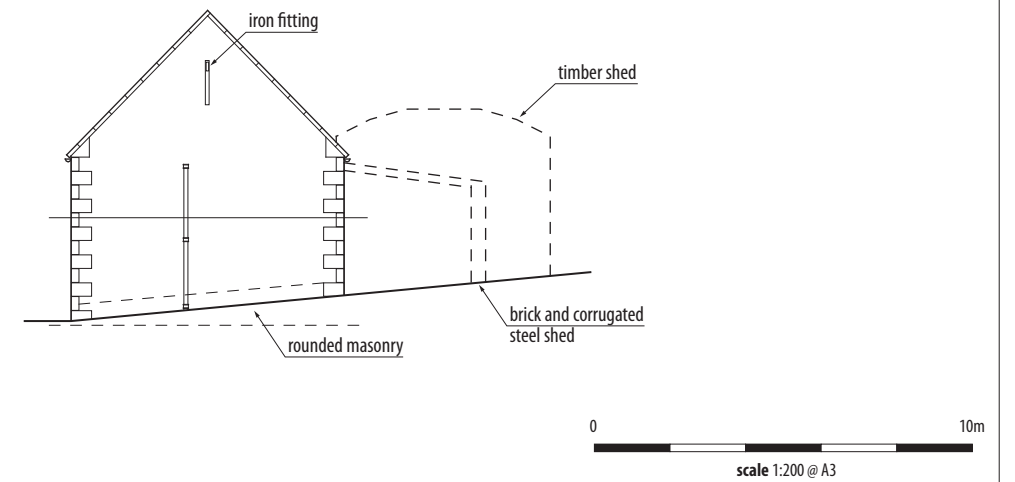
D SW ELEVATION

The south-western elevation (Illus 5d, Photo 044) comprised a plain gabled end, with only a drain pipe and a high level iron fitting which may have been a bracket for a sign. Rounded, roughly dressed stone had been used at the base of this elevation and it is possible that the ground level has been reduced at some point and exposed this less decorative masonry.

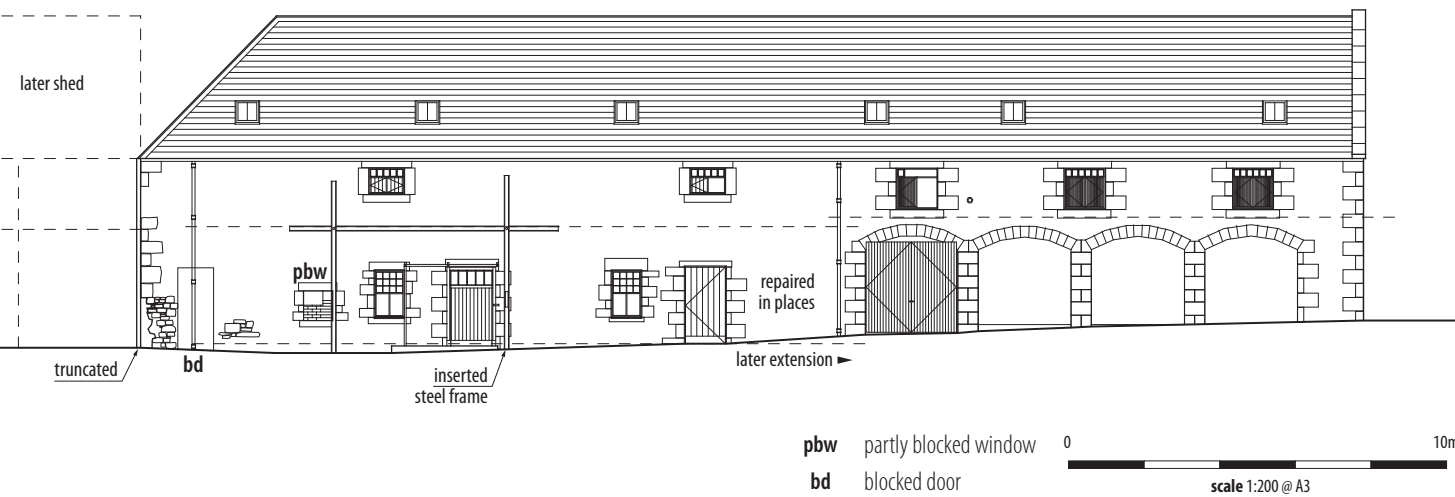
E NW ELEVATION

The north-western elevation (Illus 5e, Photos 046–7) formed the main frontage to the farmyard. The north east end had been truncated at ground level, suggesting a single-storey building had once extended further in this direction. At first floor level, intact quoins were still present. Nearly all the openings on this elevation appeared original,

with the exception of a blocked doorway on the ground floor at the north-eastern end and a partly bricked up window adjacent to it. The remainder comprised two doors, two windows and four open arches on the ground floor and five windows of two different sizes and a small chute on the first floor. The open arches were supported on substantial square ashlar columns. A pronounced outwards lean was visible at the north-east end of this elevation - a rectangular frame of steel I-beams (Photo 047) had been inserted, presumably to help mitigate this. A building line formed of large quoins adjacent to the internal lateral stone wall suggested that the south-western part of the South Range was a later addition, although it had been neatly incorporated and presumably re-roofed. This would be consistent with the map evidence which suggested that the north-eastern part of this range was incorporated into a larger building in the late 19th century.

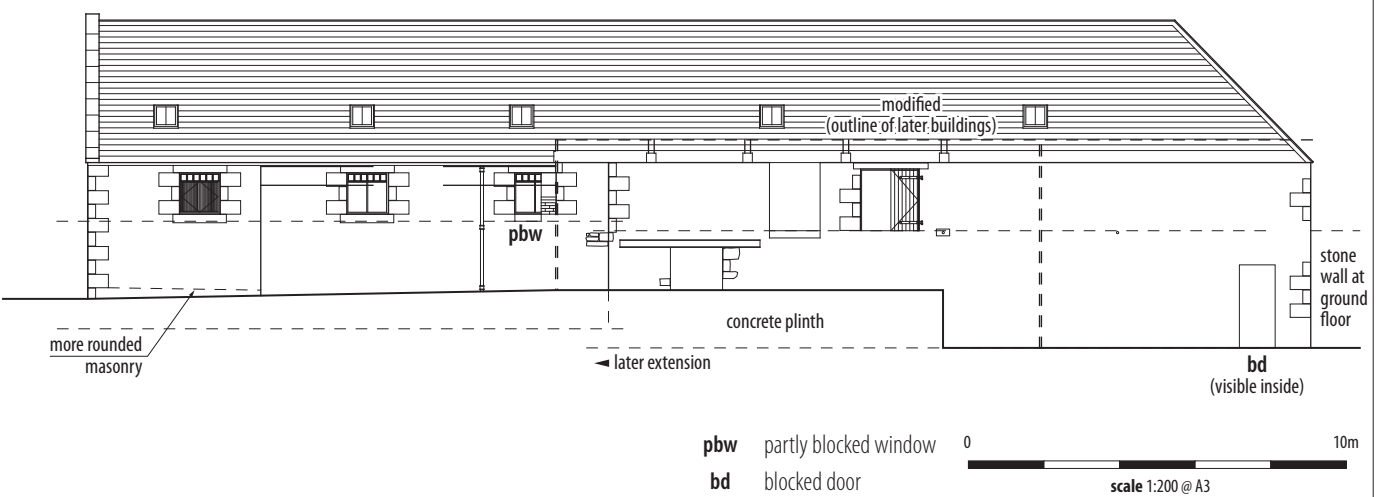
F SE ELEVATION

The south-eastern elevation (Illus 5f, Photo 045) was largely obscured by later farm buildings. The ground level on this side of the building was higher than on the north-west side, except for the north-east end, where a vertical drop had been formed in concrete to accommodate modern grain-drying machinery. A vertical break in the masonry could be seen adjacent to the lateral wall dividing the two interior spaces (Photo 072) – this was also visible inside (Photo 068). This was consistent with the building line on the north-western elevation and shows that the south-western end of the range was a later addition. Furthermore, the north-eastern part of this elevation had been at least partially rebuilt at some point in the 20th century to carry the roof of the adjacent timber shed, and some related modifications. The wallhead of this rebuilt section was

slightly lowered to support the timber roof joists of the later building (Photo 073). A ground-floor chute (with iron lintel), a (now blocked) door and two new openings at first floor level were also created. It was not clear whether the entire north-eastern end of this elevation had been rebuilt or just the central part. Part of the single-storey north-eastern continuation of this range had been incorporated into later 20th century buildings (Photo 074). The south-western end appeared largely unmodified besides some inserted beams to support the adjacent small steel-and-brick lean-to (Photo 071). As with the south-westerly elevation, the lowest masonry courses were of more rounded stone, and may suggest that the ground level had been somewhat reduced here. There were three first floor windows in this section, the most north-easterly being partly blocked to allow for the construction of the large timber shed.

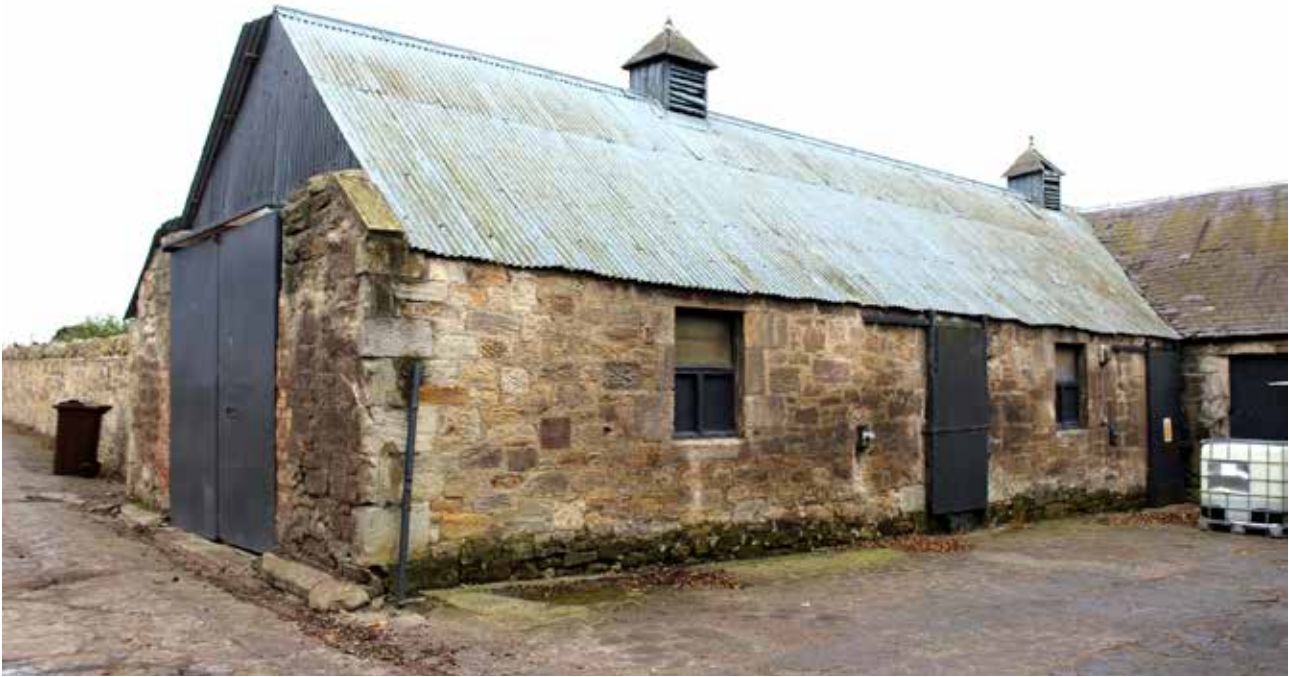
ILLUS 6

Carberry Mains – general view of North Range, facing W

The North Range (**Illus 6** and **Illus 7**) comprised a rectangular single-storey steading with a small perpendicular annex. These parts are distinguished below only to ease description – there was no evidence to suggest they were separate structures. The rectangular section was aligned north-west to south-east, measuring 23.8m x 6.8m and comprised a single internal space; the annex was 7.4m x 6.2m and split in two unequal parts. The building has been constructed onto a gentle north-westerly slope, and as such the floor level internally is some way above external ground level at this end.

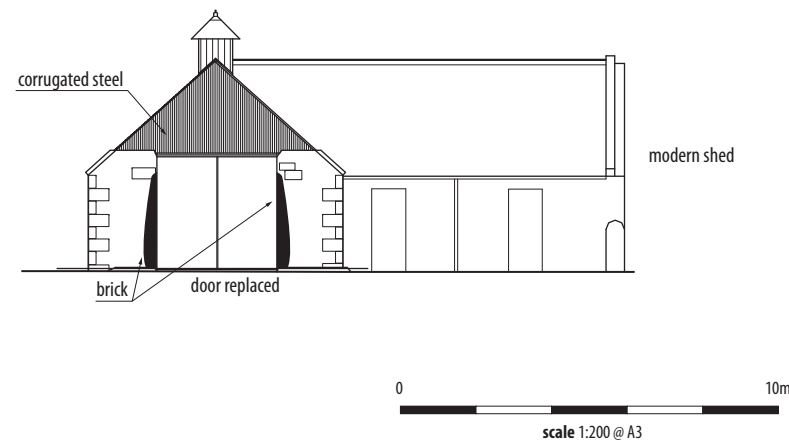
C SE ELEVATION

The south-eastern elevation (**Illus 7c**, Photo 015) of the steading may also have suffered from wind damage – the upper part of the gable had been replaced with corrugated steel. It is also possible that this occurred with the insertion of the present steel double door – this appears to have required a substantial reconstruction of much of the elevation in a combination of re-used stone and brick. The north-eastern elevation (**Illus 7f**, Photo 014) faced onto a small yard from which all the parts of the North Range could be accessed. The elevation featured two sliding metal doors and three windows, all of which were boarded up except the north-westernmost door. A small area of slate roofing was preserved to the north-west of the annex. The north-western elevation (**Illus 7e**, Photo 017) was a plain gable end with a small, square high-level window or possible hatch; the south-western elevation (**Illus 7g**, Photo 016) was featureless.

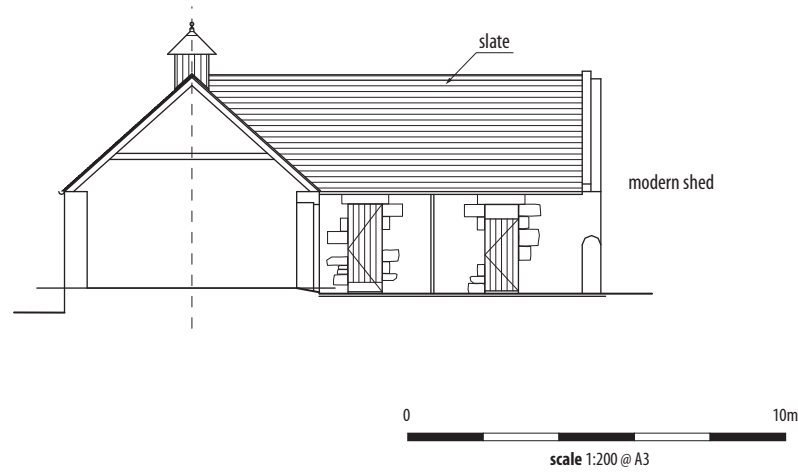
D SE ELEVATION (ANNEX)

Only the south-eastern and north-western elevations of the annex were visible externally. The former (**Illus 7d**, Photo 022) featured two doors, the south-western of which may have been a later insertion. A short, truncated section of wall protruded along the line of the north-eastern gable, suggesting further buildings had been joined here at some point. The north-western elevation (**Illus 7e**, Photo 018) featured only two windows, although it was again evident that another building had continued to the north-east (Photo 019). Both elevations retained their slate roofs but for a small patch of repair on the lower part of the north-western elevation.

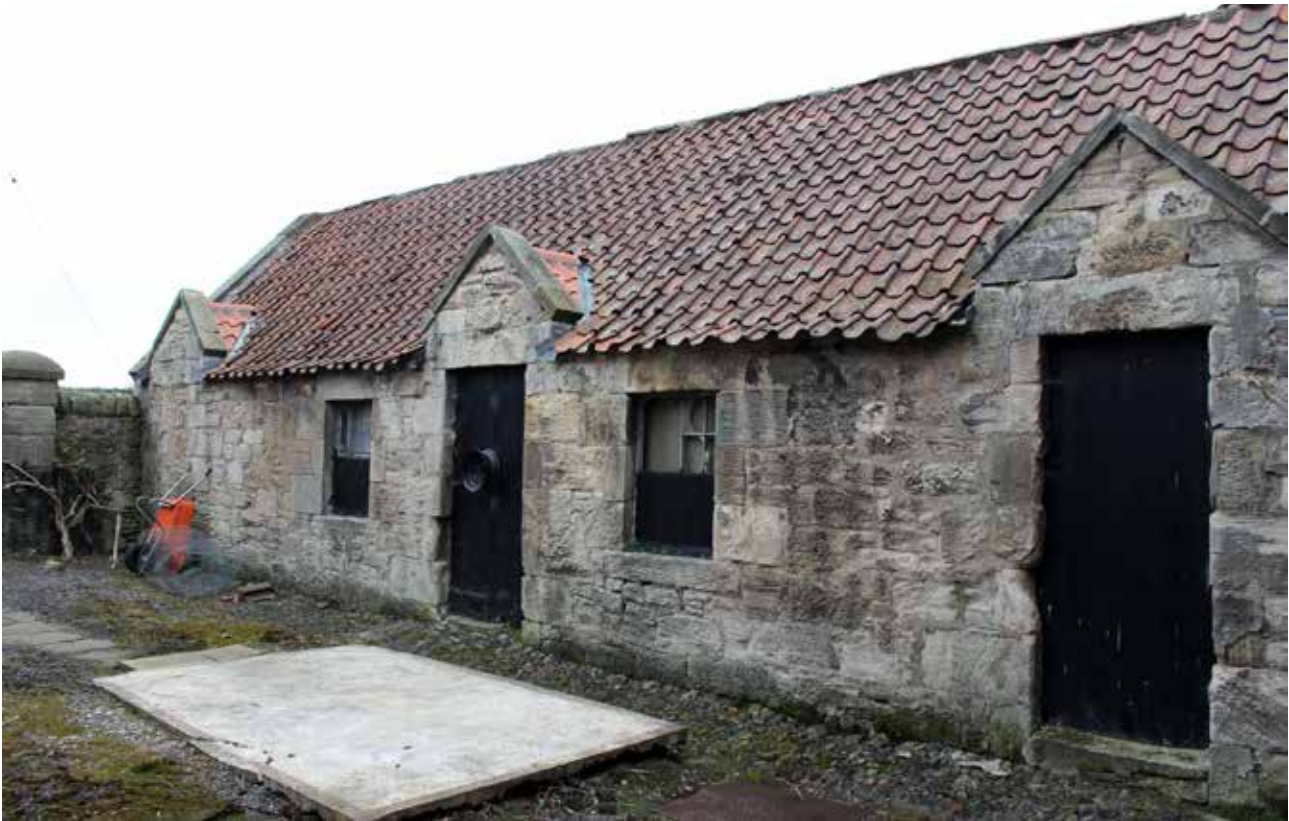
ILLUS 8

Carberry Mains – general view of Garage, facing W

The roof differs in style, being of pan-tile and featuring (recently repaired) gabled pediments over the doors on the south-eastern elevation. The building had previously extended further to the north-east, or been joined to another building – the gable end has been demolished and a modern breeze-block and steel shed have been built against where it would have been (Photo 043). The main access was through the south-western elevation (Illus 9e, Photo 030), where the sliding rail of the original door was still visible. This had been carefully replaced with a modern up-and-over garage door in a timber frame. The south-east elevation (Illus 9c, Photo 032) comprised three doorways (one of which had been neatly blocked) with gabled pediments and two small sash windows, forming a modest but attractive façade. The north-western elevation (Illus 9d, Photo 034) was plain, with a small sash window at either end.

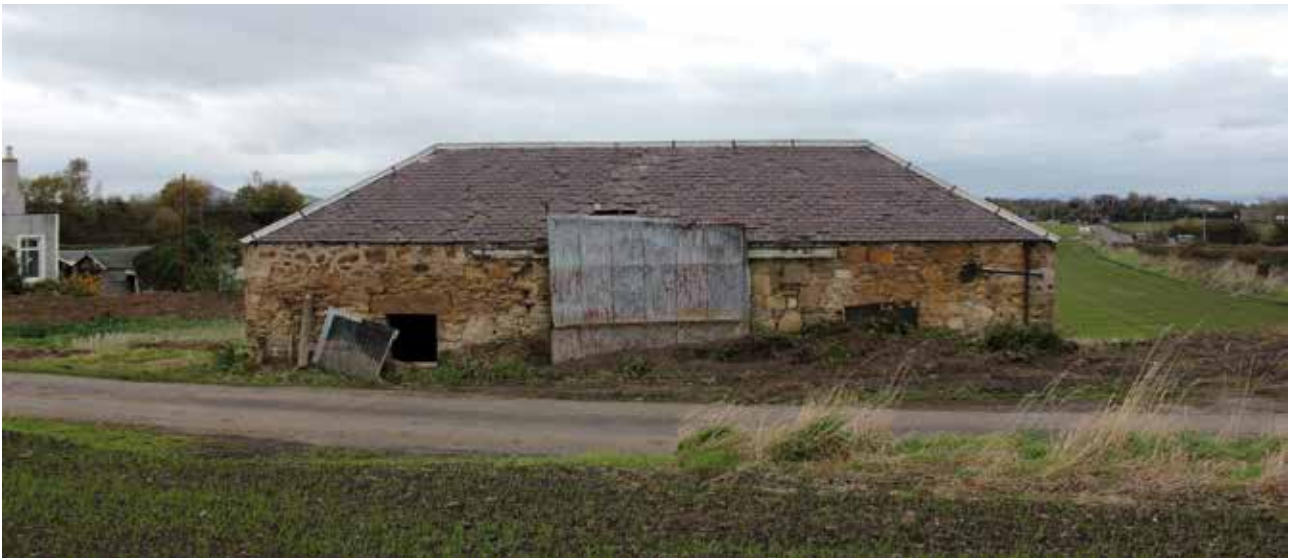
ILLUS 10

The external masonry was of random angular square faced stone which was probably originally rendered, although very little of this survives. The existing coarse grey mortar is likely to represent to more recent re-pointing. The stone was very weathered to west and south-west (Photo 082), similar to the steading buildings at Carberry Mains. Metal ties had been inserted at various places to hold stone together. The western corner and part of the north-western elevation had collapsed entirely. The slate roof was hipped at both ends and had collapsed in places. Damaged areas were covered up with corrugated steel sheeting.

Carberry Mains – general view of Barn, facing NW

was found that shows the barn without them. A high-level opening had collapsed and was covered in corrugated steel sheeting. Two small rooflights were also present. The north-east elevation (Illus 11c, Photo 077) was plain other than for several metal ties.
