SAWLEY ABBEY, CLITHEROE, LANCASHIRE

HISTORIC BUILDING RECORDING

commissioned by English Heritage

March 2016

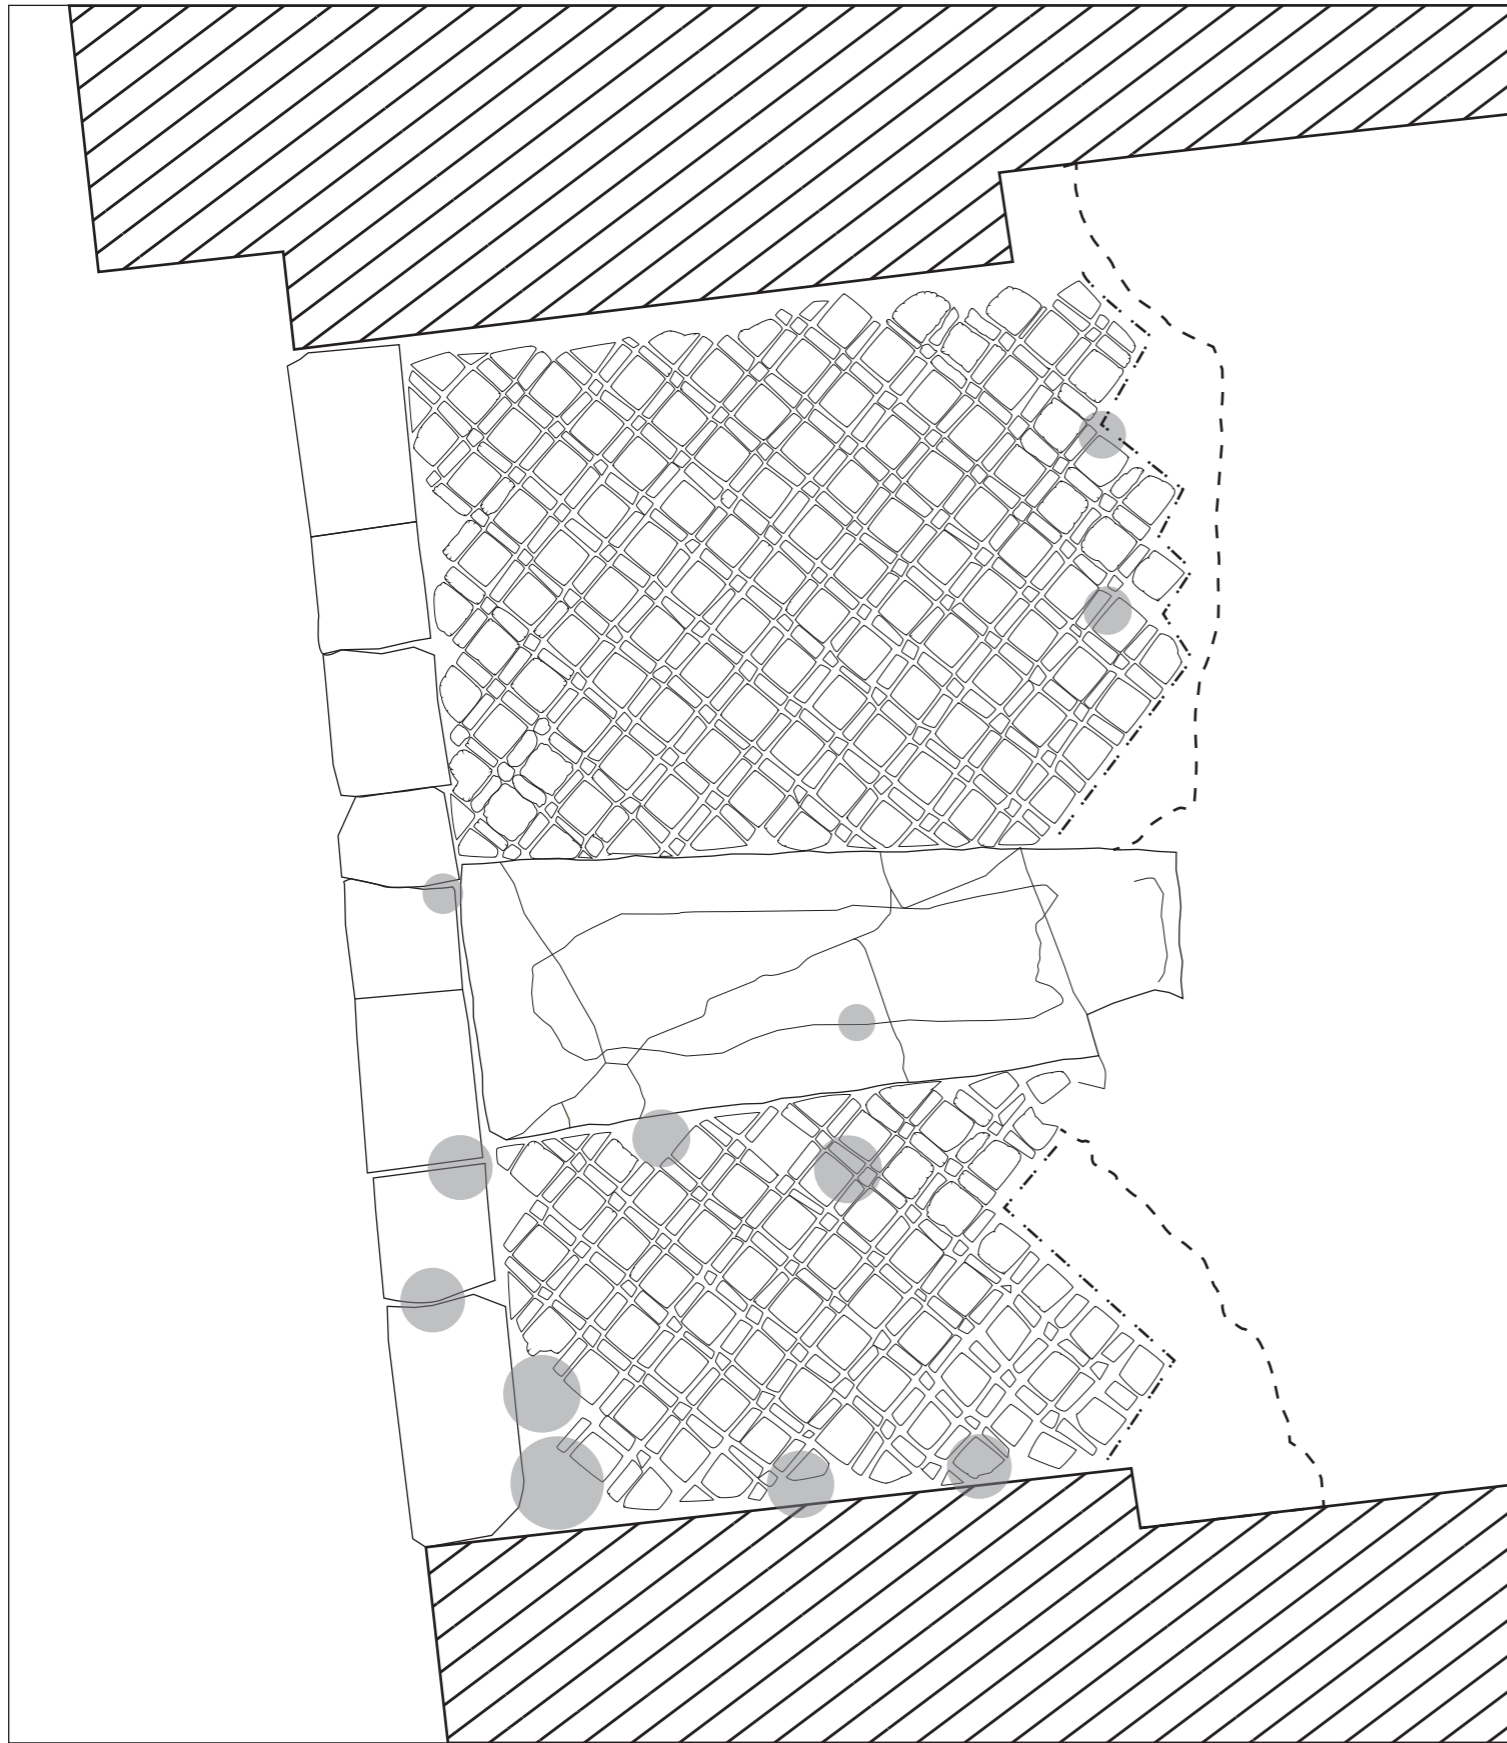
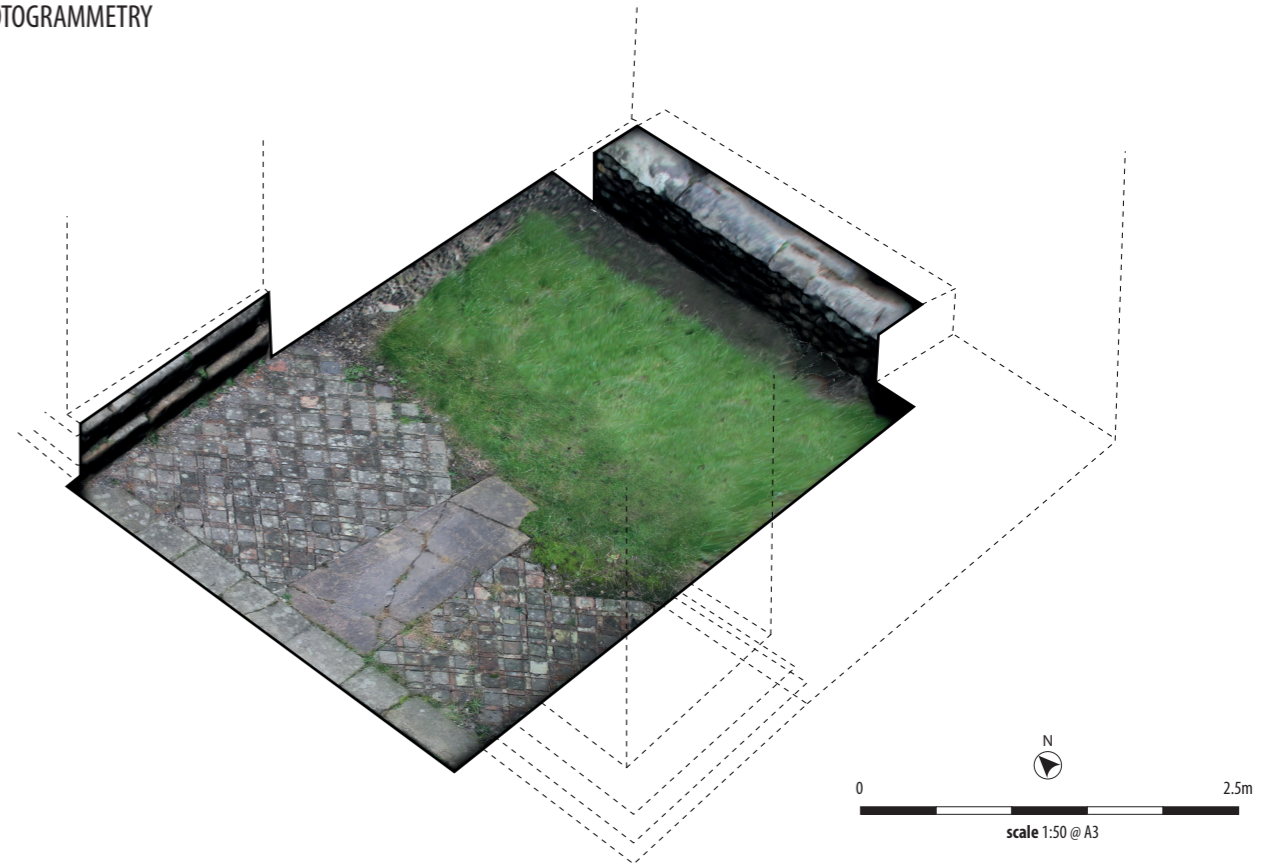
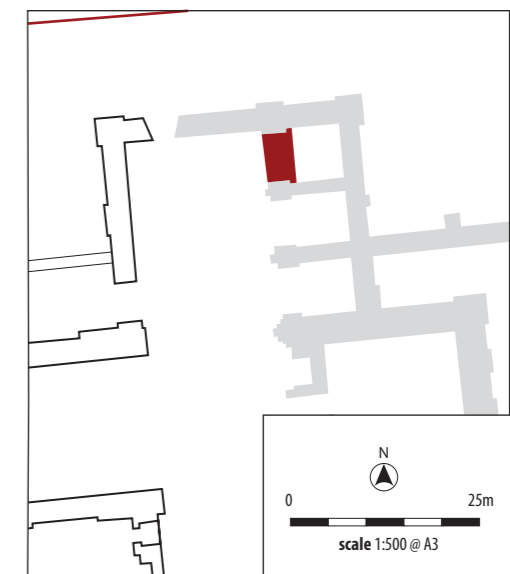
ILLUS 5 Tile floor at north transept chapel

The tiles in the north chapel are mostly well bonded to the bedding and each other. Weeds are breaking through the joints across the area. The areas where the tiles are against the walls and the edges are in the poorest condition, with abundant loose tiles and signs of disintegration in the bedding mortar. (ILLUS 05).

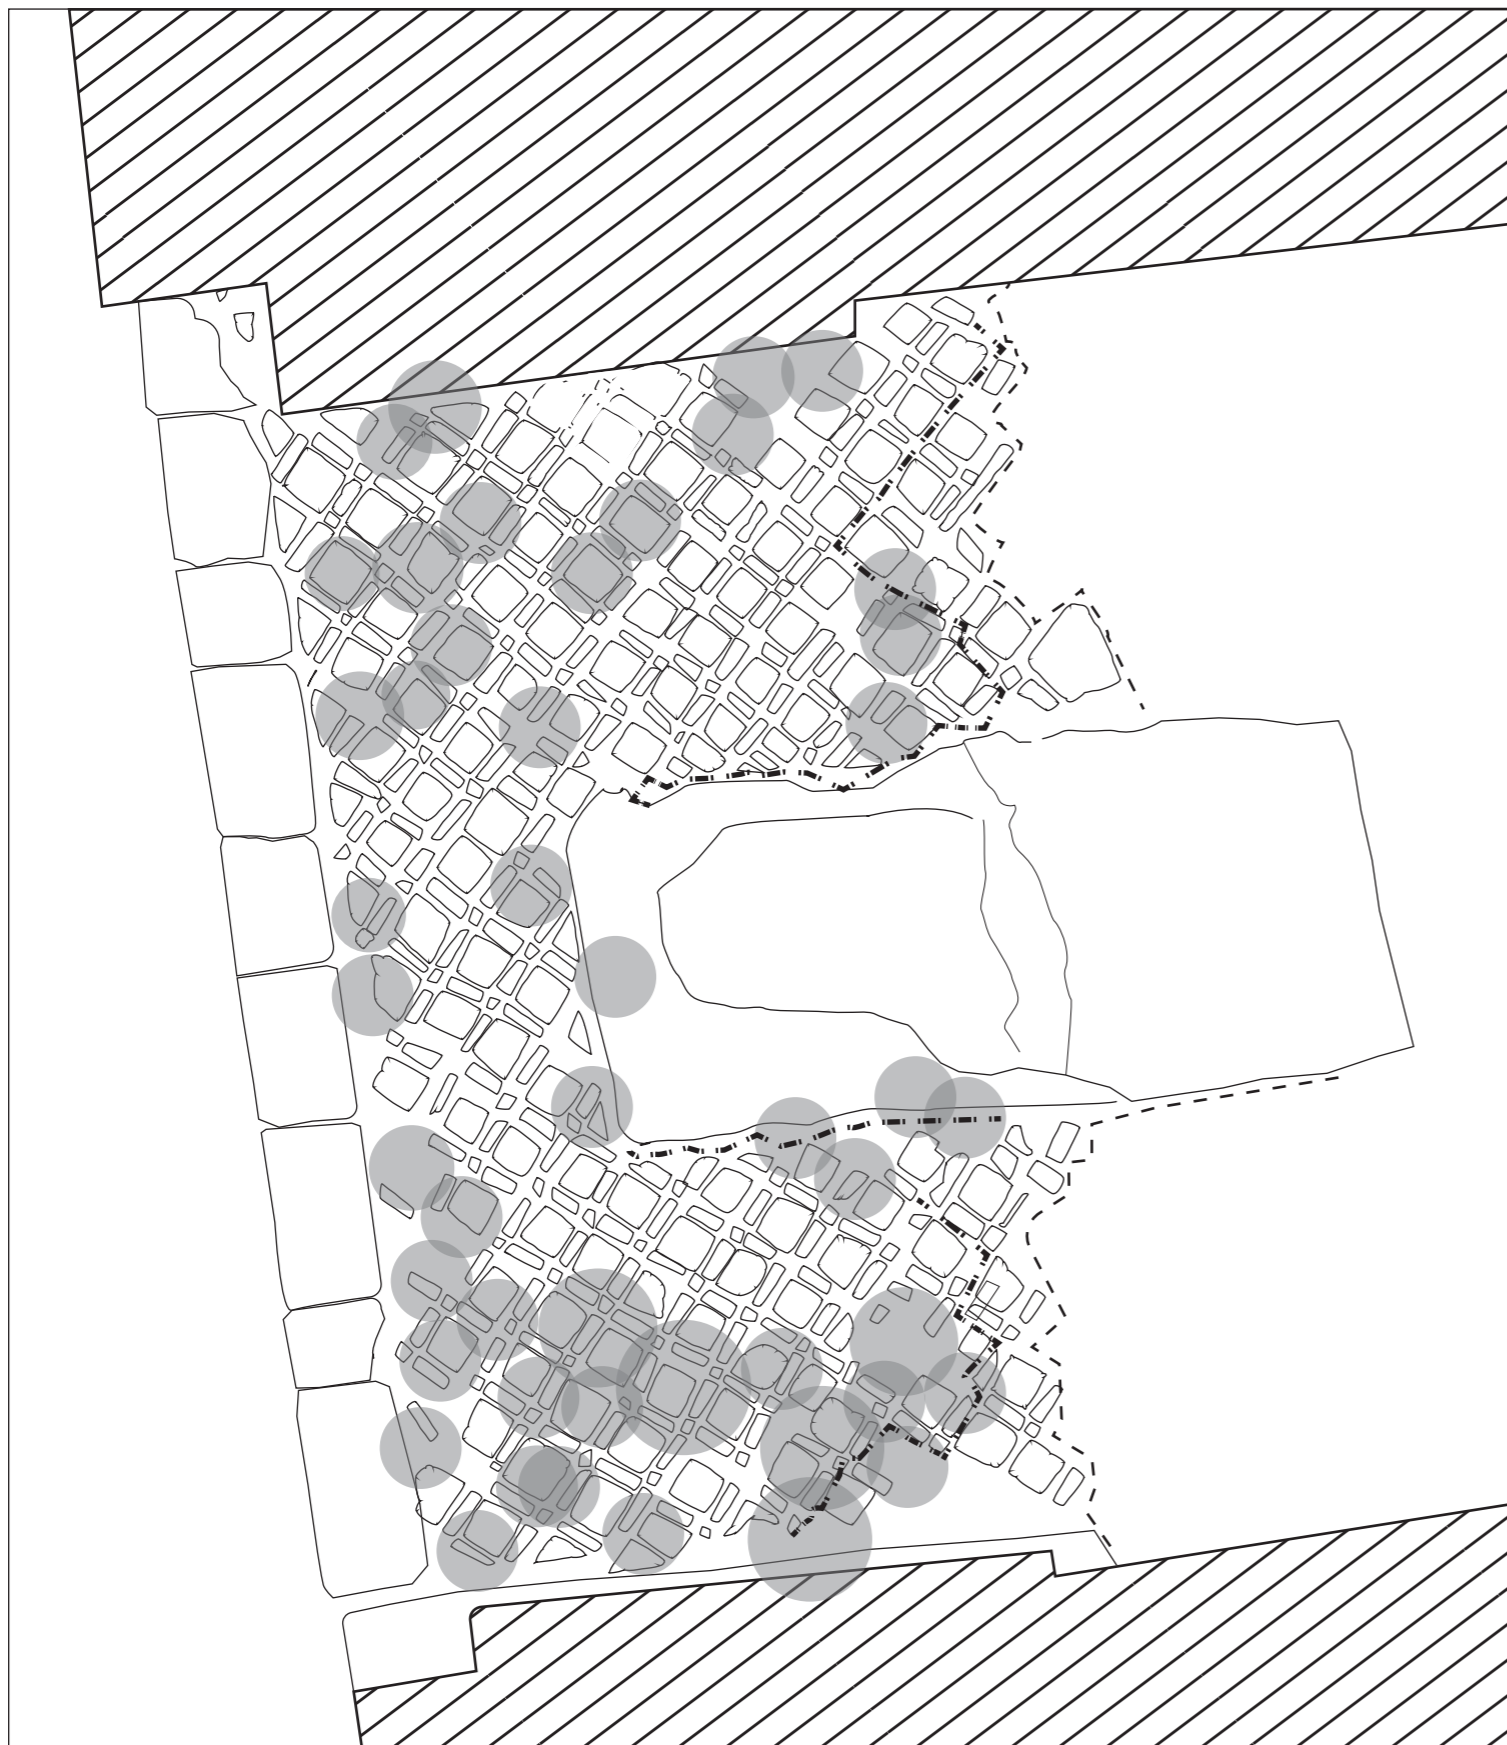
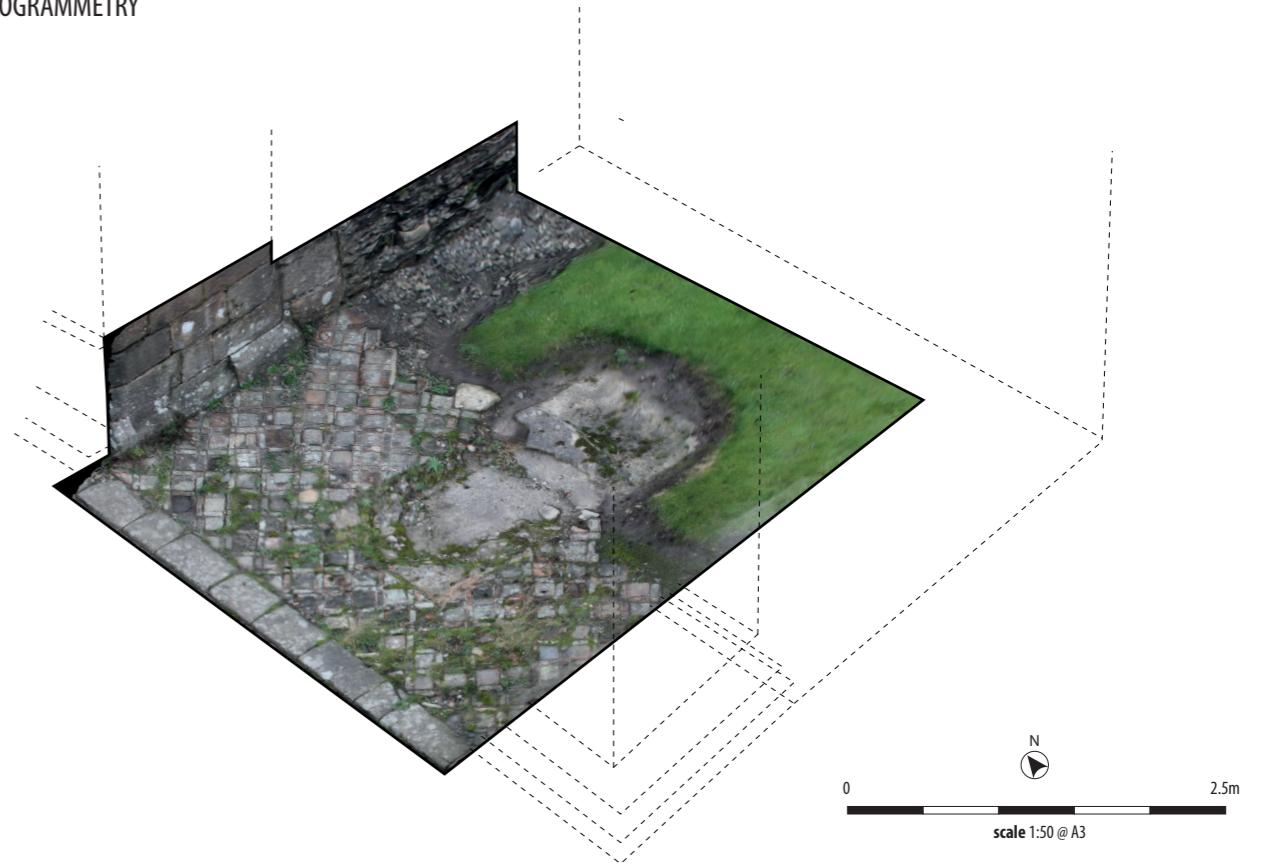
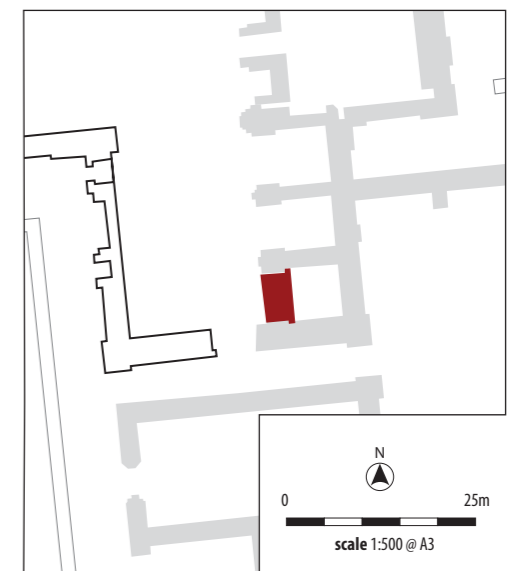
ILLUS 6 Tile floor at south transept chapel

The tile paving in this chapel presented a worst general state of preservation that that of the north transept chapel. The tiles are disintegrating at the edges and sides of the paving surface with very loose tiles in the north-west. The tiles are heavily worn out and weeds are badly cracking apart the tiles and bedding with abundant loose debris evident. (ILLUS 06)
