## SHAP ABBEY, PENRITH, CUMBRIA

*Historic Building Recording*

*Commissioned by English Heritage*

*September 2016*

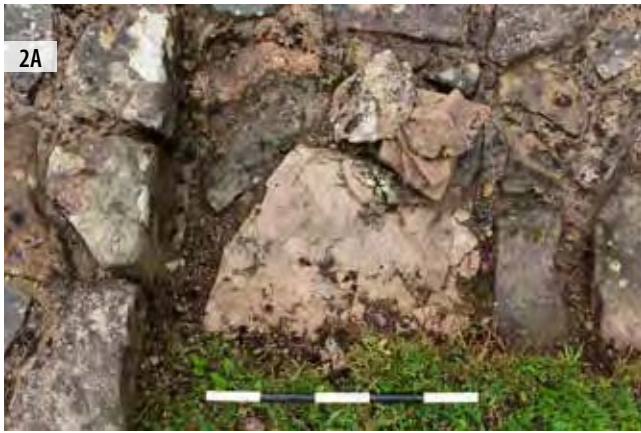
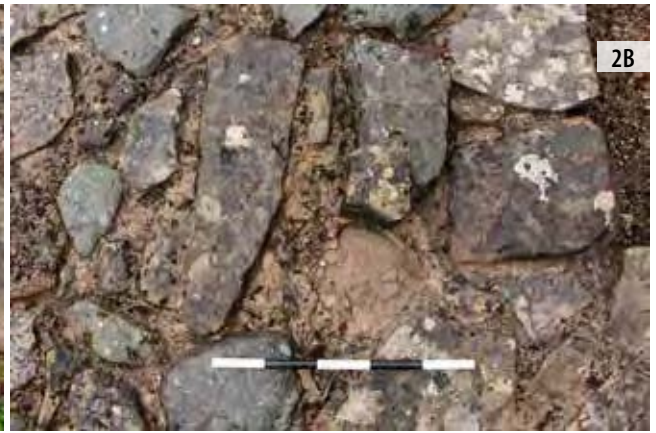
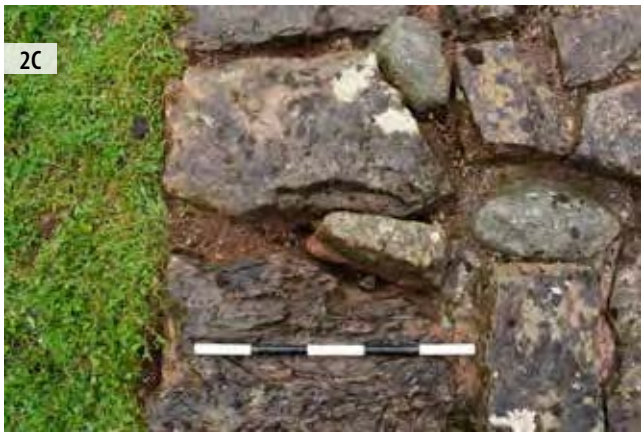
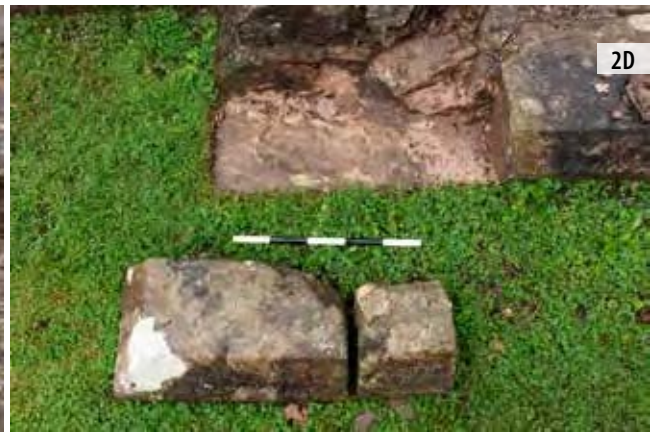
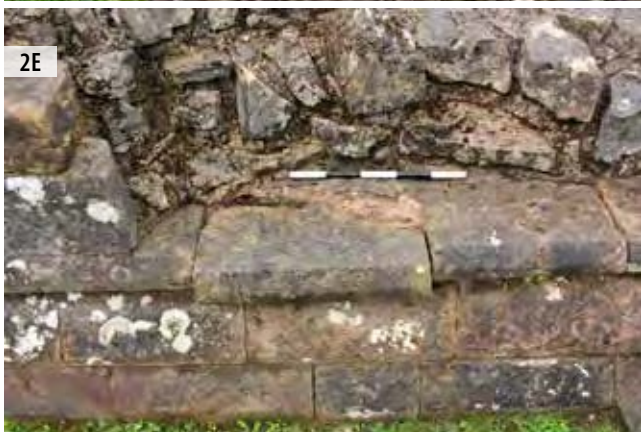
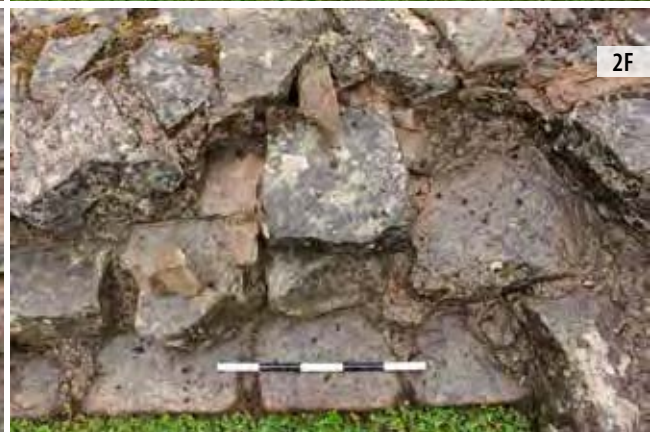
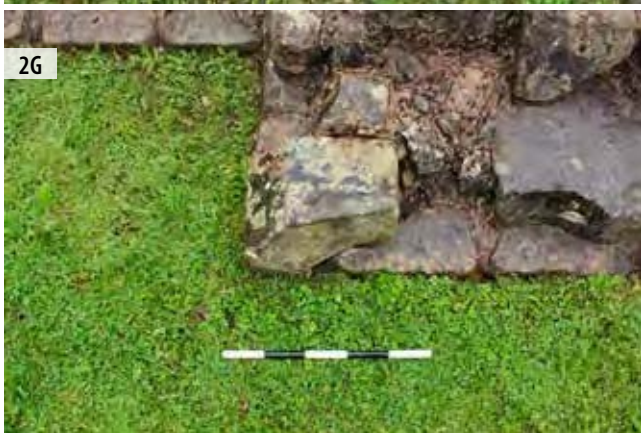
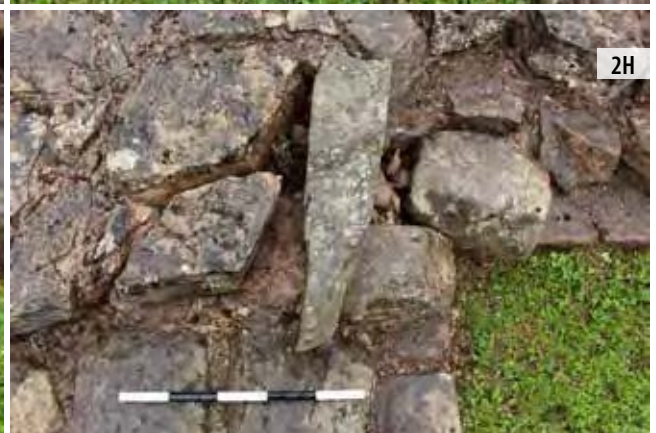
ILLUS 2A–2H Damage to walls

A total of 23 areas of abbey walls were photographed prior to their consolidation and cleaning. The locations of the photographs can be seen through Illus. 2 and the photographs are presented here as Illus 2A-2X.

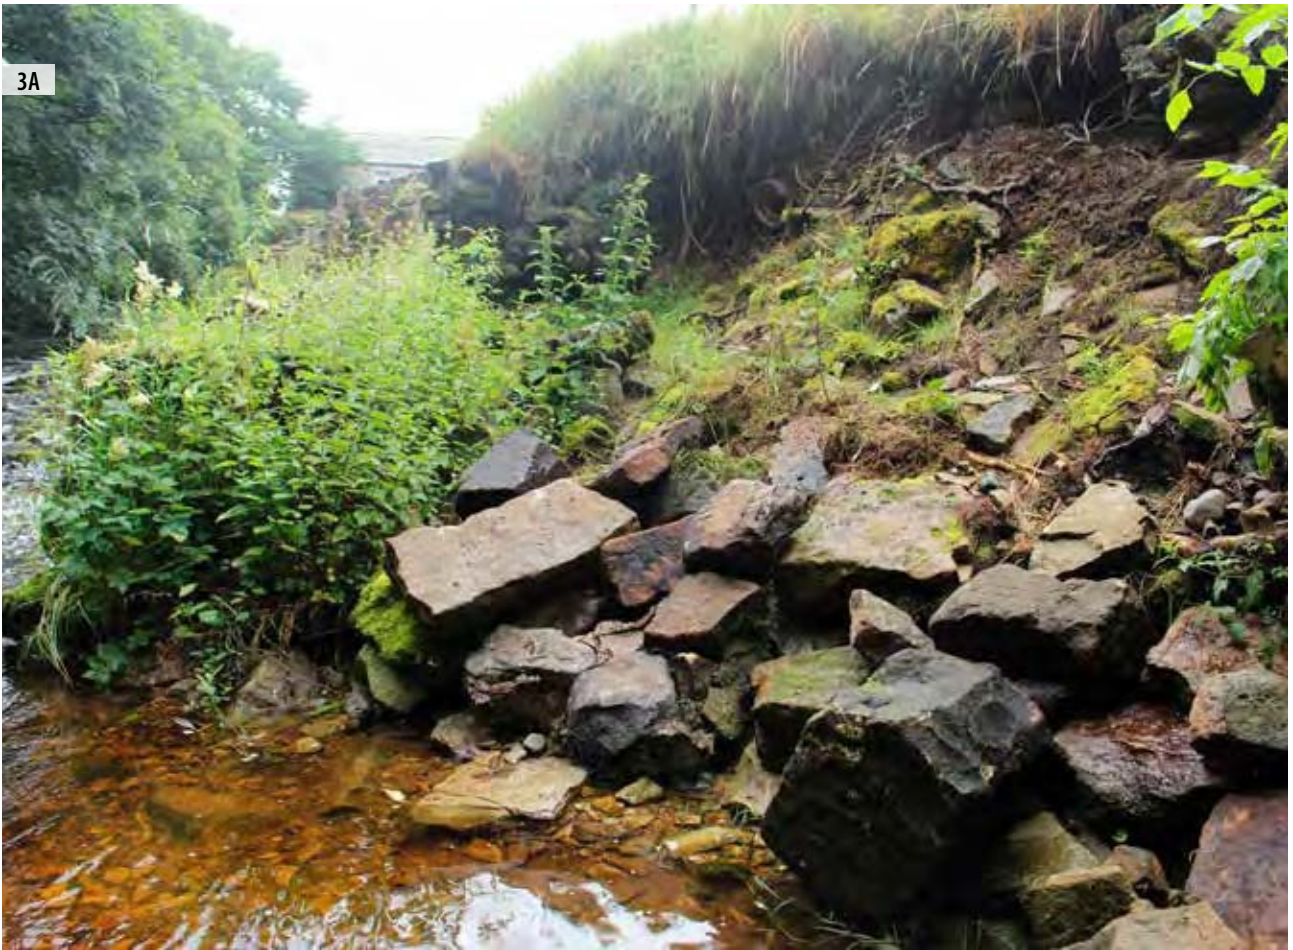
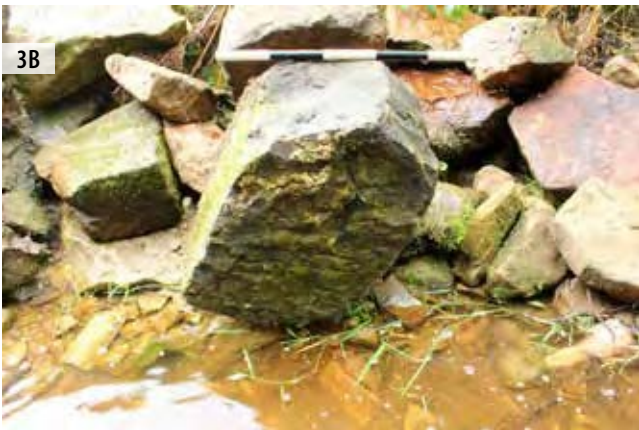
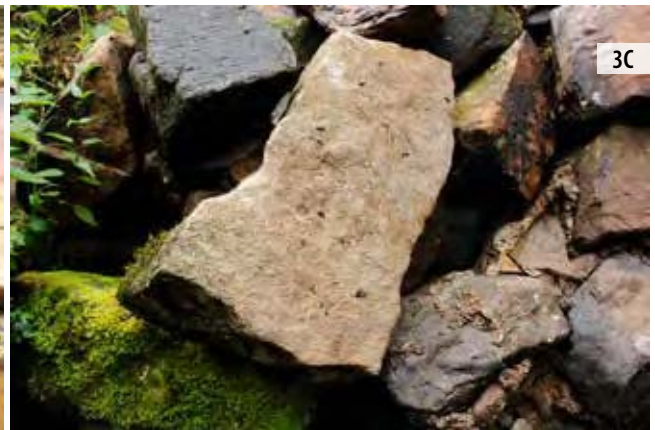
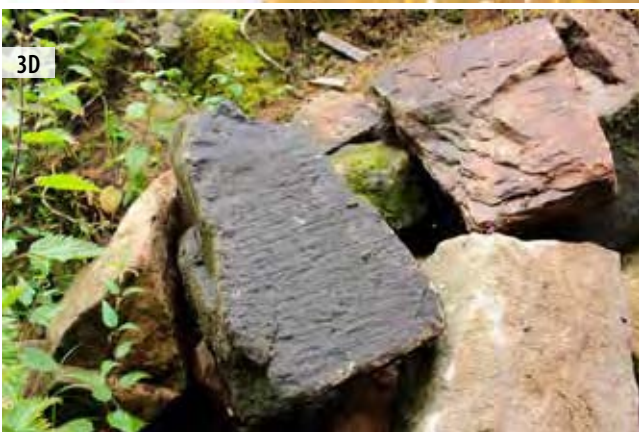
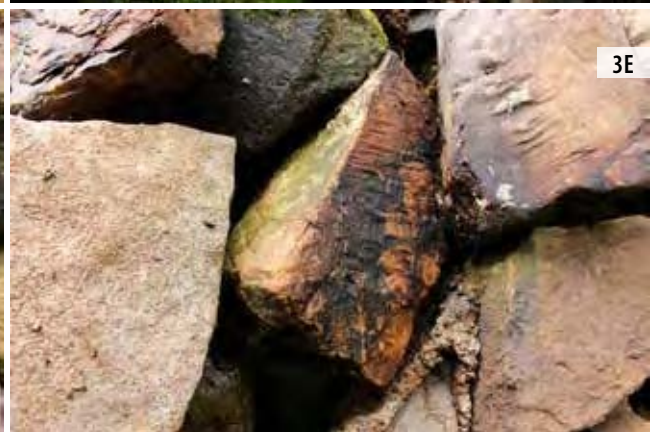
ILLUS 3A–3E S facing view of bank erosion including worked stones

Extensive erosion behind the wall has caused further damage to the bank, exposing stonework at the top of the bank (Illus. 5), some of which has recently collapsed into the river. Several of these stones show tool marks from where they have been faced (Illus. 3A-D) and bevelled (Illus. 3A), suggesting they were originally structural elements of masonry. These will be included in the consolidation of the wall.

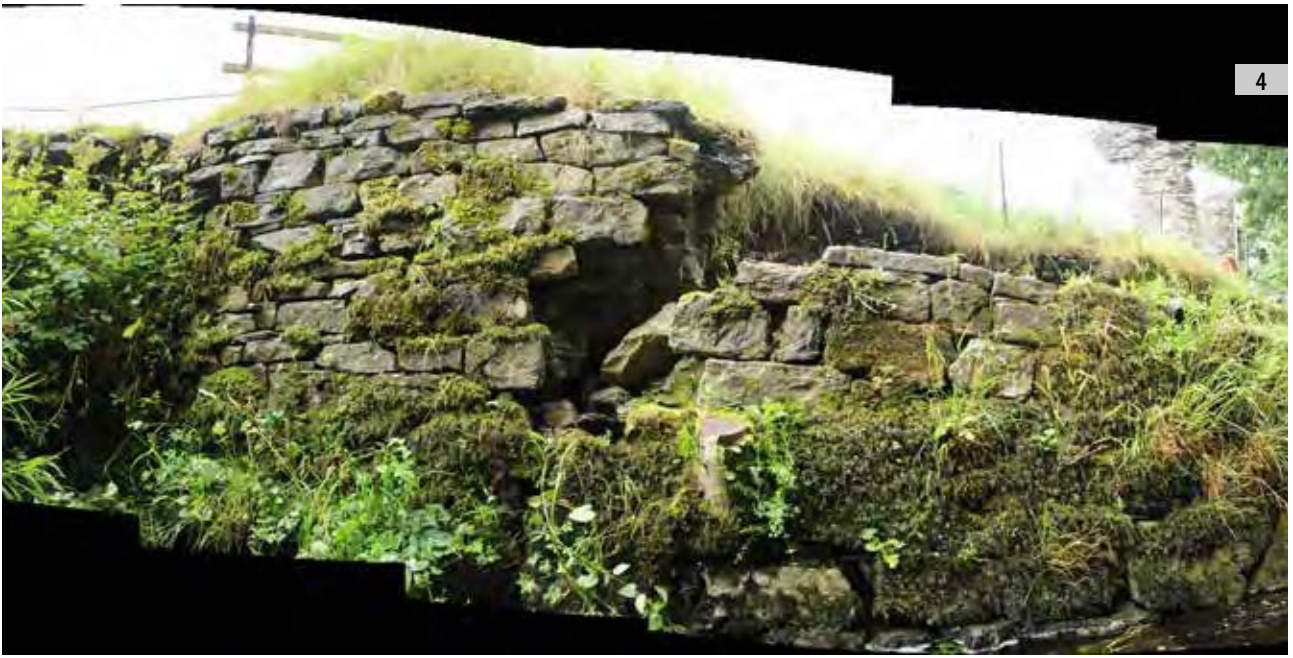
Part of the cemetery wall of the abbey, located to the east of the Chapter House, has been affected by the continuous erosion of the bank of the River Lowther (location shown on Illus. 2). A section of approximately 2.66 m in length is now located immediately adjacent to the river and is severely affected by the stability of the bank (Illus. 4).

ILLUS 4 W facing view of cemetery wall ILLUS 5 W facing view of eroded bank with faced stones

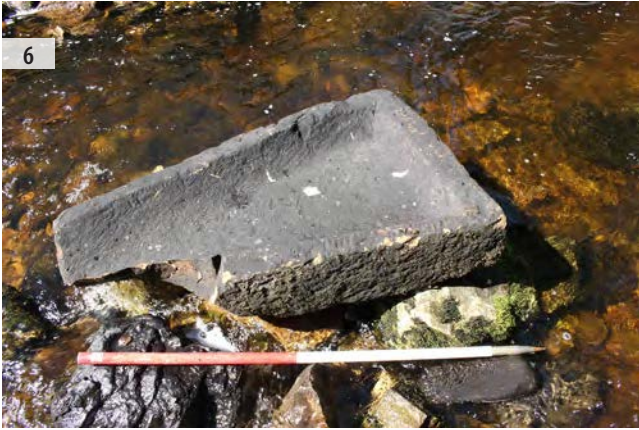
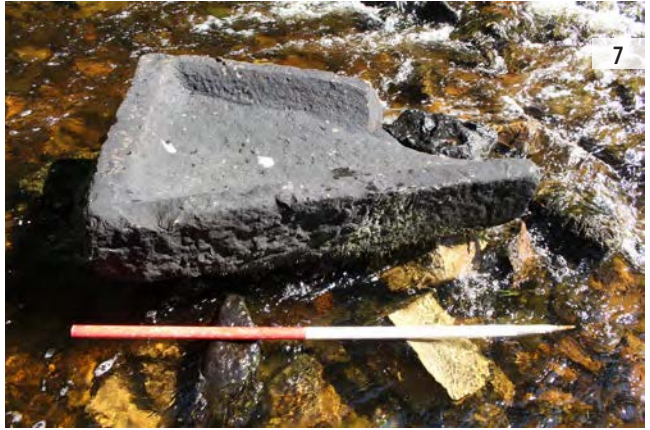
### Masonry 001 (Illus. 6 & 7)

Masonry 001 measures 1.05m in length, 0.69 m in width and 0.29 m thick. It is comprised of roughly hewn sandstone carved into a roughly triangular shape, although a small portion of the tip of the block, approximately 0.35 m in length, has broken off. The face of the block has been indented, creating a flat lip measuring approximately 0.07 m wide, which runs the perimeter of the block. The indented surface of the block slopes very gradually from, and the slope from the edge of the lip to the base of the indented surface is noticeably less steep than elsewhere on the block. This gives the impression that the block was used to funnel material or water away.

The block is in relatively good condition, with the exception of the broken tip, and occasional blemishes in the sandstone. Some masonry marks are present around the lip of the block. The sandstone itself is coarse and does not seem to have been polished. It is dark grey in colour, although small breaks in the stone revealed the block to have originally been a light brownish-yellow colour prior to discolouration, likely as a result of water activity. River weeds were present, implying the block has been present in the river for a relatively long period of time.

As the three pieces of masonry were out of their original contexts, it is difficult to interpret their original place within the wider abbey complex. It is possible that Masonry 001 was washed north from the latrine area of the abbey during flooding and lay in the river for a period of time before being discovered again during works to the wall at the river. The nature of the base of the indented surface of the block suggests Masonry 001 was used to channel water or material, implying that it may have functioned as a rudimentary sink in the latrine area of the abbey.

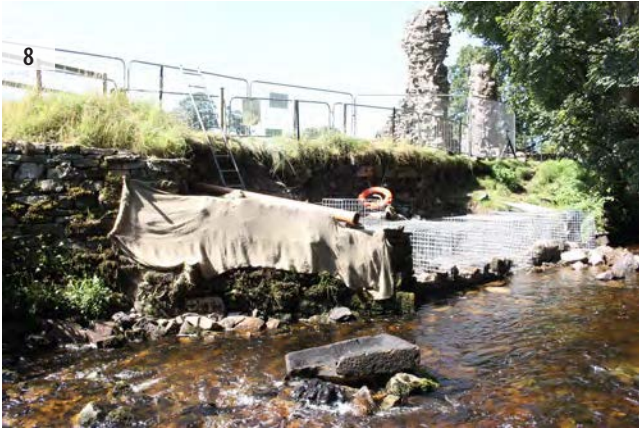
The three masonry blocks were all recovered from the River Lowther, close to the cemetery wall (Illus. 1). At the time of the visit, the largest masonry piece (001) had been placed by ground workers on top of a pile of rocks in the centre of the river approximately 3 m east of the wall (Illus. 8). The remaining pieces of masonry (002 and 003) and four fragments of skeletal remains recovered from the river had been placed on the dry high ground above the river by ground workers.

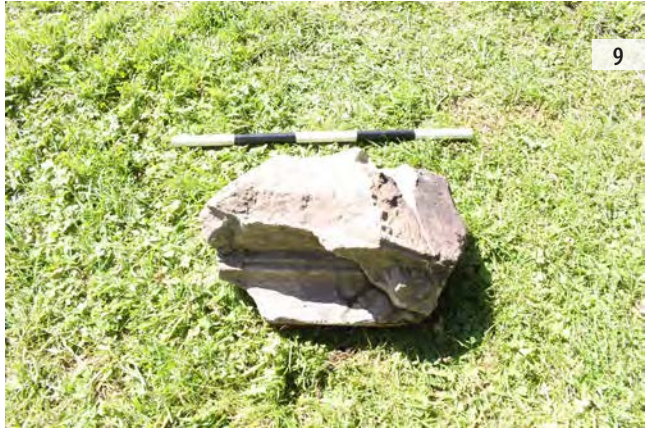
### Masonry 002 (Illus. 9)

Masonry 002 was broken into two pieces which when combined measure 0.4 m in length, 0.21 m in width and 0.2 m thick. The individual pieces measured 0.29 m in length, 0.21 m in width and 0.2 m thick and the other approximately 0.11 m in length, 0.18 m in width and 0.2 m thick. They are comprised of roughly hewn granite and

displayed evidence of possible corncicing in the form of two horizontal lines incised into roughly the centre of the larger block. The granite is light grey in colour and had quite extensive evidence of masons' marks on both pieces. A large portion of the top of the larger piece appears to have broken off, revealing the lighter coloured granite. Four sub-rounded incisions present at the top of the larger piece, are possibly evidence of a different type of masons' mark than seen on the smaller piece.

Masonry 002 and 003 had limited identifying features other than the corncicing in the case of the Masonry 002 and the one side of Masonry 003 which had been cut into a curve. Given the small nature of the surviving blocks and the lack of context for them, it is not possible to assign a definitive function to either block.

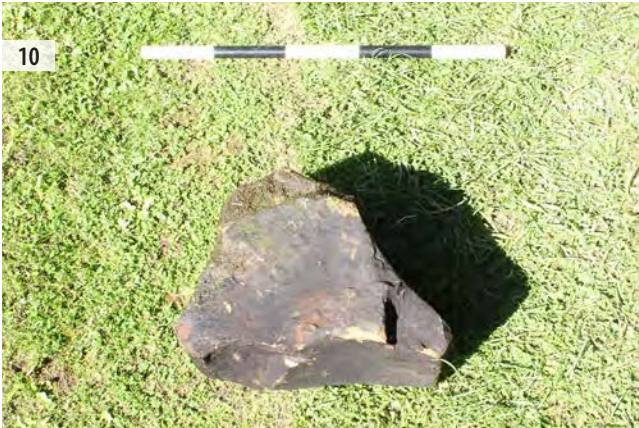
#### Masonry 003 (Illus. 10)

Masonry 003 measured 0.28m in length, 0.21m in width and 0.24m thick. It is comprised of roughly hewn sandstone which was dark grey in colour. Like Masonry 001, the block had some small blemishes on its surface which revealed the sandstone to have originally been light brownish-yellow in colour, prior to discolouration. The dark colour of the stone and the presence of river weeds on the surface suggest the stone had been present in the river for a significant amount of time. One side of the block has been carved into a curve at an angle of approximately 50°.
