# SHAP ABBEY, PENRITH, CUMBRIA

HISTORIC BUILDING RECORDING

commissioned by English Heritage

October 2016

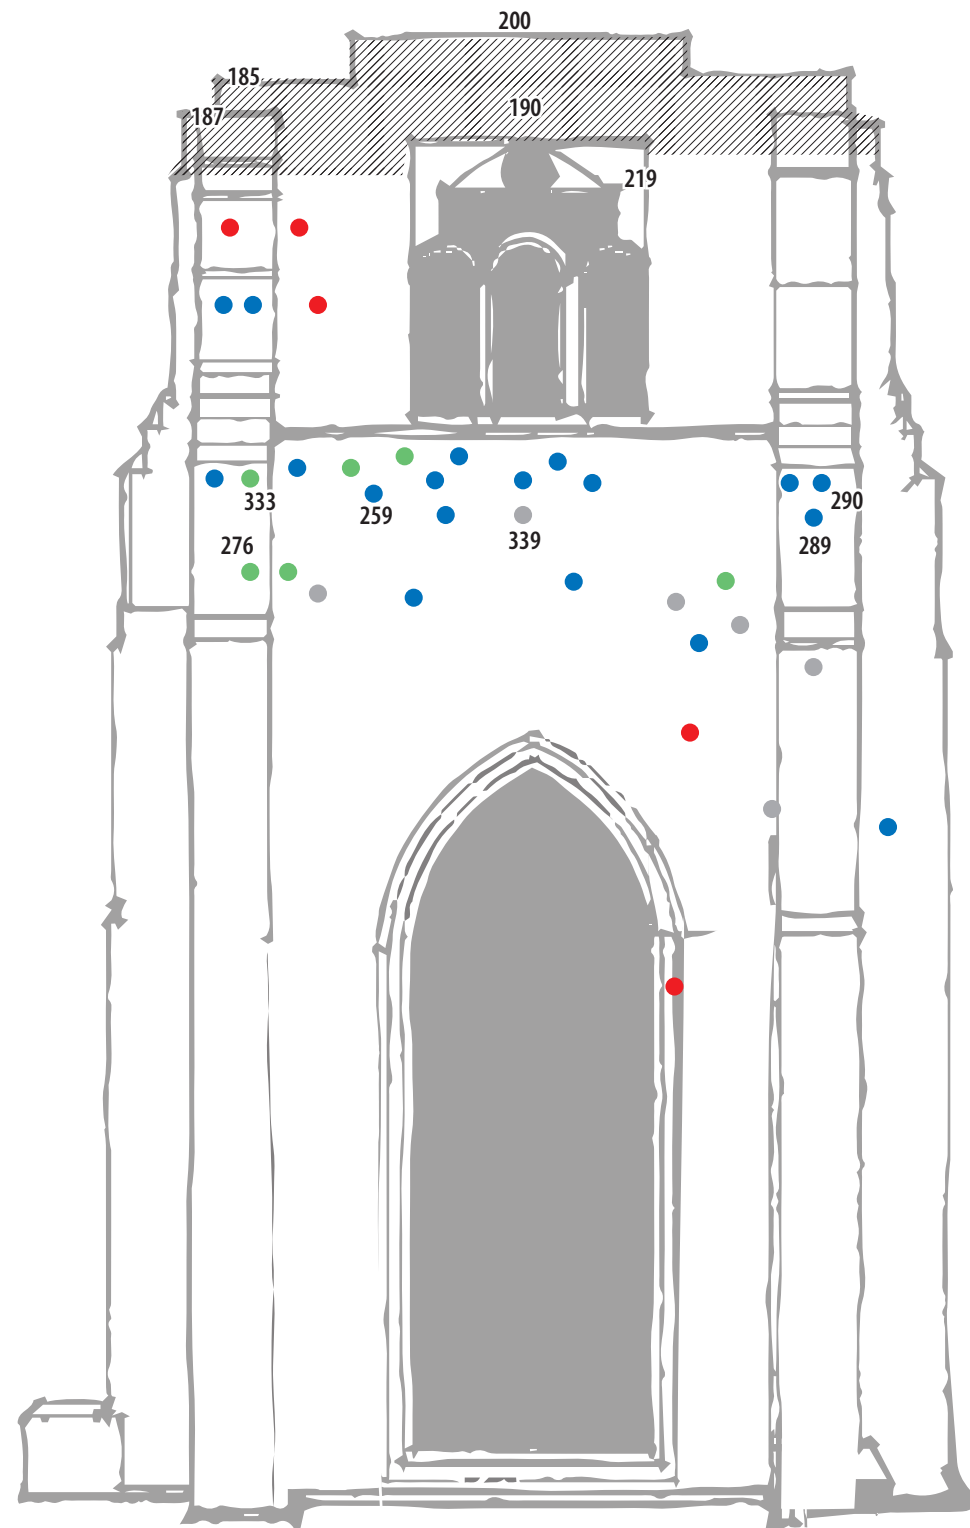
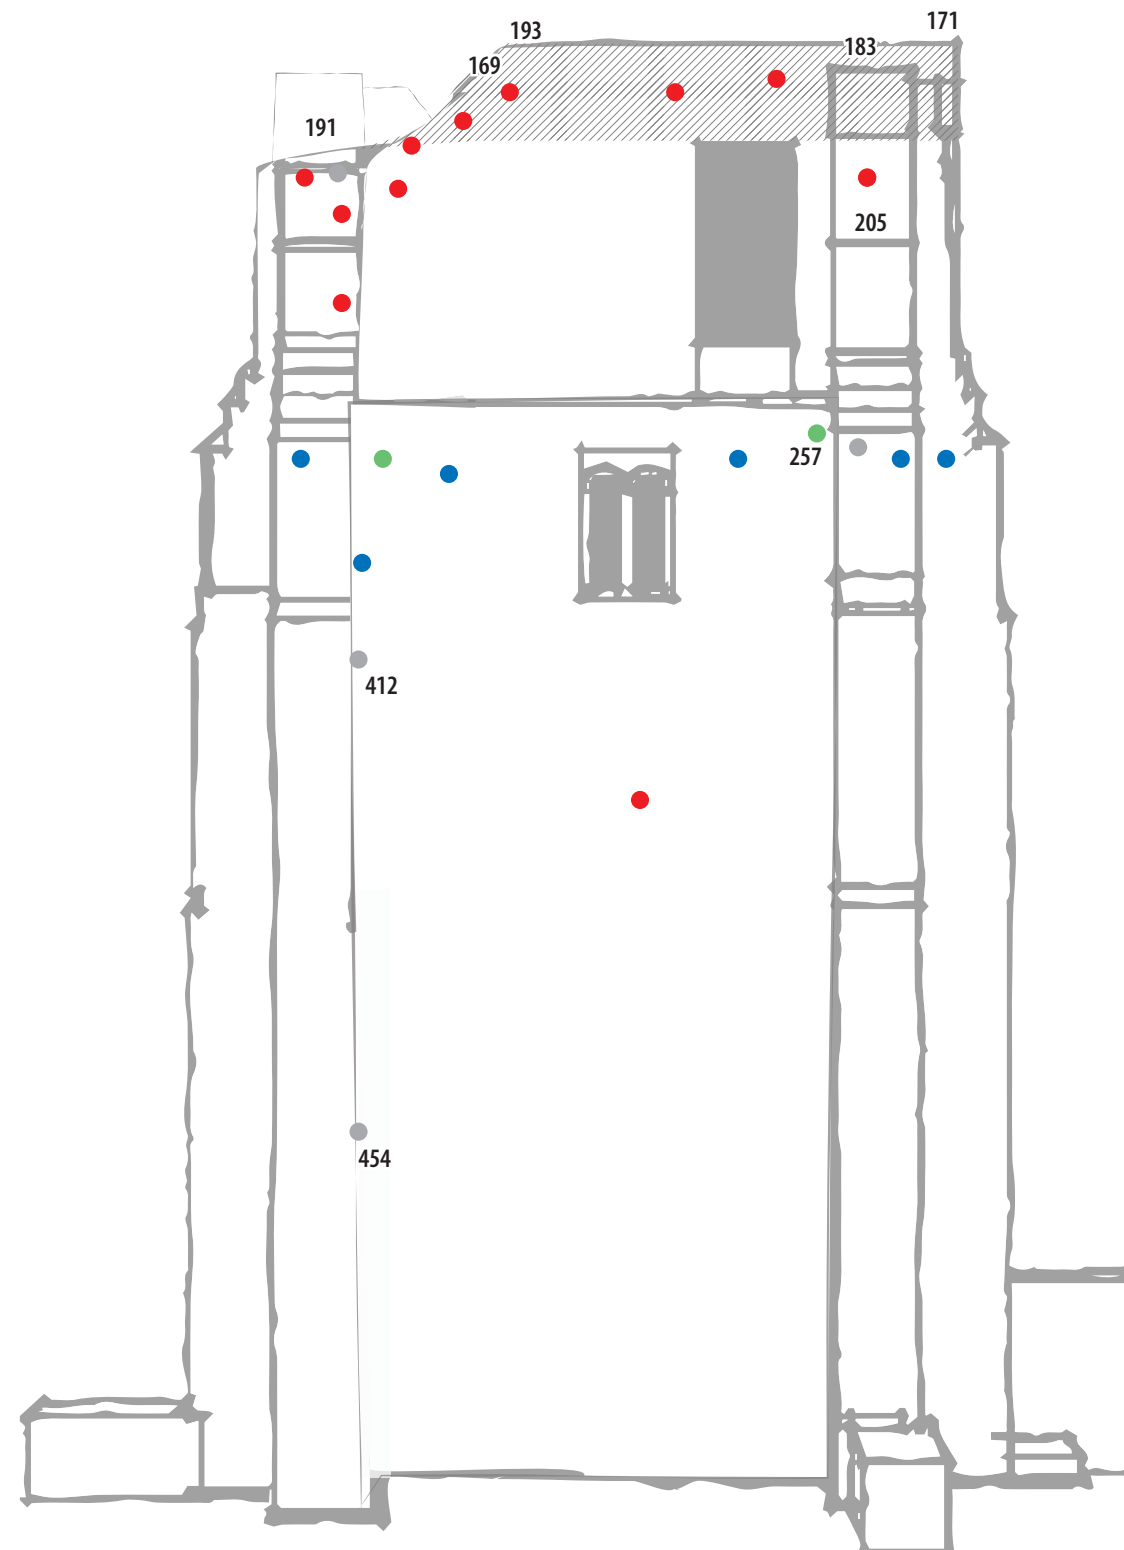
ILLUS 2A Photo locations and distribution of mason marks on W and S facing elevations

At the upper level of the tower, removal of vegetation and consolidation of masonry has been undertaken. A photographic record of this works has been completed (Appendix 1).

These were construction marks used in laying and positioning of the stone: placement marks, assembly marks, location marks and course marks (Illus 2A & Illus 2B). Many are symbols such as crosses or arrows, or derivations of these with added lines and other geometrical shapes. These marks were either used in isolation or in combination to produce a full code for masonry work (Illus 2A & Illus 2B).
