## STOTT PARK BOBBIN MILL

*Historic Building Recording of lade prior to repair  
for English Heritage*

*July 2016*

HA Job no.: SPBM16/01

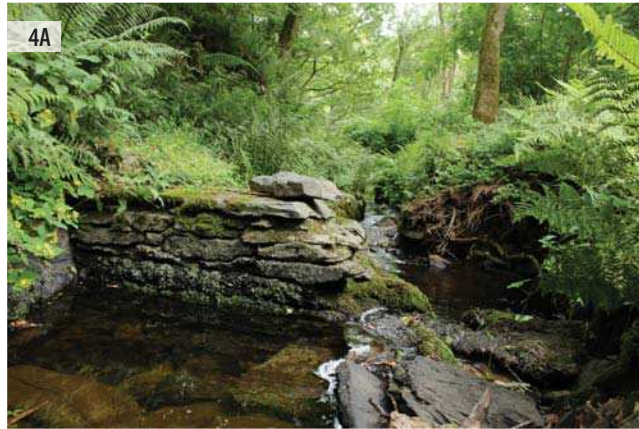
A sluice gate was once positioned on the west side of the length of lade investigated. This would have originally been a wooden gate set into a stone wall to control water flow along the lade (Illus. 4A) as indicated from the map regression (Illus. 2). On the stone element of the structure survives which has partially collapsed (Illus. 4A). The collapsed elements of the structure has forced excess water to erode and collapse a large segment of the southern bank nearby (Illus. 4B).

Illus. 4B shows a newly uncovered branch of the lade which can be seen to diverge from the course of the main lade (Illus. 4A). It has collapsed and the surrounding bank is unstable. Its course is unknown.

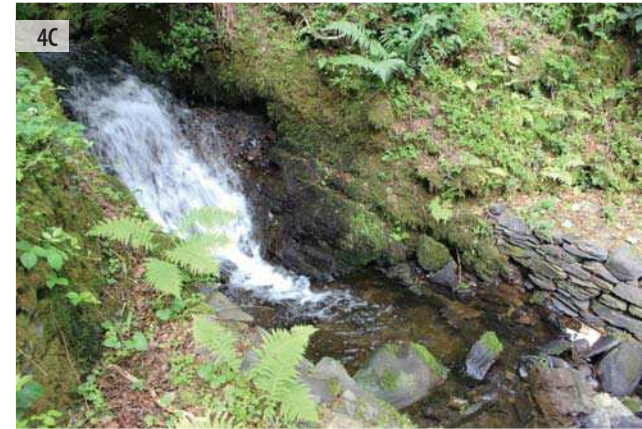
The weir has undergone serious damage. The length of the weir (from west to east) has been truncated due to the damage, and the walls themselves have been severely eroded due to excessive water flow (Illus. 4C, 4D). A large quantity of rubble can be seen in the lade, most heavily concentrated downstream from the weir, suggesting it is at least partially comprised of damaged segments of weir structure.

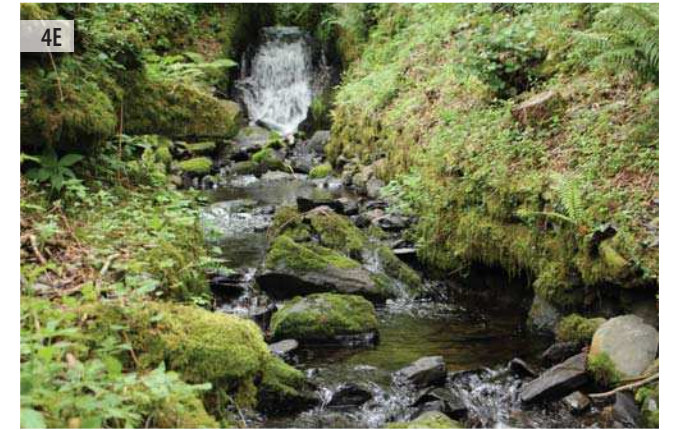
At several locations along the length of the lade significant undercutting and loss of the lower stones of these walls is apparent (Illus. 4E, 4I, 4J). This is particularly significant at the section of the lade located immediately to the east of the weir. This increase in damage here is probably due to the increase water flow in this area. Rubble from the damaged areas of the lade has also made its way

further east along the channel, pushed along by the fast flowing water (Illus. 4E, 4F). This rubble has potentially caused further damage on its way. An area to the east of this appears to have previously undergone consolidation works (Illus. 4H).
