ROINEACH MHOR, GLEN CLOVA, ANGUS

Historic Building Recording

For KDM Architects on behalf of Mr Hugh Niven

September 2016

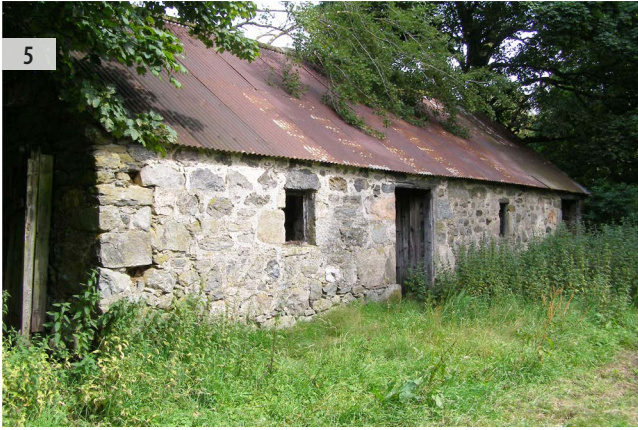
The south elevation of the building measured 13.5m and 2m from the ground to the overhang of the roof (Illus 4, 5). A window (0.6m by 0.7m) and a doorway (1.2m by 1.85m) were present on the western section of the elevation, which provided access to Area B

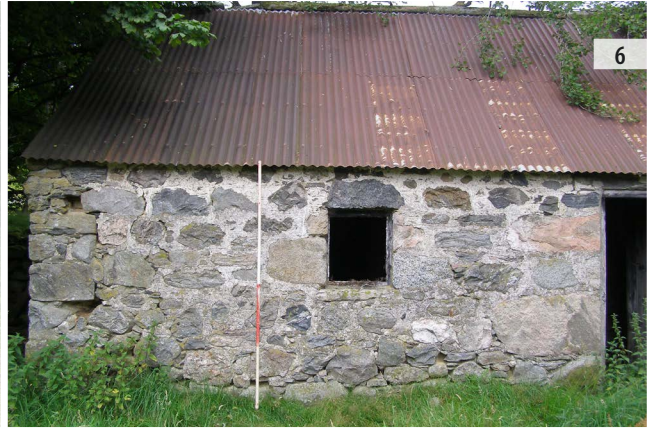
(Illus 6). The eastern section of the south elevation also contained a window (0.4m by 0.7m) and a doorway (1.2m by 1.8m), which provided access to the interior of area C (Illus 7).

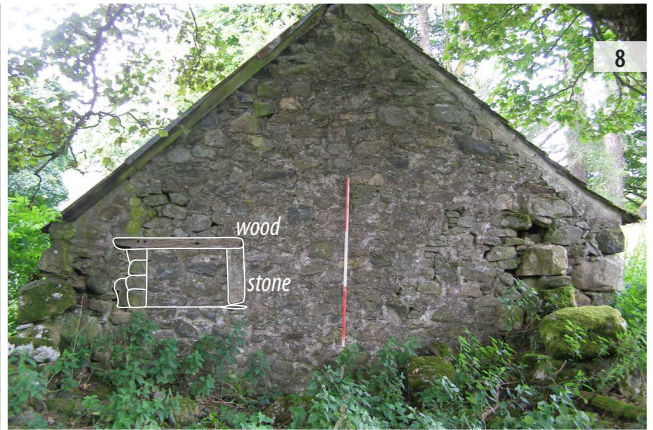
The east elevation of the main structure measured 5.5m in length and c1.75m from the ground to the eaves of the roof and c3.5m high from the ground to the apex of the roof. On the southern half of the elevation was a window which had been blocked with sub-angular stone and lime mortar (Illus 8). A wooden lintel and stone jambs were visible from the original window opening. The eastern elevation had been rebuilt on both north and south corners to incorporate the north and south walls of the enclosure, indicating that these were added at a later date from the main building. It is probable that the window was blocked during this phase of restoration and extension.

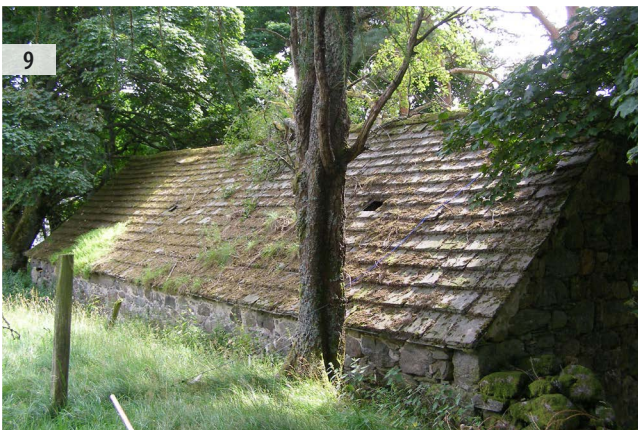
The northern elevation of the main building was partially built into a grassy bank, therefore no features were present in the c. 0.75m which was visible above the ground to the eaves of the roof (Illus 9). Where the eastern enclosure (Area D) joined the main structure, the wall had been rebuilt and it was not possible to see the join. This section of the wall runs eastwards for approximately 22m, but is extensively collapsed, possibly due to the dry-stone construction. Around 11m from the join with the main structure, a large stone block was visible in the elevation, which marks an internal north-south division within Area D.

At the western end, the north elevation shows the north wall of the western enclosure (Area A) abuts the main building, and is evident that it is a later addition (Illus 9). Part of this section of the northern elevation has collapsed, especially where it extends above being built into the slope to the north. The difference in techniques used to join the eastern and western enclosures to the main building (abutting in

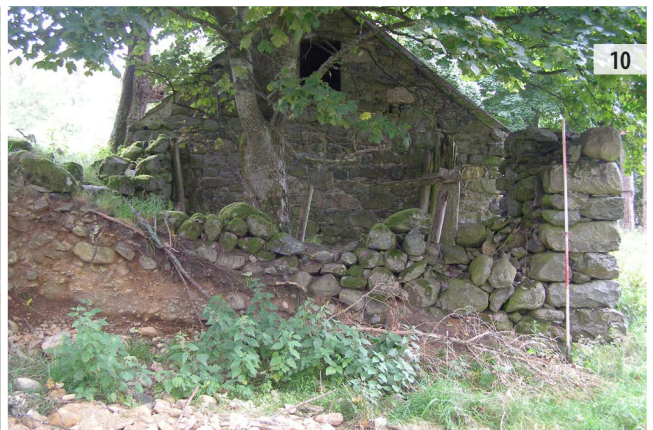
The west elevation of the main building measured 5.5m long by 2.1m high from the ground to the eaves of the roof and c3.5m to the apex of the roof. An unglazed window was present in the middle of the elevation, approximately 2.5m from the ground, measuring c0.6m by c0.7m (Illus 10).

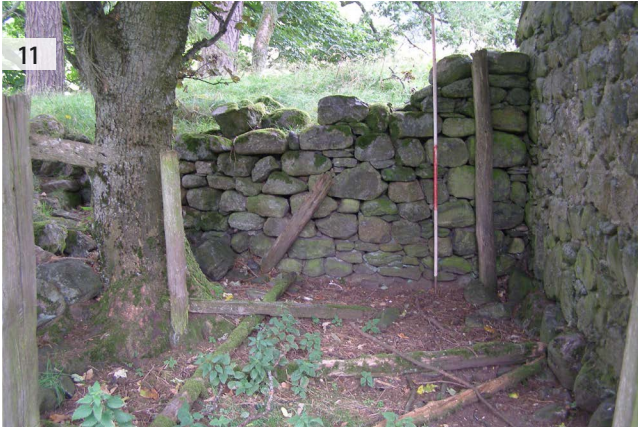
Area A was a later enclosure which was added onto the west elevation of the building, using similar materials to that of the main building. This rectangular area comprised three walls on the north, west and south, measuring 4m, 5.5m and 1.7m in length respectively. The wall survived to original height in the south, and in the north-east corner, but had collapsed elsewhere. An entranceway measuring 2.5m was present in the southern side, and was flanked by posts, probably for a gate (Illus 11). The internal area was 23.1m². Six wooden posts remained upright and *in-situ*, in a rectangular shape, and five further posts had collapsed. These posts may have divided the area into pens and could suggest Area A was used as an animal enclosure. There was no evidence that this area had ever been roofed.

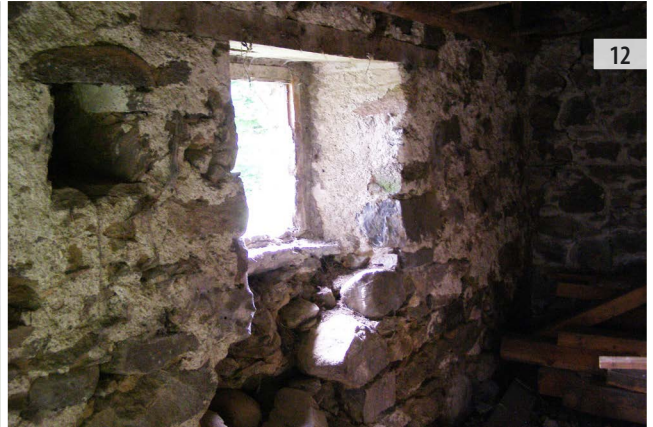
Area B was the western room within the main building and had an overall area of c 23m². The southern wall contained the doorway and a window, described above. The wall below the window had partially collapsed. To the east of the window was a small niche measuring (0.25m x 0.23m x 0.15m) 1.4m from the floor level (Illus 12). The room was roofed with wooden cross beams which supported wooden planks, forming the floor of the attic above. The wooden cross beams rested on top of the internal walls. Another niche of similar proportions to that in the southern wall was visible in the western wall (Illus 13).

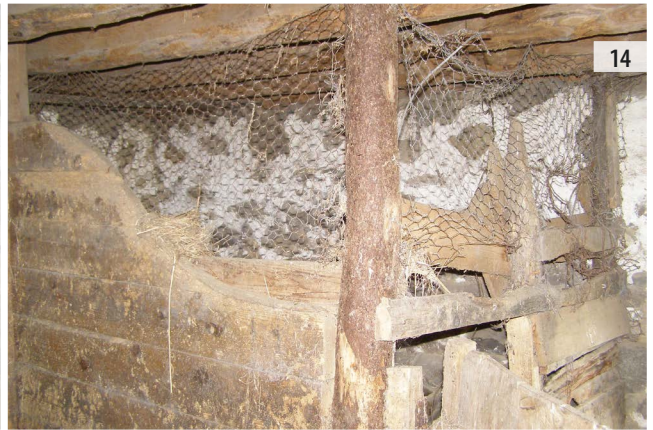
doorway and were constructed from wooden planks, posts and chicken wire to create pens. The western example measured 1m by 3m and the eastern 1.5m by 3m. The eastern pen also had a wooden door 1.3m in height, which suggests that it was used for animals (Illus 14). The other may have been used for storage.

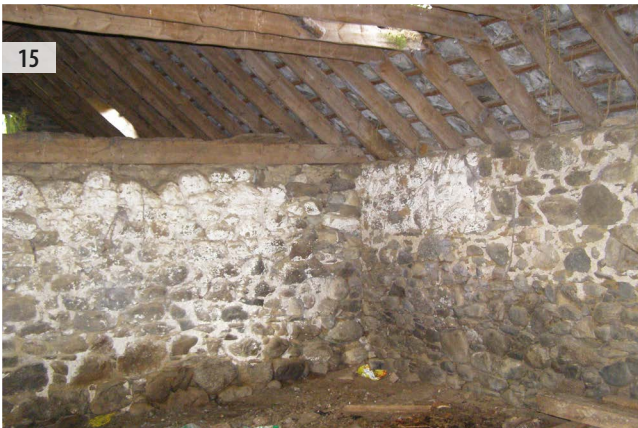
The internal walls of both Area B and C were plastered in lime, although this only survived patchily across the walls. A rectangular concentration of lime survived in the north-west corner of the northern wall of Area C (Illus 15), possible an indication of the location of internal furniture or divisions which no longer survive.

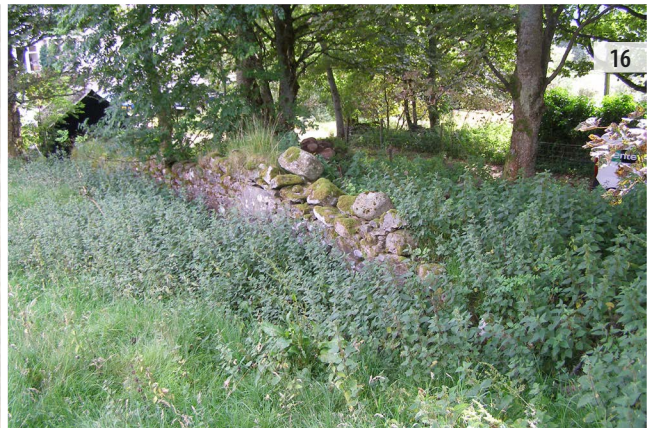
Area D comprised another external enclosure on the east end of the building. The area contained extensive amounts of rubble from collapse of the enclosure walls and was heavily overgrown with vegetation (Illus 16). As discussed above, the north and south walls of Area D appear to have been built into the east elevation at a later phase. Subsequently, the enclosure walls have collapsed, resulting in the extensive rubble. A line of rubble running north-south, approximately 11m from the eastern wall of the main building divided this enclosure into two areas. The far eastern wall of Area D had collapsed and was also heavily overgrown with vegetation (Illus 17).
