TRIGPOINT 49, STAITHES, NORTH YORK MOOR

HISTORIC BUILDING SURVEY OF A FIRST WORLD WAR BARRACKS

HBR (LEVEL 2)

NYM/2013/621FL

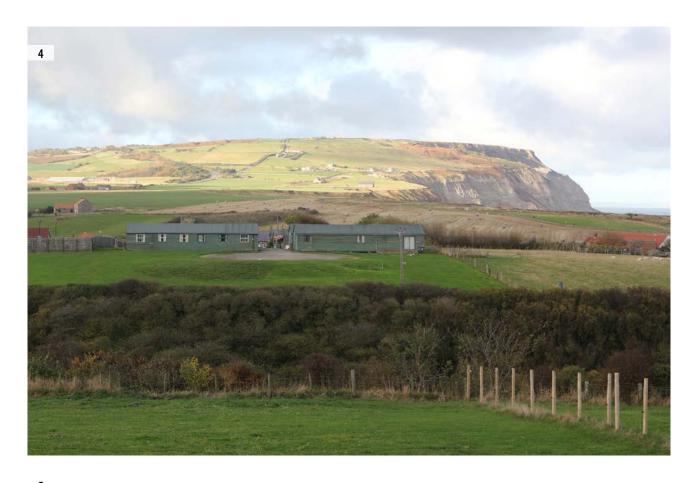
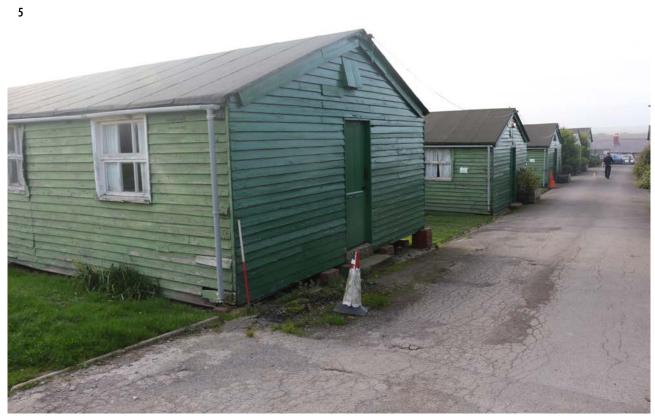
ILLUS 4 View of the site from the east **ILLUS 5** General view of the southern row of structures

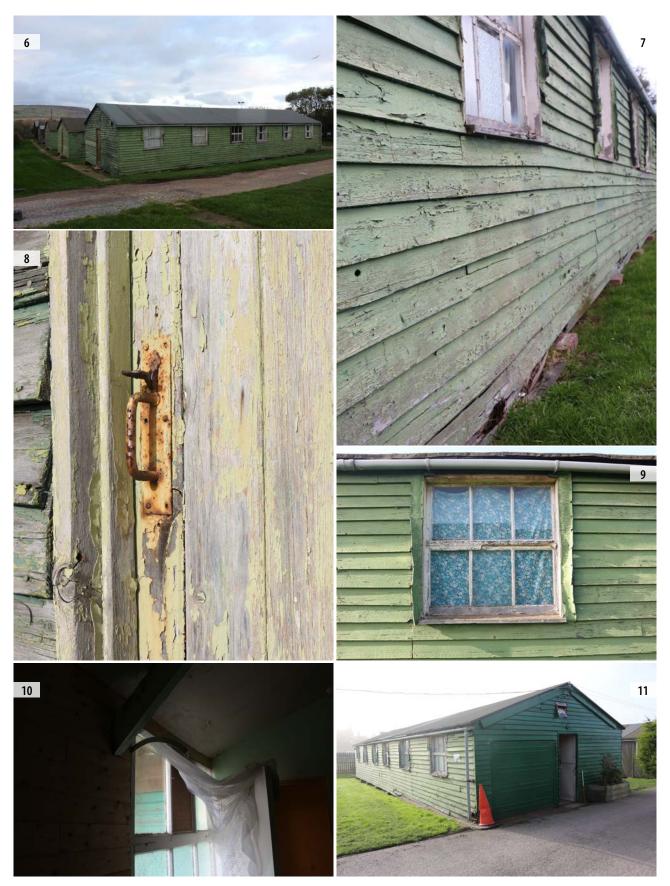
The primary construction of these blocks comprised large single storey rectangular buildings 18.52m (61ft) x 6.36m (21ft) standing to a height of 2.42m (4ft) with standard pitched roofs and gabled ends (Illus 6). The exterior of these blocks was clad in overlapping horizontal timber planks set with nails. The planks were of mixed lengths with no distinct pattern observed (Illus 7). Each block included a single timber door to each end and six timber framed windows to each side. The doors were mainly timber plank construction with a castiron latch and clasp opening mechanism (Illus 8). The window panes were set three over three (Illus 9) with a central hinge allowing the upper half of the window to partially open inwards on internal metal sliders (Illus 10). In many cases these sliders had subsequently been removed and the windows were permanently shut. The pitched roofs were covered in a felt overlay. As the ground sloped from east to west the blocks were levelled on the ground using a series of brick support plinths along the base. This was observed on both sides of each block although the plinths were always higher on the west sides of the structures. The plinths were constructed of handmade bricks bonded with cement.

ILLUS 6 View of Block 3 ILLUS 7 Detail of the timber construction of the blocks ILLUS 8 Detail of the door latch mechanism ILLUS 9 Detail of the window design ILLUS 10 Detail of the internal window mechanism ILLUS 11 View of Block 3

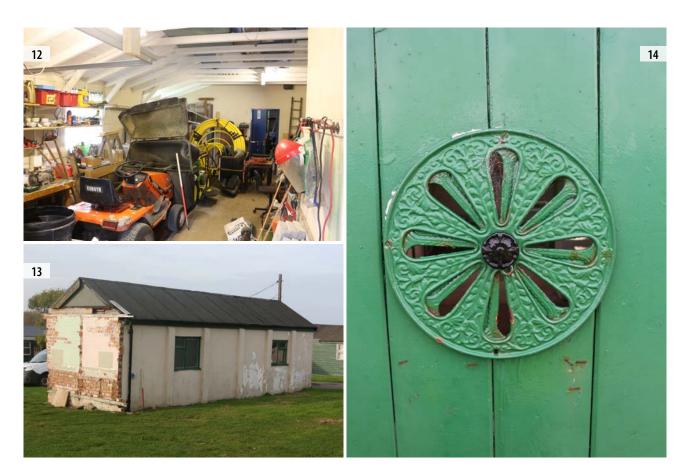
The internal layout of all three blocks comprised two rooms divided by a central plasterboard wall with a central door (Illus 12). To the north and south ends of each of the blocks was a small room constructed of painted chipboard that stopped short of the ceiling. The floors had a central linoleum covering running the length of the blocks flanked by polished timber floors to each side of the room. The internal walls were mainly painted chipboard although some areas also had plasterboard finishes. The ceilings of all three were open to the timber rafters which were constructed of a series of 'A' frames running across the length of the room. At the conjunction of the rafters and the tops of the windows additional timber supports had been included. These were thought to be original features of the blocks.

This block was constructed of brick and covered in a painted plaster render (Illus 13). This building had originally been part of a much larger structure that had subsequently been demolished prior to the site visit. It was clearly a later phase construction potentially dating to the 1960s as it did not appear on the 1950 Ordnance Survey. The dimensions of the building were smaller than that of the timber blocks being 7.2m x 4.5m in size. The construction of the walls included five projecting brick buttresses to each side along with two modern timber frame windows. It had a single entrance on the north elevation and a felt covered roof. The timber door included a circular cast-iron vent (Illus 14) which was probably associated with the buildings use as a laundry. The brick surface of the south wall was exposed indicating it had originally been attached to further buildings.

ILLUS 12 View of the internal layout of Block 3 **ILLUS 13** View of Block 6

ILLUS 14 Detail of cast-iron vent on the door of Block 6

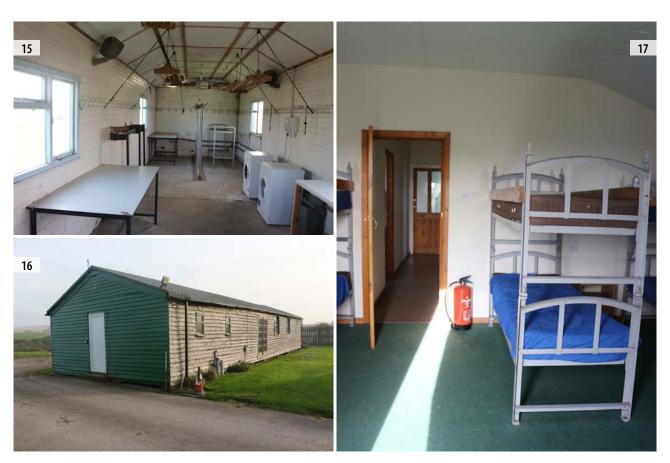
The internal construction included a concrete floor and painted brick walls (Illus 15). The ceiling was constructed of timber panels and included a number of features associated with the laundry including several clothes hangers.

The basic design of Block 7 was similar to that of Blocks 3 to 5 although it had clearly been modified (Illus 16). Although the east side of the block still included the row of six original windows the west side had been significantly altered. Three of the original windows had been removed with two smaller windows and a modern double door entrance inserted in their place. The original doors on the north and south ends had also been replaced with modern doors.

ILLUS 15 Internal view of Block 6 ILLUS 16 General view of Block 7 ILLUS 17 Detail of the bunk beds in Block 7
