# 7B LOANING ROAD, EDINBURGH

Historic Building recording for Cullross Limited 16/01415/FUL

> April 2017 Version 2

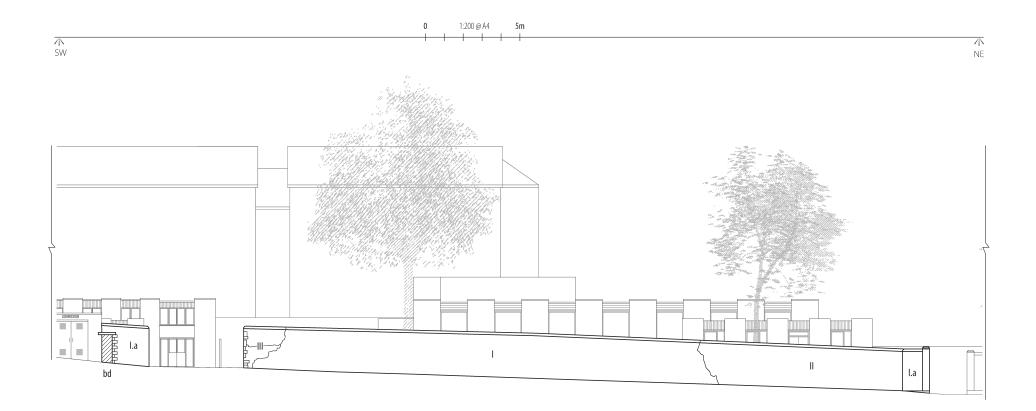
ILLUS 3 South-east facing elevation of wall

From the external elevation of the southern section it is apparent that this wall has undergone at least one phase of rebuilding. 9.5m from the eastern end of site, the wall has been rebuilt (Illus 4), ending at the south eastern corner, where it has been keyed into the existing wall fabric. The top of the wall in rebuilt sections uses mortar to form the wall top, whereas the original wall has small stone blocks mortared in place (Illus 5). The wall on the exterior measures 2.6m from the pavement, and 1.5m from the ground on the interior; the ground level on the interior is higher.

I. Original phase, angular and rounded blocks of varying size with gravelly mortar Ia. Ashlar masonry with half rounded coping stones II. Rebuilt phase similar to [1] but less well-faced fabric III. Rebuilt pressumably due to modern gate installation

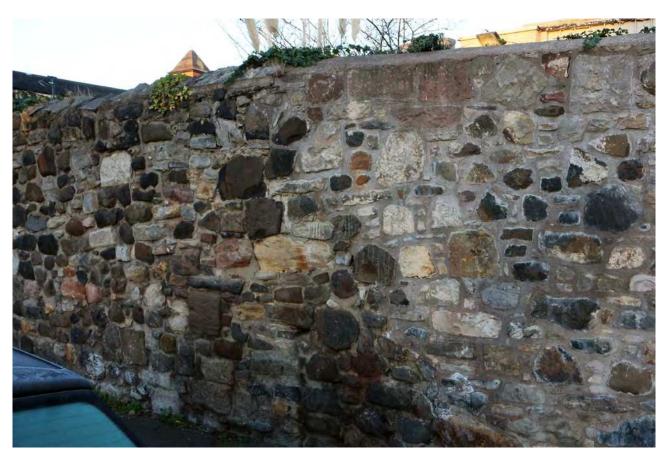
ILLUS 4 Start of rebuilding event of the southern wall. NW facing

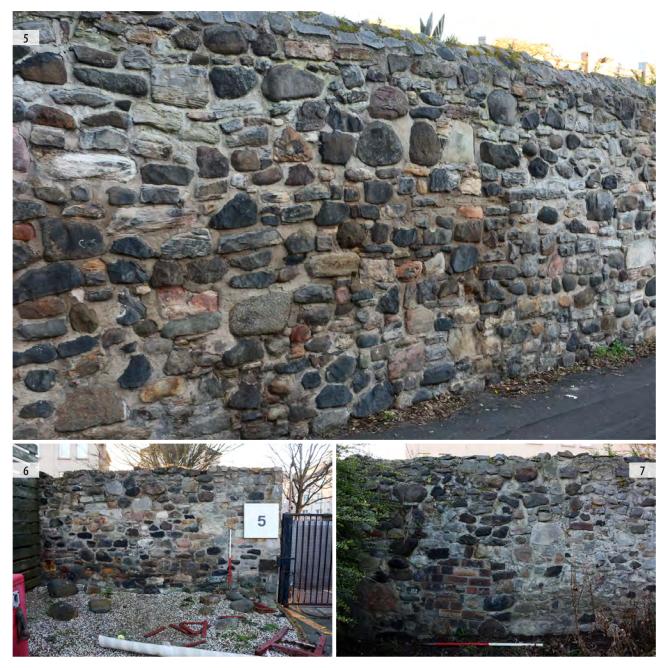
Between 9.5m and 48m from the eastern end of the southern wall much of the exterior of the structure appears to be original construction (Illus 5), and contains several small iron fixings within its fabric. These include iron pegs and brackets for hanging objects from, and are located 1.5-2.5m above the pavement. The southern wall extends for 50m until it is broken through by a modern gate. The insertion of the gate has required the modifying of the wall structure to create terminal ends onto which the modern gate has been affixed (Illus 6).

The interior elevation of the southern wall shows evidence of more recent repair, where bricks have been used to patch up a section near the base (Illus 7), In general, the northern elevation of the southern section of wall was more overgrown with ivy, so less was visible for inspection (Illus 8, 9). More sections of the wall may be able to be inspected following clearance works on site.

**ILLUS 5** NE facing shot of original wall construction **ILLUS 6** Modern entrance with gate attached to wall. Inside edge. S facing **ILLUS 7** Section of rebuilt mid-wall. S facing

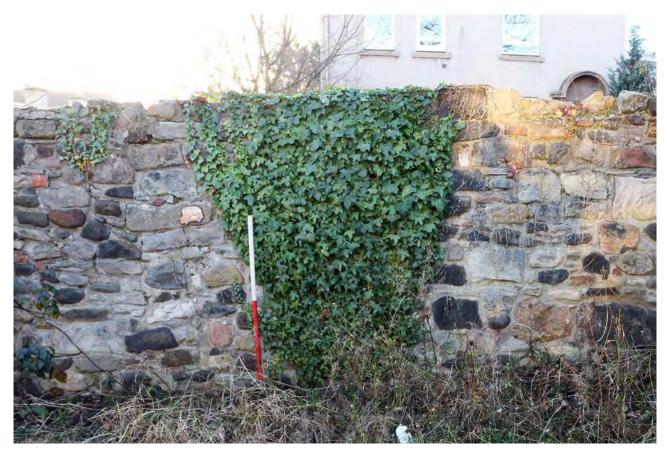
ILLUS 8 S facing shot of rebuilt wall section

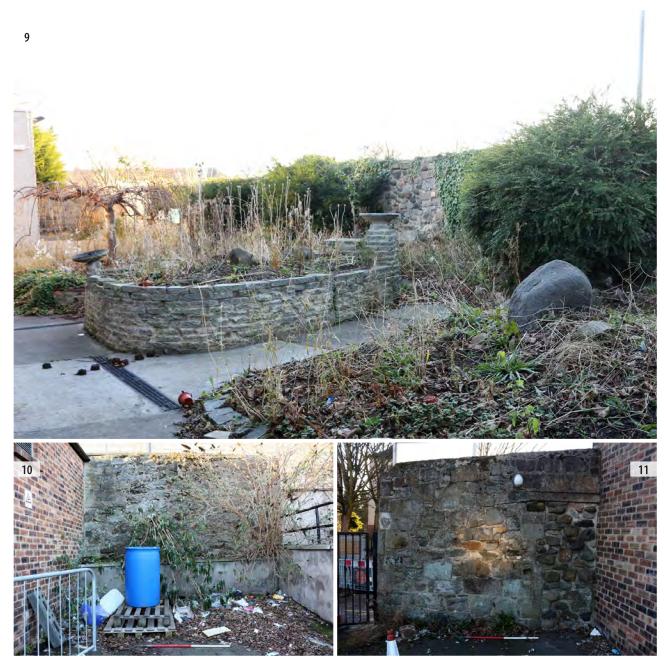
To the west of the gate, the wall survives but has been heavily modified, both as a result of the gate, and by the creation of a doorway through the wall (Illus 11). This doorway has then been truncated by the construction of a brick building (substation), with the wall being modified to abut the brick structure. It is likely at this stage the doorway was blocked up. Several metal fastenings have been inserted into this section of wall, some appear original, (small iron pegs and brackets), and some very modern (lighting fixtures).

A 3m stretch of wall survives on the western boundary of the site. It is of similar construction to the rebuilt section of the southern wall (Phase II) and has also been extensively altered (Illus 10). It also appears to abut the brick structure, however the construction is very similar to that of the southern wall. Therefore it is more likely that they were all original constructed at the same time and the southern end of the western section was carefully dismantled and rebuilt following the construction of the sub-station.

ILLUS 9 General shot of southern wall. SE facing ILLUS 10 General shot of rebuilt western wall. W facing ILLUS 11 Shot of western end of southern wall showing rebuilding and blocked doorway. S facing
