# KINFAUNS OLD PARISH CHURCH, PERTH & KINROSS

## ARCHAEOLOGICAL WATCHING BRIEF

commissioned by Tay Landscape Partnership

July 2017

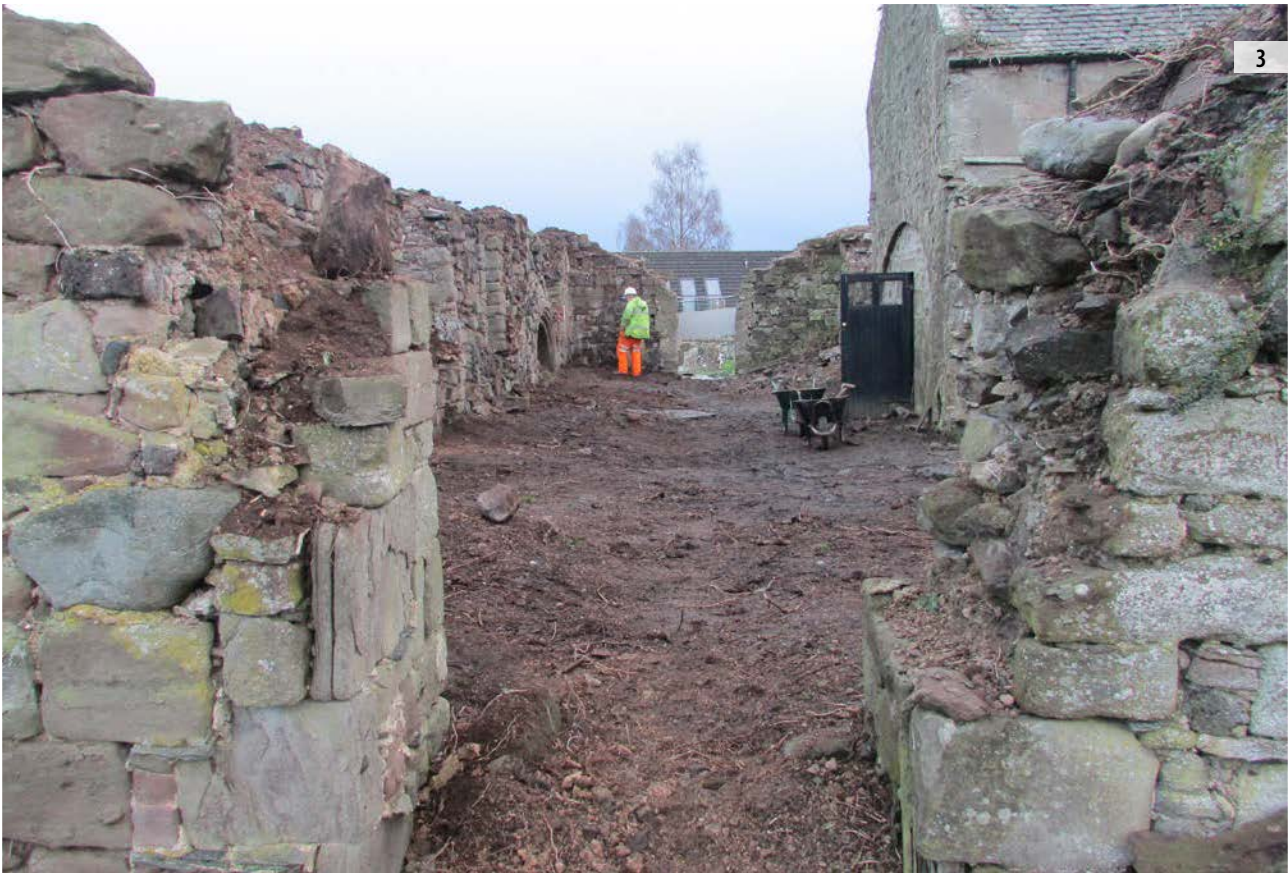
**ILLUS 3** East facing view of the interior of the church

The present ground surface was uneven comprising a mix of dark brown stone rich silty sand and larger sub-rounded stones. Two areas in particular formed large mounds of earth and stone, one abutting the inner side of the south-east wall and the other abutting the south-west corners of the church wall (Illus 2 and 3).

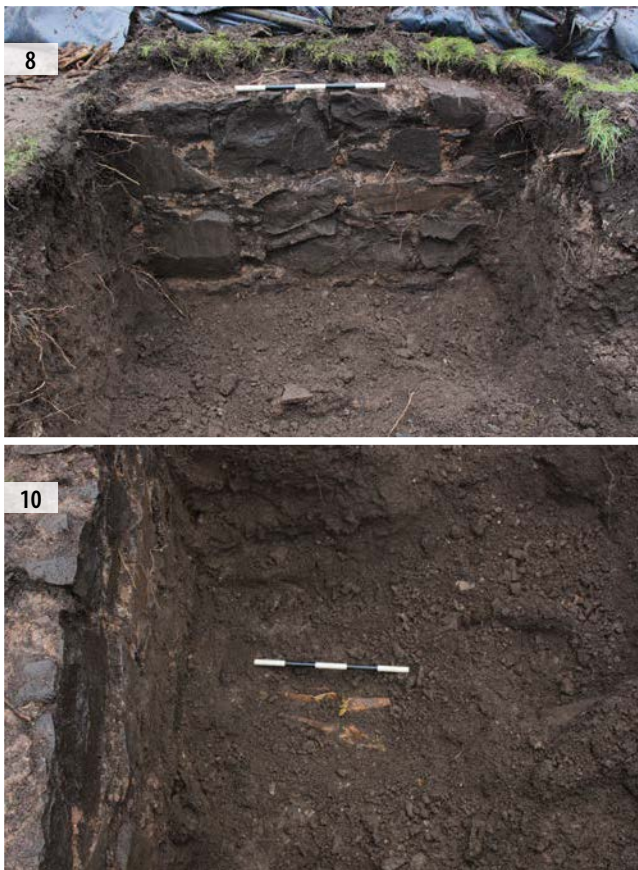
**ILLUS 8** East facing detail view of the wall foundation in the soakaway pit

The trench was then excavated by machine through deposit (004). The trench exposed the west facing elevation of the buried foundation wall (005). This was constructed of large rubble stone bonded with a yellow-brown course lime mortar 0.8m tall located 0.25m below the current ground surface (Illus 8).

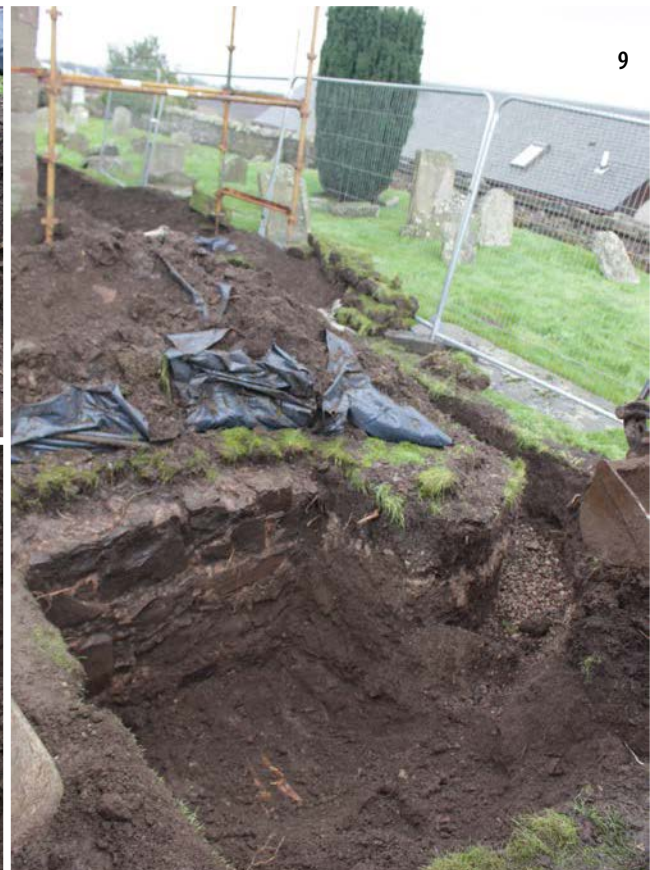
**ILLUS 9** South-east facing view of the burial within the soakaway pit

At a depth of 1.15m the graveyard soil (016) was exposed below (004). Partially exposed within this soil was a burial (Illus 9). The lower part of two femurs and the upper parts of two tibias and fibulas (Illus 10) were exposed indicating the position of an east-west aligned

inhumation with the upper body to the west. Excavation ceased at this level and the remains were left in situ. The initial depth of 1.9m required for the soakaway was subsequently reduced to the level reached. A geotextile membrane was placed over the exposed burial soil and the soakaway was constructed over this.

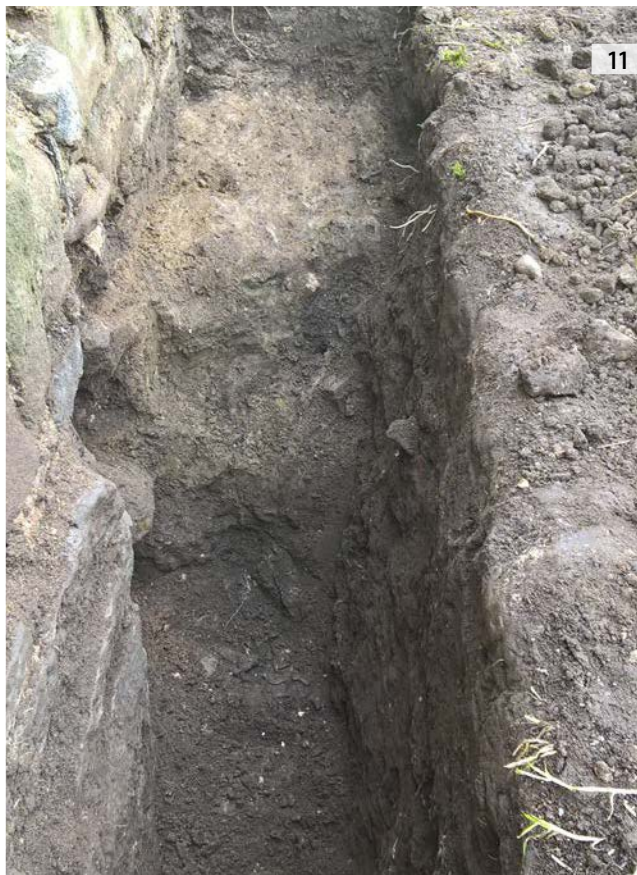
**ILLUS 11** West facing view of the clay fill in the monument trench

The excavation revealed two different fills. To the west a 0.5m deep clay backfill (009) was present below 0.25 of overburden (008) (Illus 11). Below the clay was a 0.25m deposit of pebble rich sandy silt (012). To the east side of the trench a 0.7m deep deposit of re-deposited graveyard soil was overlain by overburden (008). The graveyard soil was clearly a later deposit than the clay (009) indicating a secondary phase of activity at this location. A buried soil (011) was exposed at the base of the trench although this was not excavated.

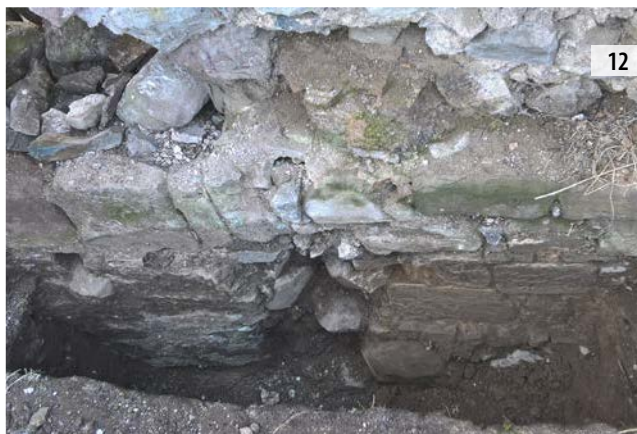
**ILLUS 12** South facing detail view of the wall fabrics exposed in the monument trench

The exposed wall foundation, where the deposits changed, not only displayed a large void in the wall but also seemed to show two distinct construction styles. To the east side the stonework was more regular with coursed squared stone with a drainage hole present. The stonework to the west side is coursed with a slight step below which the coursing is more random with more rounded stones present (Illus 12).

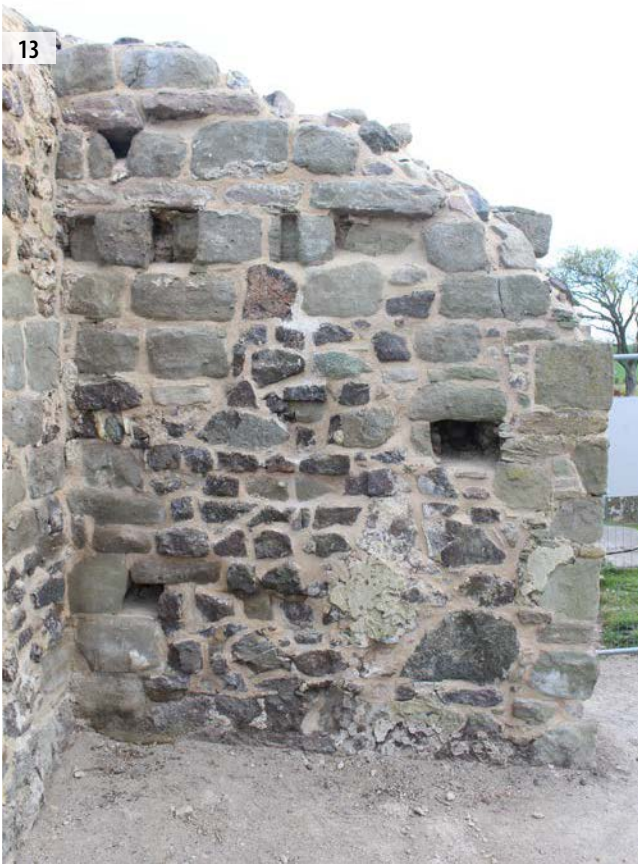
**ILLUS 13** The beam slots on the internal elevation of the north side of the east wall

The majority of the beam slots and voids were identified on the internal elevation of the east wall of the church. On the northern half of this elevation a row of four slots were visible 2m above the current ground surface (Illus 13). Although these varied in size they were all 0.22m high and 0.5m deep providing evidence of an upper floor level at this end of the church. These slots were repeated on the southern half of the elevation although in this case three of the slots had been stone-filled and the fourth had been damaged by the reduction of the wall top (Illus 14). Three further wall slots or timber dooks were visible on the northern half of the eastern wall. These did not form a regular pattern and their purpose was unclear (see Illus 13).

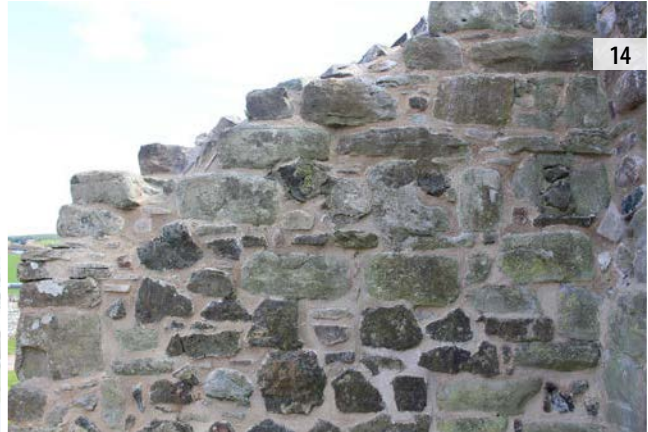
**ILLUS 14** The beam slots on the internal elevation of the south side of the east wall

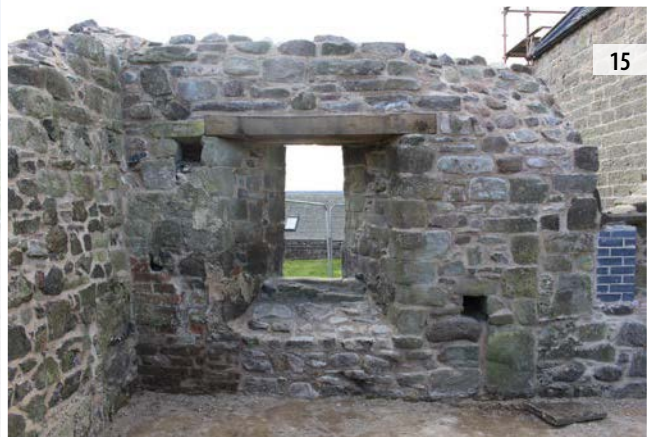
**ILLUS 15** View of the two holes on the internal south wall of the church

Three wall slots or timber dooks were also identified on the internal elevation of the south wall. Two of these were close to the east end of the building (Illus 15), one of which was located at a similar height to the beam slots recorded on the east wall and may represent further evidence of an upper floor in this part of the church. The second slot was approximately 1m from the floor and 0.9m deep. Its purpose was unclear. The slot at the western end of the elevation was 0.9m above the floor being 0.9m x 0.77m in size. Again its purpose was unclear.

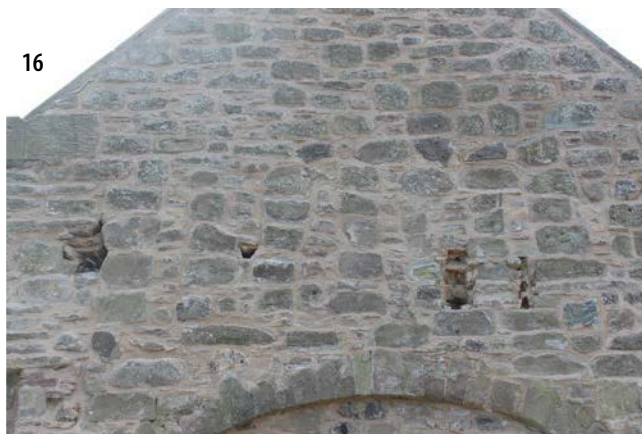
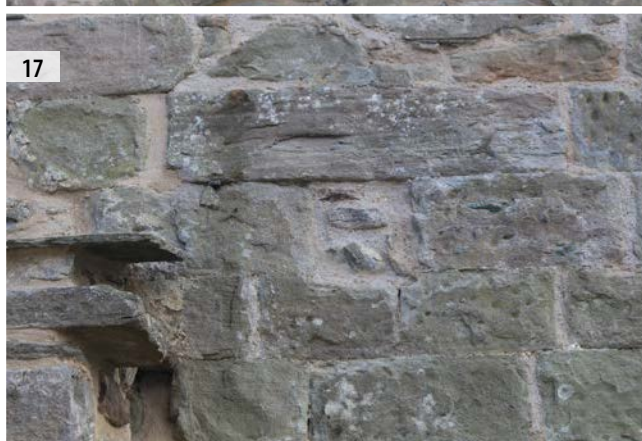
The upper half of the external south facing elevation of the aisle building also included a number of slot/recesses and stone-filled vertical slot features (Illus 16). These all appeared above the arch of the door of the building. The four recesses ranged in size and shape with no coherent pattern or spacing evident. Interspersed between

**ILLUS 16** Slots and holes on the external north wall of the aisle building at the base of the south-east corner of the church

these recesses were a series of almost vertical slots filled with small stones. It was unclear what these represented but it is likely that they served a structural purpose as they were not regular or similar enough in shape to be a design feature.

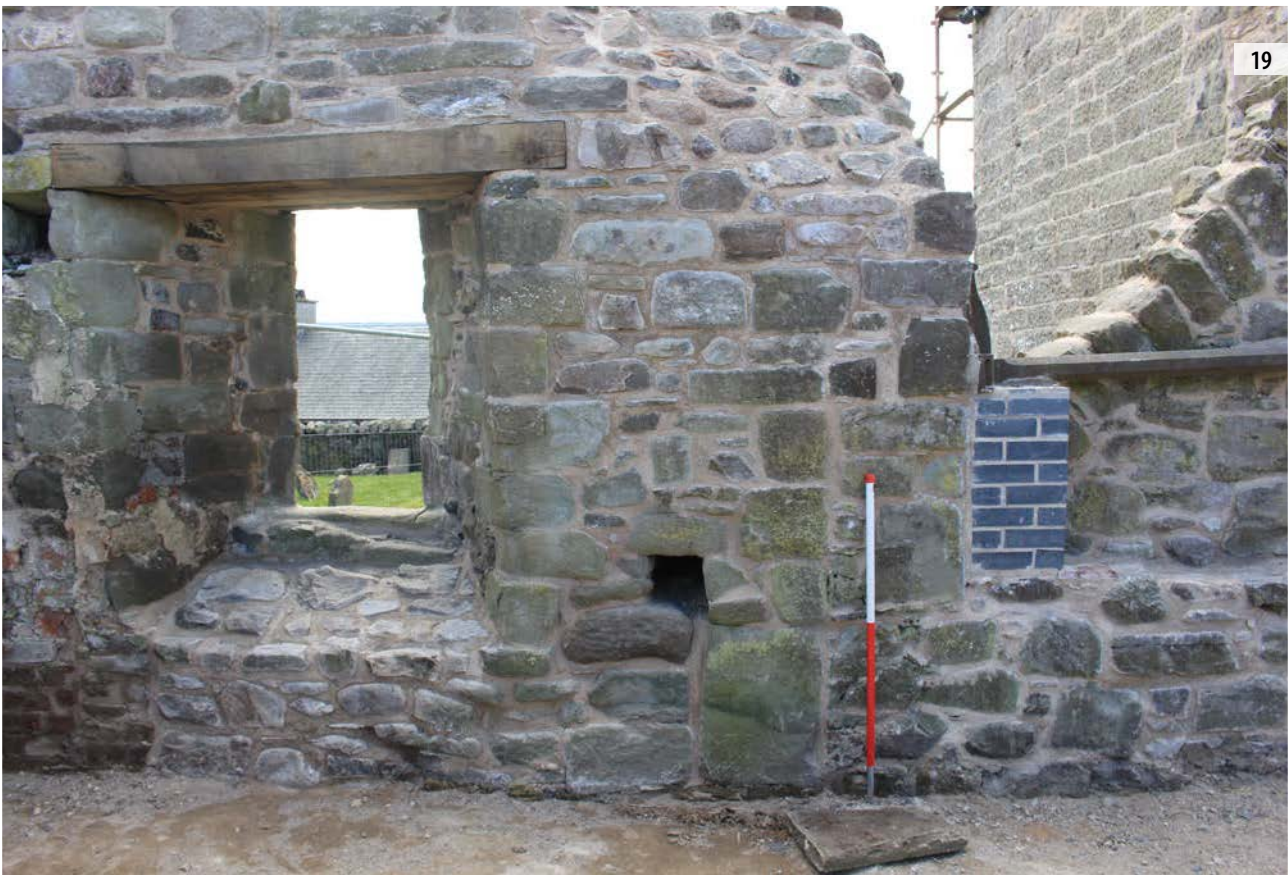
The remains of a stone constructed door surround, approximately 4m from the south-east corner of the church was also exposed on the internal elevation of the south wall (Illus 19). It was constructed of four large roughly squared stones 1.4m high forming a vertical edge to the west side. The other side of the door surround had been truncated by the construction of the aisle building with the later phase wall abutting the extant surround stones.

**ILLUS 19** Detail of the exposed grave slab lintel on the interior elevation of the south wall

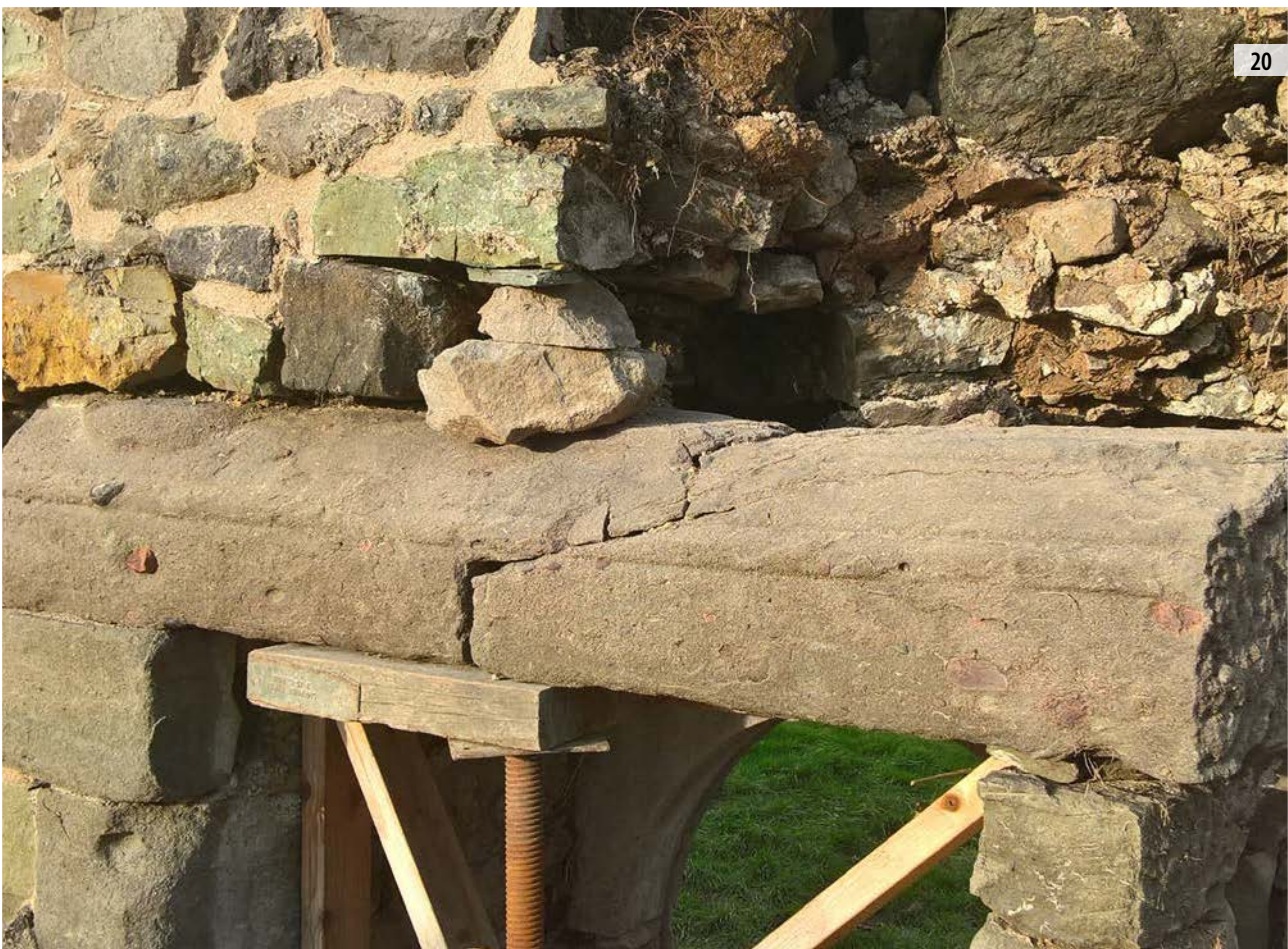
**ILLUS 20** North-west facing detail photograph of the exposed grave slab lintel on the interior elevation of the north wall
