# WINDHOUSE, MID YELL, SHETLAND

ARCHAEOLOGICAL EVALUATION AND  
HISTORIC BUILDING RECORDING  
PLANNING REF. 2012/253/PPF

commissioned by Bell Ingram Design Ltd

November 2017

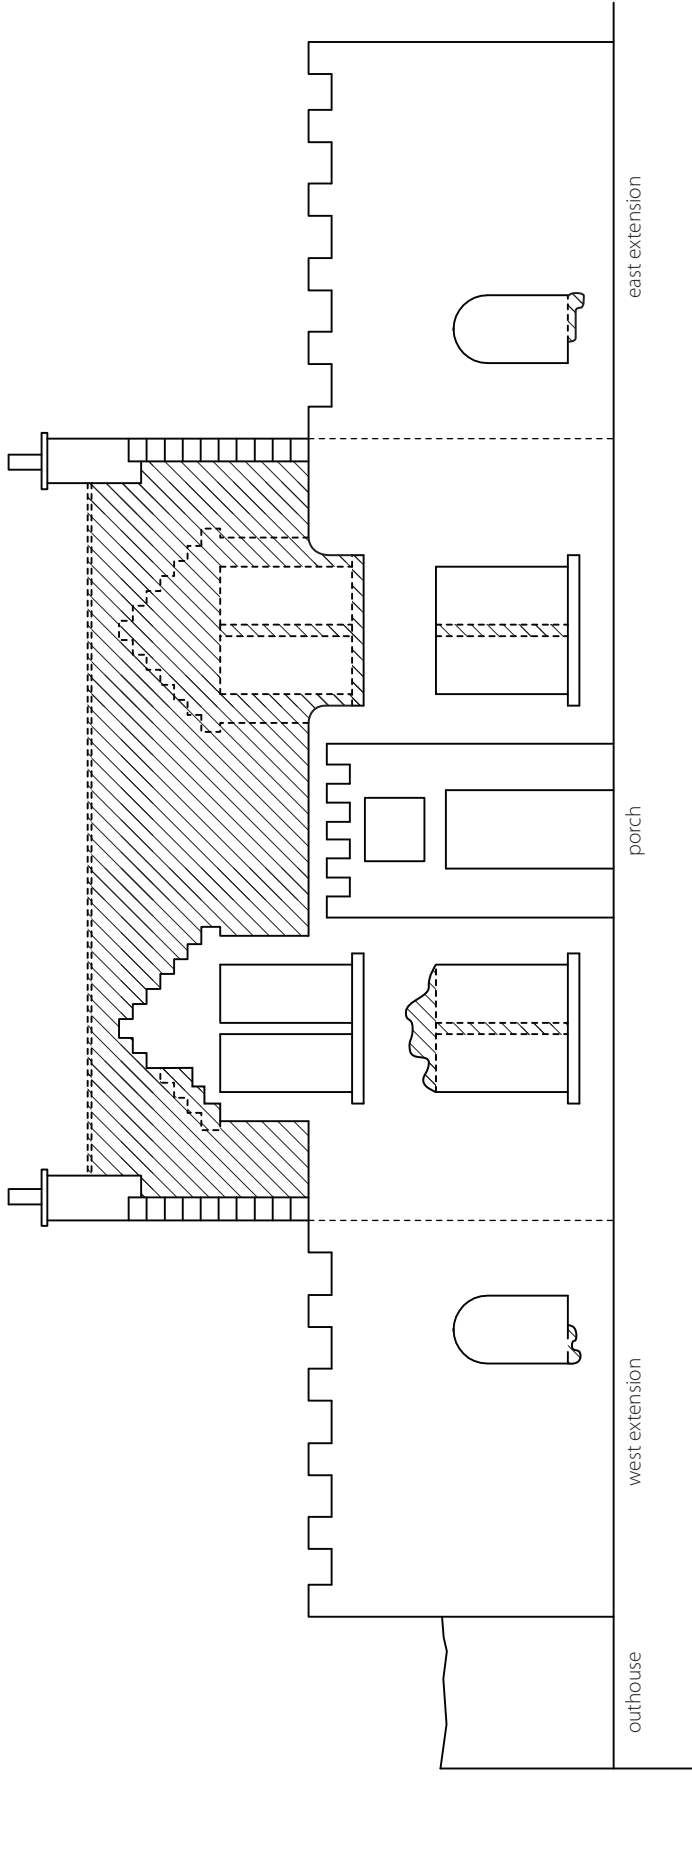
ILLUS 3 South facing elevation drawing

The south elevation is the principal, or front, facade of the building. It has a symmetrical elevation with a rendered brick porch at its centre (Illus 7 and 8). The four-panel flush-beaded timber entrance door,

as described by HES Designation, was not present at the time of this survey. The armorial panel centred in the crenellated wallhead above the front door is weathered, but intact (Illus 9). Purple-grey slates have fallen from the roof of the porch and it is anticipated that the porch roof will rapidly deteriorate. The decorative tile floor of the porch is covered in debris, but is intact. The concrete crenelated wallheads on the porch, east wing and west wing are intact. However, the harling has cracked and crumbled in places.

The west dormer window is leaning precariously inwards, and some of the crowstep dormer heads have fallen. The east dormer has completely collapsed. The slate roof has fallen in, taking with it the piend-roofed timber dormer. The round-arched doorways, as described in the HES Designation, have been partially blocked to form windows (Illus 10). Archive photographs from 1931 show these features as windows (Photo collection Ref #04380, Shetland Museum and Archive).

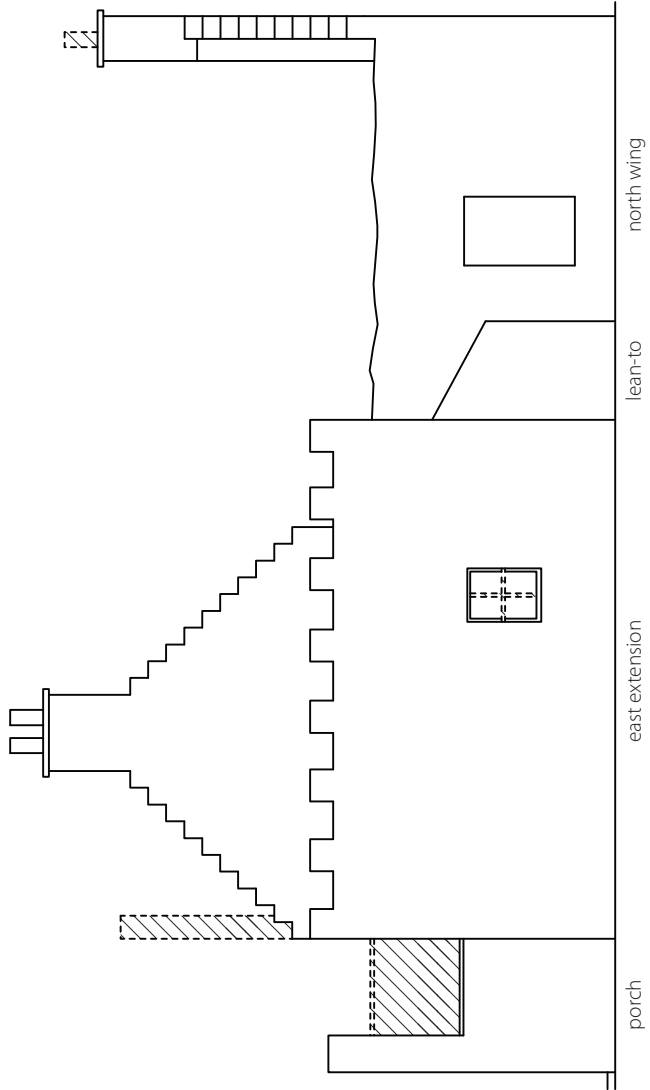
ILLUS 4 East facing elevation drawing

The east elevation is dominated by the crenelated east wing extension dating from circa 1885. The window is off-set to the north of the façade. The window has blown in and the window frame has rotted, providing a glimpse of the large masonry blocks used in the construction of the window surround. To the north side of the east extension is the north wall of the original build plus a roofless single-storey lean-to (Illus 11). This abuts the eastern side of the north elevation of the original building. The harling, although pitted and cracked, remains largely intact across the whole of the east façade. There are remnants of the cast-iron downpipes on the east façade of the porch and on the lean-to.

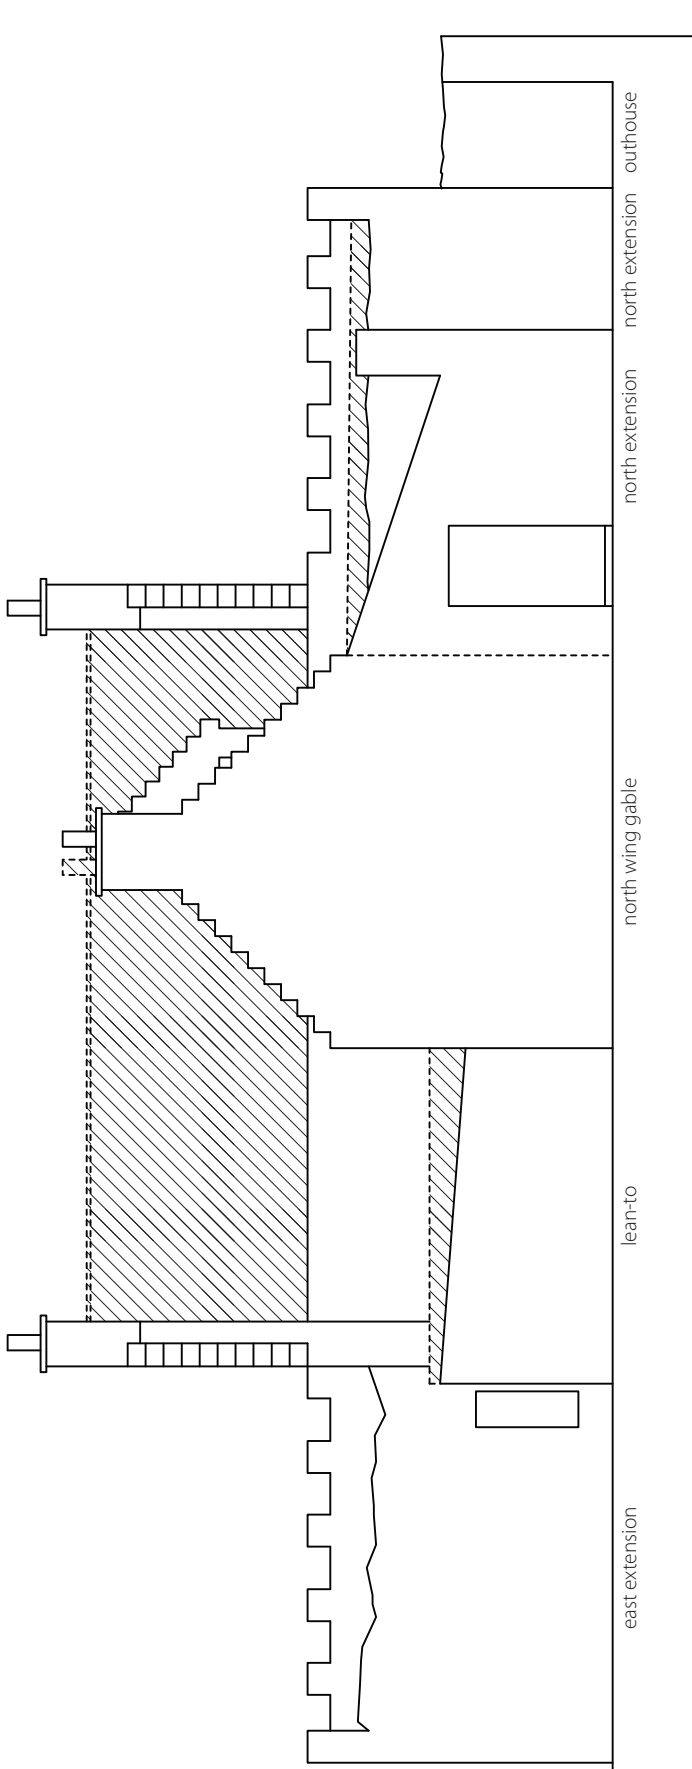
ILLUS 5 North facing elevation drawing

The north elevation is at the rear of the building (Illus 12). From this view the following are visible: the rear of the east wing, the rear of lean-to, the gable end of the north wing of the original building, the rear of the west wing, and the outbuilding to the west. The north gablehead still stands and includes the stone copes and octagonal cans of the chimney stack. The roofs of the north wing and lean-to have both collapsed and hence the wall heads have started to crumble. The concrete crowstep skews on the gable end are intact, however one of the chimney pots has fallen. All timber framed windows and doors have blown out and rotted. The harling, although severely cracked in places, still adheres to the external walls.

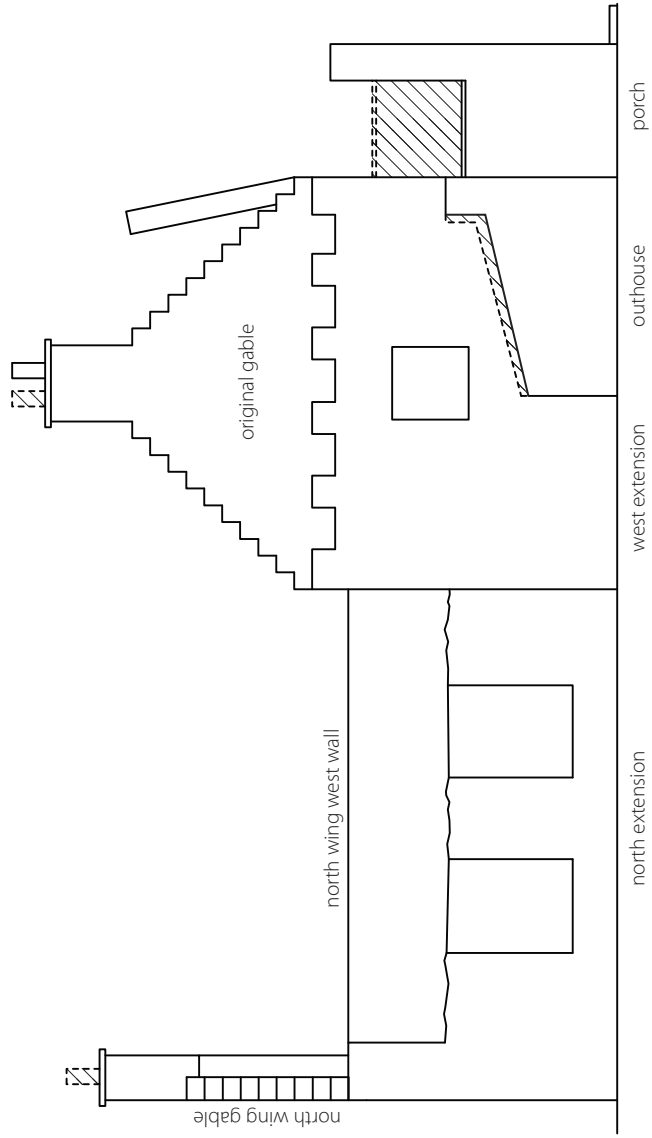
ILLUS 6 West facing elevation drawing

As with the east elevation, the west elevation is asymmetrical (Illus 13). It consists of the west extension, the west elevation of the north wing, partially masked by the north extension, and a mono-pitch outhouse attached to the south side of the west extension. The wall head crenellation and the square window on the west extension are intact. However the timber window and frames are missing. The roof of the rear extension has collapsed, taking with it the upper courses of the wallhead and lintels of the two windows. Two door openings are found on the north wing of the original building. The southern door includes an arched brick overhead suggesting this

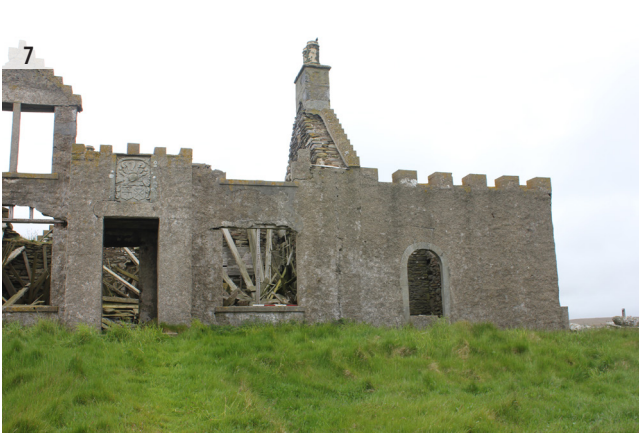
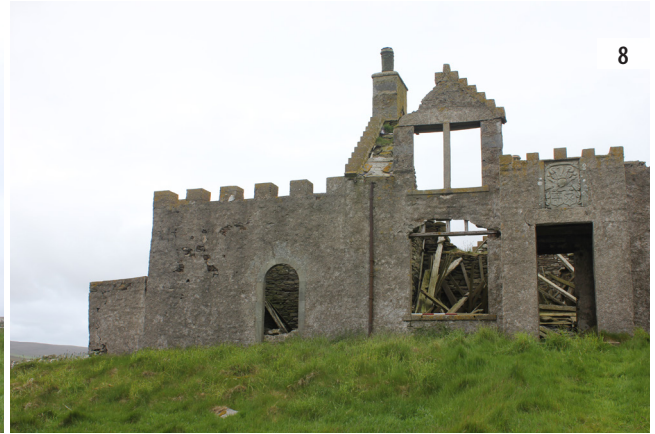
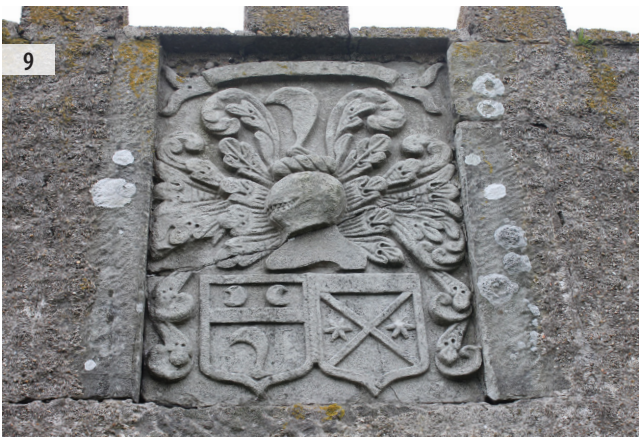
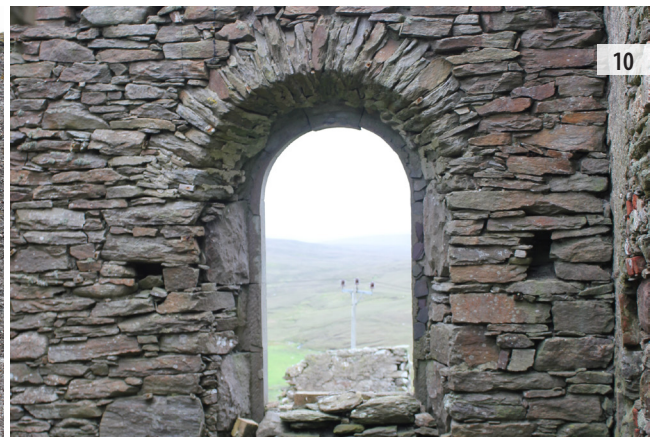
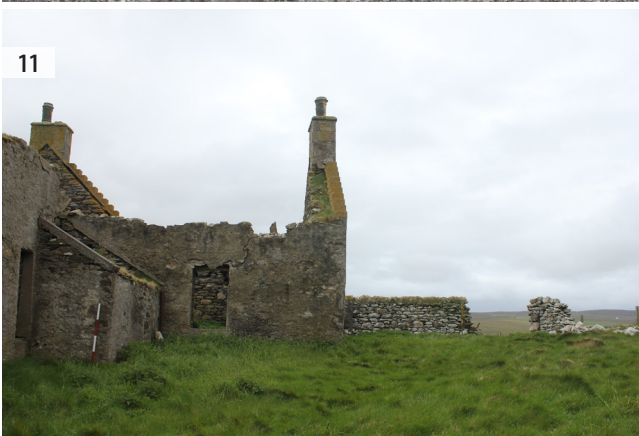
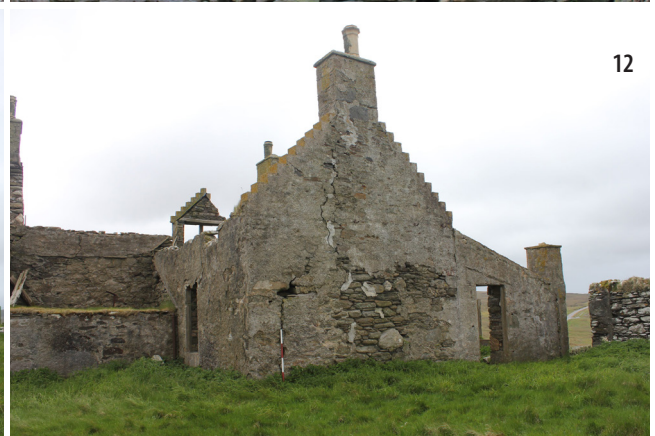
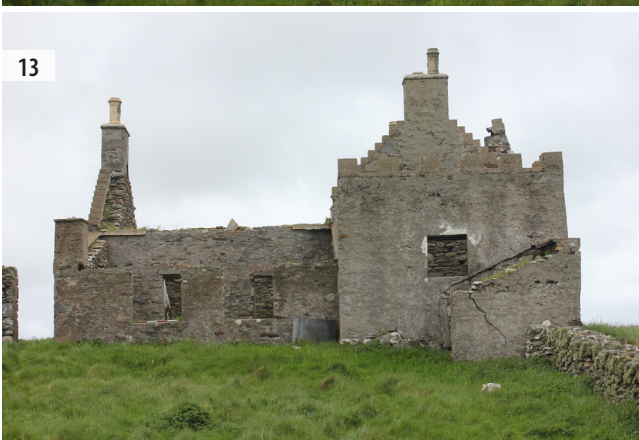
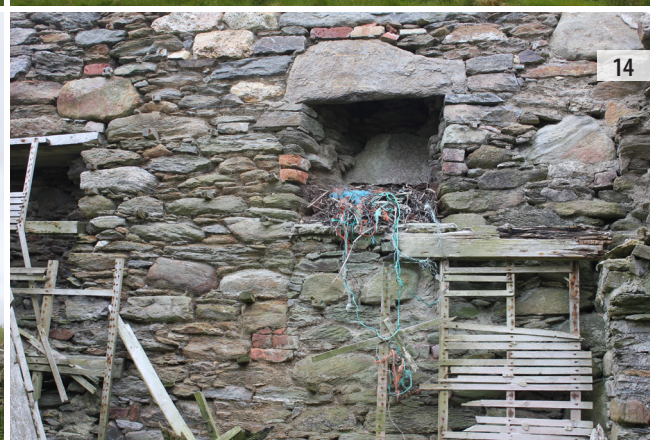
**ILLUS 7** The east side of the front south facing elevation    **ILLUS 8** The west side of the front south facing elevation    **ILLUS 9** Detail of the stone plaque above the entrance    **ILLUS 10** Internal elevation of the arched doorway in the east extension    **ILLUS 11** North side of the east elevation of the house    **ILLUS 12** North elevation of the house    **ILLUS 13** West elevation of the house    **ILLUS 14** Fire place on the internal east wall of the original building

A cursory examination of the interior of the property from the window openings and entranceway indicates that the internal linings are ruinous. There are some remnants of the fittings for timber cladding in the main rooms of the building. However, the majority of the interior lining has collapsed and now reveals the bare stonework of the building. There is no evidence of the timber staircase as described in the HES Designation. One of the more prominent internal features was an upper floor fireplace visible on the east wall of the original building (Illus 14).

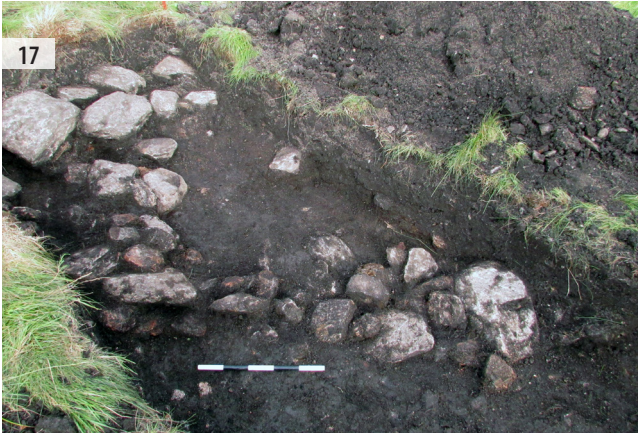
This trench was situated within the walled area to the west of Windhouse. A spread (303) of dark brownish grey sand was recorded at the base of the trench which contained fragments of burnt peat. At the north-east end of the trench an arrangement of stones [304] was recorded (Illus 17). The stones formed a north-south alignment which turned east-west at its northern end, and are interpreted as the base of a wall. More stones were observed in the rest of the trench but as there was no pattern to their distribution they are interpreted as the remains of wall collapse. The wall was sealed by deposit [302] which spread throughout the trench and contained fragments of modern pottery, glass, tile and slate.

**ILLUS 17** North facing view of wall (304) in Trench 3    **ILLUS 18** East facing view of stone drain (407) In Trench 4    **ILLUS 19** North facing view of wall (410) in Trench 4

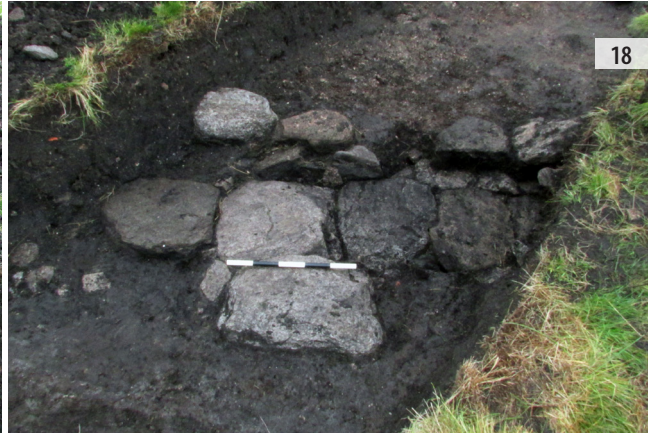
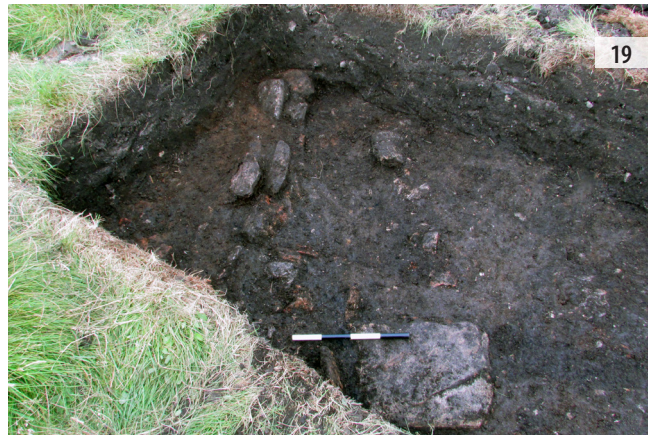
This trench was situated within the walled area to the west of Windhouse. A spread (408) was observed in the north-west half of the trench, a mid-grey sand 0.1m at its maximum depth which appeared to contain fragments of burned peat indicative of an anthropogenic component. A foundation cut [405] was dug into this spread which contained a number of large stones (407) (Illus 18), some laid on their horizontal axis to form a drain. To the west of the drain two shallow 'terraces' were observed which may indicate a levelling of the ground surface to contain flagstones for a floor surface. To the north-west of the drain a crude arrangement of stones (410) and (409) was recorded (Illus 19); some of the stones appeared to be laid on their vertical axis which may indicate they functioned as the base of a wall. In the south-east area of the trench a small pit [403] was recorded, cut into the natural geology. Its fill (404) was a dark grey peaty sand which is interpreted as a deliberate organic deposit, but no dating material was recovered.

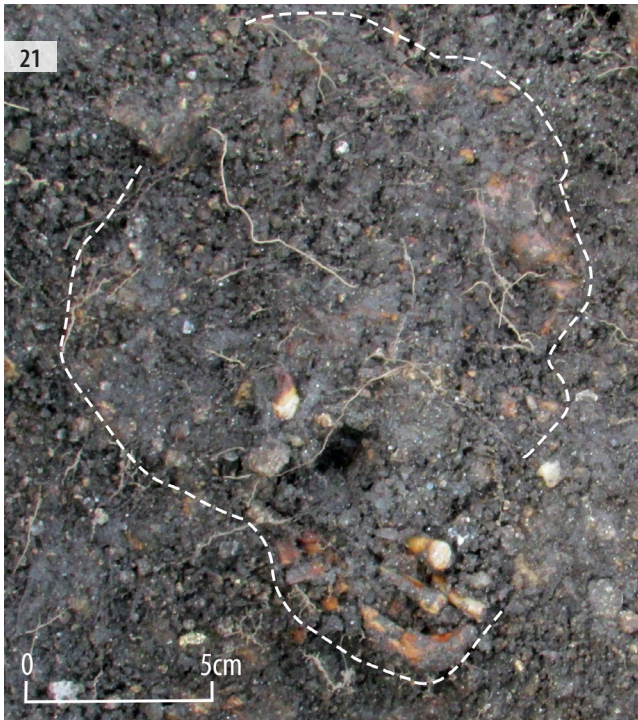
This trench was situated within the walled area to the north of the building. A grave cut [502] was recorded in the south-west corner of the trench extending to the west beyond the baulk. Within the cut six poorly preserved human metatarsals were recorded. A second grave cut was recorded 0.36m to the east extending beyond the trench baulk to the east. Within the cut a very poorly preserved mandible was recorded along with parts of the skull (Illus 21). The skull appeared to have been flattened probably by the weight of the soil above it.

**ILLUS 21** West facing view of skeleton (507) in Trench 5 **ILLUS 22** East facing view east of Trench 6 **ILLUS 23** The arrangement of stones (903) in Trench 9

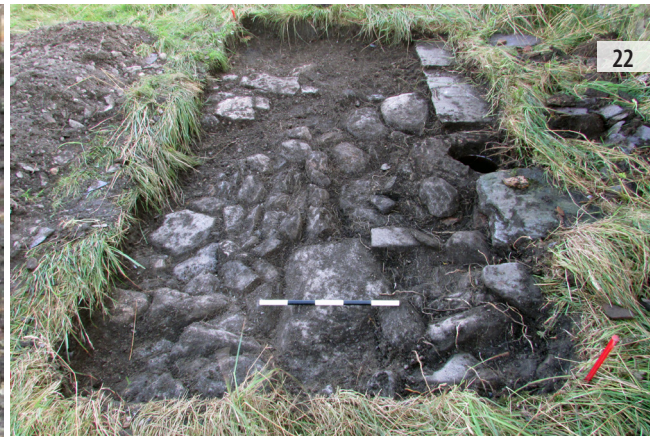
This trench was situated in the walled area to the north of the building and was targeted on local information regarding the location of the grave disturbed during work in the 1890s. A spread of irregular-shaped stones (605) formed a rough external floor surface was recorded throughout the trench. At the southern edge of the trench three flagstones (603) and a ceramic drain (604) were recorded, and are interpreted as external elements of the current building.

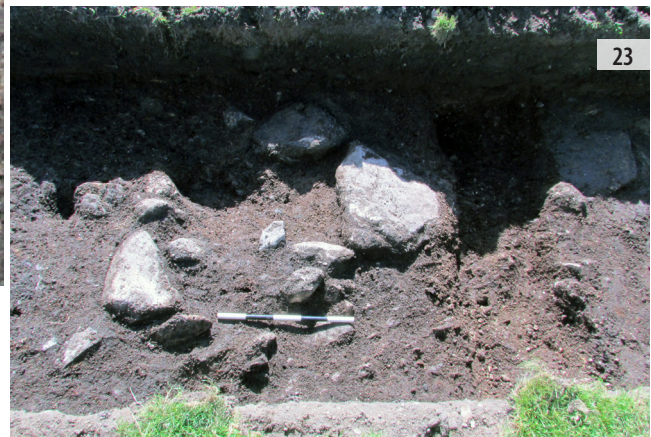
This trench was situated to the north of the building outside the walled areas. An arrangement of stones (903) (Illus 23) was recorded towards the centre of the trench. The pattern of distribution of the stones was far from clear but it may have formed the base of a wall. The stones were sealed by a deposit of dark grey peaty sand (902) which spread throughout the western part of the trench and got thicker to the west (downslope).
