Woodhall Mains Farm Steading, Edinburgh

HBR (Level 2) And Archaeological Monitoring

for Blagdon Equestrian Ltd

June 2019

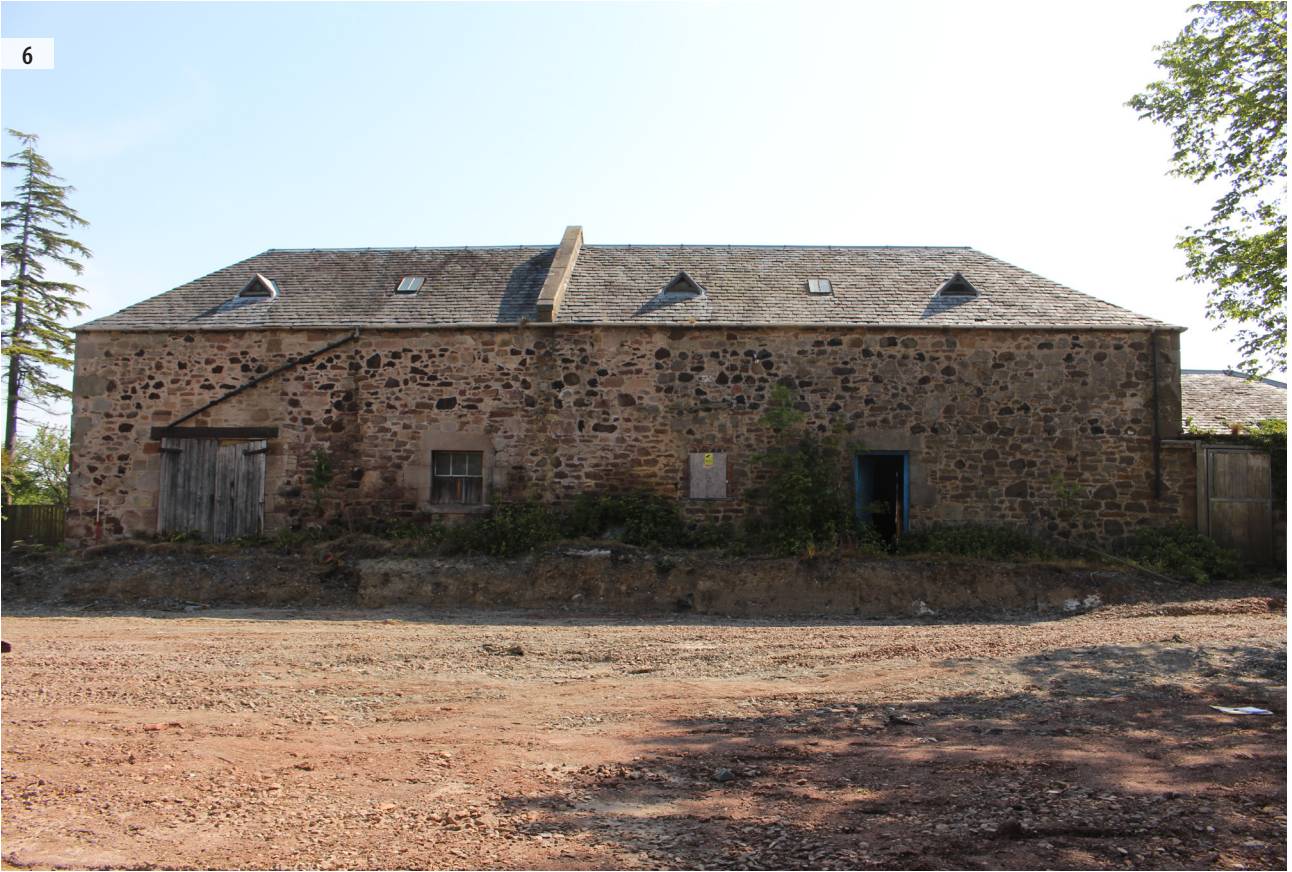
The west facing elevation (Illus 6) faced onto a recently landscaped area for parking; the lower parts of the wall were obscured by vegetation and some excavated material. The elevation featured three original openings – a double door and window to the north and a single door to the south, all with ashlar surrounds and neat tooling, similar to the east elevation. An additional ground floor window between the southern door and original window was surrounded by brick and showed signs of rebuild in the fabric, indicating it had been inserted at a later date. No features were identified on the first floor.

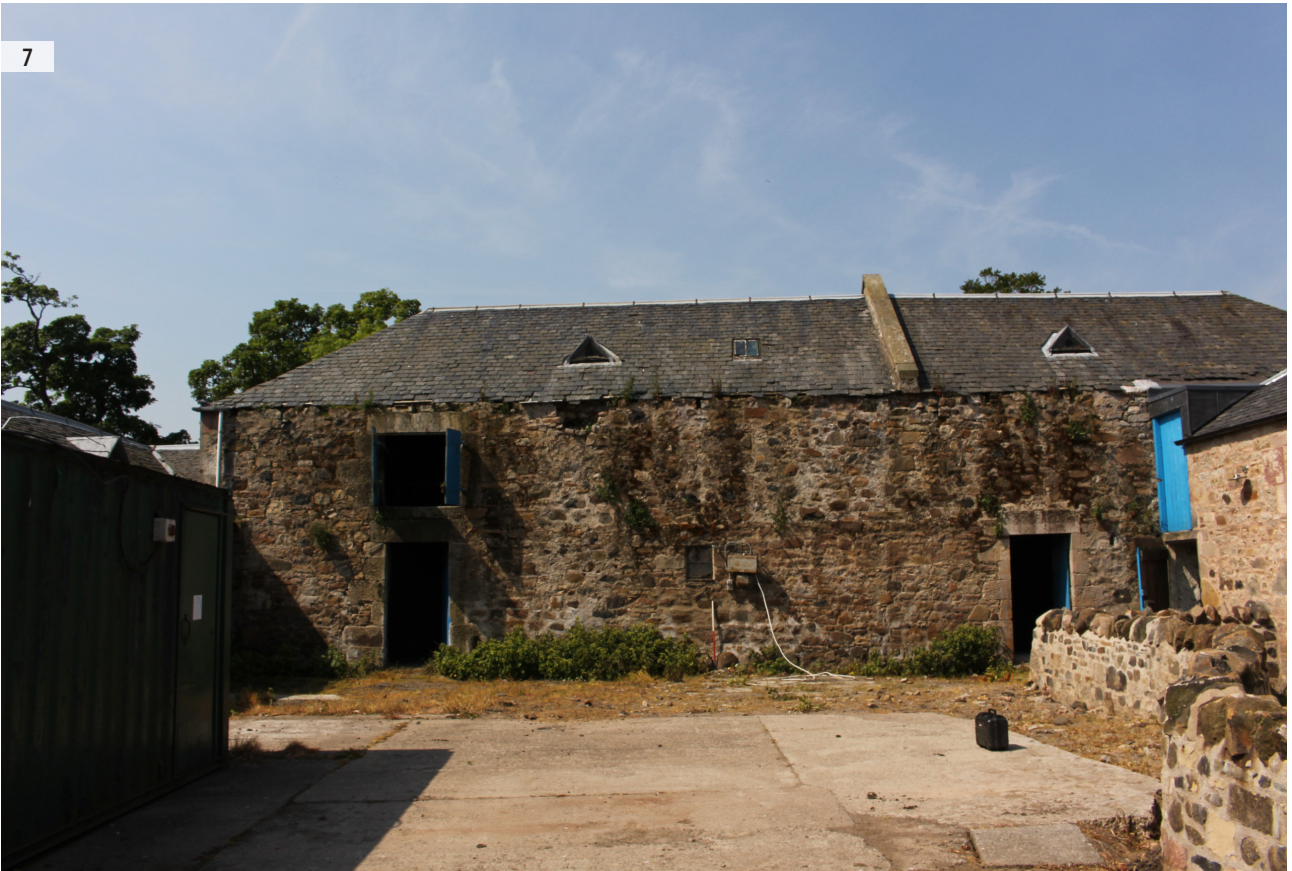
The east facing elevation (Illus 7) had two doors at ground level, a door at first floor level above the southernmost door which would allow access to the upper floor of the barn, and a single small window between the two ground floor doors, roughly in line with that on the western elevation. Unlike the western example, it was less clear that the small window was a later addition. However, the 1852 Ordnance Survey plan depicts a threshing machine room attached to this side of the building; the faint remnants of a horizontal construction line were visible in the central area of the elevation at the height of the ground floor and may represent evidence of this earlier arrangement. It is possible that there was some remodelling and repair to the outer face of the fabric at this point.

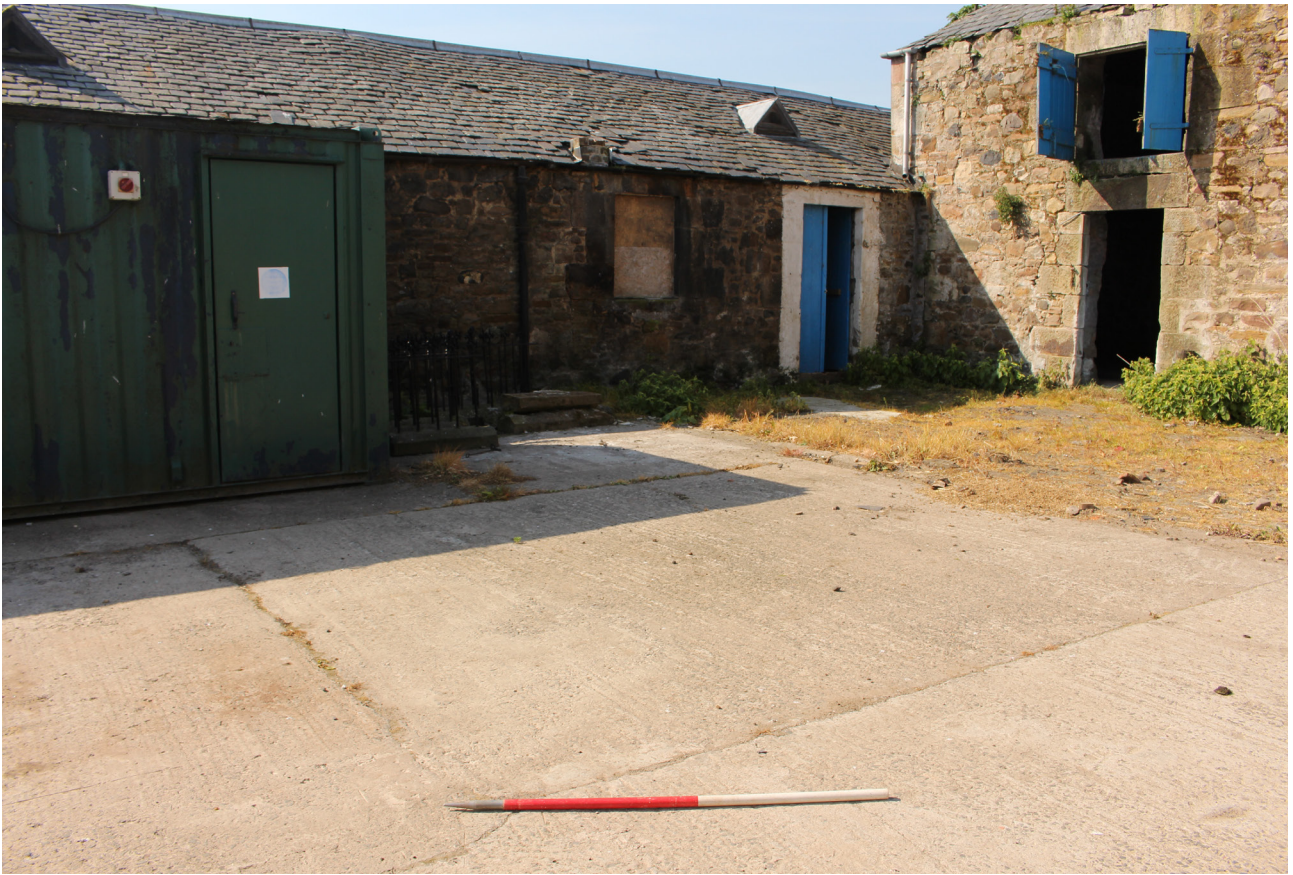
ILLUS 8 North facing elevation of Unit 2

The north facing elevation faced onto the courtyard (Illus 8) and was partly obscured by a shipping container at the time of the survey. The elevation featured two openings at the east and west ends respectively, one obscured by the container, and two boarded up windows. A third window to the east has been blocked in stone and brick. The roof

on this side included two small pointed dormer windows.

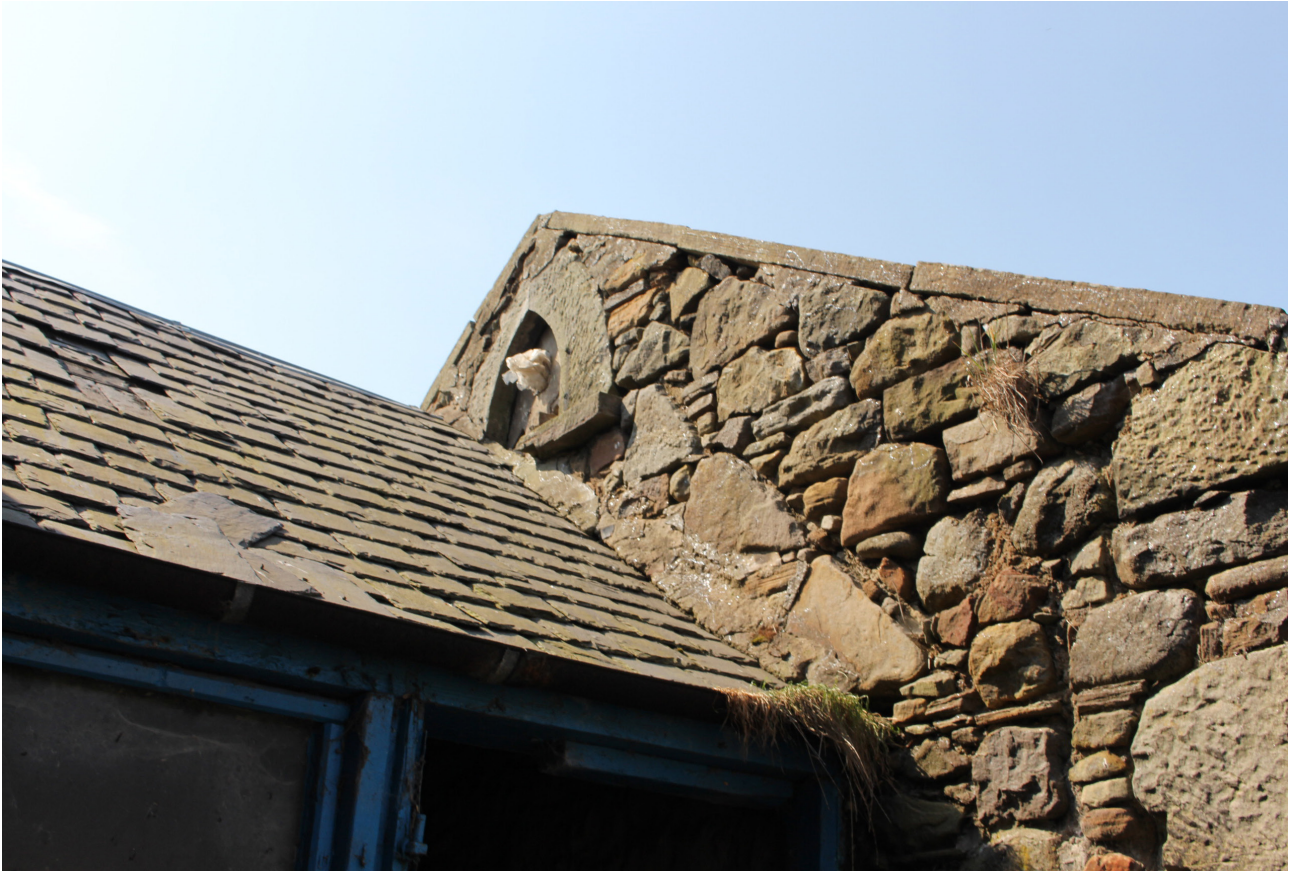
ILLUS 9 Gable south end of Unit 2

The east facing elevation was partly obstructed by a modern addition to Unit 3. What was visible comprised a gable end with a pointed arched alcove and projecting sill (Illus 9). There is evidence for alteration to the roof line beneath this alcove, where the modern outbuilding of Unit 3 joins Unit 2. It is likely that there was once a different building or lean-to at this end of Unit 2.

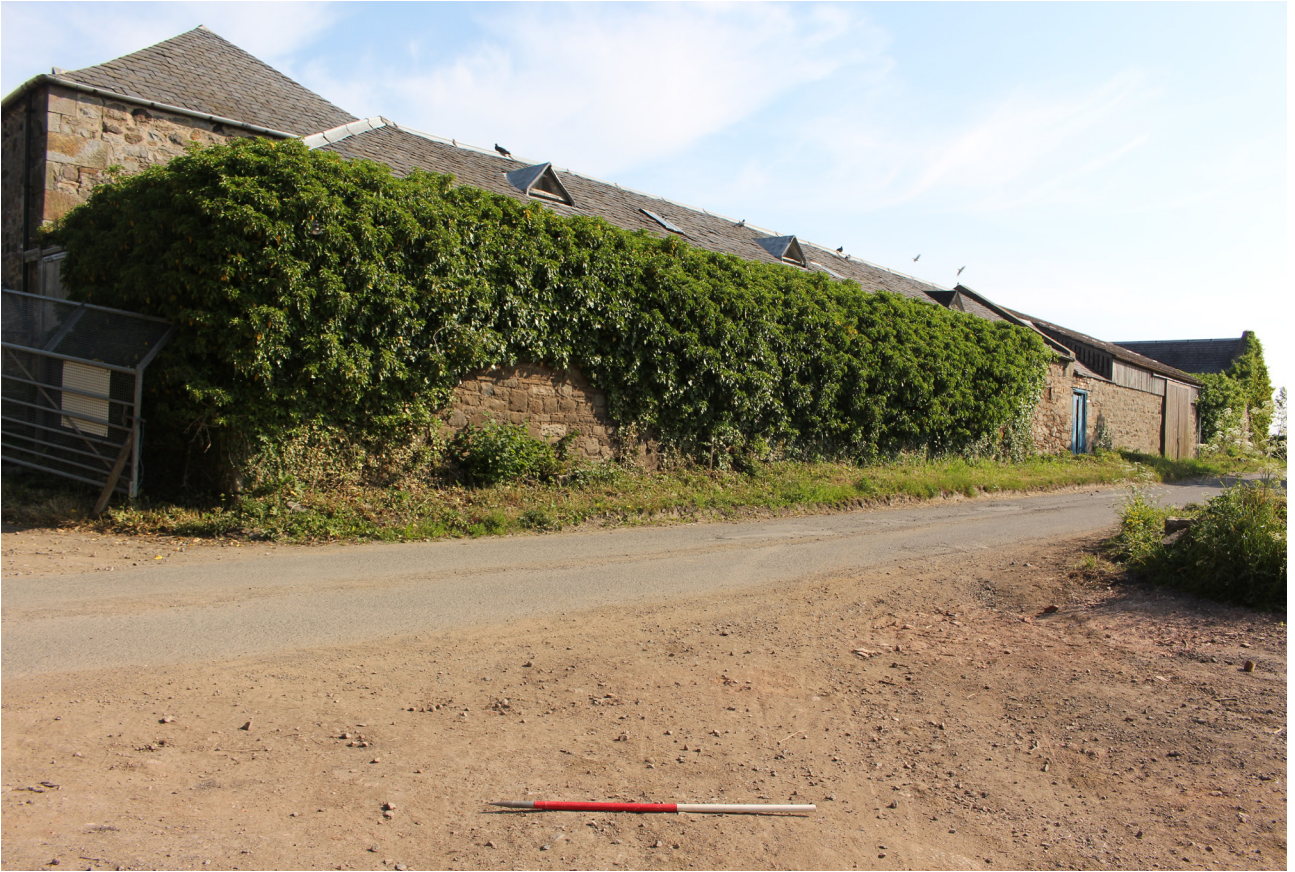
ILLUS 10 South facing elevation of Unit 2

The south facing elevation was almost entirely obscured by ivy (Illus 10). No visible openings could be seen, and it is unlikely that any existed. The slate roof was in moderate condition and included two modern skylights and three small dormer windows added for illumination.

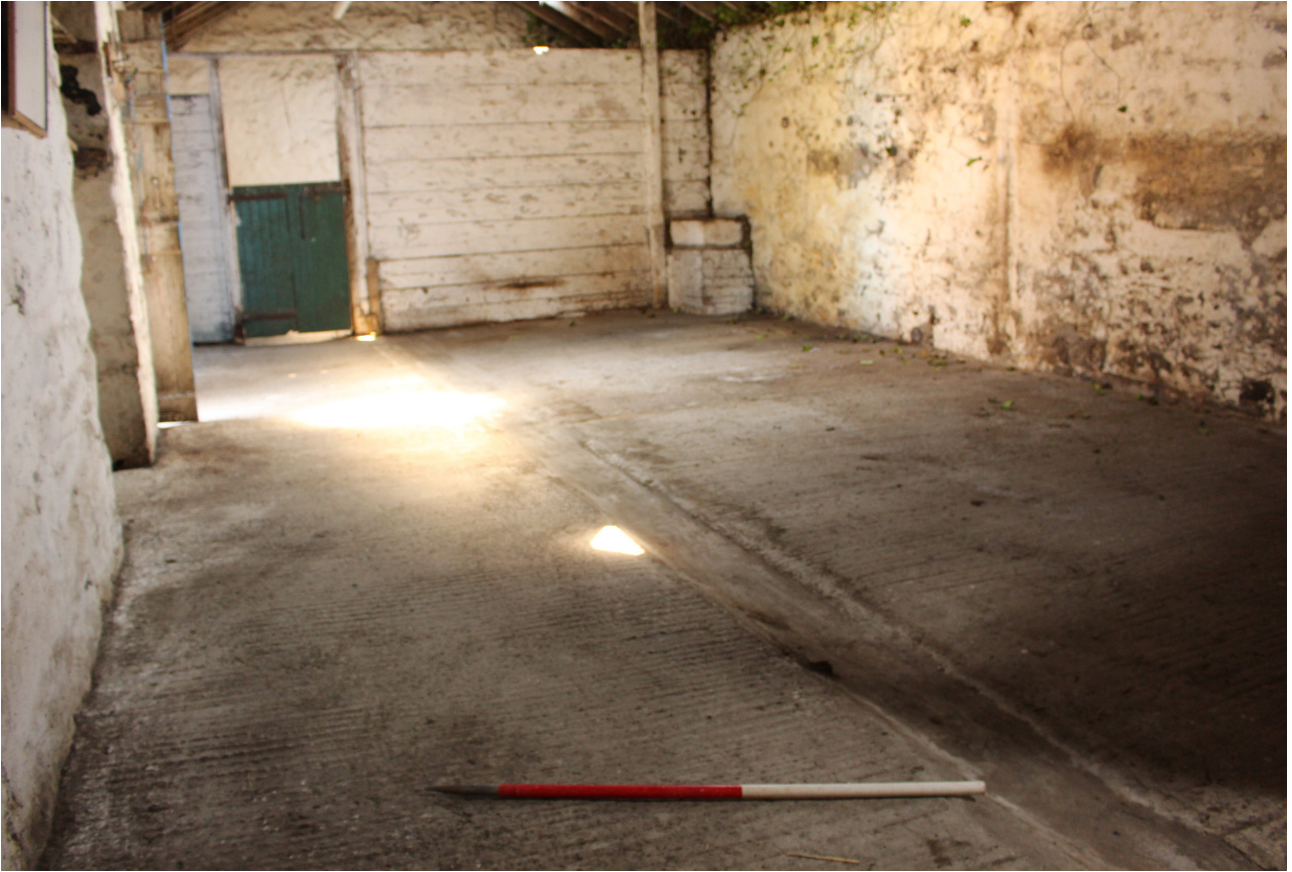
ILLUS 11 Internal view of Unit 2

The interior was separated into two rooms by a whitewashed stone wall towards the eastern end. The larger western room (H) has a concrete floor with a central drain running north-south and appears to have been used as a stable/tack room (Illus 11). This room is further partitioned to the east by a later whitewashed timber stud wall with a wooden opening – likely forming a separate stable or storage area (G). The easternmost room (F) is similarly whitewashed with a concrete floor. Some traces of stone floor cobbling, possibly original, were observed at the north west corner of the floor.

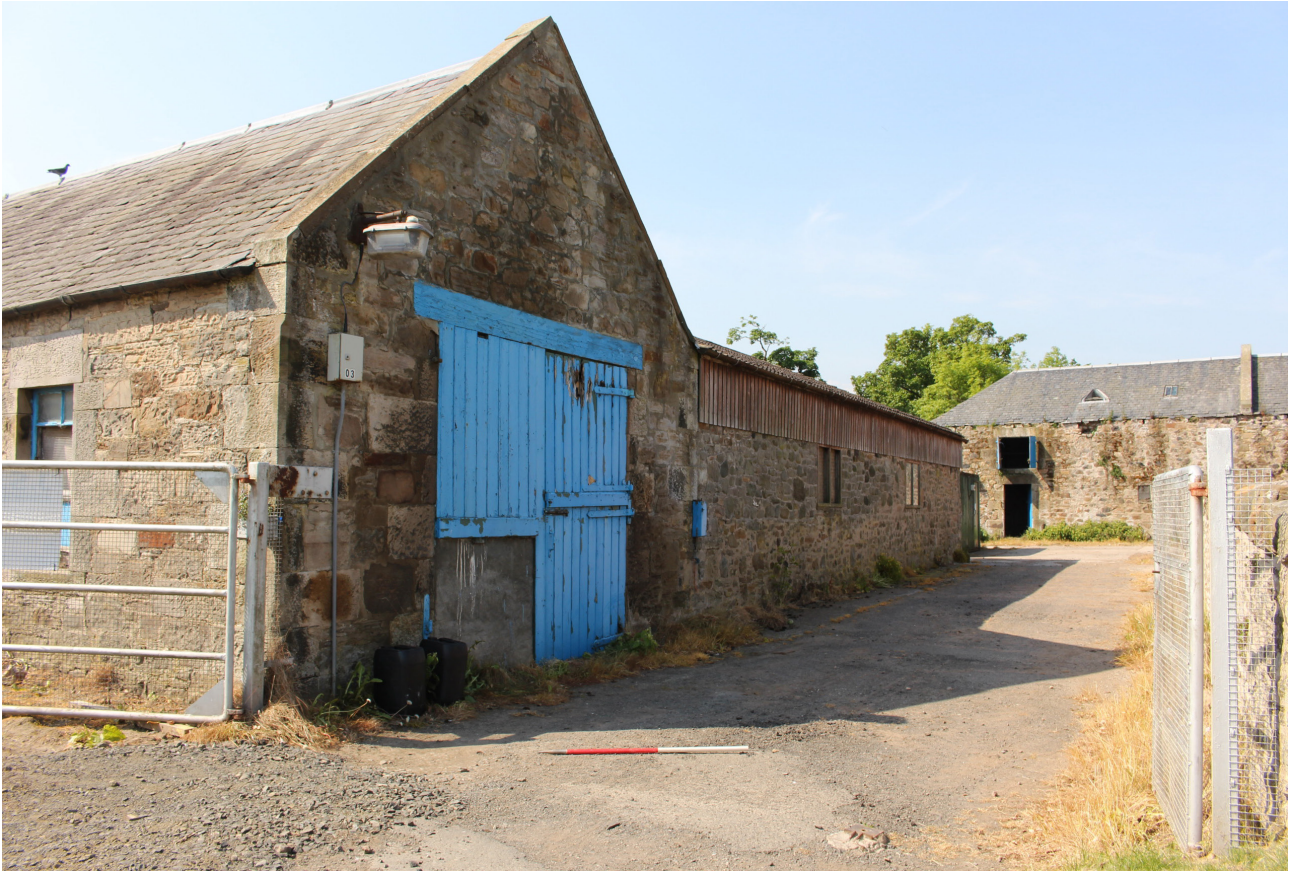
ILLUS 12 View of Unit 3

The east end of the north facing elevation (see Illus 12) was gabled with a hipped slate roof along the

remainder of the building. The gable end had a double opening which had been partly blocked to form a stable-type entrance door. To the west of the gable the remainder of the elevation showed signs of alteration. The original roof has been replaced with a timber and slate construction to raise its height above the original steading level. The stone walls also appear to have been repointed and retooled. Two different types of mortar have been used for this repair – a light grey layer mainly at the east from the centre of the building up to the wall head, and a layer of yellowish-orange mortar at the west and base indicating the repairs were carried out at different times. Two modern windows have also been inserted at the level of the wall head.

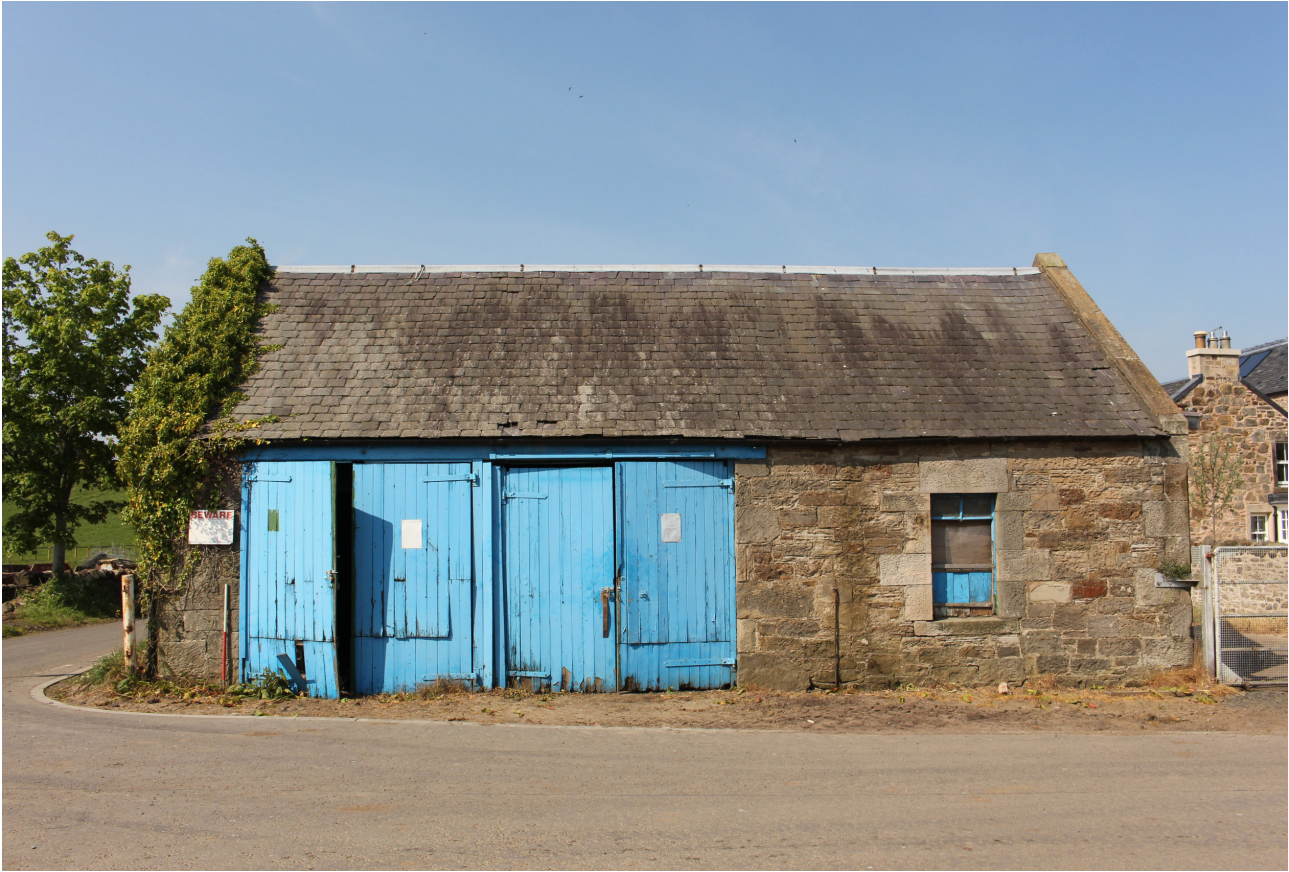
ILLUS 13 East facing elevation of Unit 3

The east facing elevation (Illus 13) had a pitched slate roof in moderate condition. It had raised stone copes at each end. The elevation featured an original window and two timber double door openings, all with tooled ashlar surrounds.

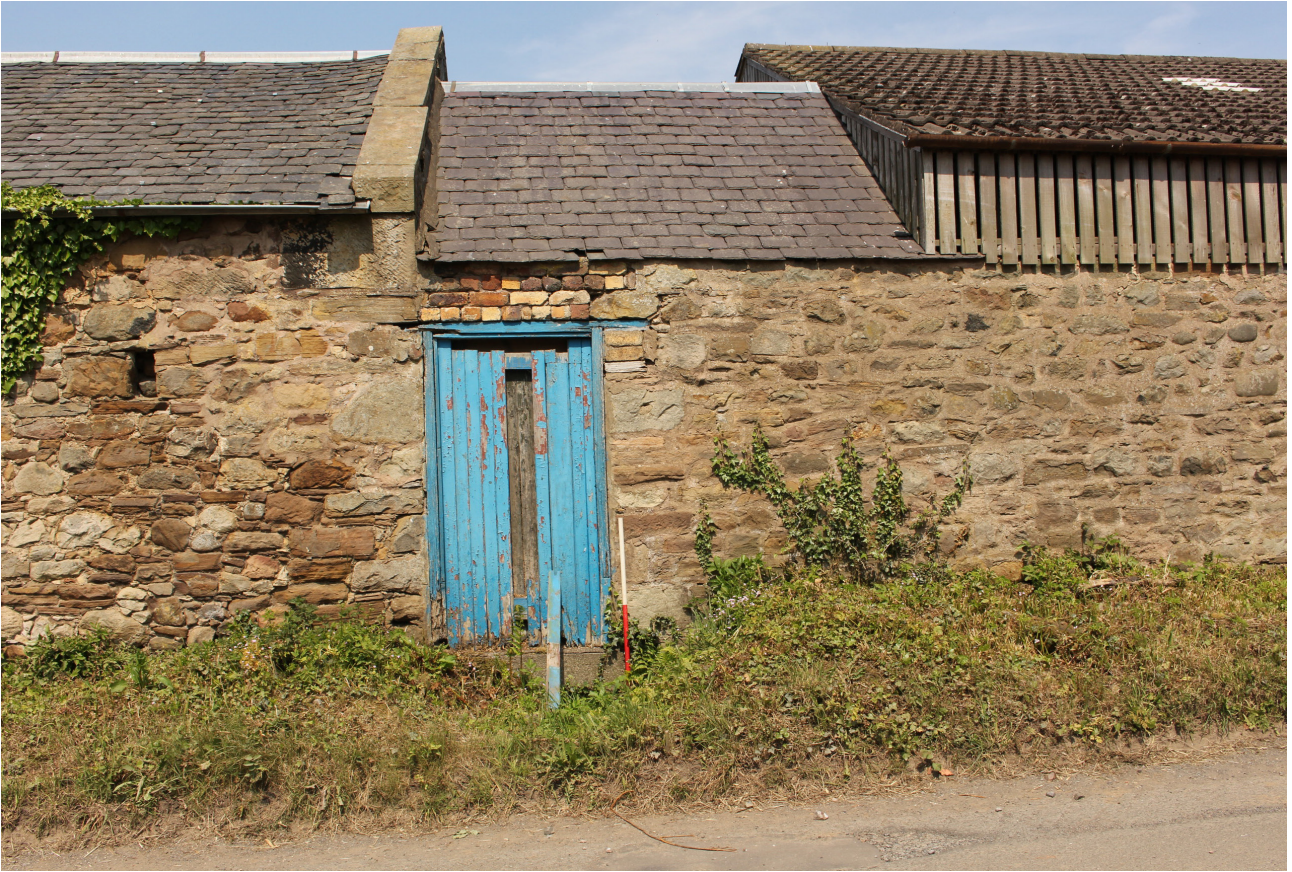
ILLUS 14 South facing elevation of the annex attached to Unit 3

The annex could only be observed in north and south facing elevations. To the south side (Illus 14) the elevation demonstrated that the annex was originally part of the main steading building of Unit 3 and adjoined Unit 2 at its eastern extent. This can be confirmed from the 25-inch OS map from 1893 in which the annex is clearly shown (see Illus 3). The single opening on this side seems to be a later insertion based on the brickwork above the door and no convincing evidence of surround stones. The pitched slate roof likely represents the original line of the main steading roof before it was removed and raised.
