Project Code: HLU07
Date: 11th July 2007
Client: The National Trust for Scotland

Lund House, Unst, Shetland Islands

Historic building recording

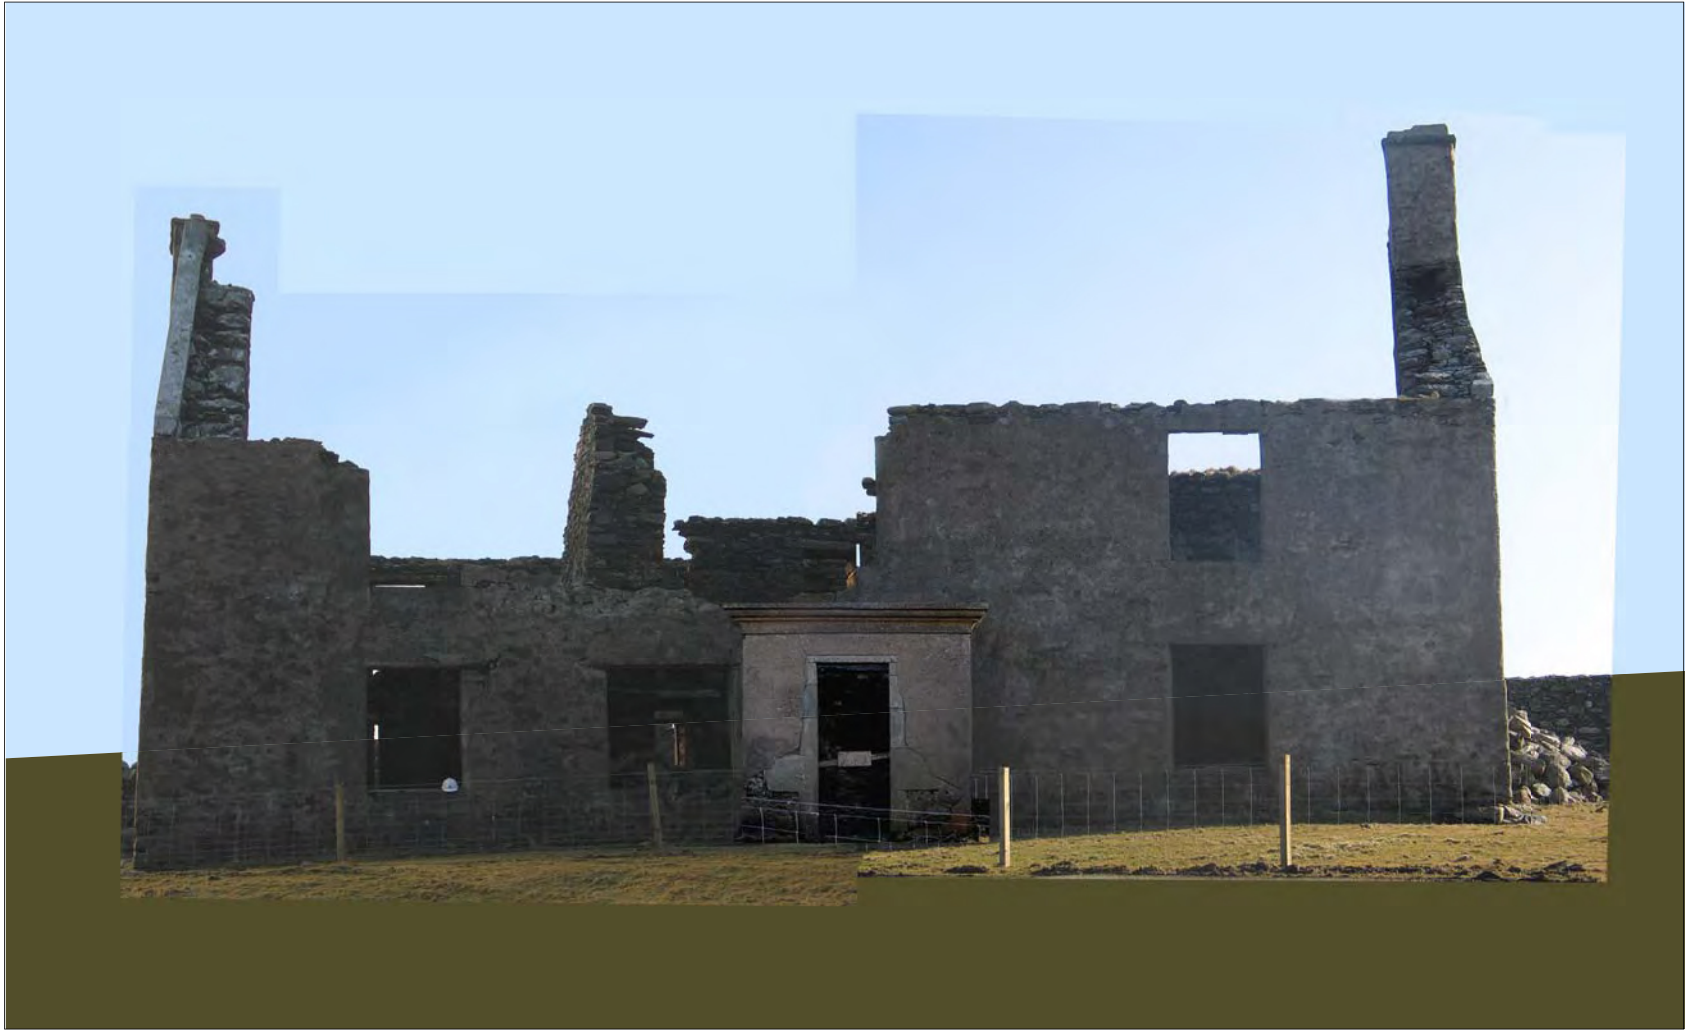
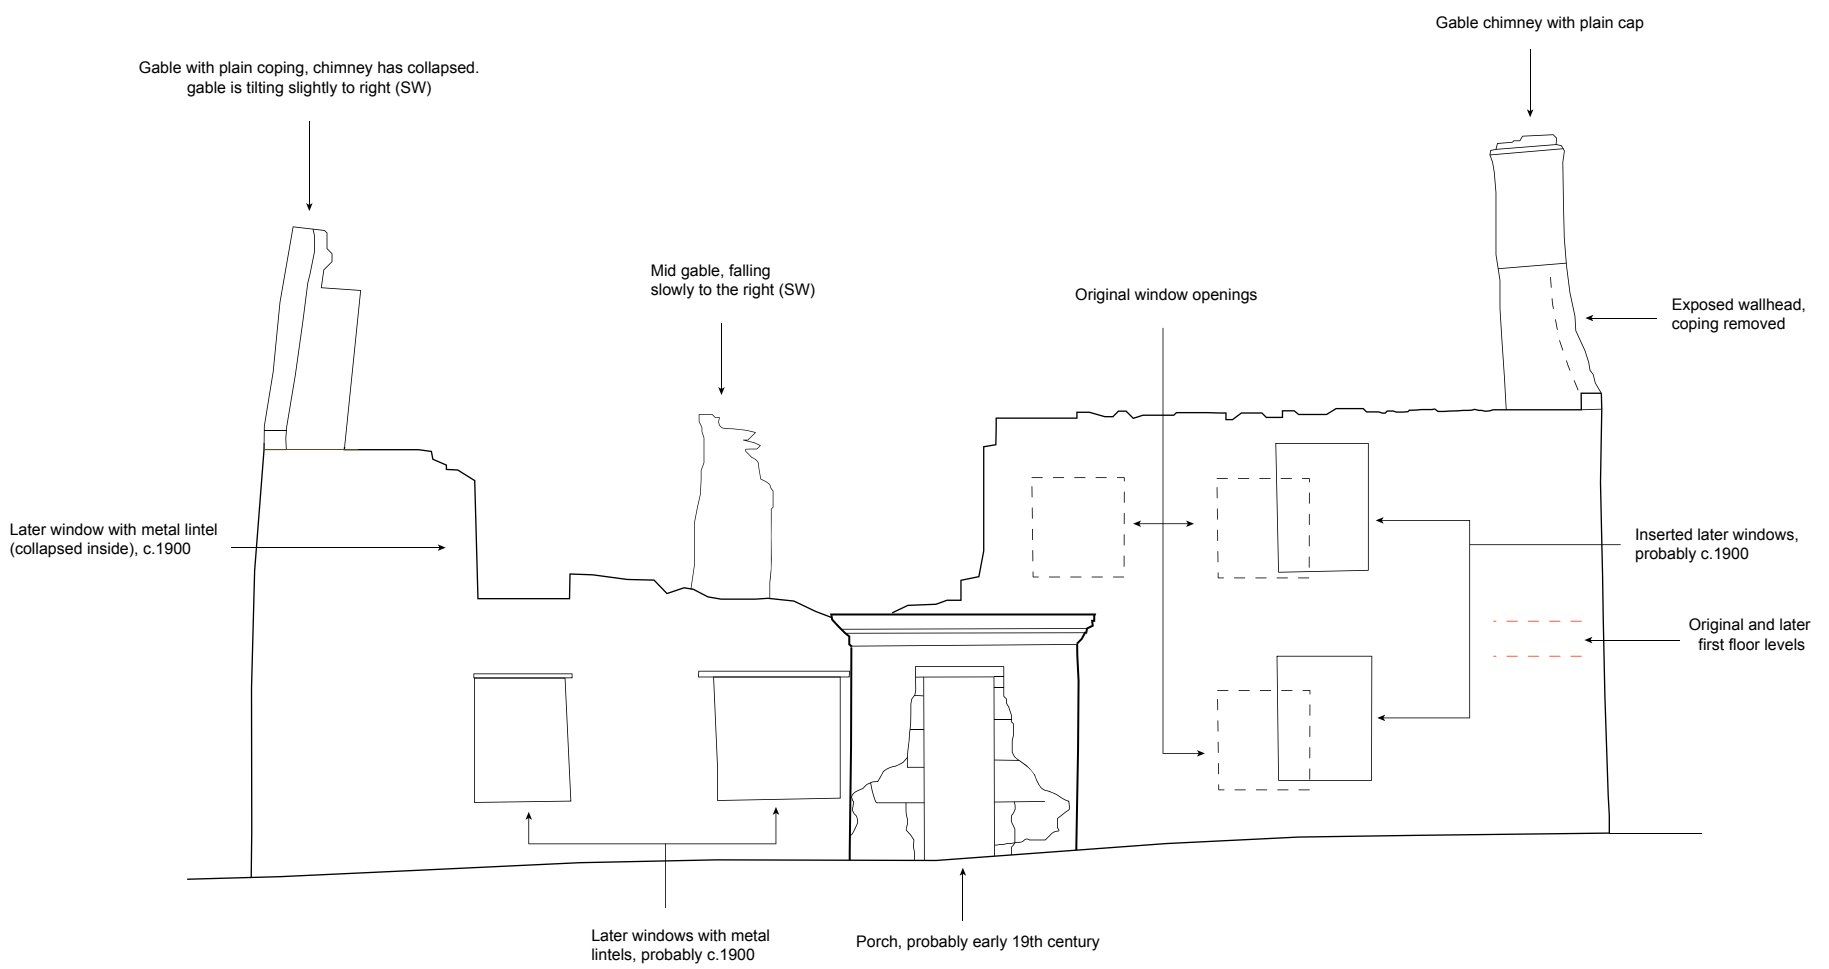
Figure 6 - HLU07: north west elevation, and photo montage

The main NW elevation of the building is 5-bay, with a later porch slightly offset to the right (W). A large section of the upper wall has collapsed to the interior (Plate 4). The wallhead has probably been raised (see interior description and the copes are probably later). Since the elevation is harled (with a number of phases), physical relationships are generally obscured on the exterior.

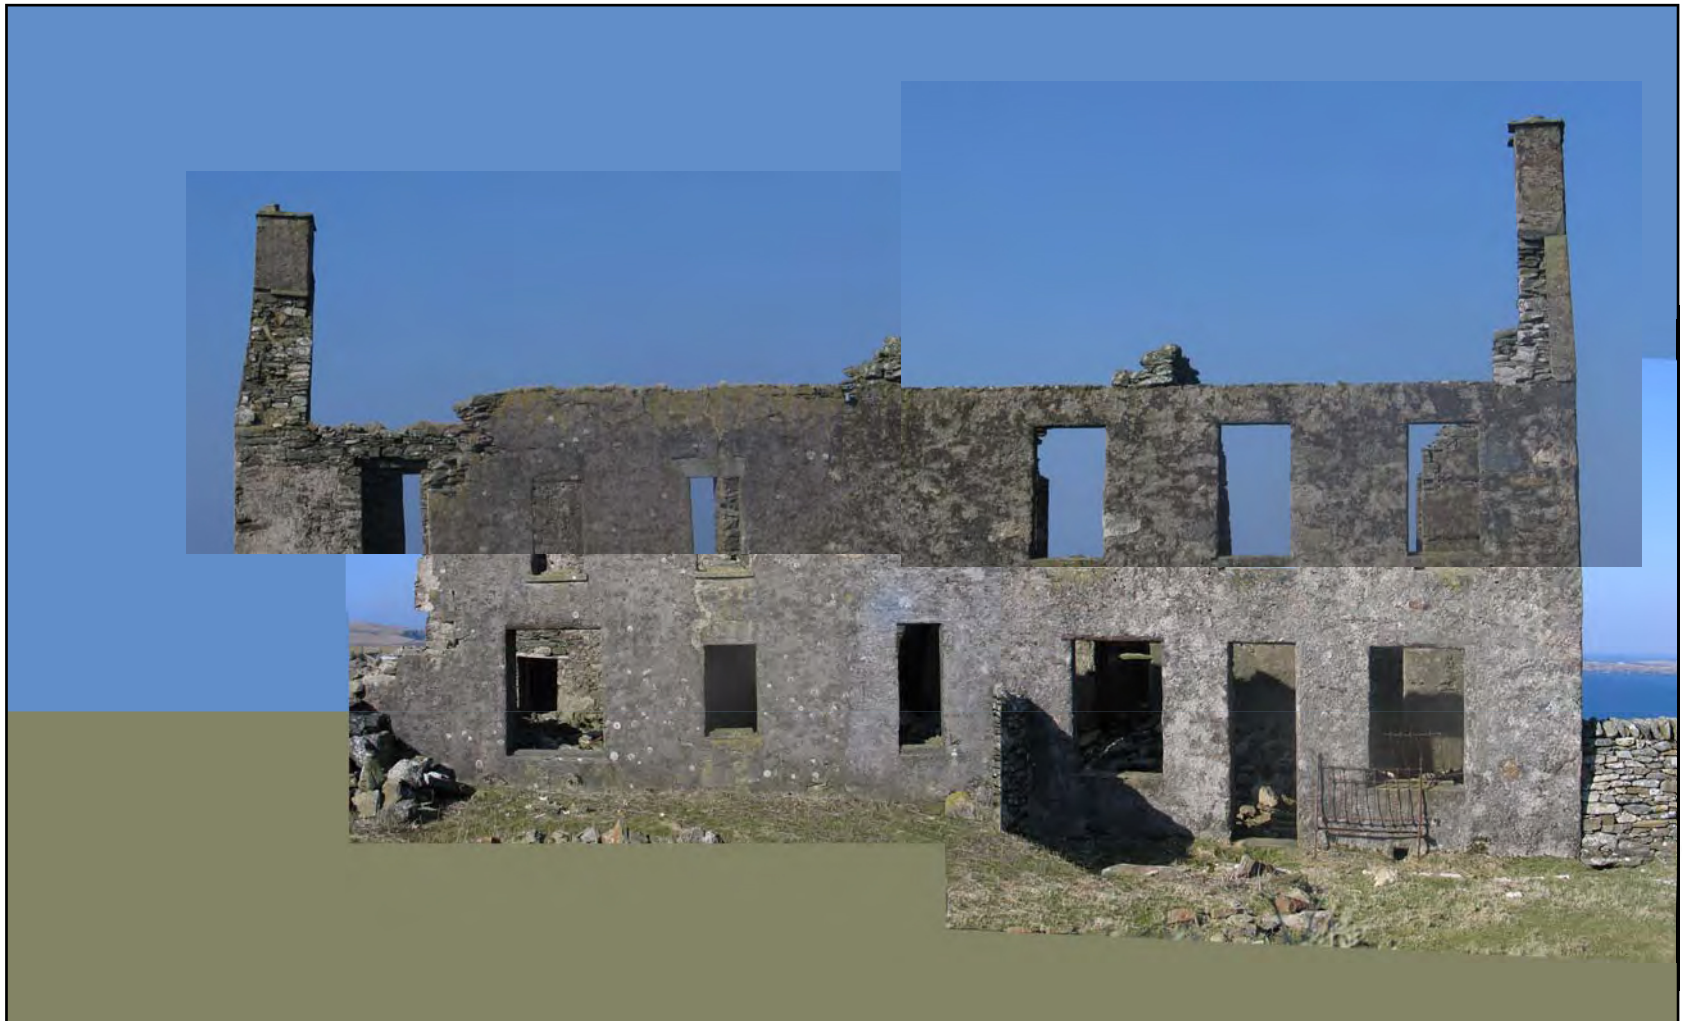
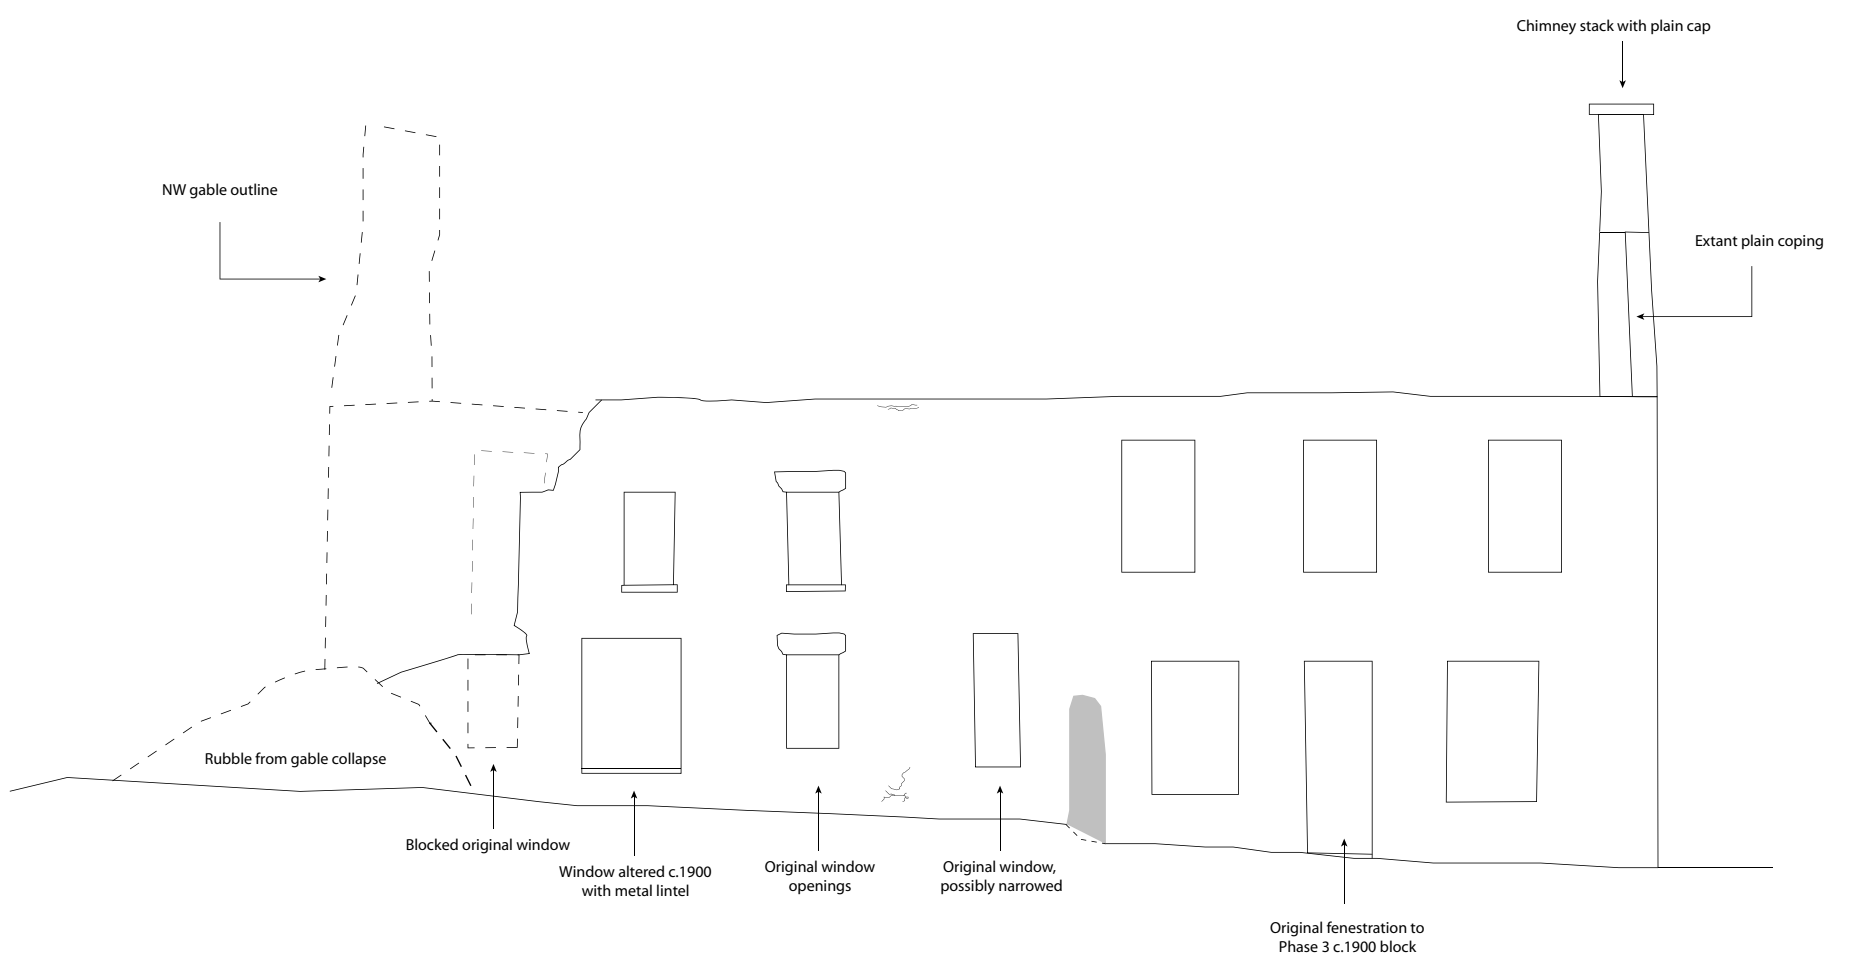
Figure 7 - HLU07: south east elevation, and photo montage

The SE elevation is 7-bay, the 3 bays to the west are earlier than the 4 to the east (Plate 9). The earlier west block is partially collapsed but it has three small upper windows, all with the frames removed (Plate 10). These upper openings have heavy stone lintels and raised cills. There are three matching lower window openings, the W has been blocked and harled over and the central one has been enlarged and has a metal lintel.

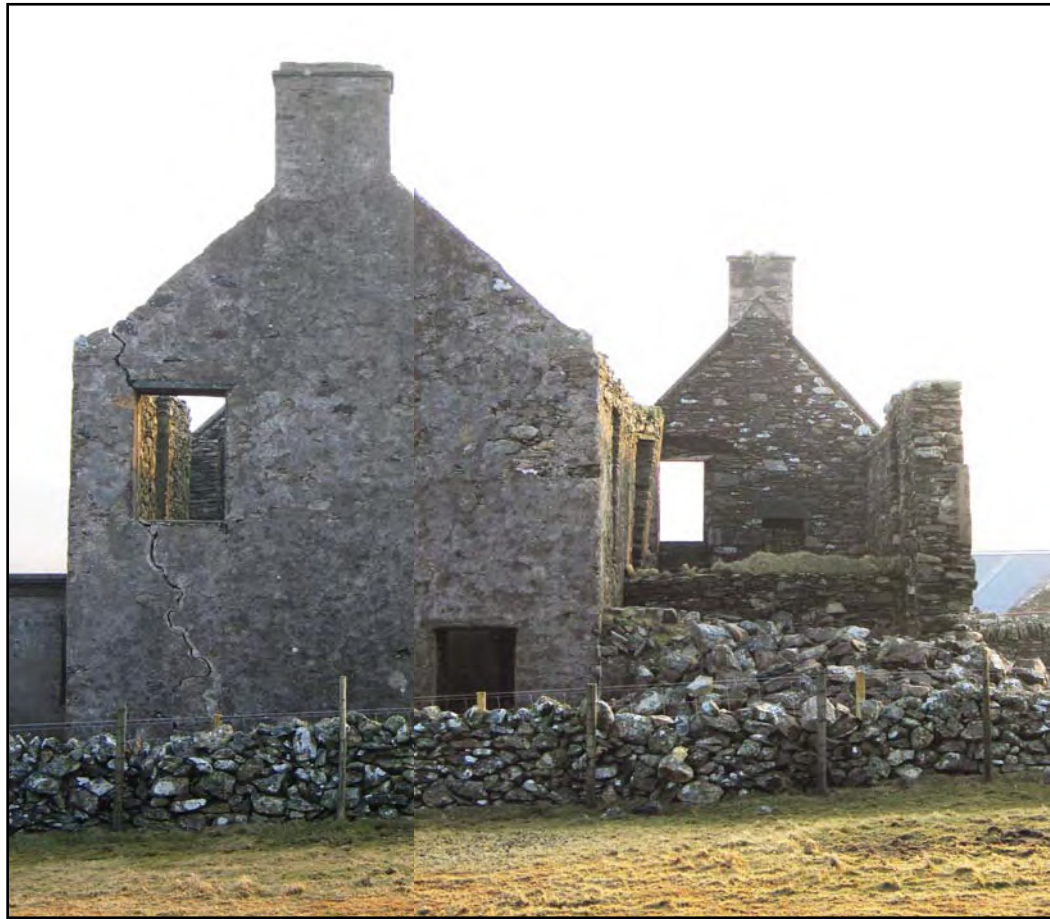
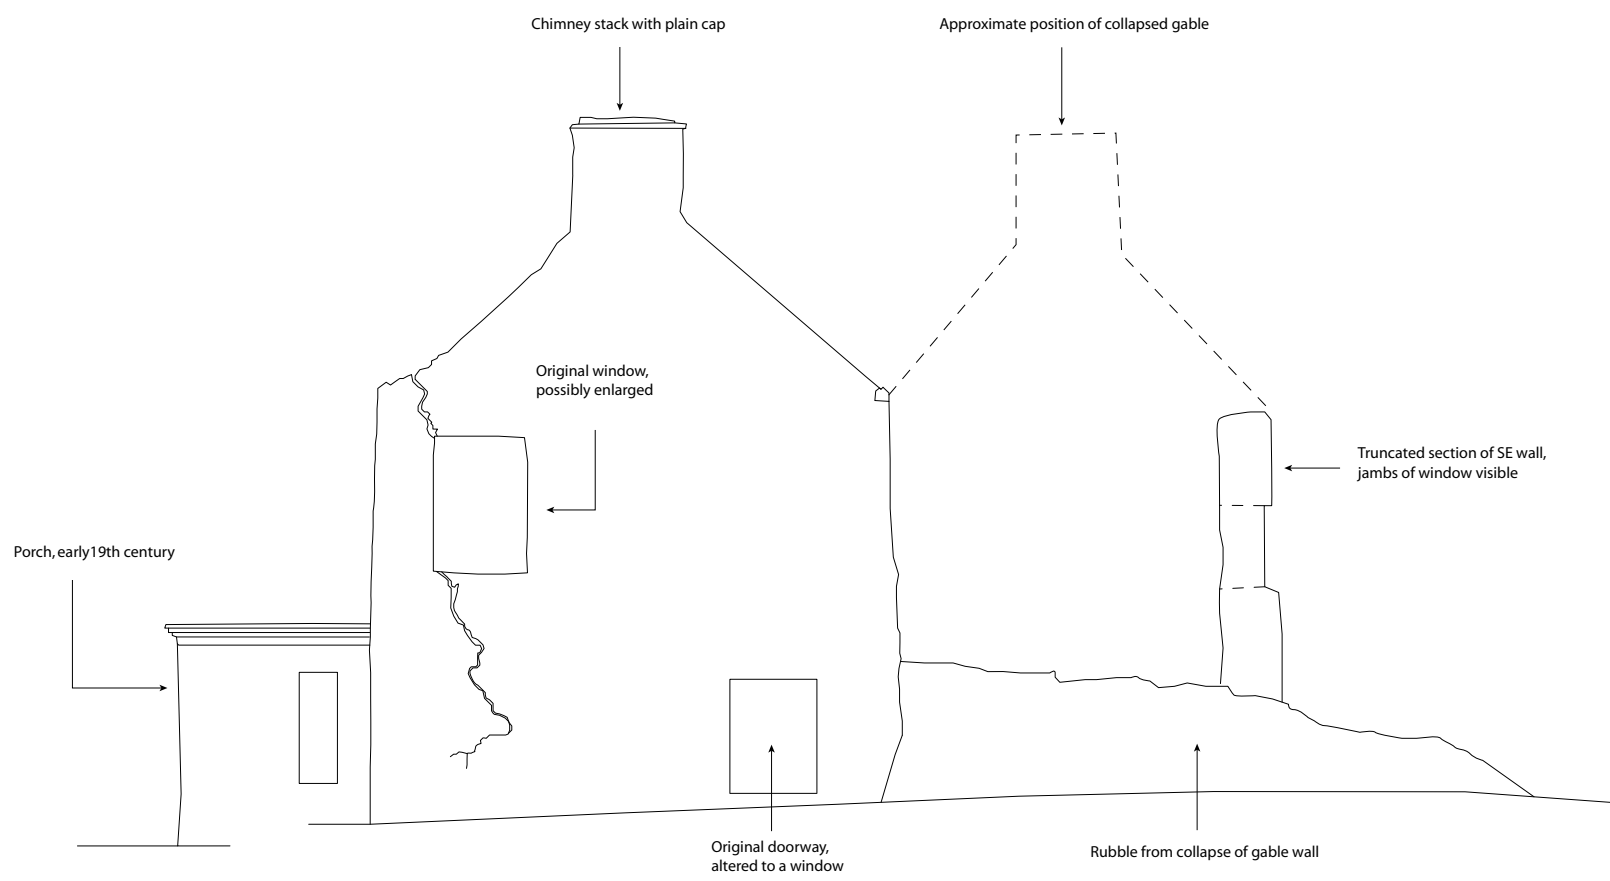
Figure 9 - HLU07: south west elevation, and photo montage

The SW elevation is comprised of two gables; the north gable of the main earlier block is gabled and harled, with two openings (Plate 7). Attached to the SE, the later gable of Phase 2 has largely collapsed and most of the rubble is still *in situ*. The rubble boulder foundation is visible at the base of the north gable (Plate 8). The north gable has two openings, an upper window and a lower doorway. The window may have been inserted, though the harl obscured the detail – the frame has been removed. The lower doorway opening has been partly filled and re-used as a window. The bolt hole remains from its use as a doorway and it has very heavy stone lintels inside and out, with a re-used intermediate timber lintel. Both openings have had the timber elements removed.

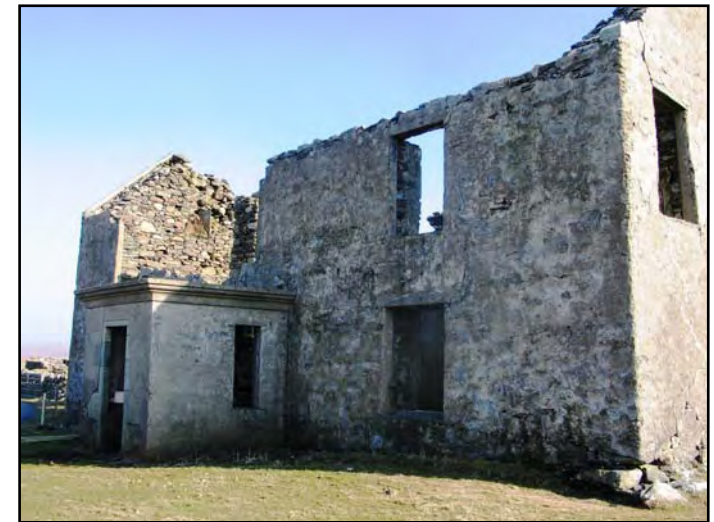
Plate 4 - view from NW

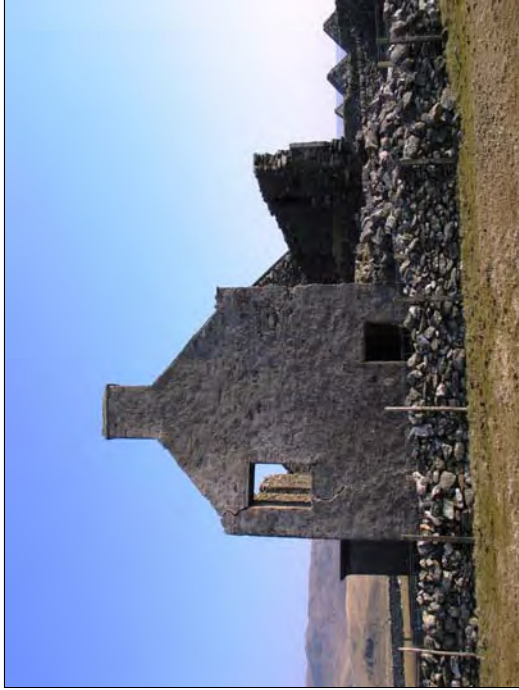
Plate 7 - view from SW

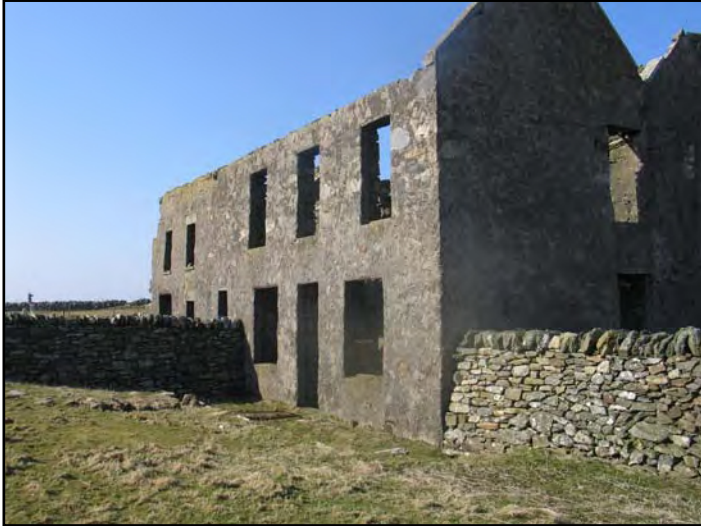
Plate 9 - SE Elevation, later east section

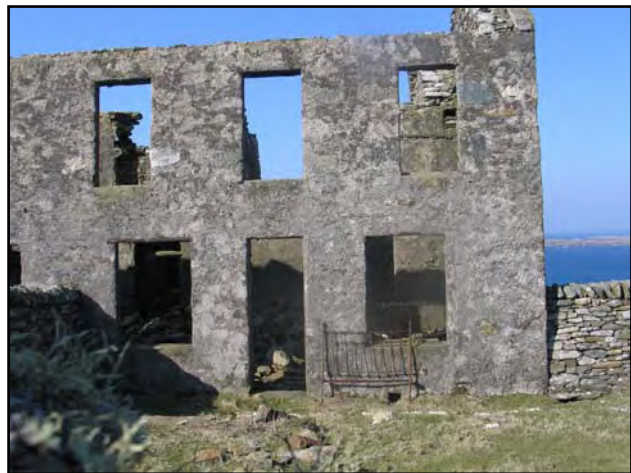
The 4-bay east part has a tall ground floor window in the middle bay of the elevation. East of this, bays 5-7 have a central doorway flanked by two large windows. Above these, there are three regular windows, more widely spaced than the ground floor openings (Plate 11).

Plate 11 - SE Elevation, later east section

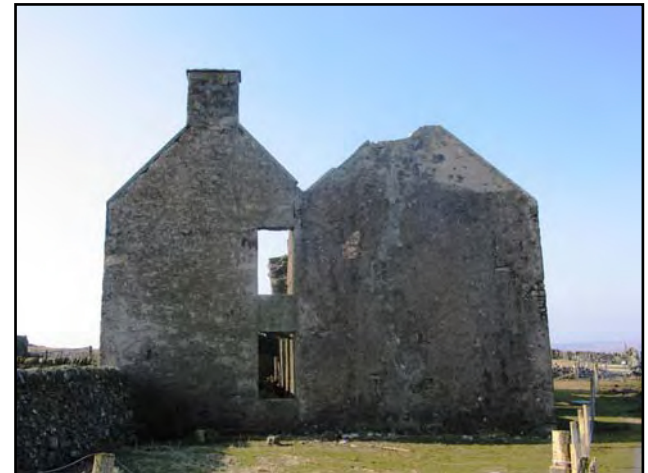
The NE gable survives almost to its full height and is harled with later cement patching (Plate 12). Only the later S gable has two openings which are probably original to this part of the building. The south block clearly abuts the north with the gable 'clasping' the original north coping. The north gable chimney has collapsed into the interior and most of the coping is missing. The south gable has a large gable stack with a plain cap and plain coping. Both of the large window openings use the central wall of the building as their north jamb. The lower window retains cement fillets which suggest it had an 8-pane sash and case window.

Plate 12 - NE Elevation

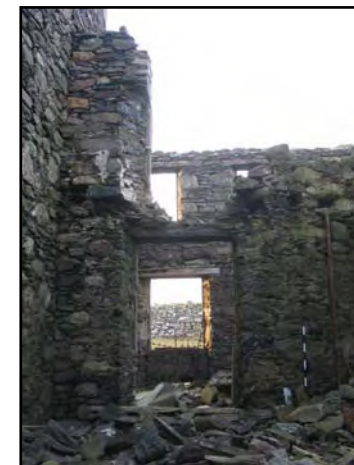
The main early range had three joisted internal floors and a thick partition wall separating each floor into a smaller NE room and a larger SW room (later subdivided). On the ground floor, the NE room is rubble filled but some late lathe and plaster remains (Plate 13). The rooms above retain some plaster on the hard which shows a subdivision on the first floor (Plate 14). The east gable houses a fireplace for each floor; the upper two have been altered when the floors were raised. The first floor fireplace has also been moved to the centre from the left (Plate 15). The windows in the NW wall have been altered obscuring their original form and the doorway to the south was probably inserted around 1900 when the 3rd Phase was built. The upper doorway to the SE incorporates the splayed jamb of an original window opening (Plate 16).

Plate 16 - Interior, NW block, NE room, doorway to latest block

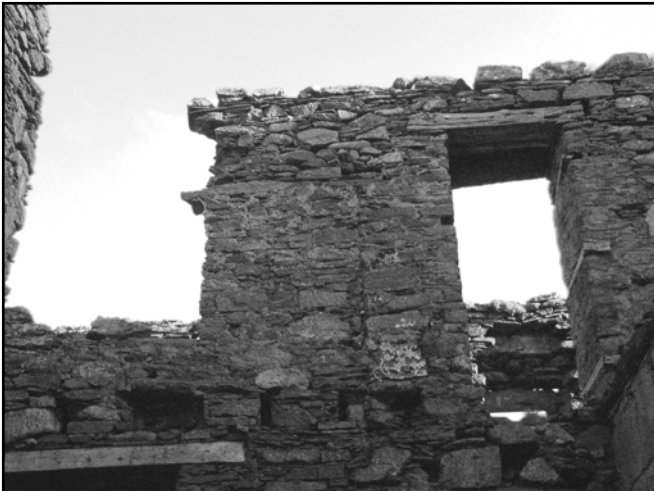
to the Phase after the building was raised. The SW doorway is lower, with a stone lintel below the original level of the floor joists. Between these doorways, two straight joints might indicate the position of an original opening. The ground floor fireplace in this internal wall has a large relieving arch and probably functioned as the original kitchen fireplace (Plate 18). The first floor fireplace above is also large and marks the principal room of the house. This fire was subsequently raised with the same lintel reset higher. There are also original first floor window openings in the SE and NW walls in the central area showing the drastic alteration in fenestration (Plate 19).

Plate 19 - Interior, NW block, mid-room, view to NW

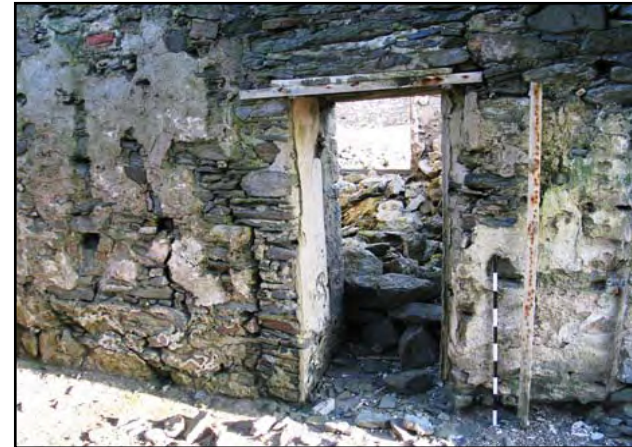
In the SE wall of this room, the doorway to the later block has been inserted and altered, possibly in an original window opening (Plate 20). The door above this has also been raised and altered with at least one jamb rebuilt. This again utilises an earlier window opening. Both NW window openings in this room have been inserted – the earlier and smaller windows have been blocked and are visible to the right of the current windows (Plate 21).

Plate 20 - Interior, NW block, SW room, view to SE

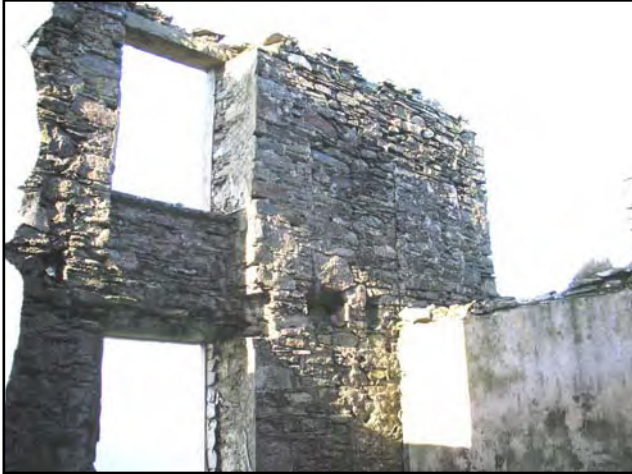
Plate 21 - Interior, SE block, SE wall, detail of joint between phase 2 and 3

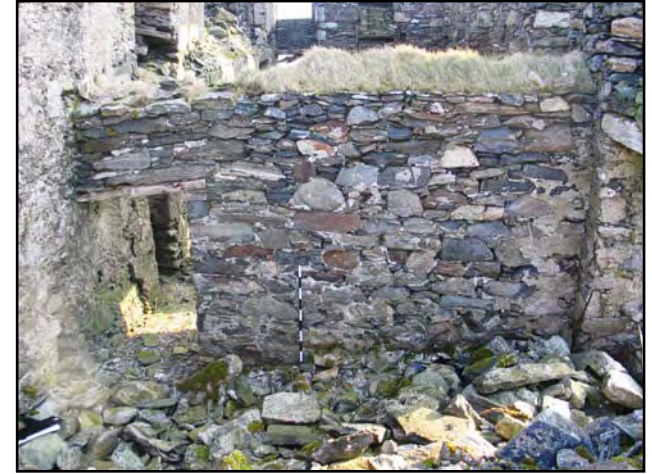
The small south-west block was attached to the back wall of the original building. Most of this SW block has collapsed and its NE wall was removed when the building was further extended in 1900. The surviving rubble internal wall is later, probably post dating or contemporary with this final extension (Plate 22).

Plate 22 - Interior, SE block, partition wall in phase 2 block

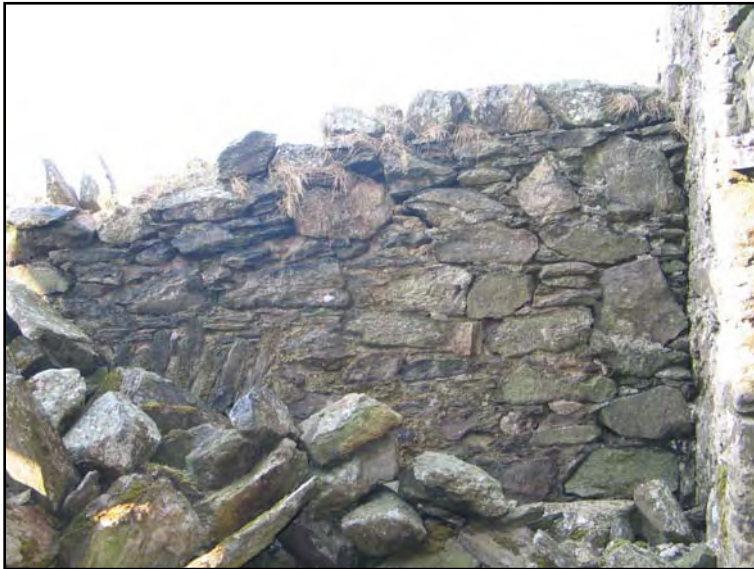
The SW room is mostly rubble filled from the collapse of the gable though the relieving arch from a large ground floor fireplace is just visible behind the collapse (Plate 23). In the outer wall of this room, an original window is blocked and harled over. Adjacent to this, an earlier window has been enlarged to match the larger windows in the main façade. As mentioned, both internal doorways into this block from the main building are insertions. According to June Owers' research, this SW room (the original extension) was a kitchen, replacing the kitchen within the house itself. The inner wall (NW) of this room has earlier external harl and holes for dooks which probably held later timber panelling or lathe and plaster.

Plate 23 - Interior, SE block, collapse and blocked fireplace in SW gable
