P21-024

WATERMILL COTTAGE, CUDDINGTON

*Level 2 Historic Building Record
for Cranage Construction*

February 2021

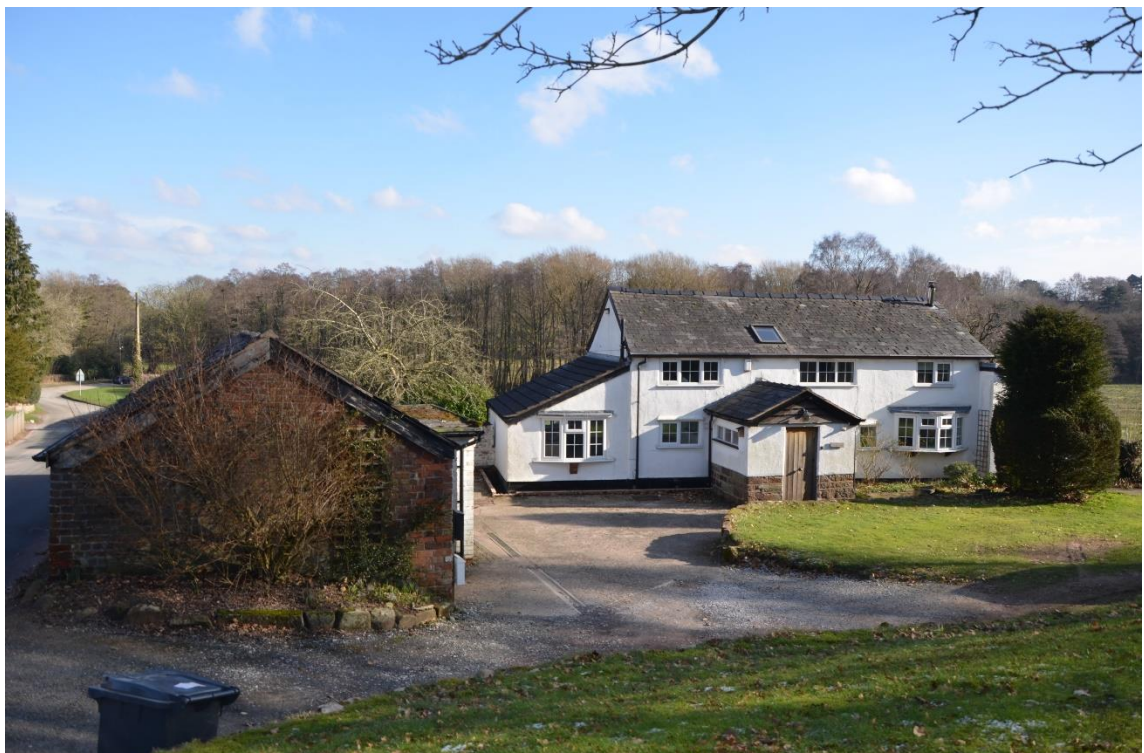
Figure 2. Watermill Cottage, general view facing east

1.3.1. Watermill Cottage is located at NGR 359240, 371721, on the south side of Norley Road in the village of Cuddington, approximately 4 miles to the west of Northwich, Cheshire (Figure 1). The cottage is oriented roughly north-south within the northern half of an elongated plot, with gardens under lawn to the south and west. There is an area of hardstanding surrounding the property which has access from Norley Road immediately to the west of a range of north east – south west oriented low sheds flanking the roadside. There is generally an open aspect to the east and south across fields towards the tree-lined Cuddington Brook (Figure 2).

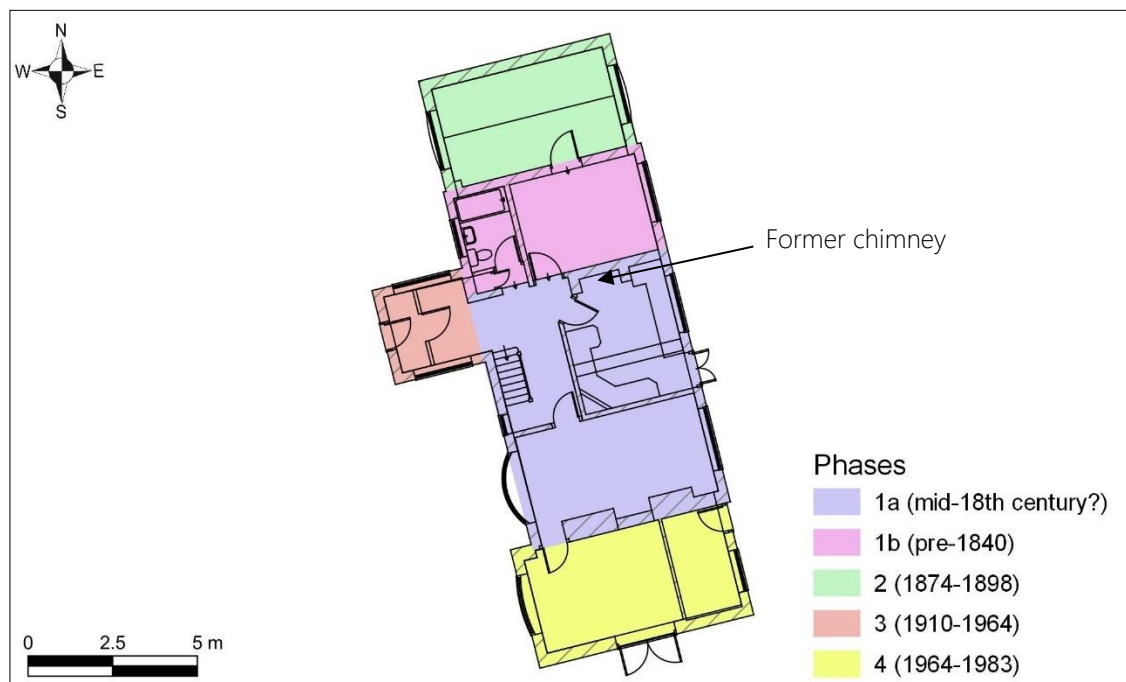
Figure 10: Watermill Cottage Phase Plan

- 8.1.3. The presence of two former fireplaces in the eastern and western halves of Room 6 further suggests the cottage was originally two rooms deep.

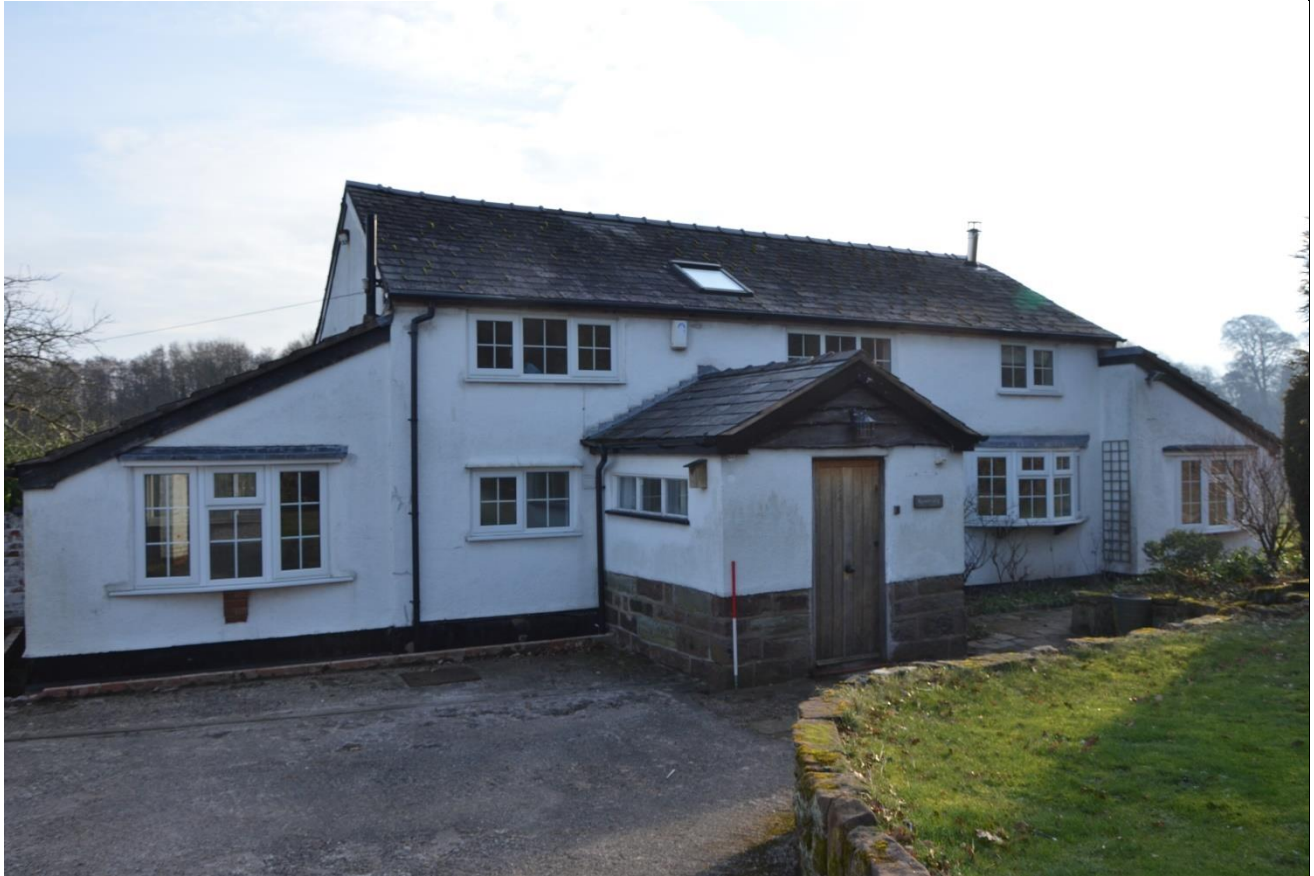
Client: Cranage Construction	Photo No. 009	Date: 12/02/21	Direction Taken: E
--	-------------------------	--------------------------	------------------------------

Description: Western elevation, northern extension

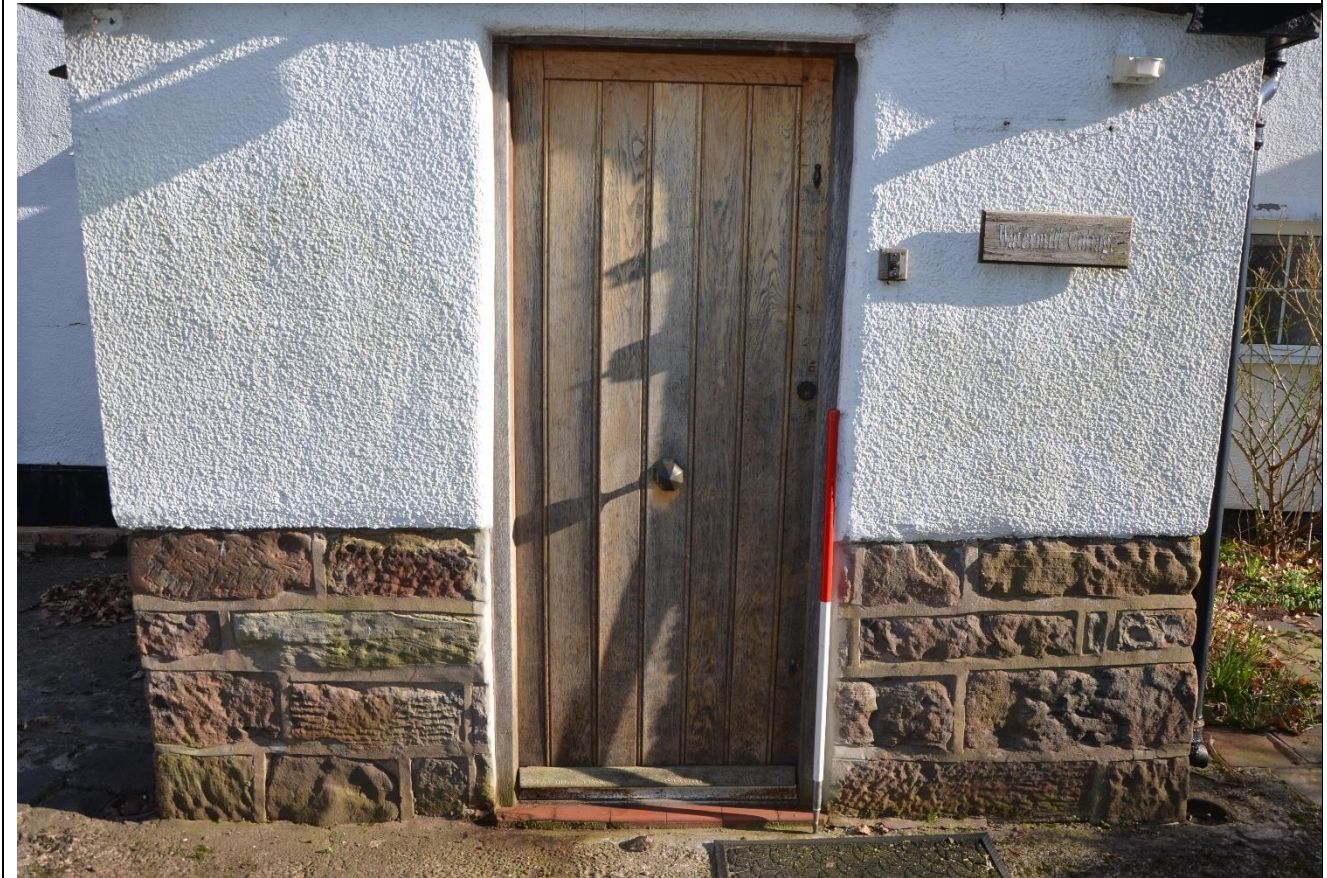
Client: Crannage Construction	Photo No. 012	Date: 12/02/21	Direction Taken: NE
---	-------------------------	--------------------------	-------------------------------

Description: Southern elevation of porch, detail of sandstone lower courses

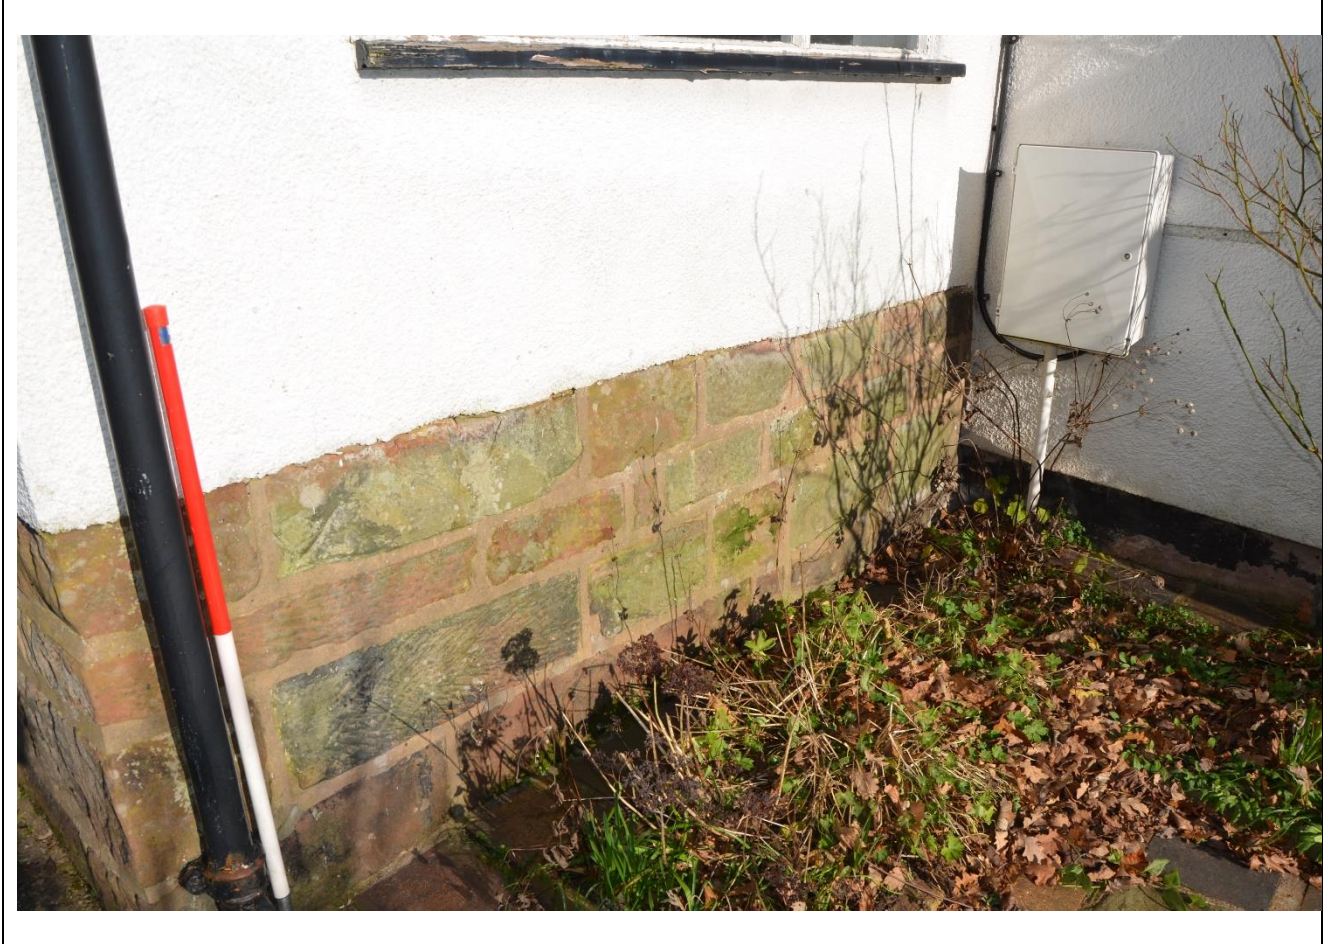
Client: Crannage Construction	Photo No. 013	Date: 12/02/21	Direction Taken: NE
---	-------------------------	--------------------------	-------------------------------

Description: Oblique view of modern southern extension

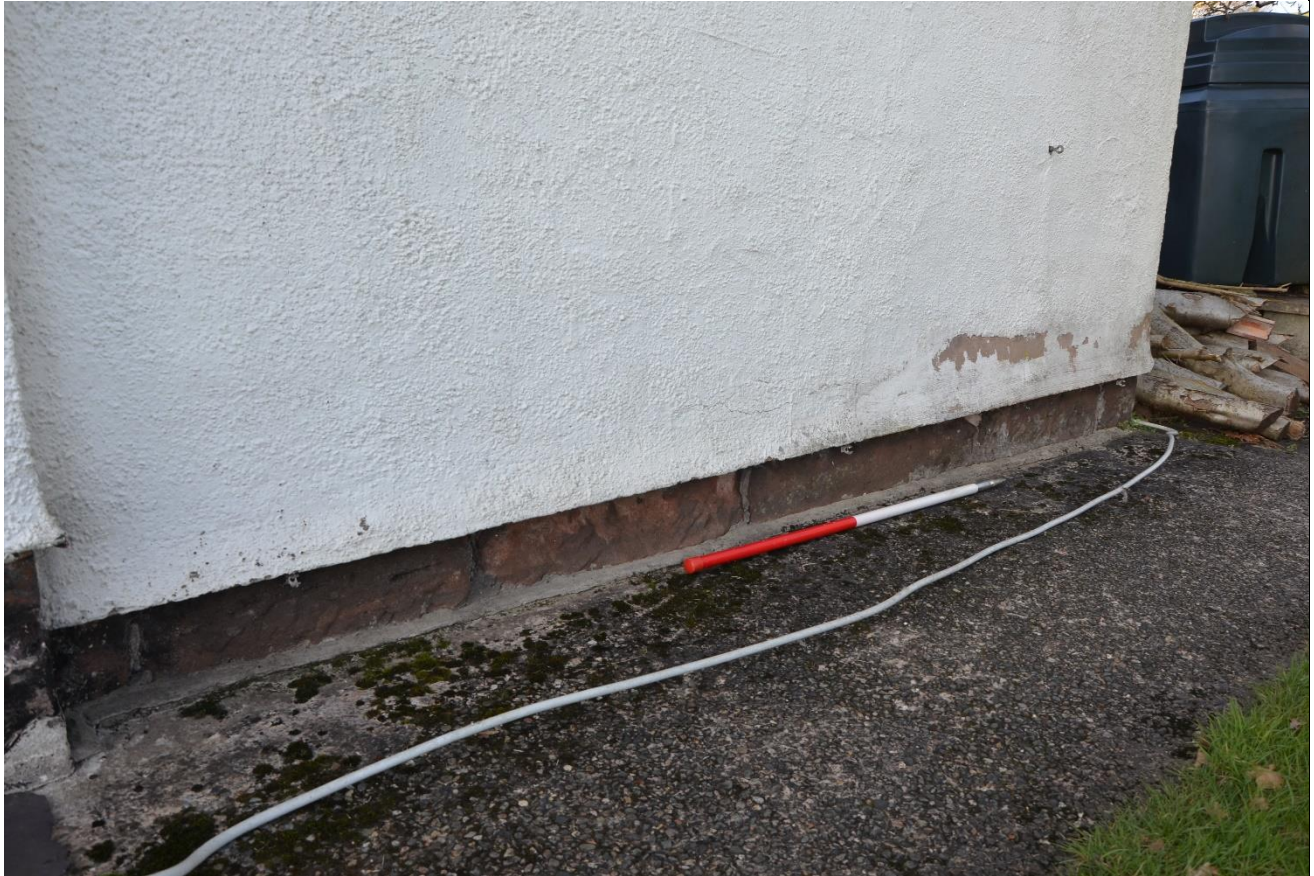
Client: Crannage Construction	Photo No. 018	Date: 12/02/21	Direction Taken: W
---	-------------------------	--------------------------	------------------------------

Description: Room 1, view to west

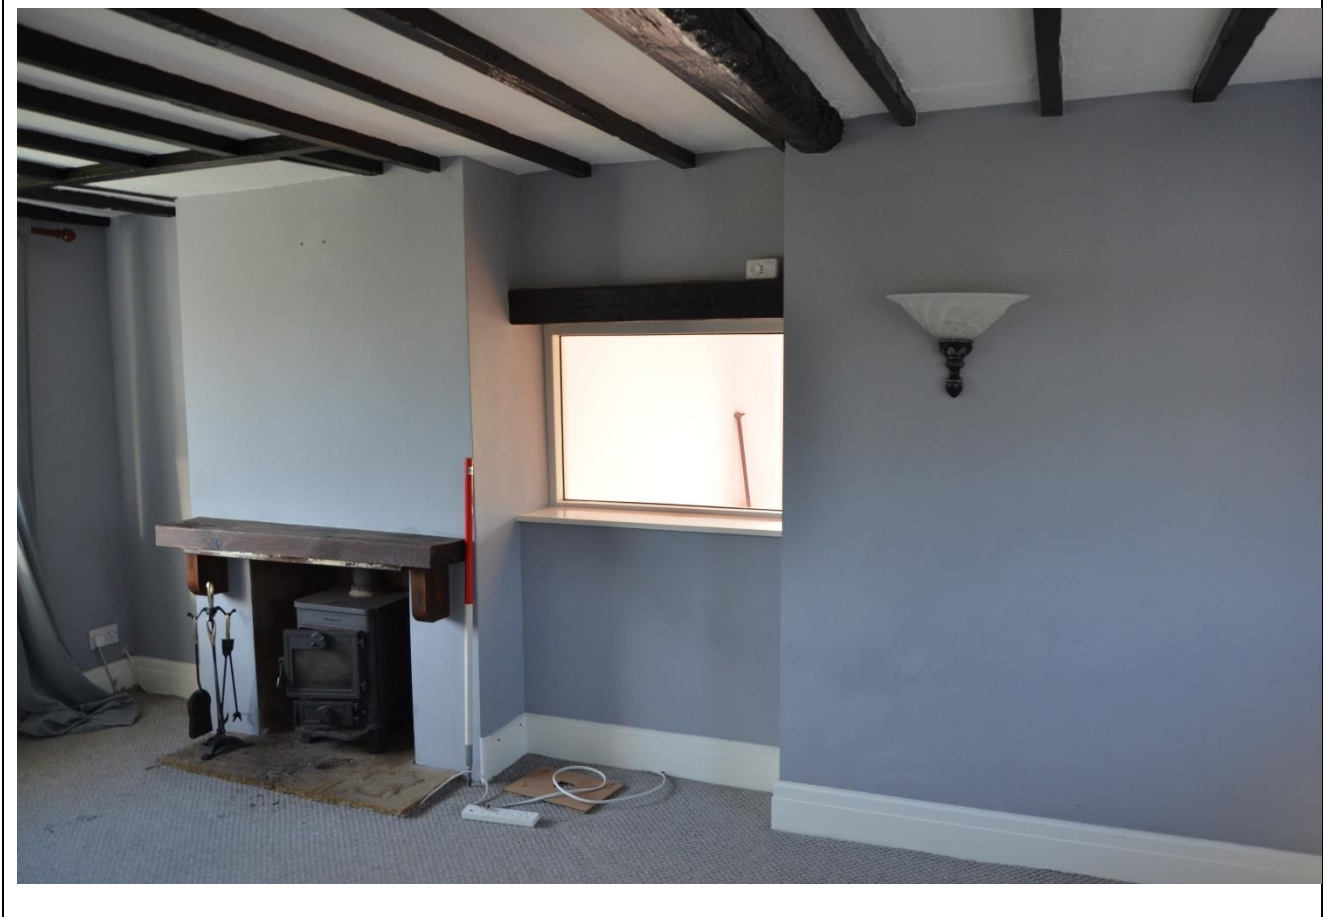
Client: Cranage Construction	Photo No. 033	Date: 12/02/21	Direction Taken: SE
--	-------------------------	--------------------------	-------------------------------

Description: Room 6, view to south east (note inserted window into Room 7 and fireplace with wood burning stove)
