## BEAL FARM, NORTHUMBERLAND

*Level 2 Historic Building Record  
for Edwin Thompson (Berwick upon Tweed)*

*March 2023*

HA Job no.: P23-050  
NGR: 406626, 642750  
Parish: Kyloe  
Council: Northumberland County Council

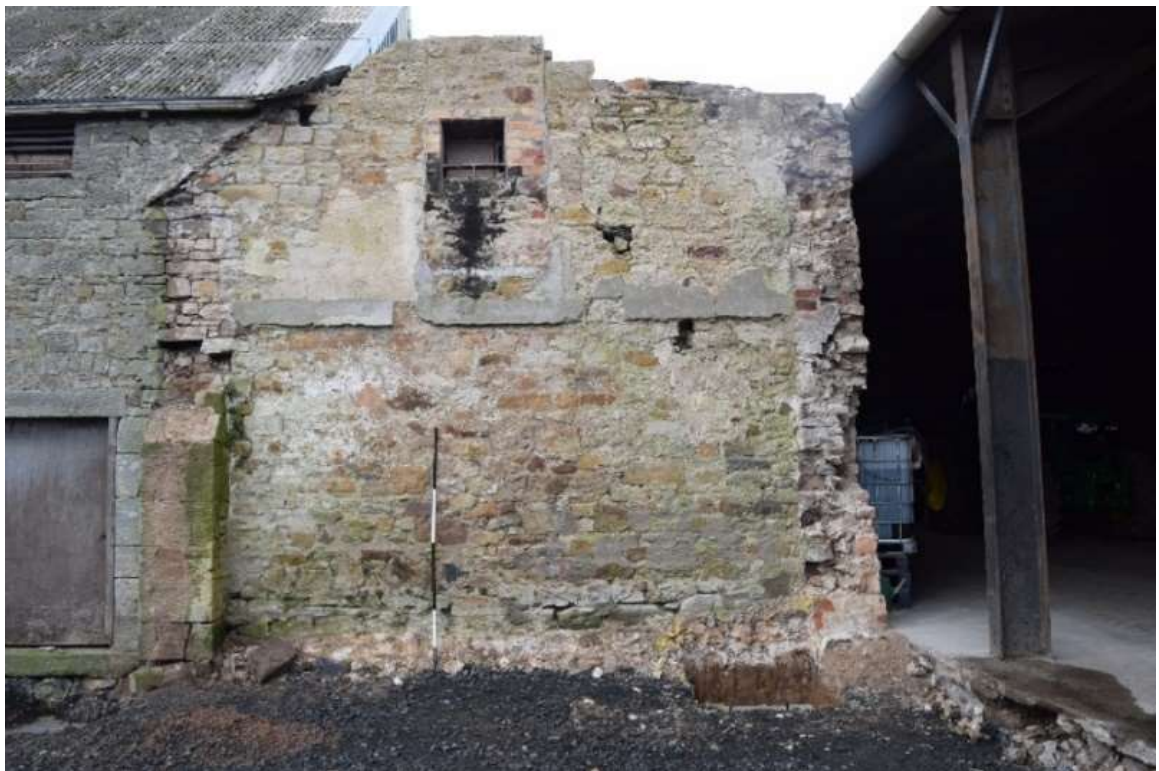
*Figure 10. Detail of the internal east facing gable of Building 1*

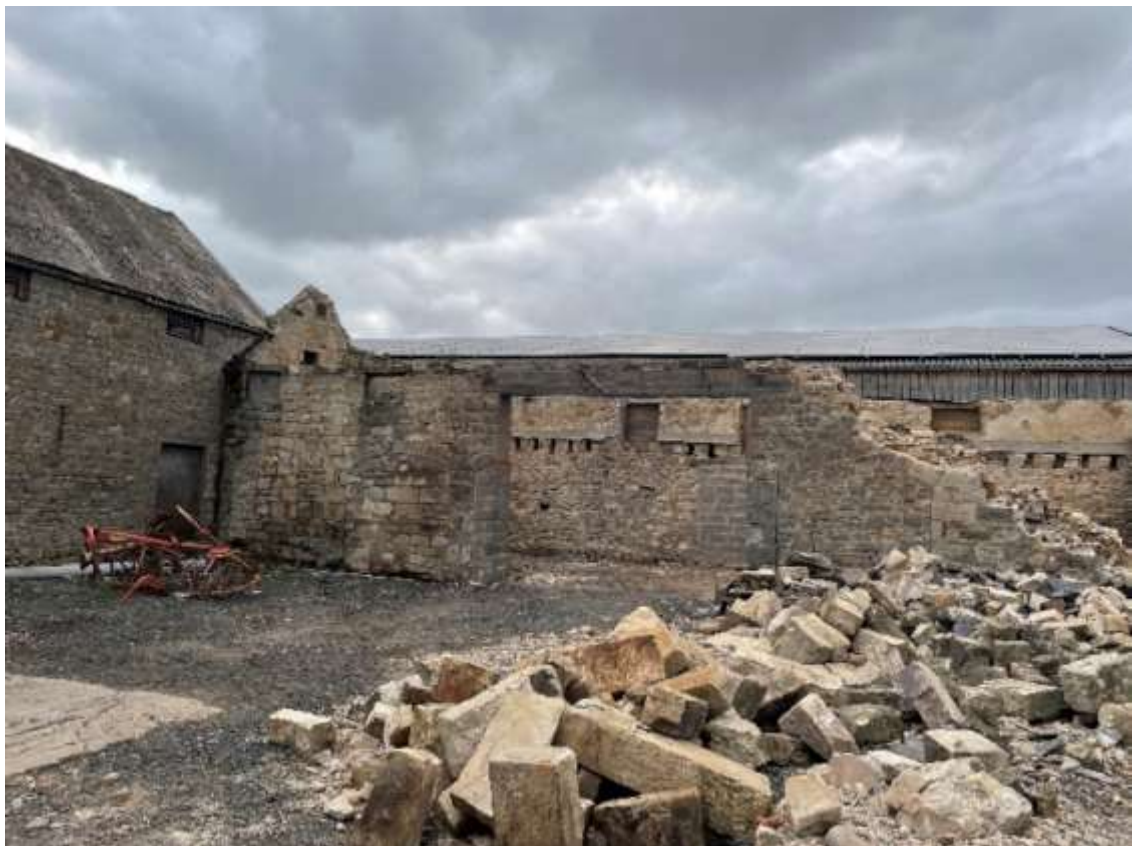
Figure 11. Detail of the south facing elevation of Building 1

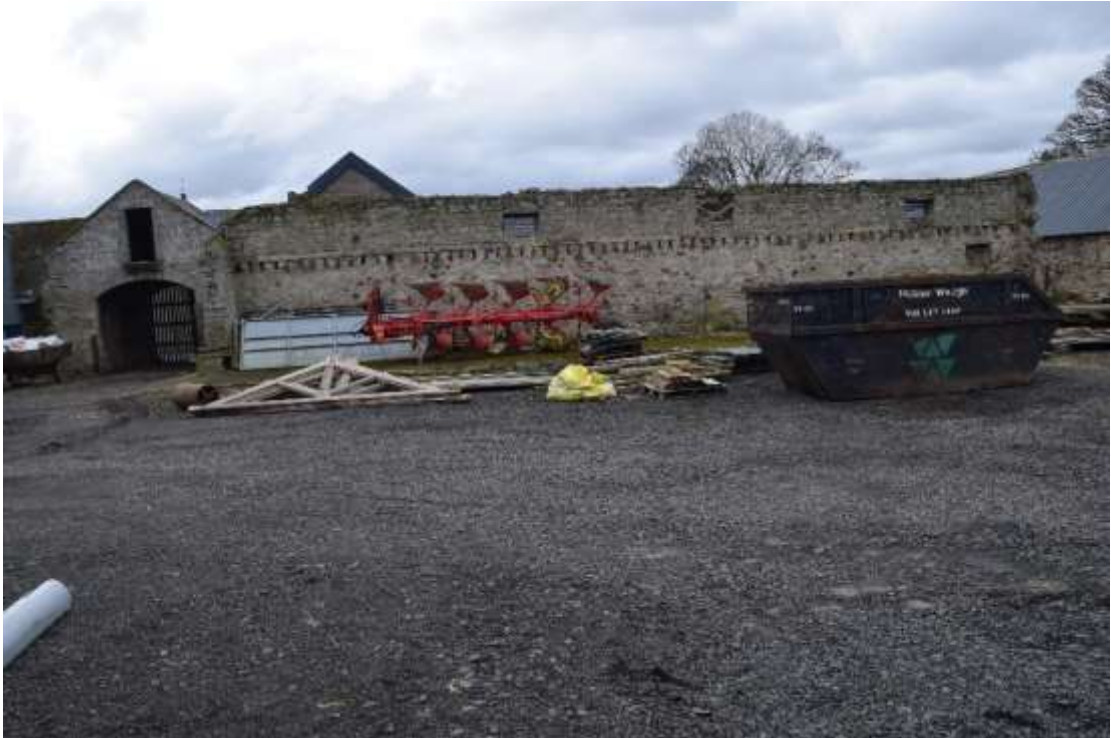
Figure 15. View of the surviving wall of Building 6 facing south

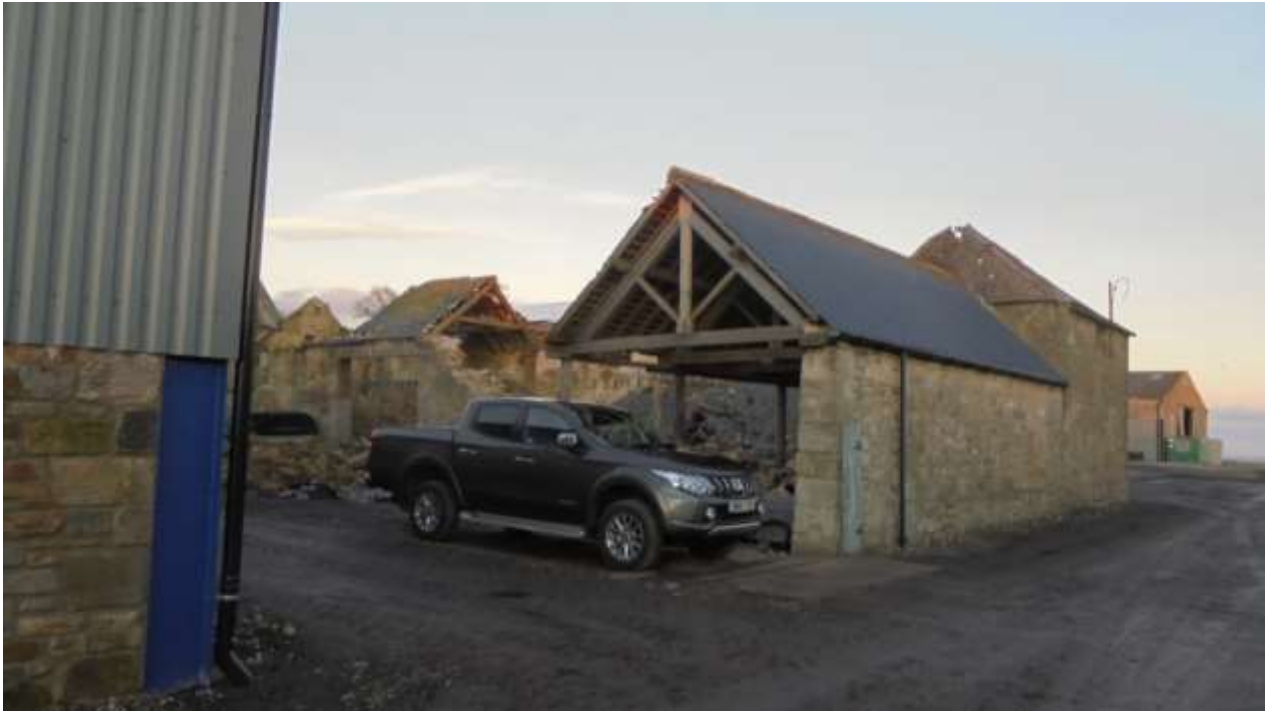
<i>Client:</i> Edwin Thompson	<i>Photo No.</i> P23-050-038- client	<i>Date:</i> 06-03-23	<i>Direction Taken:</i> N
----------------------------------	--	--------------------------	------------------------------

*Detail of damage to south elevation of Building 1*

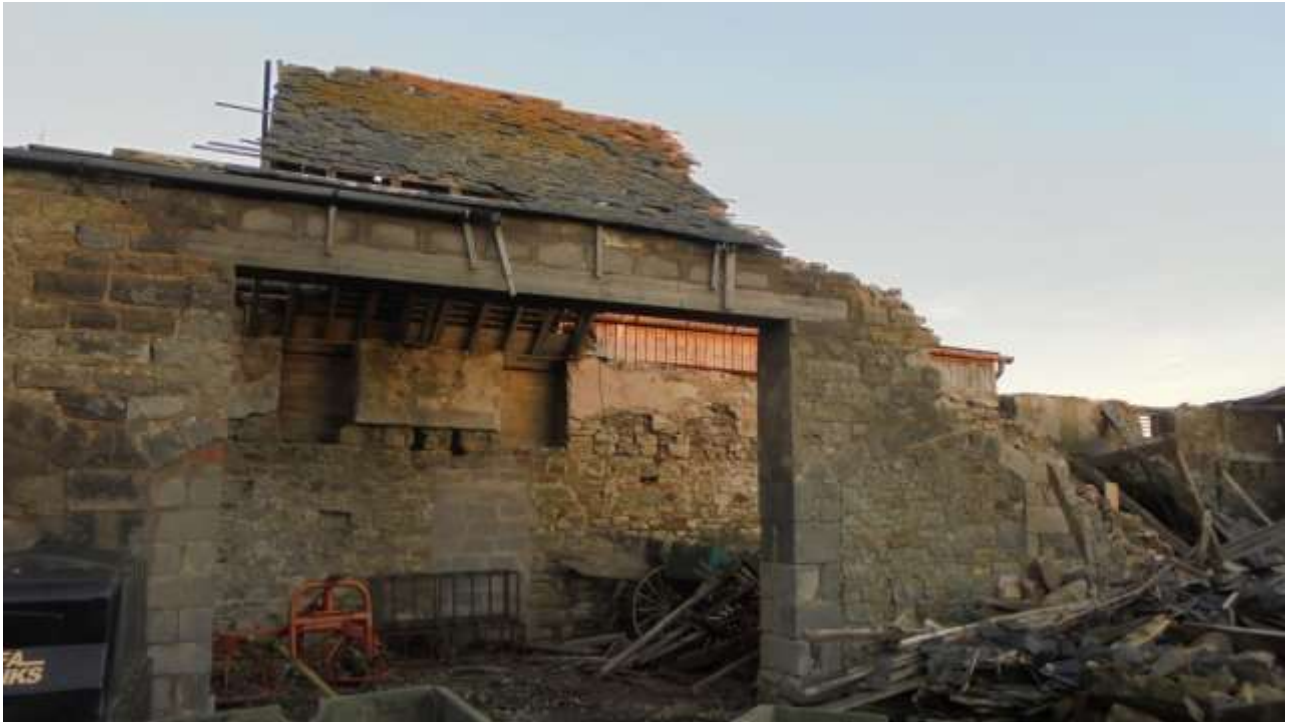
<i>Client:</i> Edwin Thompson	<i>Photo No.</i> P23-050-042- client	<i>Date:</i> 06-03-23	<i>Direction Taken:</i> NE
----------------------------------	--	--------------------------	-------------------------------

*Detail of damage to south elevation of Building 1*
