Project Code: GUYZ09
Planning application reference number: A/2006/0232
Date of report: August 2009
Client: The Northumberland Estates

GUYZANCE MILL, GUYZANCE, ALNWICK,
NORTHUMBERLAND GRAIN MILL
Results of Historic Building Recording
and Watching Brief

Results of Historic Building Recording and Watching Brief

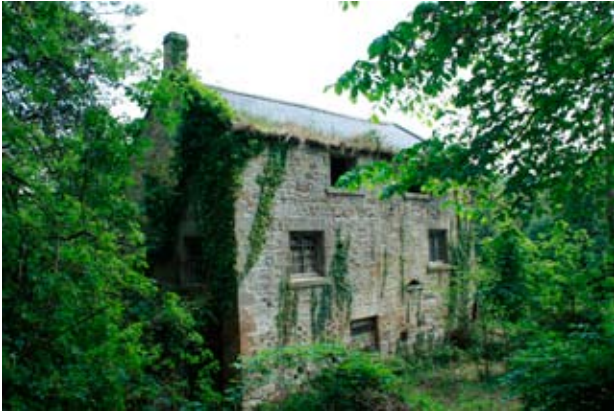
The south-west façade has one original window at ground floor and two on the 1st and 2nd floors. All windows sit within chamfered alternating block surrounds with slightly projecting sills. The 1st floor windows each have the surviving 24-pane Yorkshire sashes. There is a coped gable roof with small stepped and banded north-west end stack.

There is a secondary window/door opening at ground floor with timber lintel. Two square and one arched secondary chute openings are located at the ground and 1st floor level.

Illus 4
 South-west façade

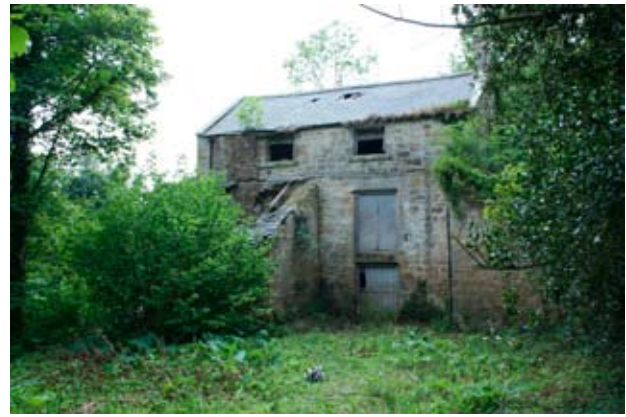
The north-east façade has a stable door at ground floor level located below a boarded double pitching door at 1st floor, both doors are within chamfered surrounds. Two windows are located at 2nd floor level, each with slightly projecting sills. The windows have no surviving carpentry.

Illus 5
North-east elevation

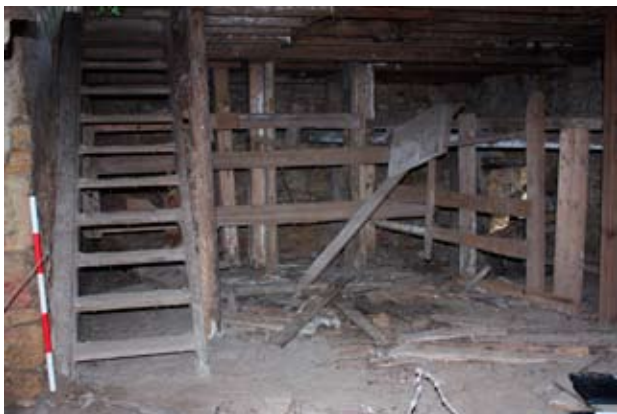
The south east end of the room is partitioned off by a timber wall, separating off the inner wheel pit (Illus 9). The base plate for the inner headstock is located to the north-west of the inner wheel pit. No other machinery fittings survive *in situ*.

Illus 9
The ground floor stairs and wooden partition

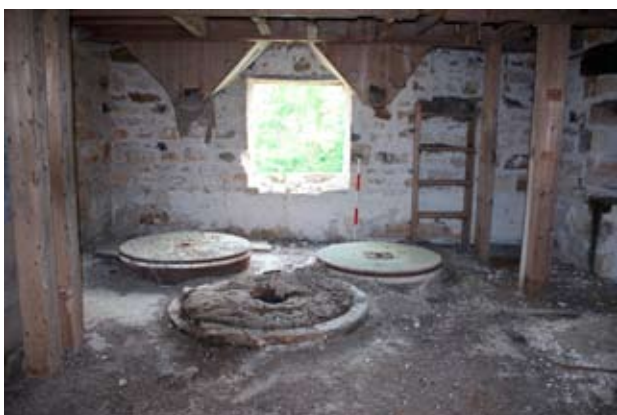
Access to the first floor is via the staircase. Located at the top of the stairs, on the south-east side of the room are three single mill stones on iron and stone base setting (Illus 11). These are *in situ* nether stones which have been

Set into the ceiling against the south-east wall and above the rough and smooth mill stones are two wooden hoppers with sackcloth dampers to direct the grain into the stones via a wooden shoe. A third hopper may have been present over the composite stone which has been removed, leaving a void in the ceiling above.

Illus 11
The mill stones and hoppers

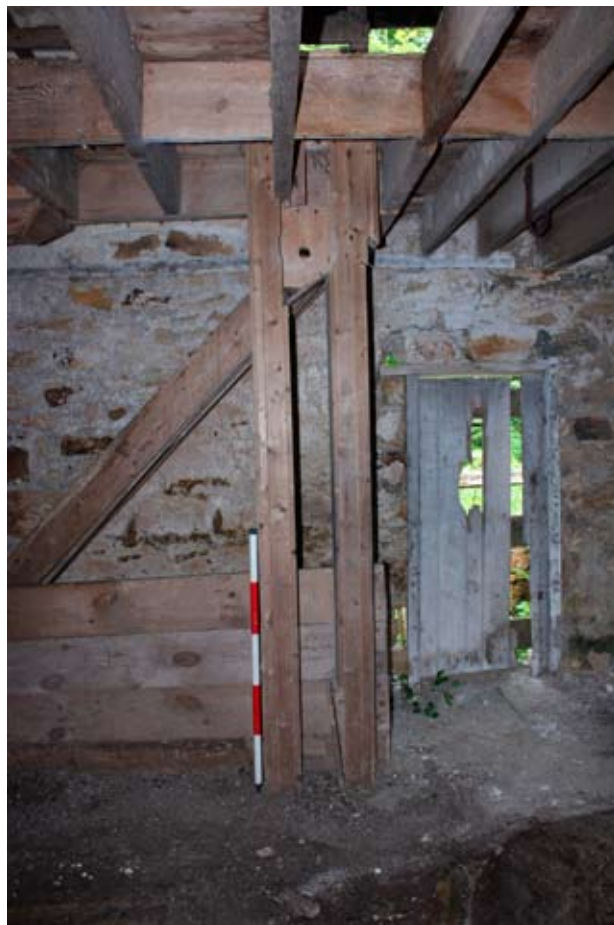
Door access into kiln is located at the top of the staircase, set into the north-east wall. A wooden grain elevator runs from the ground floor transporting grain to the stones via a counter weight system (Illus 12). Graffiti in pencil on the side of the elevator indicates numbers of sacks and weights on certain dates.

Illus 12
The grain elevator on the 1st floor

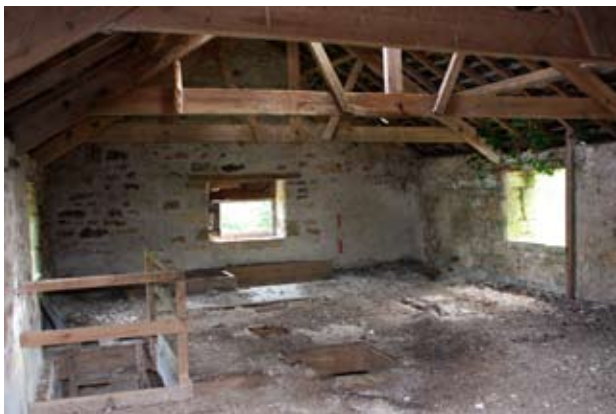
The 2nd floor was clear apart from the upper half of the wooden hoppers located against the south-east wall (Illus 14). A grain chute and square aperture for the sack hoist were located in the wooden floor immediately to the south of the stair well. Signs of rope wear was noted on roof trusses above the sack hoist.

Illus 14
Second floor

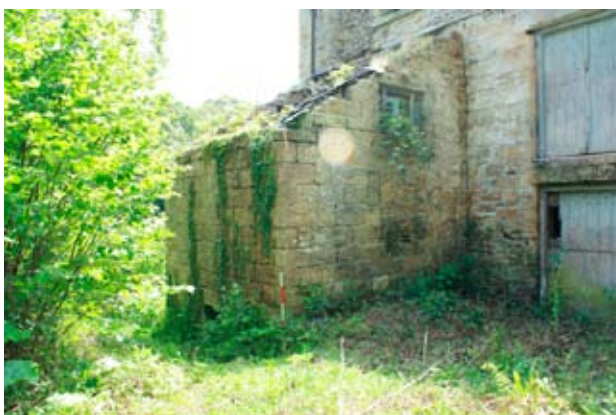
2nd floor windows of the mill building and is partially collapsed. The north-west elevation has a window at the first floor with chamfered alternating block surrounds. A blocked doorway is located directly below the window.

The north-east elevation of the kiln has a central ground floor aperture leading into the drying chamber pit. The south-east elevation has a matching window to north-west at first floor level. This wall continues down to the base of mill race.

Illus 15
The corn drying kiln

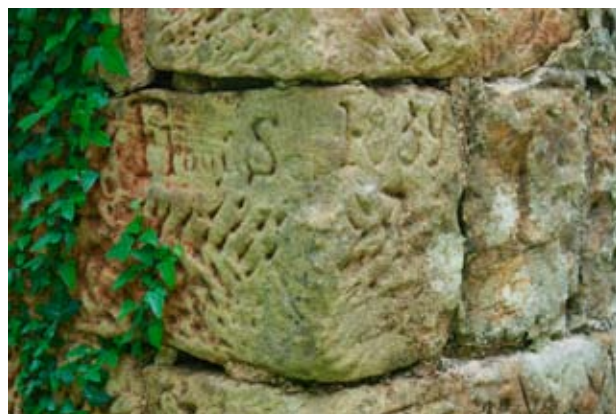
Stone carved graffiti was identified on the north corner and the north-east façade of the kiln building. The graffiti identified on the corner appears to record the level of two different floods. The upper line reads 'Floods 1839' (located 1.50 m above the ground, approximately 20.32 OD) and the lower 'Flood Aug 20 W W? 9' (located 1.20 m above the ground, approximately 20.02 OD). There are other

possible numbers and letters beside and below the second inscription but they are unreadable. The third inscription is located beside the kiln aperture in the north-east elevation (located 1 m above the ground, approximately 20.12 OD). This reads 'W W C C 183?'. The final year number is badly worn and illegible.

Illus 16
Graffiti of the kiln

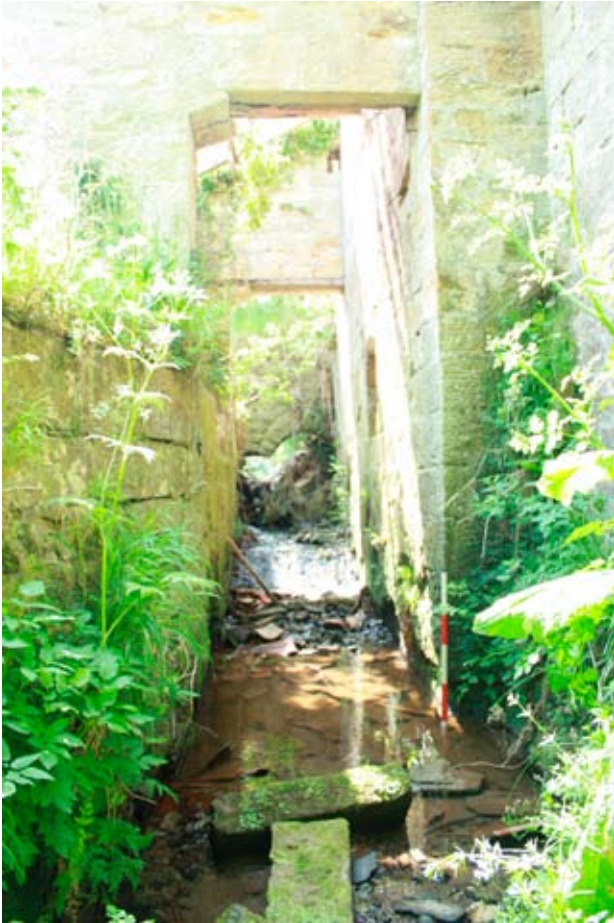
The wheel house would have housed an iron and timber waterwheel which has now been removed. The mill race runs through the south-west opening into the wheel pit formed by the south-east wall of the mill and the raised platform south-east wall of the wheel house (Illus 16). The race is controlled by a (now removed) sluice gate located at the south-west entrance. To the south-west of the wheel house is an L-shaped length of wall running from the outer wall of the wheel house to the south-west corner of the mill. Located at the base of this wall is an

Illus 17
The mill race

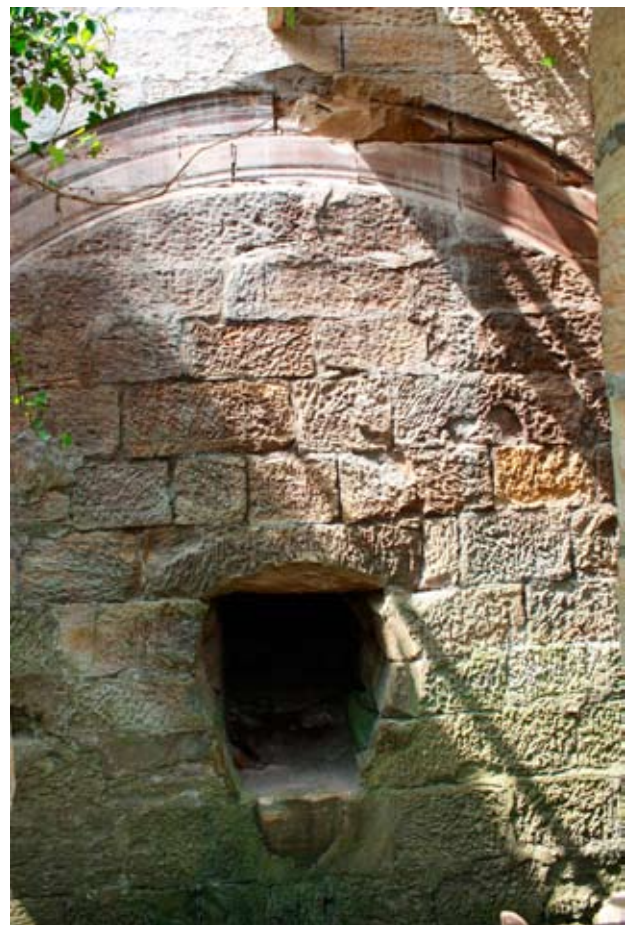
Within the wheel pit are surviving elements of the mechanism. The bearing plate of the outer headstock is located on the platform formed by the south-east wall. The groove worn by the wheel on the south-east wall of the main mill indicates it was approximately 4.20 m in diameter (Illus 18). A survey in 1988 indicated that the wheel was still *in situ* at this date.

Illus 18
The axle aperture and water wheel grooves

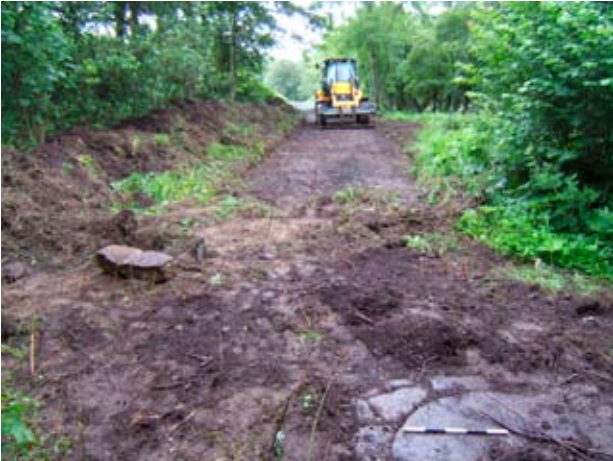
At the north end of the track an existing tarmac surface was revealed extending approx 10 m from the entrance onto the road. Further south, towards the mill, the tarmac gave way to a surface of gravel and stone chippings. The existing tarmac/gravel surface was uncovered at a depth of around 0.1 m and was left *in situ*, with the new road built over it.

Access track following machine-stripping

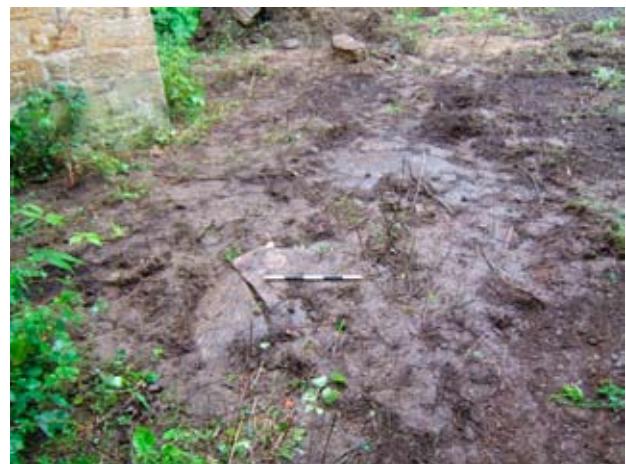
On the north side of the mill, in front of the door and between the kiln house and stone lean-to, the machine was used to clear away a pile of corrugated iron sheets dumped in front of the building. Part of an irregular paved surface, which incorporated two millstones, was revealed in this area (Illus 8 and 21). The north edge of the surface was partially revealed, aligned with the front of the kiln house to the east. The paved surface was not fully exposed but was left *in situ*.

Paved area on NE side of the mill
