Project Code: SNCS09
Date of report: March 2010
Client: McEachern MacDuff Architects

STANDING STRUCTURE RECORDING

St. Ninian's Chancel, St. Ninian's (Stirling)

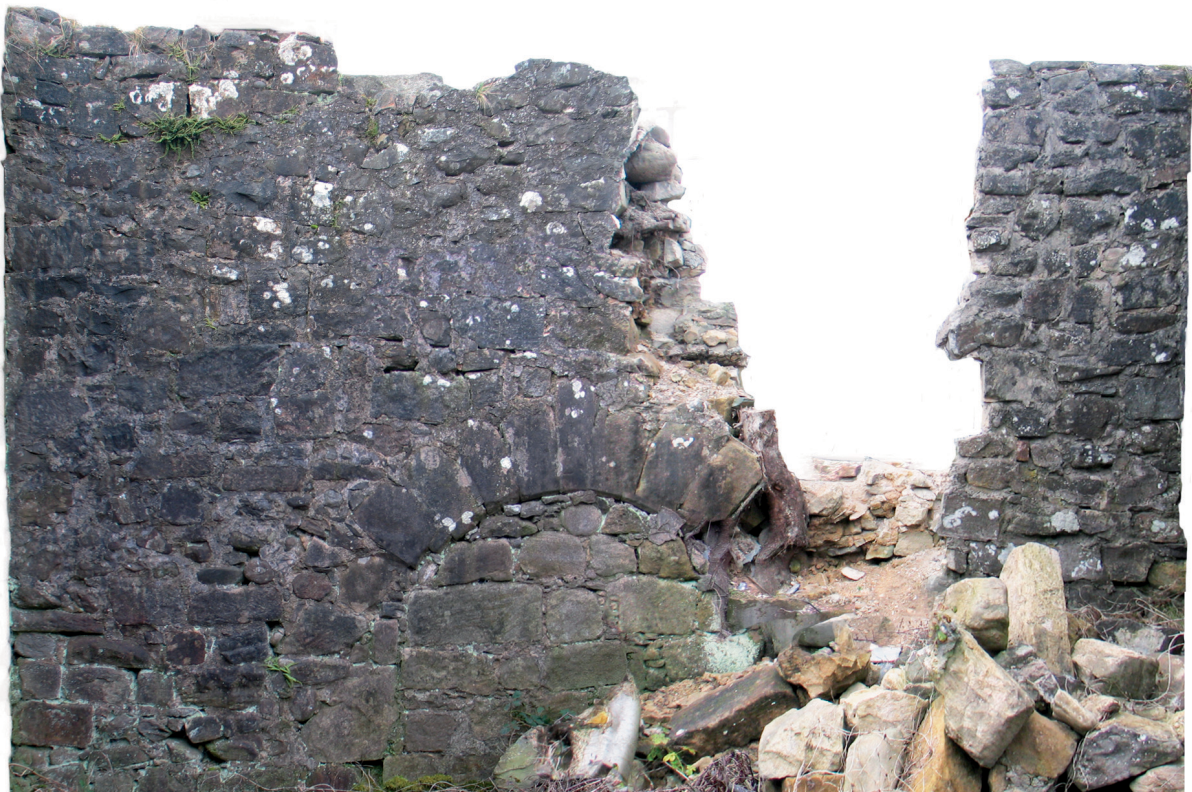
The only other features visible on the exterior of the wall are two small depressions (see Illus 4), one immediately adjacent to it to the west just above ground level and one above and slightly east of the arch's extent. The depression near ground level is roughly 10cm by 6cm and only 1cm deep. The depression higher on the wall is 17cm by 15 cm. It is 2cm deep.

Damage to the wall began when removal of a tree that had grown into the inside face of the wall resulted in almost parallel structural cracks running diagonally from south to North down the wall, the furthest east of these running into the North side of the arch (see Illus 4). These cracks precipitated a partial wall collapse in this area. The line of damage is not identical on both the interior and exterior faces of the wall, so its rubble core and the normally unseen back sides of the facing stones are visible (see Illus 4 and 5).

This record of the damaged wall and fallen stones should assist in planning for the stabilisation and possible consolidation of the west wall in line with the requirements of the Historic Scotland.

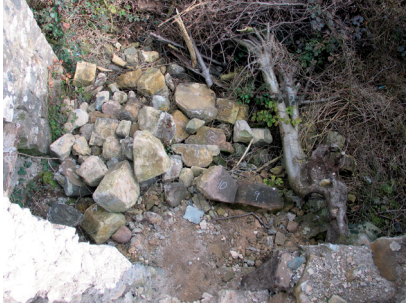
Pile No. A
Stone No. 1-15
Direction E
Description View of pile from above (to west) - stone 15 No.t visible (under fallen tree).

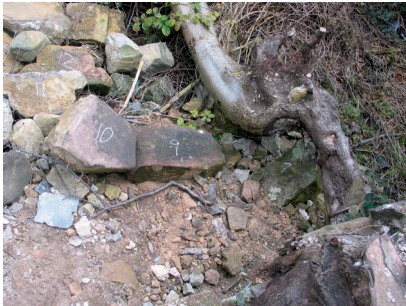
Pile No. A
Stone No. 7-12, 15
Direction E
Description View of pile from above (to west) - location detail stone 15.

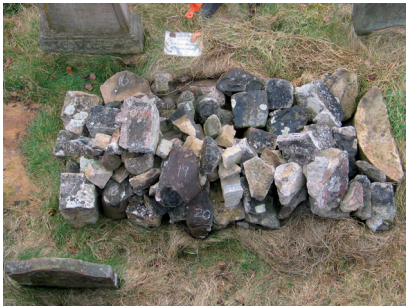
Pile No. B
Stone No. 16-22
Direction W
Description View of pile from above.

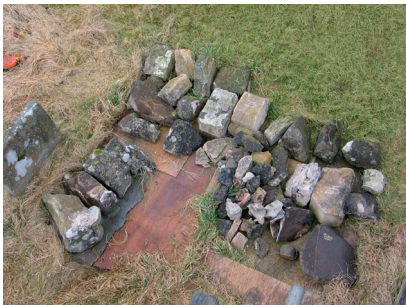
Pile No. C
Stone No. 23-25
Direction NW
Description View of pile from above.

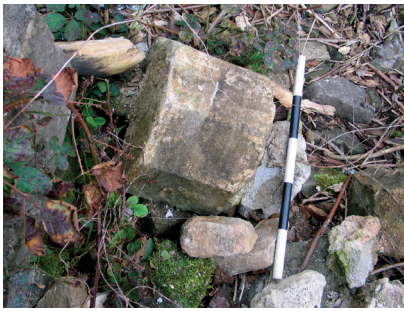
Pile No. A
Stone No. 1
Direction E
Description Block of buff or grey ashlar with chamfered edges - face side.

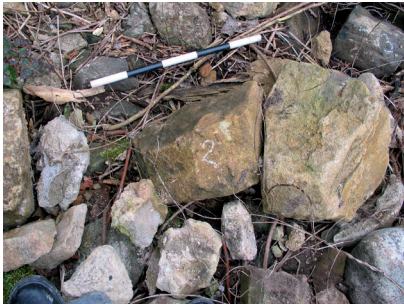
Pile No. A
Stone No. 2
Direction E
Description Block of grey ashlar with chamfered edges - face side.

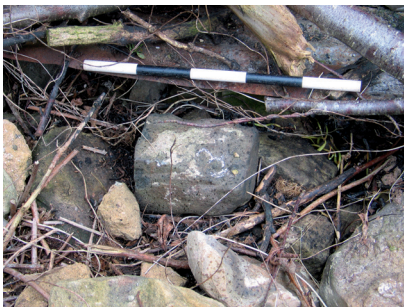
Pile No. A
Stone No. 3
Direction E
Description Hexagonal grey sandstone block? (appears so from face side).

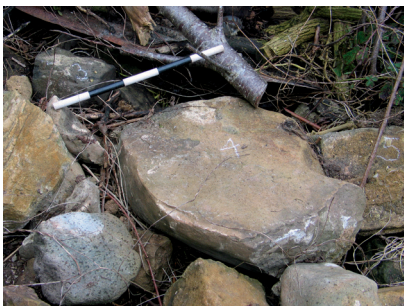
Pile No. A
Stone No. 4
Direction E
Description Buff ashlar stone - unclear if carved on underside.

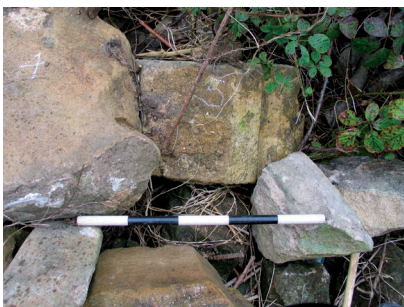
Pile No. A
Stone No. 5
Direction E
Description Block of buff ashlar with chamfered edges - face side - and splayed base in one piece.

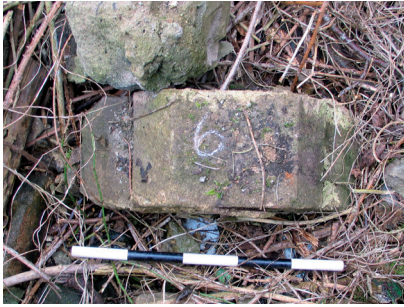
Pile No. A
Stone No. 6
Direction S
Description Block of buff ashlar with chamfered edges - face side - and splayed base in one piece.

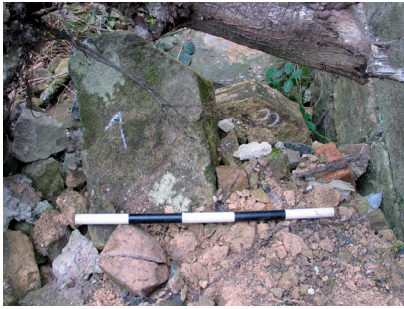
Pile No. A
Stone No. 7 & 8
Direction S
Description Block of grey ashlar with chamfered edges - face side (7).
Block of buff ashlar with chamfered edges - face side (8).

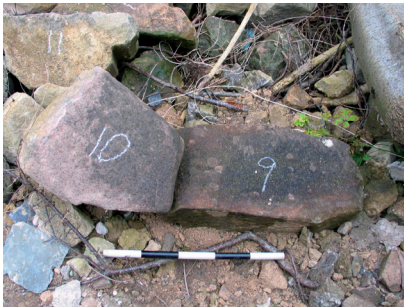
Pile No. A
Stone No. 9 & 10
Direction E
Description Red sandstone voussoirs.

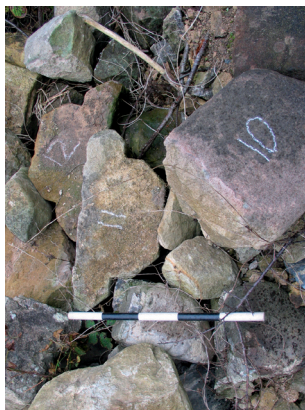
Pile No. A
Stone No. 11
Direction E
Description Block of buff ashlar with chamfered edges - face side - and splayed base in one piece.

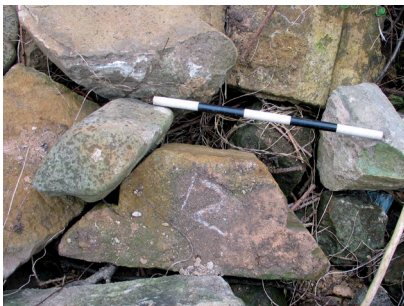
Pile No. A
Stone No. 12
Direction E
Description Block of buff ashlar with chamfered edges - face side - and splayed base in one piece.

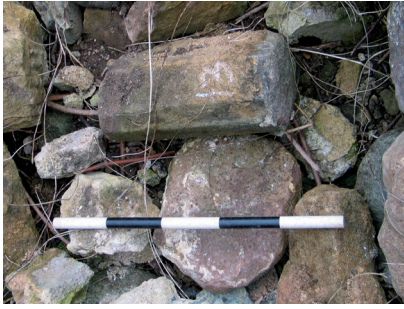
Pile No. A
Stone No. 13
Direction S
Description Grey/buff fluted column section?

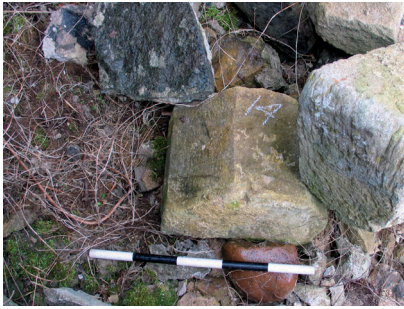
Pile No. A
Stone No. 14
Direction NE
Description Block of buff ashlar with chamfered edges - face side.

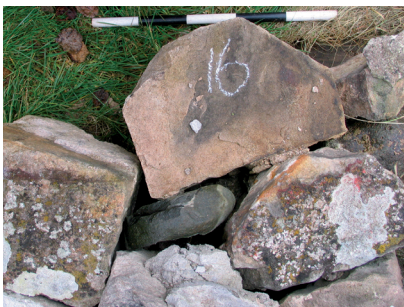
Pile No. B
Stone No. 16
Direction W
Description Block of buff ashlar with chamfered edge.

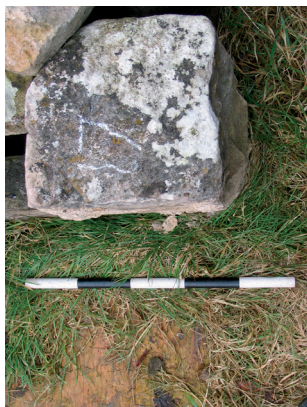
Pile No. B
Stone No. 17
Direction W
Description Block of buff ashlar with chamfered edge.

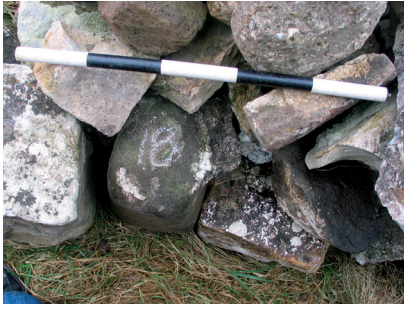
Pile No. B
Stone No. 18
Direction W
Description Grey sandstone voussoir.

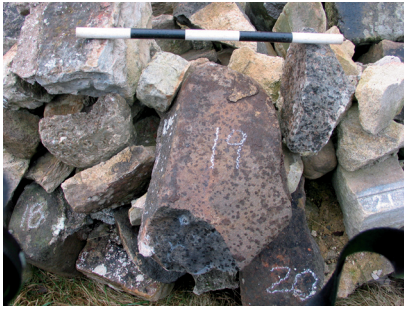
Pile No. B
Stone No. 19
Direction W
Description Red sandstone voussoir.

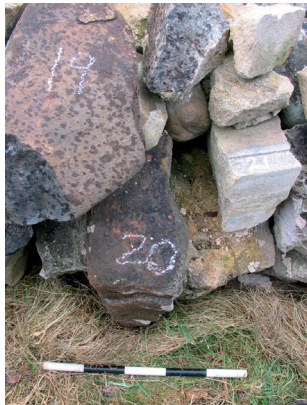
Pile No. B
Stone No. 20
Direction W
Description Red sandstone voussoir.

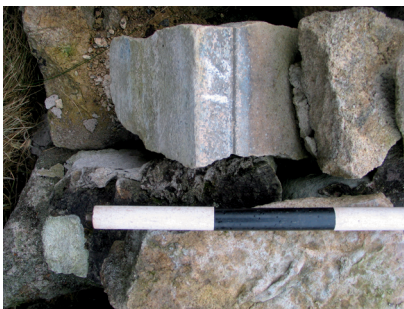
Pile No. B
Stone No. 21
Direction W
Description Block of buff/light grey ashlar with saw marks - unclear if underside is irregularly shaped/weathered or carved.

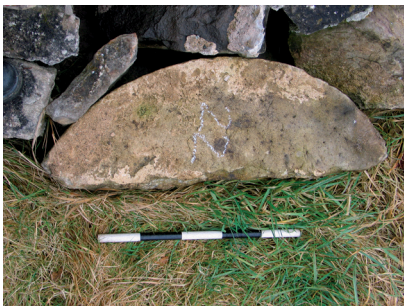
Pile No. B
Stone No. 22
Direction S
Description Buff ashlar stone rounded smooth top with flat faces.

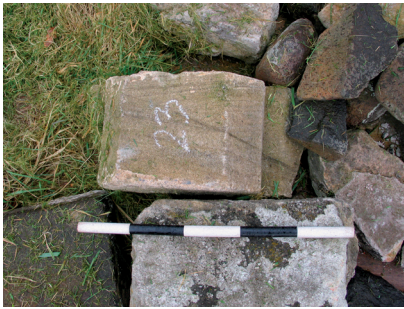
Pile No. C
Stone No. 23
Direction S
Description Block of buff ashlar with chamfered edges - face side - and splayed base in one piece.

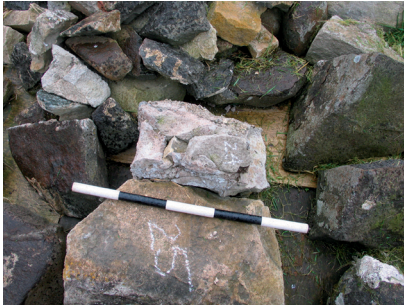
Pile No. C
Stone No. 24
Direction S
Description Broken off astragal moulding in grey ashlar (embedded in a block of concrete).

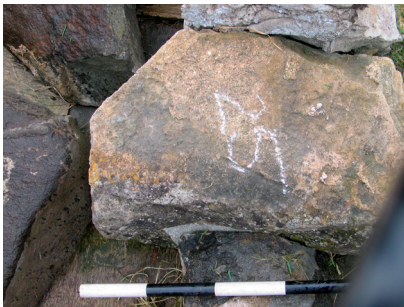
Pile No. C
Stone No. 25
Direction W
Description Block of buff ashlar with chamfered edge - face side.
