Project Code: MYRE10
Date of Report: October 2010
Client: OMI Architects on behalf of Mr Callum Ford

# HISTORIC BUILDING SURVEY OF MYRETOUN BARN, MENSTRIE

Donald Wilson BA AIfA FSA Scot

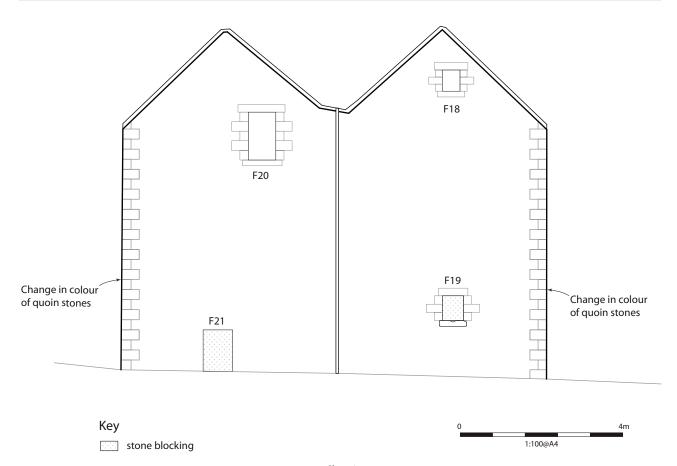
**Illus 4** External elevation of south wall

One of the most striking external elevations to the building is on the south wall. Being the lower part of the slope the wall stands very tall here. The rubble masonry comprised the two gables of the double pitched roof with in-out stone quoins to each side (Illus 5). These quoins were of red sandstone to the height of the ground floor and grey sandstone above and could represent an area of repair to the south end of the barn although no construction line or repair could be seen in the actual wall.

Each of the two gables in this elevation supported a high level window with the one to the east lighting Room A (F18), being somewhat smaller and slightly higher than its counterpart (F20) in Room B. This clearly suggests a difference in levels/use of the upper floors in the interior.

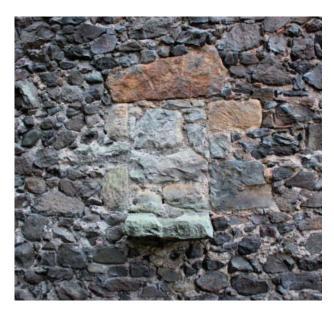
**Illus 6**View of Window F19 (from the south)

Access to the ground floor of Room B was via a now-blocked doorway (F21). The eastern side of this wall also included a window (F19) which incorporated a slop stone (a wide stone with a rounded channel that narrowed towards its end) into the sill (Illus 6). There was evidence that the wall had been repaired, probably in the 20<sup>th</sup> century, as the central section of the wall included areas of cement mortar.

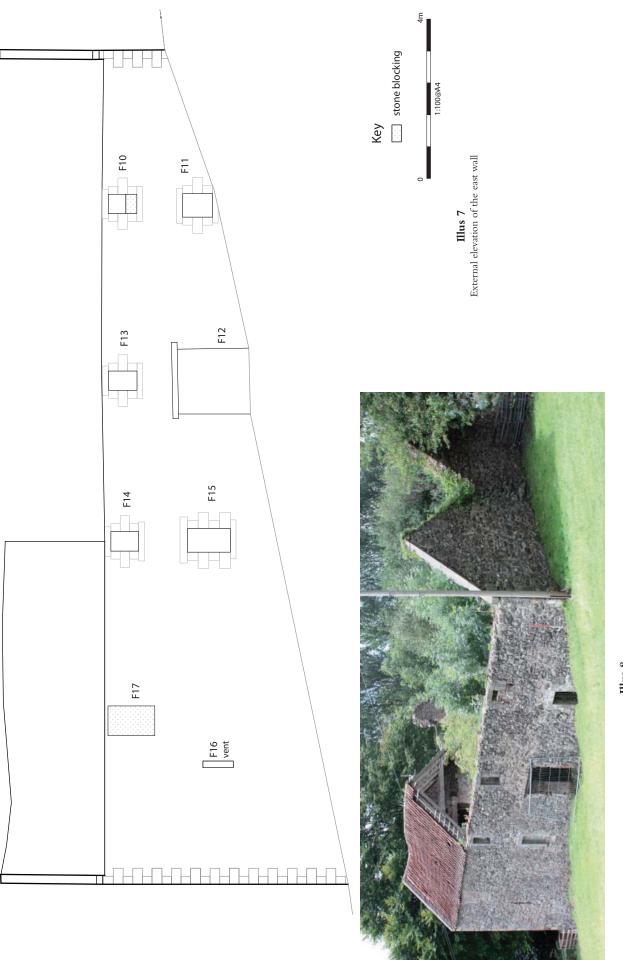
$\label{eq:line_section} Illus~8$  General view of the barn (from the north-east)

The eastern external elevation showed the true incline of the slope with the southern end of the barn more than twice the height of the northern end (Illus 8). The northern part of the elevation comprised a symmetrical unit with wide central door (F12) with window above (F13) flanked, on both floors, by windows (F10 & F11 to the north and F14 & F15 to the south). Even though the current door (F12) had clearly been rebuilt, the symmetry of the features on either side would suggest that it replaced an earlier example in the same location. Certainly there is a suggestion that this part could once

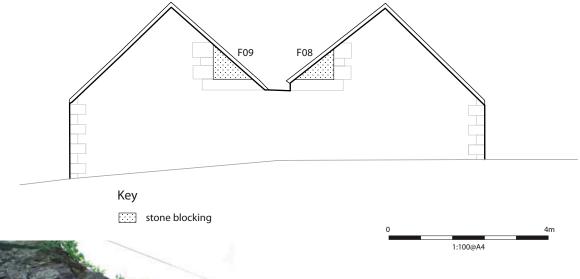
Illus 10
Photograph of window F09 (from the north)

The double gable of the north elevation was very low and included two windows (F8 & F9) that had been truncated by the roof line. These, together with the poorly seated skewputs, indicate that the current structure is not its original form and that there had been a significant change to the roof (Illus 10). In all probability the original build was as a single, wide pitched or hipped roof.

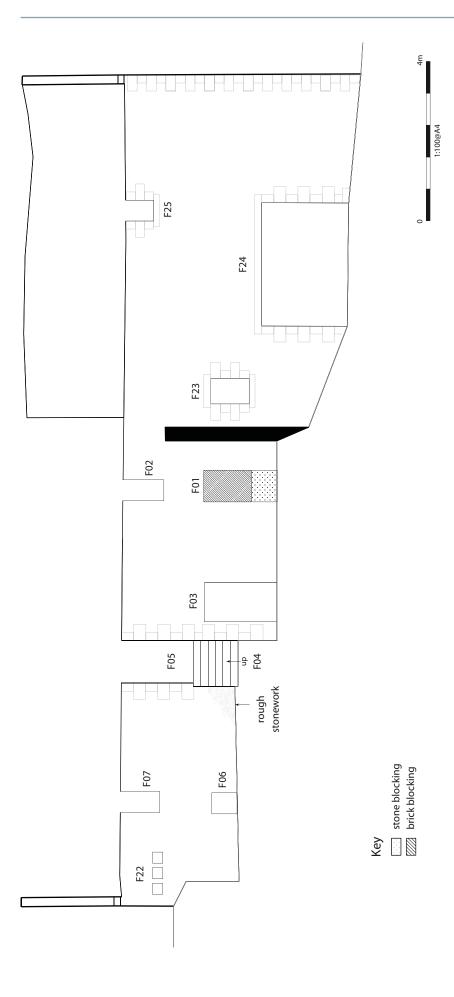
Illus 11
External elevation of the west wall

The west wall is the most complicated elevation with various phases of re-modelling and rebuild. As with the east wall the wall-head has been lowered to accommodate a revised roof structure.

At the southern end of the elevation the wide barn door (F24), albeit somewhat modified, confirmed the evidence from the east wall for an agricultural function as a shed, barn or byre for this southern end of the building.

Further up the slope were a number of doors (F01, part stone-blocked & F03) giving access to the ground floor. There was also an external masonry stair (F04) that gave access, west to east, to the first floor doorway (F05) into Room C. It is clear from scars on the wall to the north of the stairs that these once ran up the side of the wall from north to south.

Other features of note on this elevation were a number of windows (F06, F07, F23, & F25) and a series of beam slots at the far north end of the wall. The slots were probably associated with a now-demolished feature against the west wall.

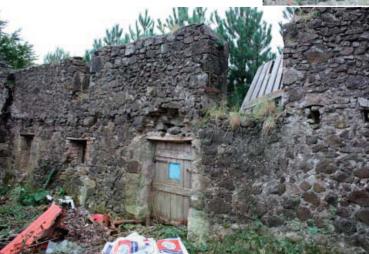
Illus 13
View of Room A & D (from the north)

The entrance to Room A on both floors was though a wide opening (F27 – IIllus 13) on its north wall. On the south wall the base of window F19 was level with the floor indicating that the original levels were probably much lower. The current arrangement evidently brought the Ground floor in Room A to the same level as that in the north part of the building. The wall separating Rooms

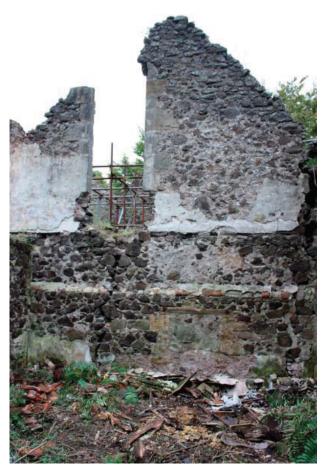
Illus 16
View of Door F31 at the base of the south wall of Room C
(from the north)

A stone blocked door (F31 – Illus 1) on the ground floor of this wall had rough surround stones suggesting it provided the original access into Room B (Illus 16), although due to the change in floor levels between Rooms B and C it was higher up the north wall of Room B suggesting it may have been accessed by timber steps from this room.
