LAMB'S HOUSE LEITH, EDINBURGH

Historic Building Recording and Monitoring of Ground Works

for Groves-Raines Architects

August 2012

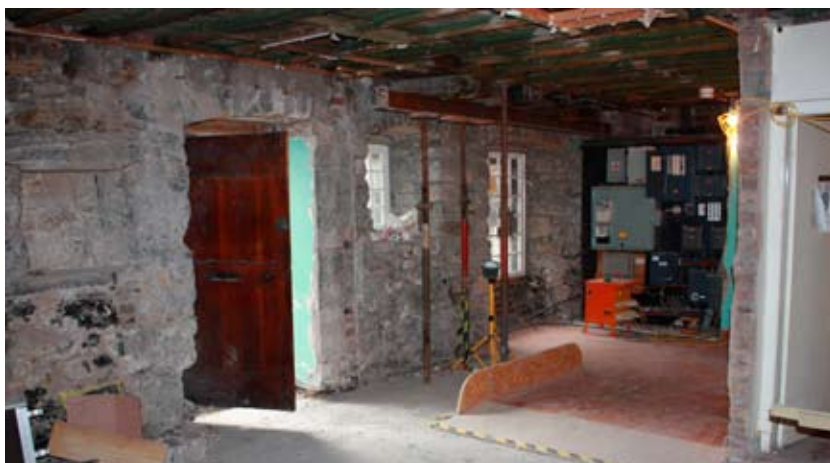
Illus 6

View of door F88

Inserted into the east end of the SW wall was a doorway (F88) with a stone surround, the west side of which has been rebuilt (Illus 6). The slightly wider segmented stone arch above indicated that the door had originally been slightly wider. Window F74 was much wider than many of the other windows and was recessed to the floor, the wall below the window being constructed of brick clearly indicating that this opening had originally been a further door.

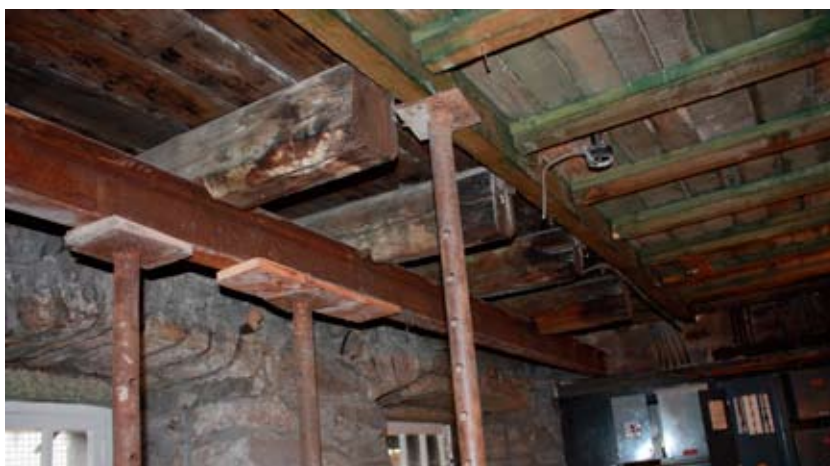
Illus 7

View of ceiling joists on ground floor

Of the surviving ceiling timbers on this level only four (G01–G04) were thought to be of any real antiquity and indeed G03 and G04 provided dendrochronological dates for felling of 1601 and 1598 respectively. These were all located above windows F74 and F89 on the SW wall (Illus 7). They all projected about 1m from beam slots in the main wall above the windows across to a modern steel cross beam. The stone turnpike staircase located at the centre of the SW wall led to all the upper floors.

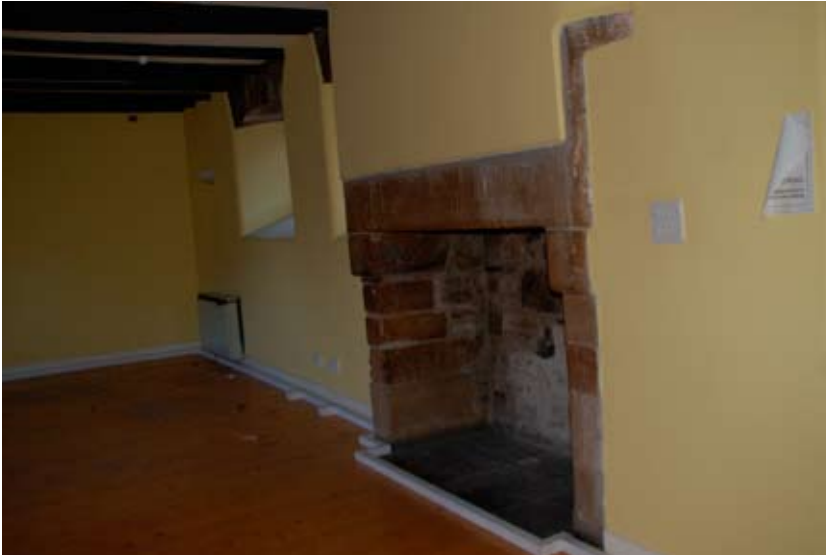
Illus 9

Fireplace F54 on 1st floor

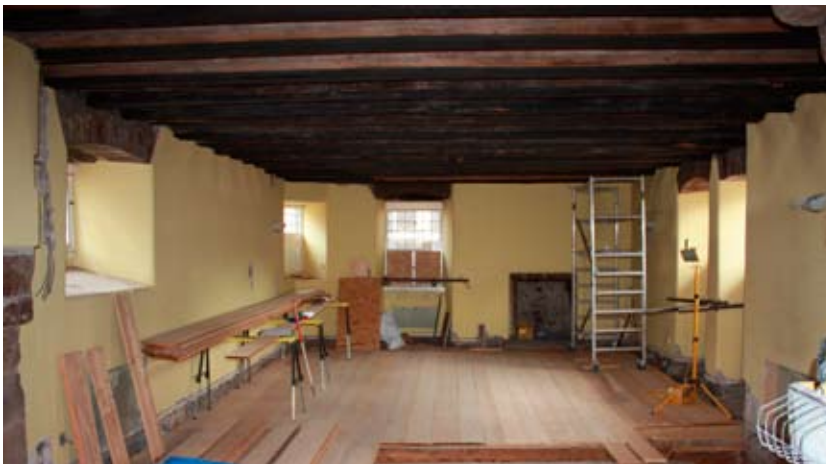
Illus 11

View of NE half of 2nd floor

The second floor (Illus 10 and 11) was similar to the first floor in that the walls were finished with a painted plaster masking any possible early alterations. All the timber floorboards had been replaced except for a small area close to the entrance. The fenestration on the SW wall mirrored that

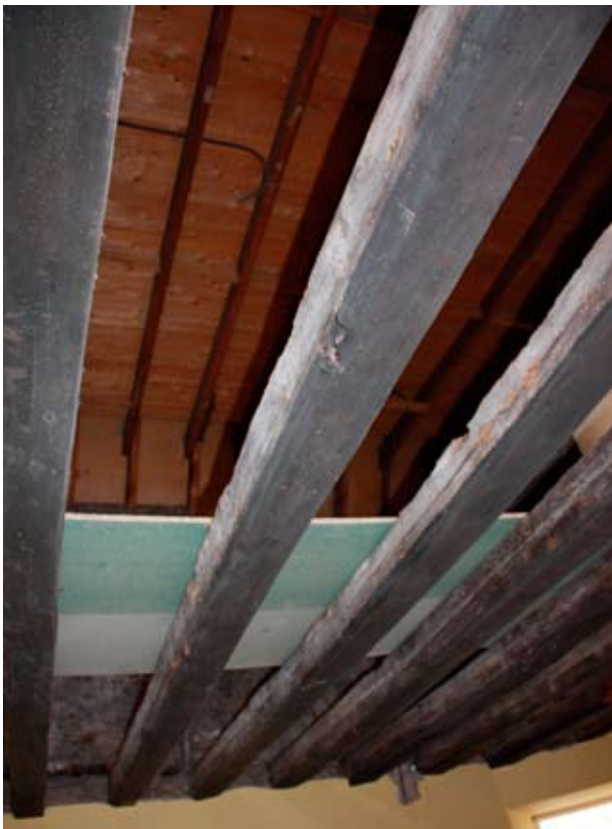
Illus 12

View of 2nd floor ceiling joists

Joists 2-33 and 2-16 included a number of small checks in their underside (Illus 12). These probably identify the location of previous partition walls. Also of note were timbers 2-30 to 2-32, all of which had split joints clamped with iron bolts at their SW ends. This may have been due to an alteration/insertion of the fireplace (F25) on the floor above.

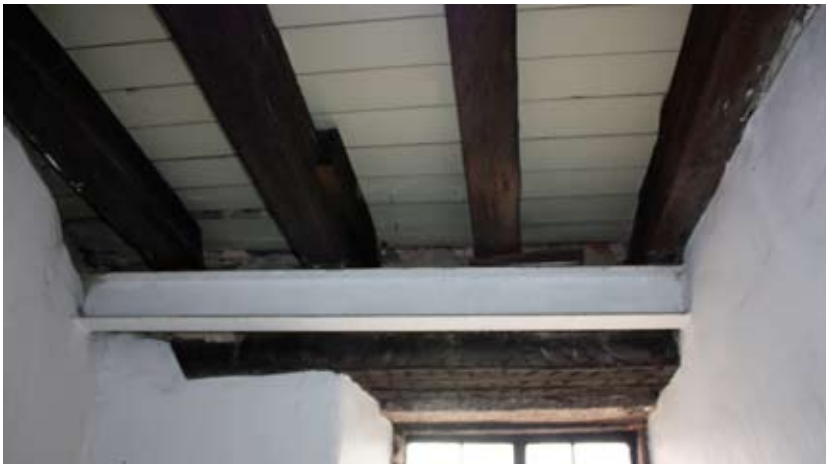
Illus 14

The entrance to the third floor (Illus 13) was reached by the top of the main stairwell but also included a smaller stone turnpike stairwell to the SE that led to the a garret room and the attic space above. The treads of the smaller turnpike stair were much less worn than those of the main stairwell, indicating that the third floor was probably less regularly used. It is possible that this floor was originally accessed by ladders or wooden steps although no evidence for this was recorded. The ceiling of the main stairwell included a number of original timber beams (Illus 14), timbers 3-01 to 3-07.

View of timbers in stairwell on the 3rd floor

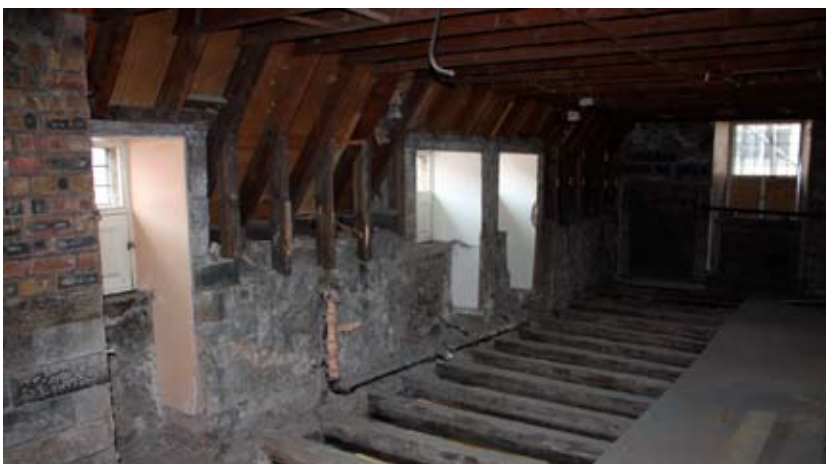
Illus 15

View of NE & SW walls on the 3rd floor

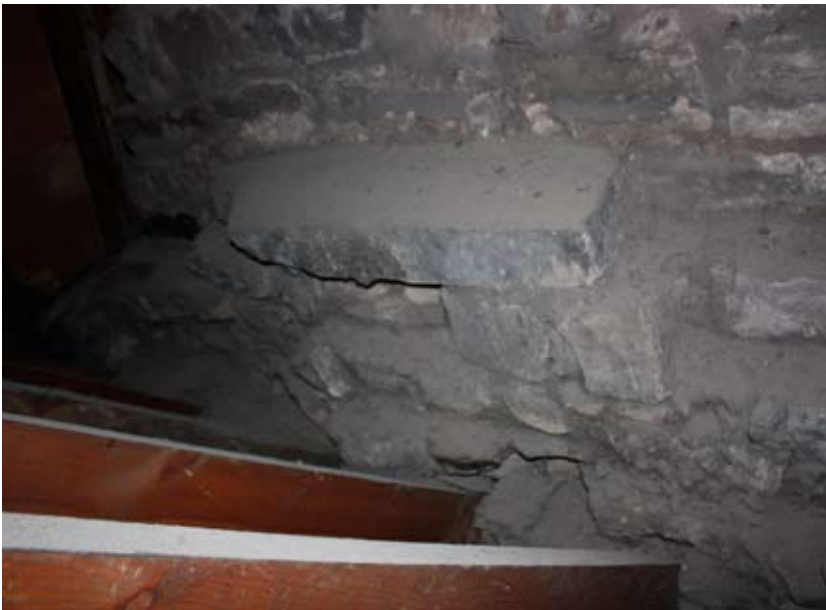
◀ **Illus 17**

Detail of SW wall-head gable showing the change in thickness

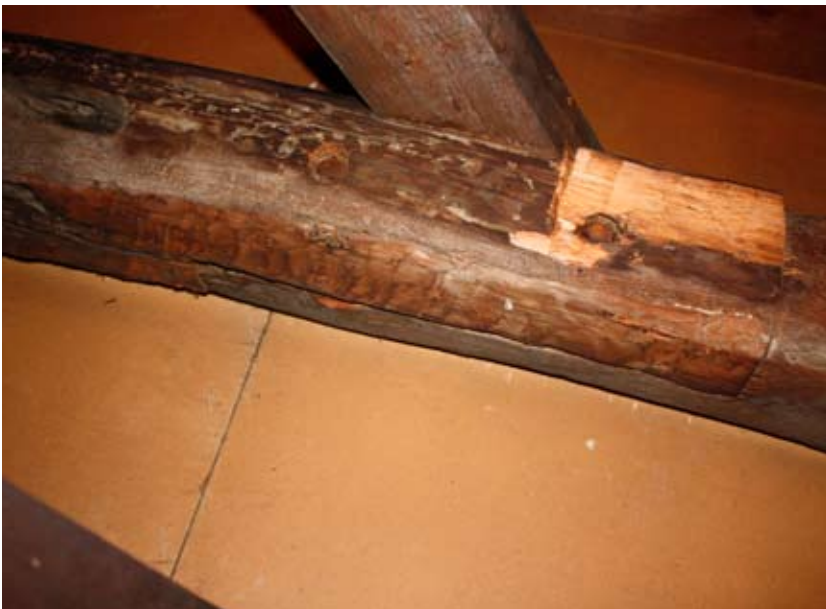
◀ **Illus 18**

Detail of splice joint on timber rafter

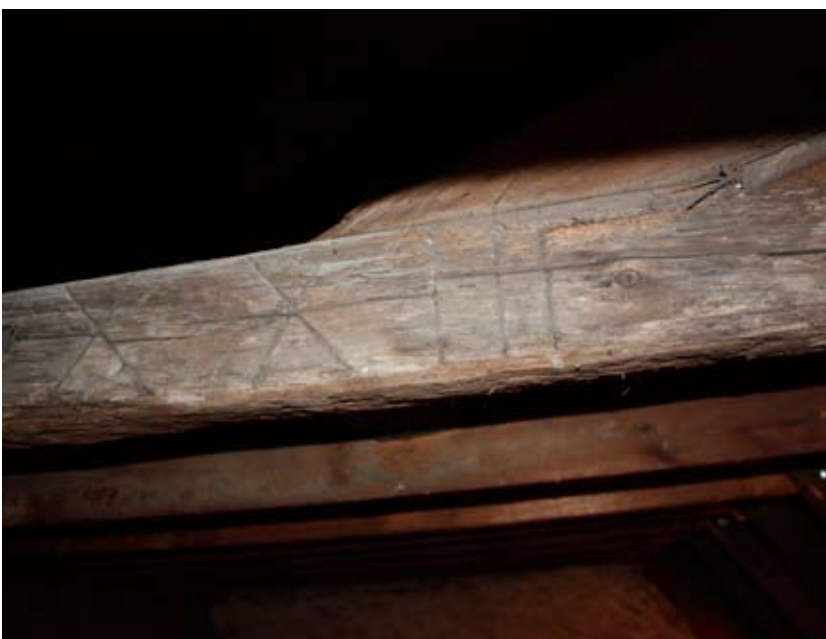
◀ **Illus 19**

The majority of the rafters had been replaced but a number of older and possibly re-used roof timbers were recorded in the attic space. Of these timber rafters A-01 to A-03 included half lap splice joints two of which were top over bottom joints the third having a side by side joint (Illus 18). All three rafters had one or more mortice and tenon joints at various points along the timbers. This may indicate that they are re-used timbers. Rafter A-03 also had a carpenter's mark 'XXIII' (Illus 19).

Carpenter's mark on timber rafter

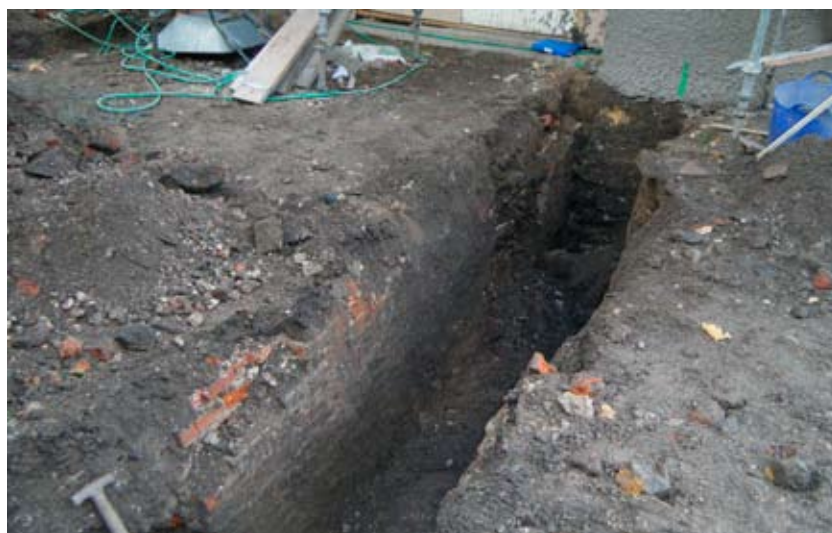
Illus 21

View of brick wall [048] from the SW

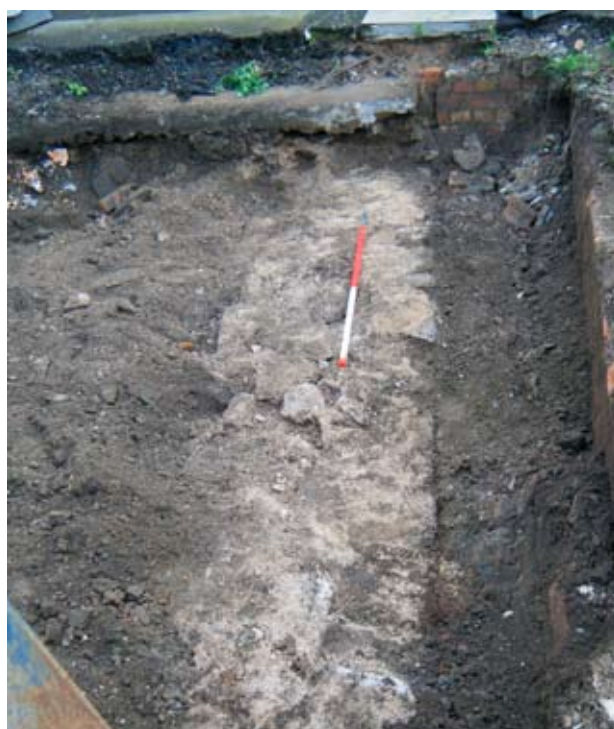
Illus 22

View of wall [050] from the NW

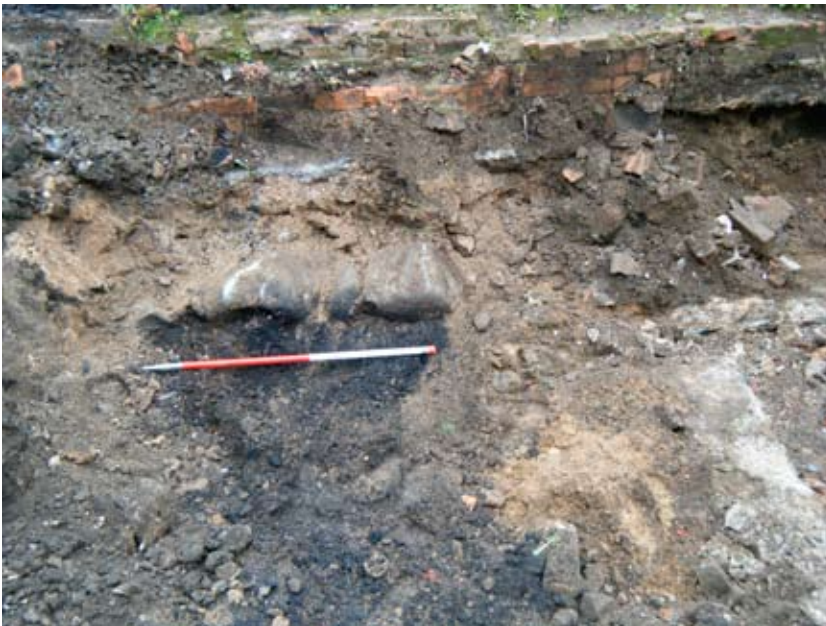
◀ **Illus 23**

Detail of wall [050] exposed further to the west

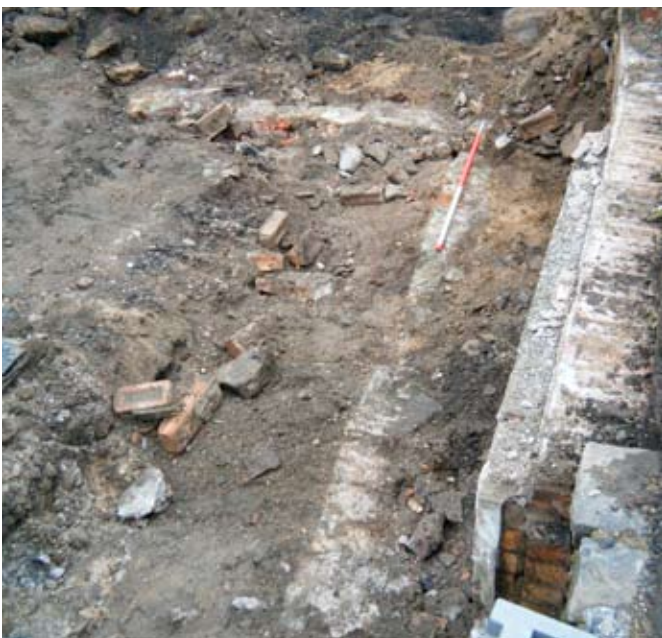
◀ **Illus 24**

View of wall [054] from the west

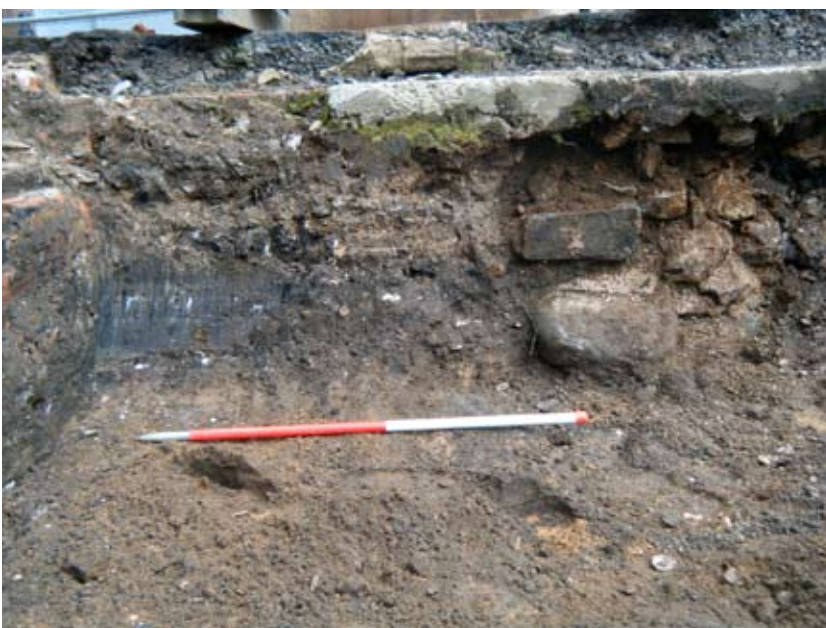
◀ **Illus 25**

Detail of NW facing section showing the remains of wall [055]

Disturbed remains were recovered of what are thought to be the footings a further wall [055] running parallel to both Lamb's House to the N and wall [050] to the S. In plan, this was formed of two areas of loose rubble bonded with lime mortar sitting on the alluvial sand. This wall was removed during the ground reduction works but was recorded in the NW facing section (Illus 25) of the development area. This wall along with wall [050] probably represent the remains of the building first clearly depicted on the 1852 Ordnance Survey map but potentially having much earlier origins. This mapped building may even have originally been contemporary with Lamb's House as we know this faced onto a narrow lane leading down to the shore. Immediately N of wall [055] a small spread of dark brown sand [052] with frequent oyster shell and animal bone, possibly represents the remains
