## KIRK LOAN, CORSTORPHINE

*Historic Building Recording*

*for Ms C Leeson*

*10/00519/FUL*

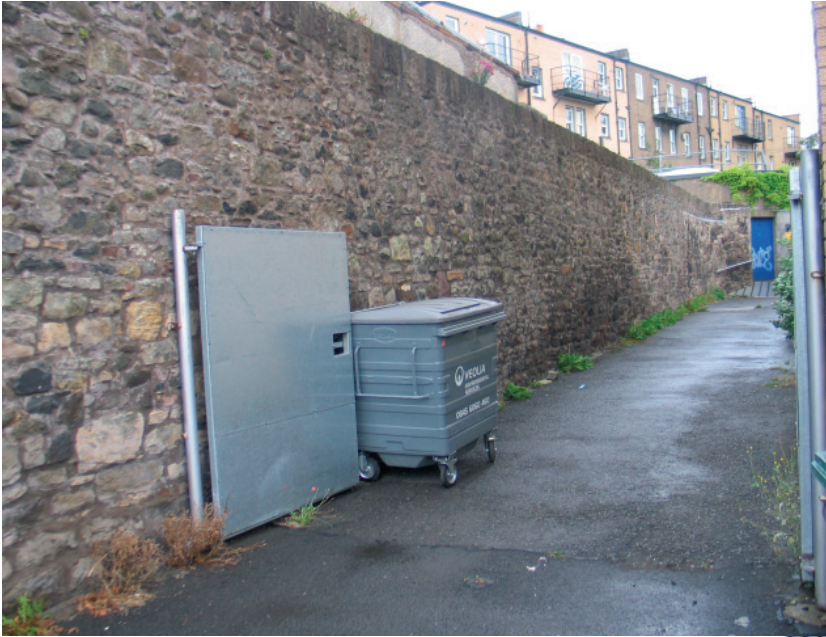
The S edge of the site is defined by a substantial wall (Illus 6). It is approximately 3.5m in height and consists of random uncoursed stone with dressed copestones. It has been consolidated with concrete at the W end.

◀ **Illus 6**  
*The boundary wall from the SW*

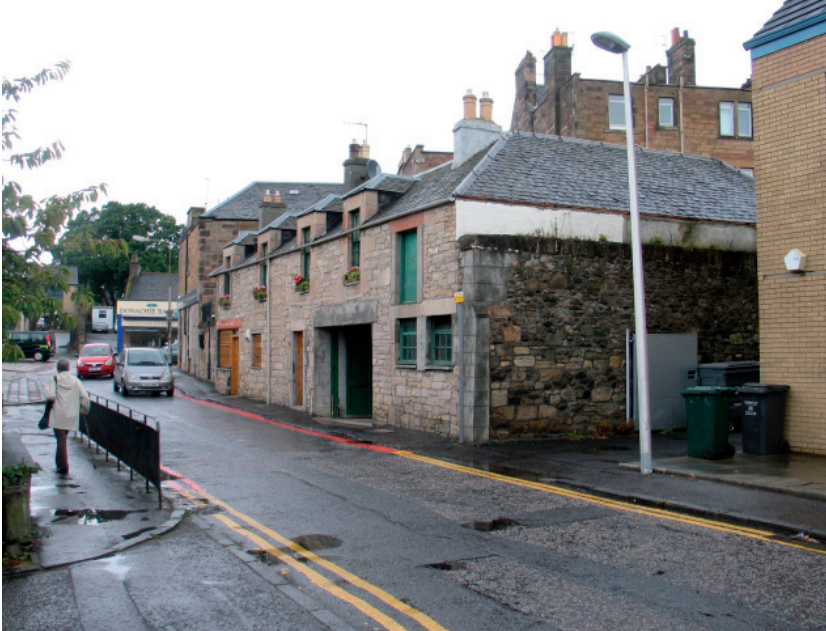
To the immediate NW of the site, a two-storey, four bay row of dwellings faces onto Kirk Loan (Illus 7). It is built of coursed, squared stone, with a double-pitched slate roof punctuated by four tall 15-pane dormer windows. A pend near the S end (Illus 8), suitable for vehicles and closed with a sliding wooden door, allows access to the courtyard behind, but this appears to be a later modification with a substantial concrete lintel and internal walls of whitewashed brick.

Building A is an extension of the above row that continues the street façade southwards to meet the boundary wall (Illus 7).

◀ **Illus 7**  
*Building A from Kirk Loan, showing boundary wall*

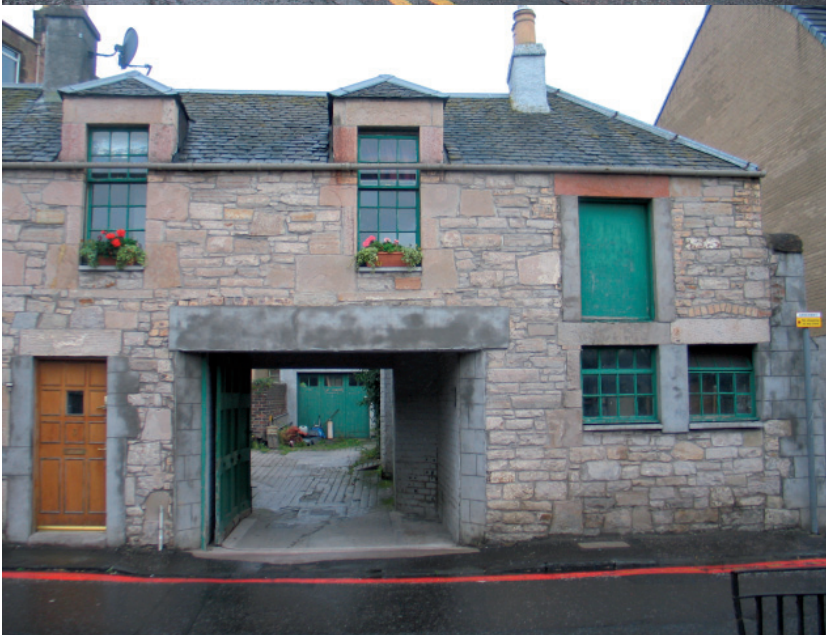
Although the style of masonry of Building A matches, well with the rest of the row, it can be identified as a later addition by a clear straight-line joint and differences in architectural detail. The regular pattern of dormer windows is broken, the S facing roof is higher, and the chimney stack is somewhat smaller. Two small 12-pane ground floor windows and a larger access door on the upper floor are surrounded with concrete frames (rather than stone), and one has a small decorative brick arch above.

◀ **Illus 8**  
*W elevation of Building A*

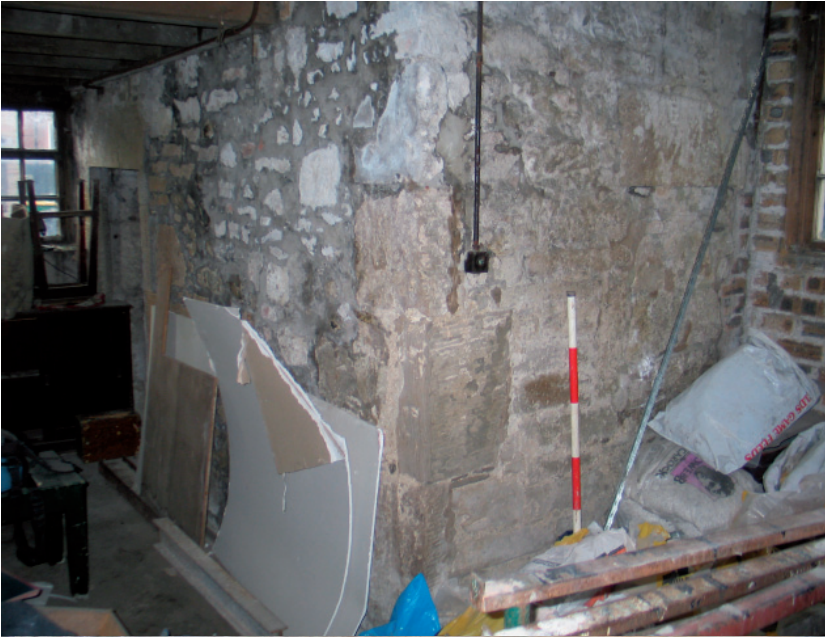
◀ Illus 9

Inside, the ground floor of Building A is a continuation of Room B1. The former S and E walls of the original row now form an internal corner (Illus 9). A blocked ground-floor window is visible in the E facing elevation. The construction of the pend has truncated a ground floor room, leaving a narrow space accessed through an original external doorway (Illus 10). At the interface between Room B1 and Building A, a change in the loft floor level is accommodated by a slope supported on wooden rafters (Illus 11).

*Building A – former SE corner of original building*

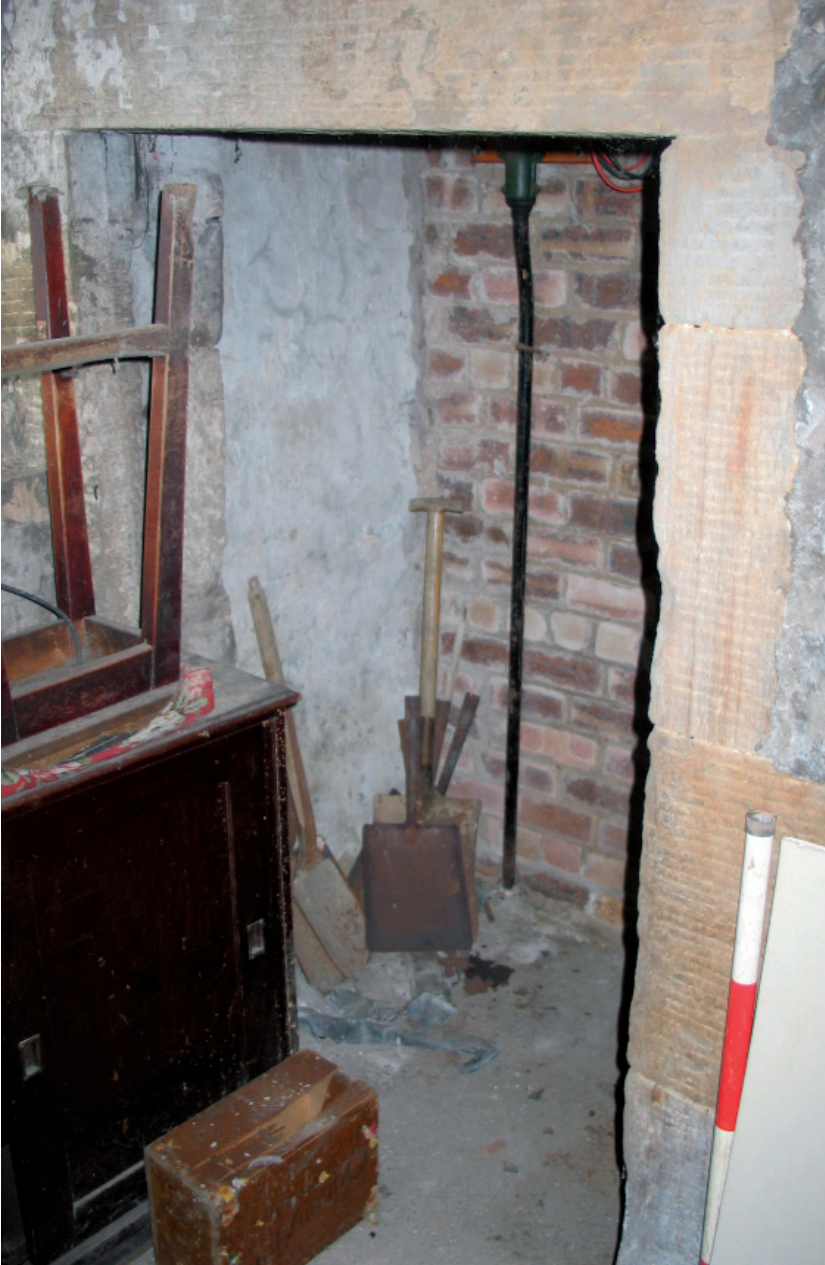
◀ Illus 10

*Building A – doorway to the alcove*

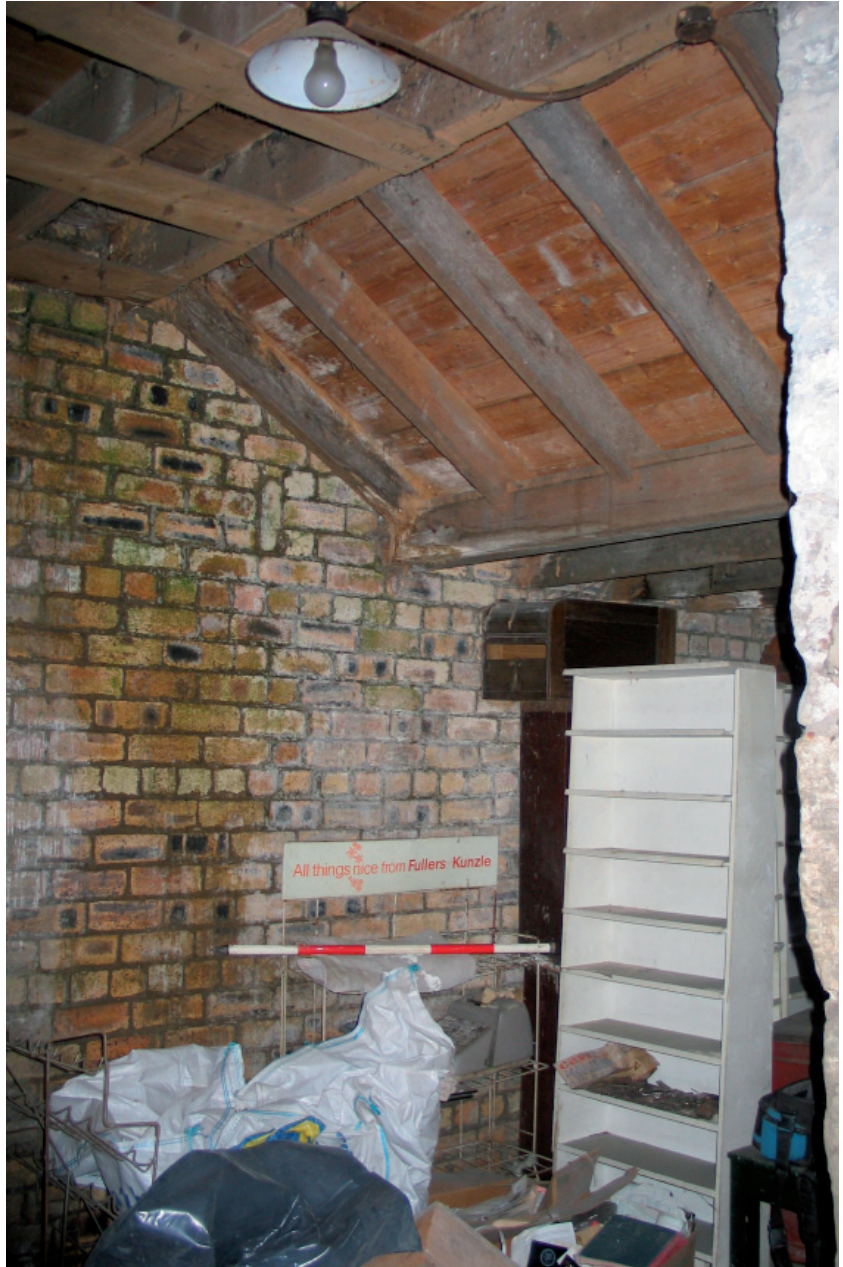
Illus 11 ►  
*Building A – change in level of loft floor*

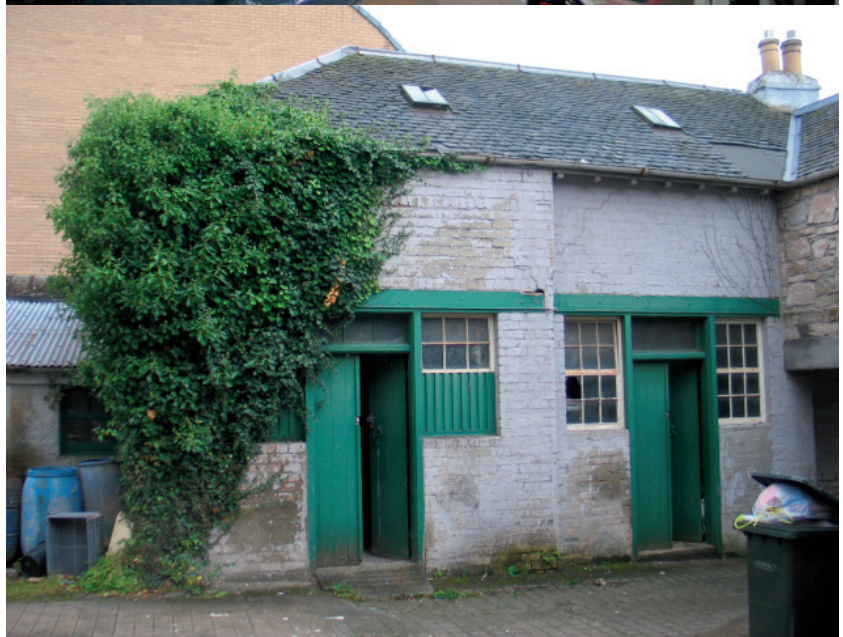
Building B is a 1½ storey, two bay structure facing to the S side of the courtyard (Illus 12). The W bay is slightly recessed. The building is of whitewashed brick with a double pitched slate roof providing the height for an upper floor. This loft is lit by two N facing rooflights. Access to the ground floor rooms is provided by two pairs of narrow doors, each flanked by two 12-pane windows and a 3-pane transom window above. Long wooden lintels support the wall above each.

Illus 12 ►  
*N elevation of Building B*

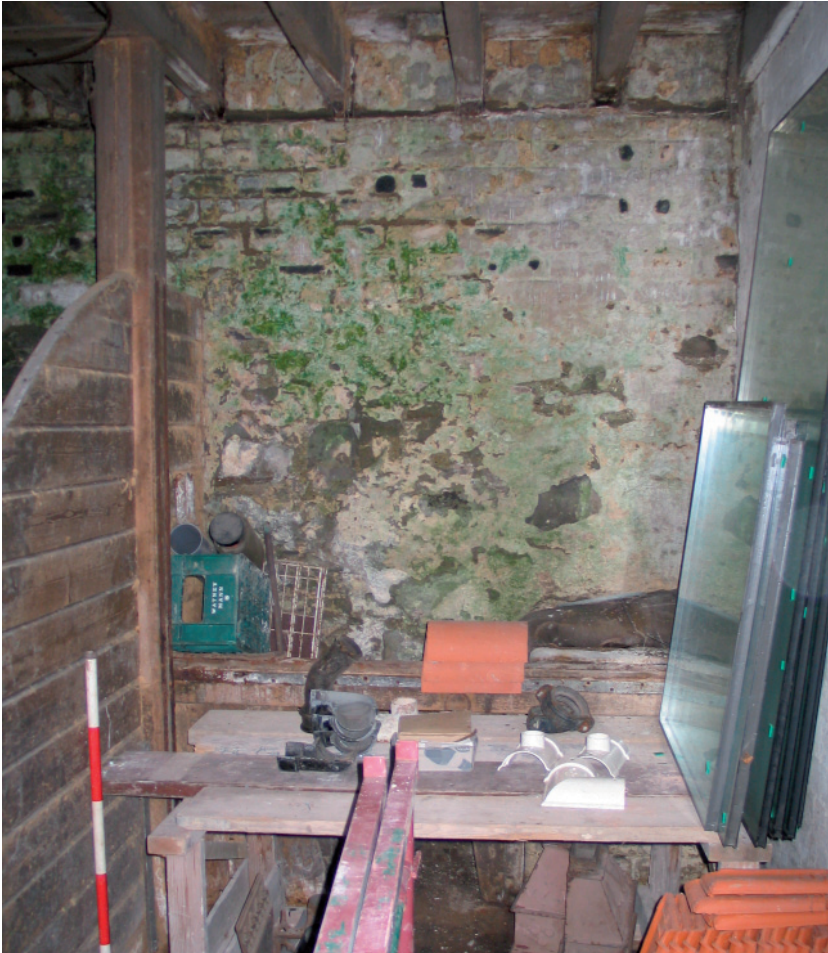
The adjacent room to the E (B2) has a S wall of stone (Illus 13), which has been consolidated with brick in

places especially nearing the top of the wall to provide support for the loft floor joists. It is unclear whether the stone is part of the boundary wall, or is a separate facing. The floor is of concrete and has a shallow drainage pattern cut into it. The building has clearly been used as a stable as a timber trevis and mangers are still *in situ* (Illus 14). A panelled wooden structure in the NW corner reaches from floor to ceiling, and has a small access door (Illus 15). A ladder in the NE corner leads to a small hatch providing the only access to the loft space. The timber floor joists are in a poor state along the S side.

◀ **Illus 13**  
*S internal elevation of Room B2*

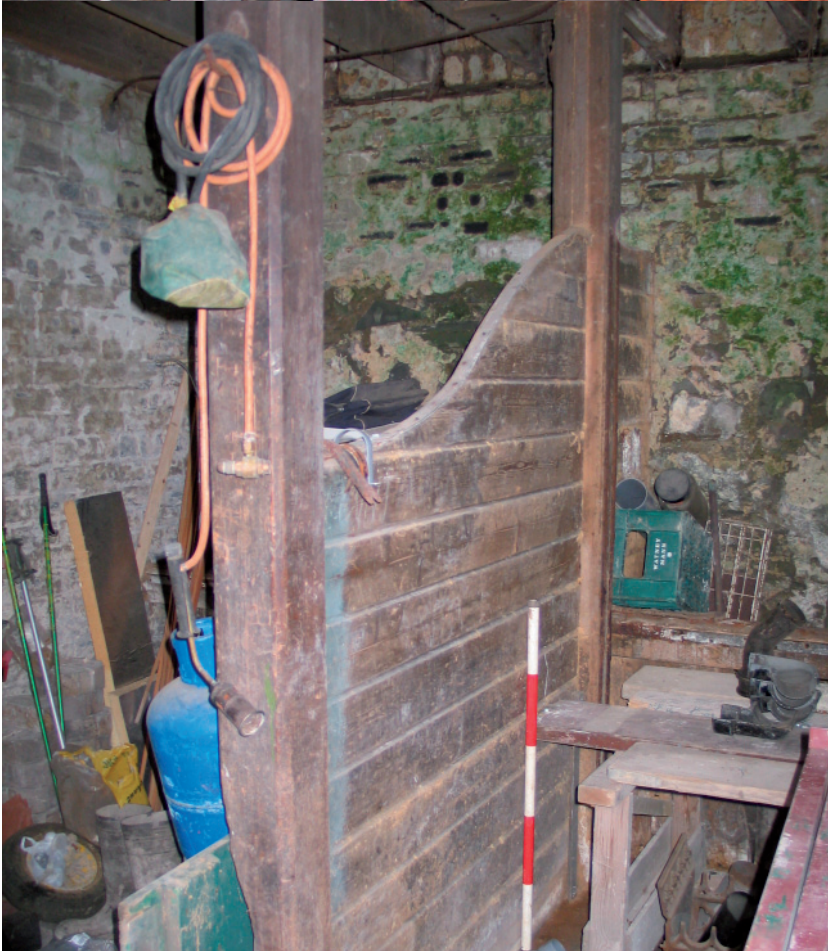
◀ **Illus 14**  
*Room B2 – timber divider*

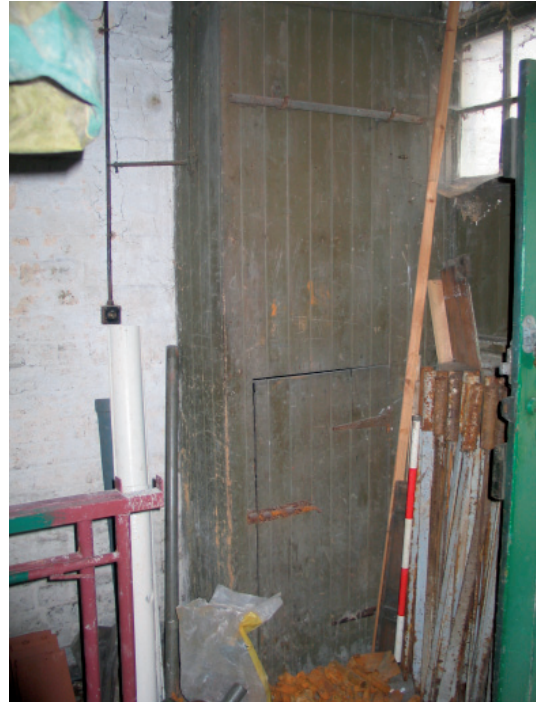
Illus 15 ►

Room B2 – wooden structure

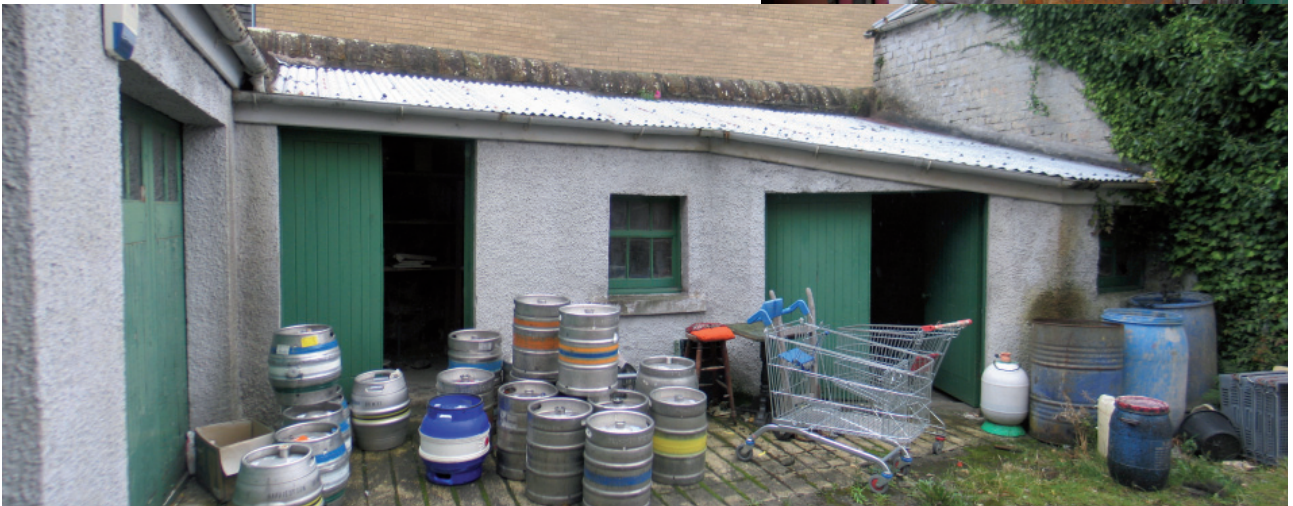
Illus 16 ▼

Building C continues E of Building B (Illus 16). It is a single floor lean-to (against the boundary wall), built of harled brick and pitch-roofed with corrugated iron over timber beams. This building may have been modified to accommodate the construction of the garages (Building D). Where the two abut, the flat timber roof of the garages is continued over to the boundary wall. Additionally, Building C has been narrowed substantially at this point.

N elevation of W end of Building C

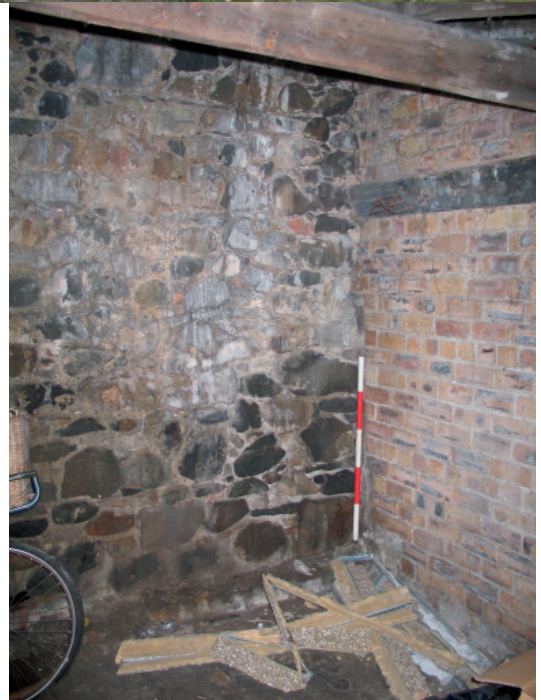
Illus 17 ►

The change in width is accommodated to the W by an angled NE facing wall. Room C1 is accessed by a wide double door in this wall. A small 6-pane window punctuates the N wall. The floor is of flagstones with a small raised lip running along the boundary wall (Illus 17).

Room C1 – showing boundary wall and lip in floor

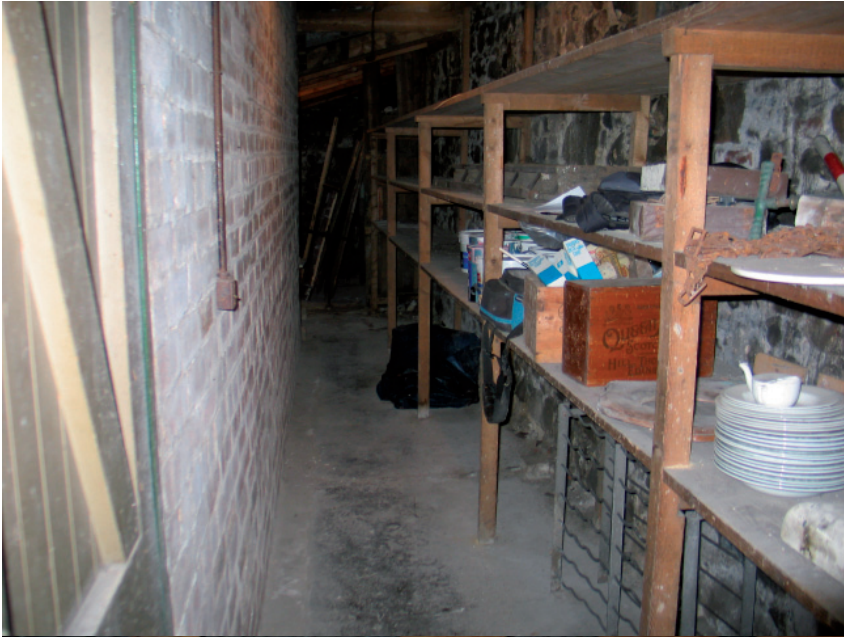
◀ Illus 18

*Room C2 – narrow section looking E*

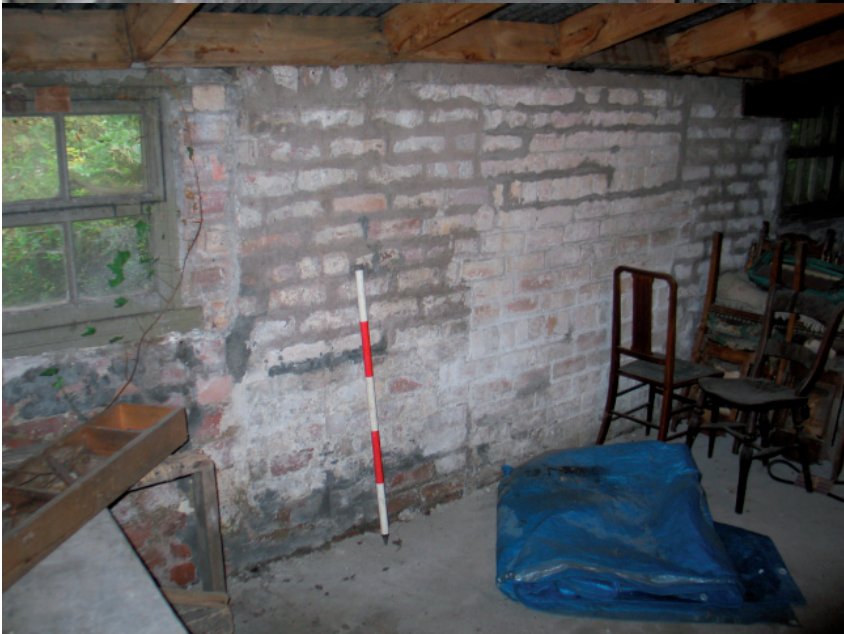
◀ Illus 19

*Room C2 – possible blocked doorway*

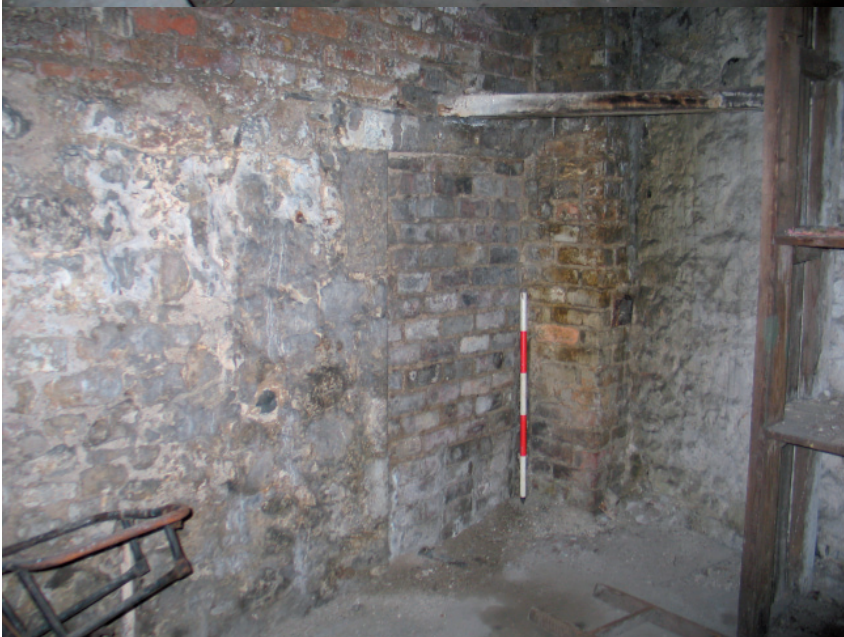
◀ Illus 20

Room C2 is entered through a double door in the N wall. A small 6 pane window (as that for Room C1) can be found slightly to the W. The W of the room is narrow (Illus 18), but E of Building D it is of similar width to Room C1. The floor is of poured concrete. Many rafters appear to have been replaced. The wall dividing this room from C1 is constructed of similar brick to that of Building D. Full height wooden racking runs along the exposed boundary wall for the whole length of the room. At the E end, two windows (6-pane and 12-pane) flank a possible blocked doorway on the N wall (Illus 19). The SE corner of the room is built out with brick (Illus 20). A second blocked doorway leads out of the E of the building.

*Room C2 – blocked door and brick corner*

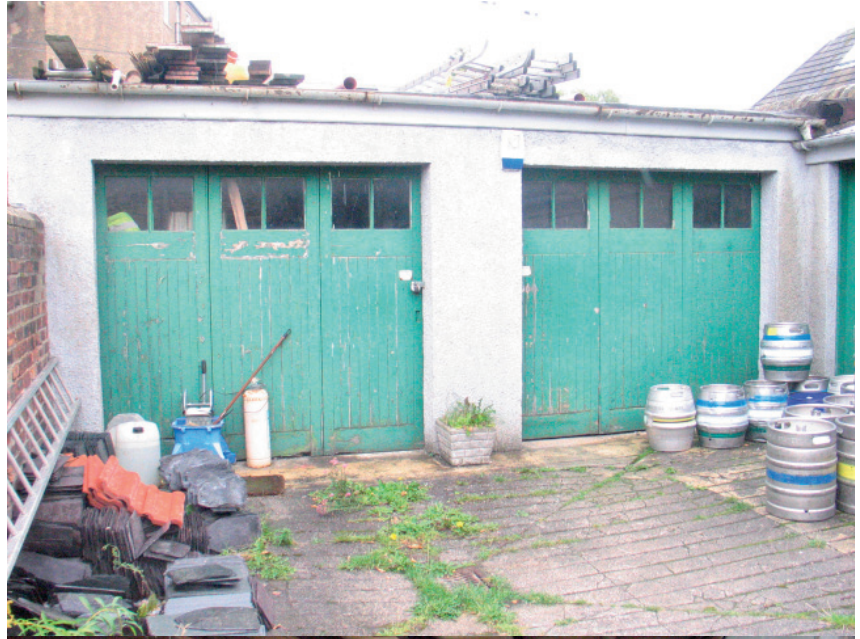
Building D is a flat roofed double garage of harled brick (Illus 21). The garages are accessed through large folding doors with 3 double pane windows and a smaller access door in each. These are of a similar style to the doors and windows of Building C, as well as the sliding pend door. Each garage has a poured concrete floor and a small window in the E wall (Illus 22).

Illus 21 ►  
*W elevation of Building D*

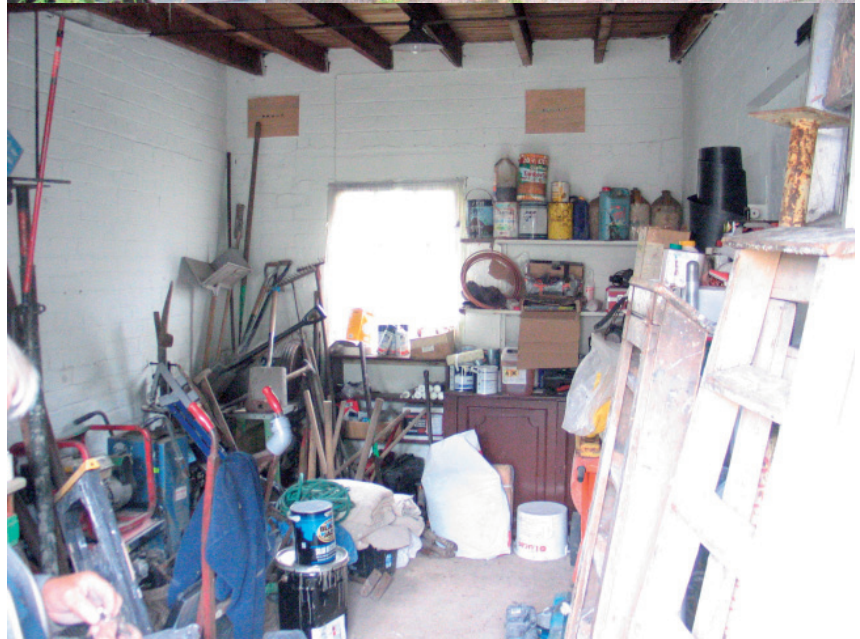
Illus 22 ►  
*Building D – interior of N garage*
