Project Code: CFRH10
Planning Ref No: DMCE/092578/F
Date of Report: July 2010
Client: Tracey Goodwin
HAS: 854

ARCHAEOLOGICAL WATCHING BRIEF AND HISTORIC
BUILDING SURVEY ON CHURCH FARM,
ROTHERWAS, HEREFORD

David Doyle
BSc

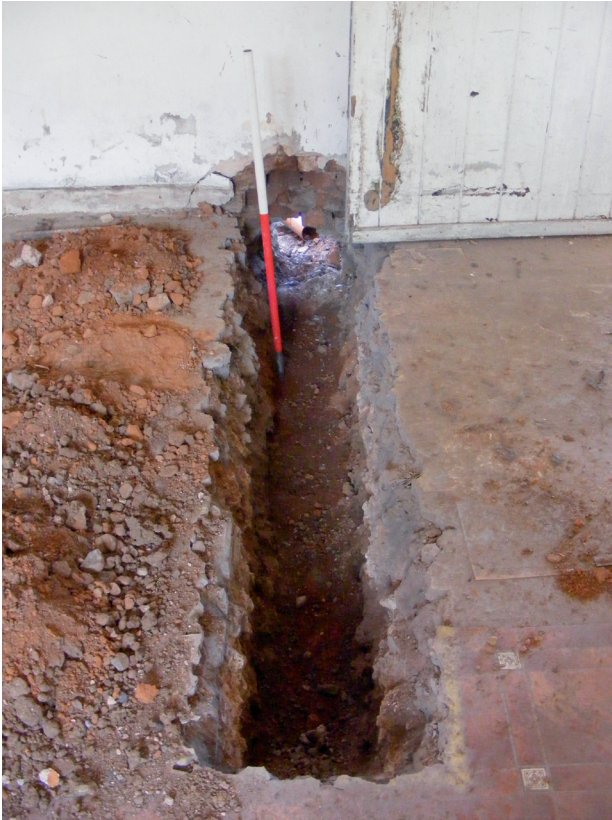
Illus 5

The external foul services exposed some of the building's footing as they entered the rooms GF001, GF003, GF008, GF009, GF010 and GF014 (Illus 5). The footings were approximately 0.4m deep and below this was a former topsoil [002]. The floor surfaces in all rooms were approximately 0.1m in depth and below this was a mixed rubble topsoil [001].

Drainage entering Church Farm at room GF008, Unit 4

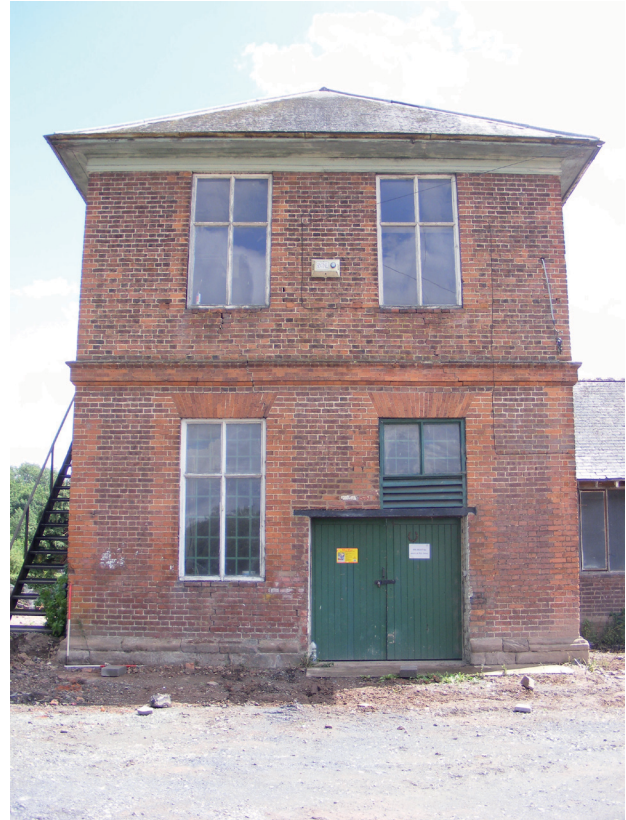
Illus 6

Altered opening on the N-W elevation of two storey pavilion, Unit 1

The northwest elevation of Unit 1 shows a large altered opening with a steel lintel that is now its main entrance (Illus 6). This will be reinstated and the window restored. The southeast entrance will then become the main entrance.

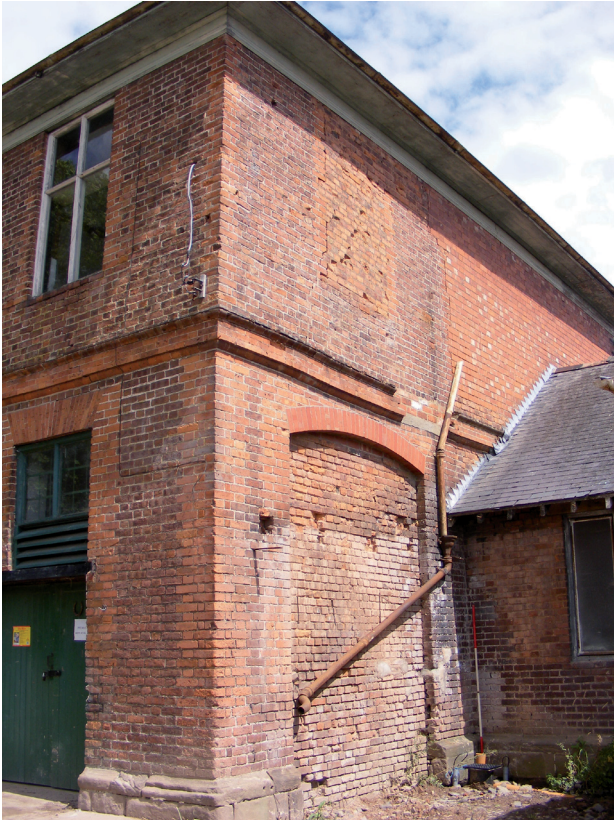
Illus 7

The north end of the southwest exterior wall contains a blocked doorway, with a shallow arched lintel, that was most likely a coach entrance in the 19th century. Above this is some damaged masonry and an infilled window (Illus 7). The metal stairs on its northeast side do not form part of the listed building and will be removed. On the southeast elevation two narrow windows are visible, which were most likely air inlets relating to the earlier use of the building as a stable house, and the northwest elevation shows clear brickwork restoration at first floor level. There is no evidence of the small attached building seen on the OS 1885–1886 or 1903 maps.

Infilled window, infilled arched doorway and repaired masonry on S-W elevation of two storey pavilion, Unit 1

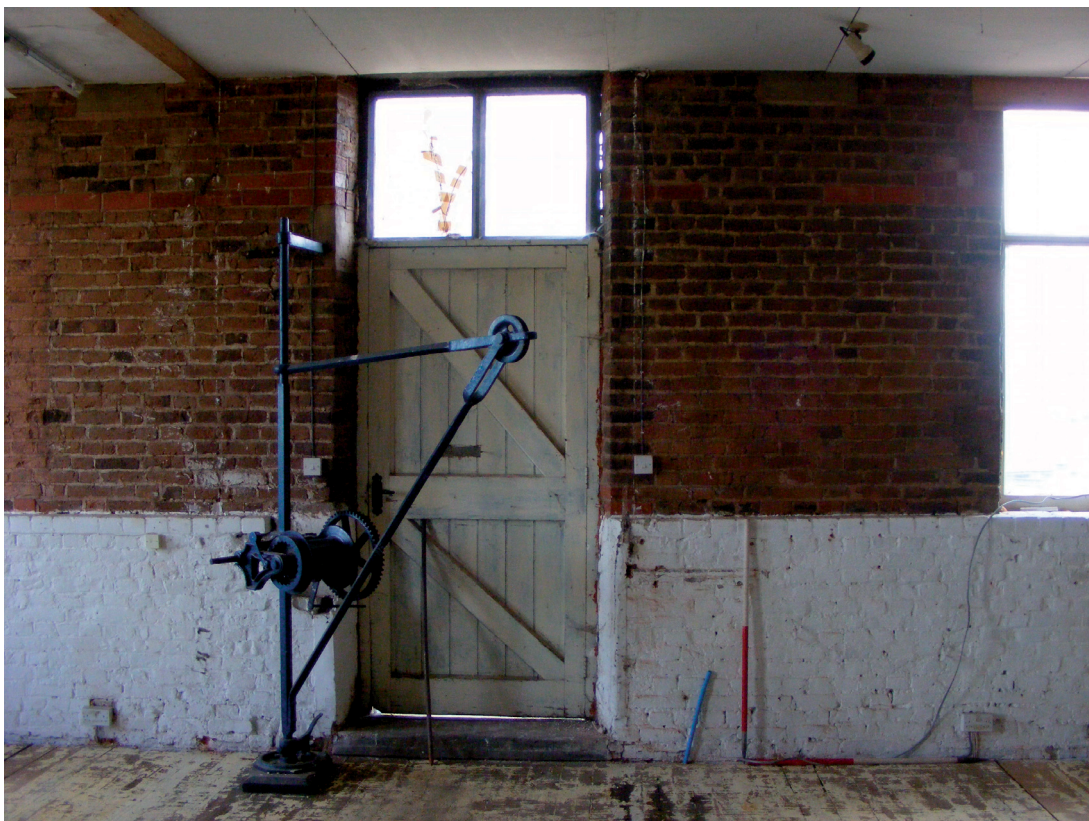
Illus 8

Possible original Winch on the first floor, room FF001, Unit 1

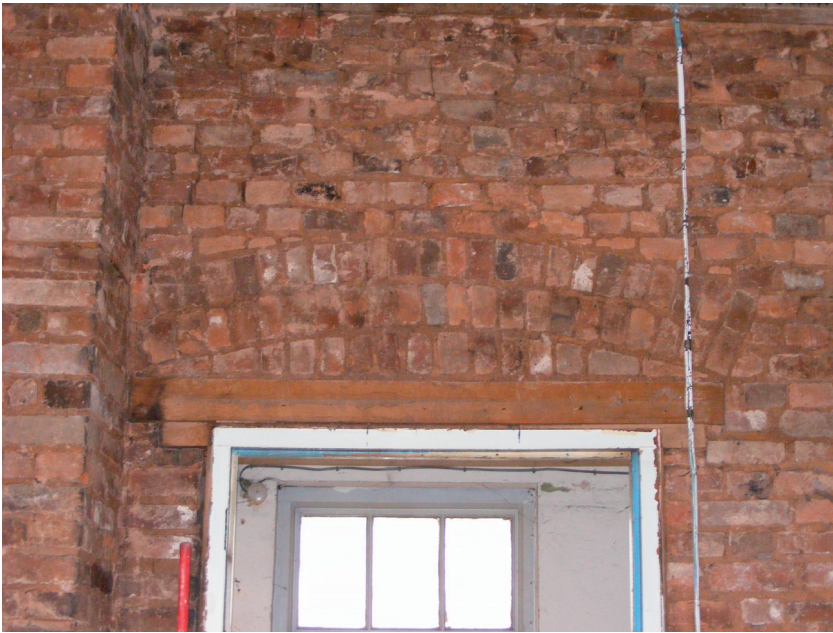
Illus 9

Arched doorway with modern wooden lintel, room GF010, Unit 4

The southwest two storey pavilion (Unit 4) was also modernised for use as a domestic dwelling in the later 20th century resulting in painted rooms on both floors and evidence from the remains or removal of modern fixtures and fittings throughout the structure. As such not much of the original building fabric is visible. GF 009 has a 19th century segmented arched doorway leading to GF010, visible from the interior of this room. A modern wooden lintel has been fitted to support the doorway (Illus 9).

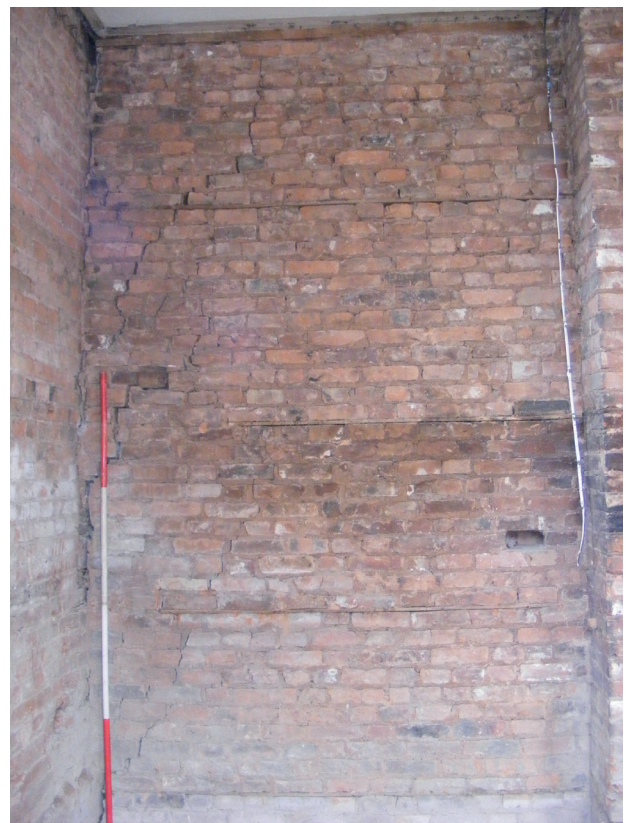
Illus 10

This room has been stripped revealing a series of wooden stringers running horizontally between the brick (Illus 3 & 10). There is a partially blocked window on the southwest wall that may have served as a recessed cupboard. Some of the window is still visible at high level (Illus 3). Large cracks on the northwest wall indicate structural deteriorations here (Illus 10). There is also a blocked arched fireplace.

Structural deterioration of N–W wall in room GF010, Unit 4
