Project Code: WCWW10
HAS 855
Date of Report: January 2011
Client: English Heritage

WITLEY COURT WEST WING

Building Recording

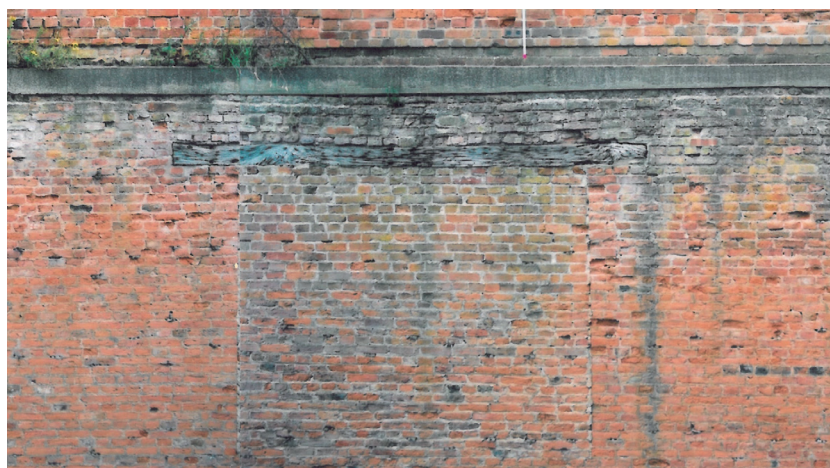
Illus 2

Photograph shows original wall face prior to collapse

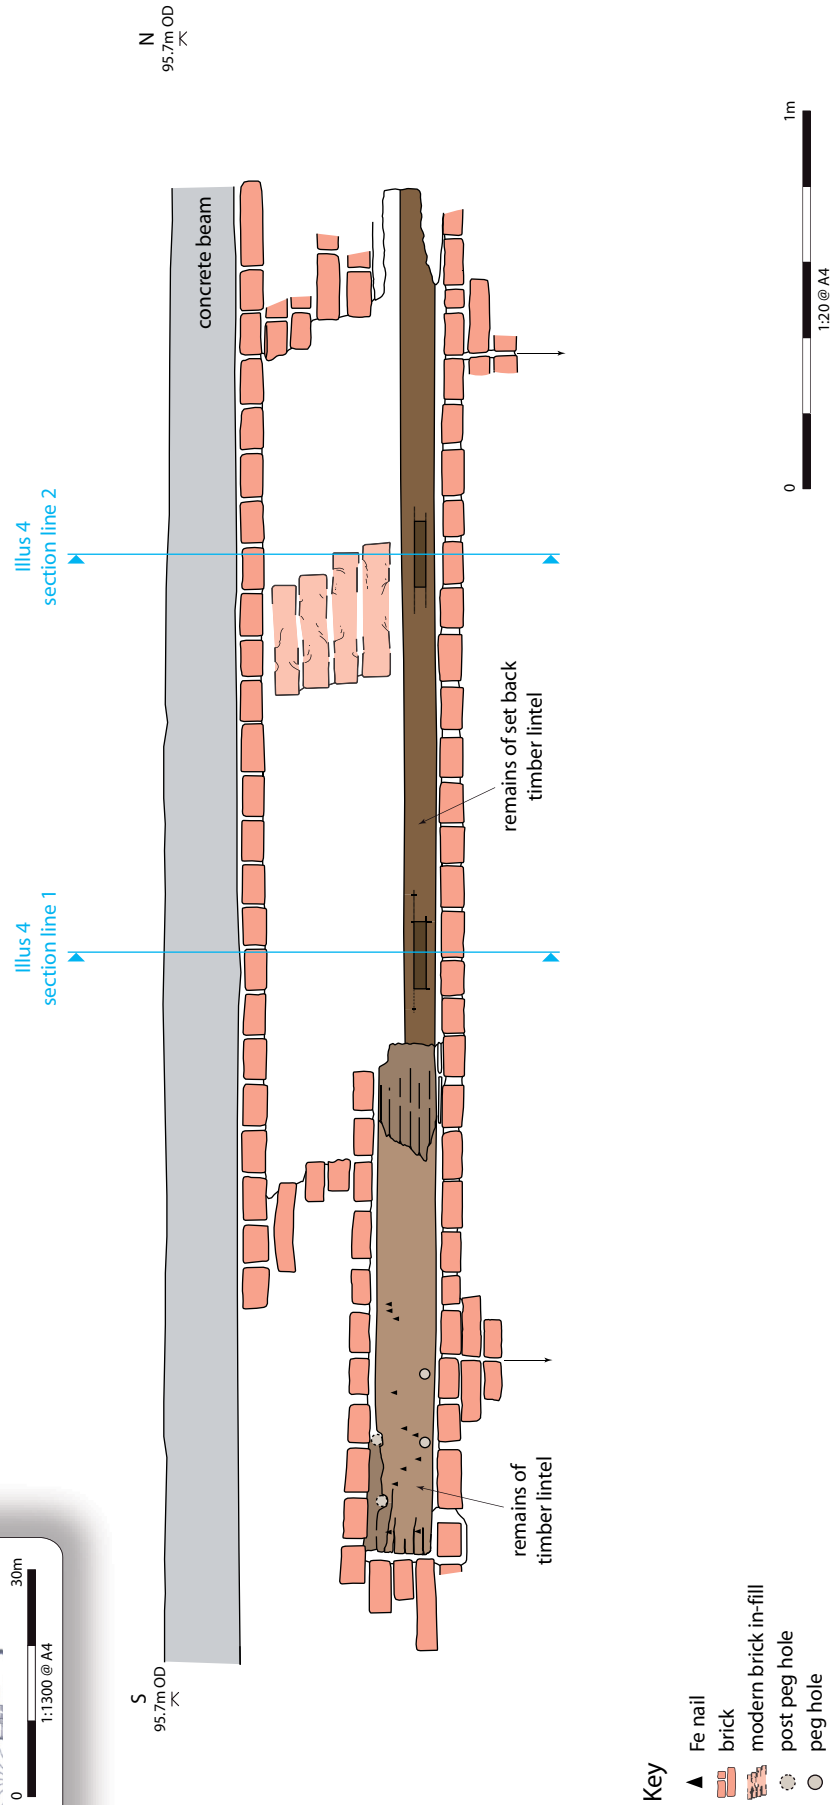
Illus 3
Elevation showing area of masonry collapse

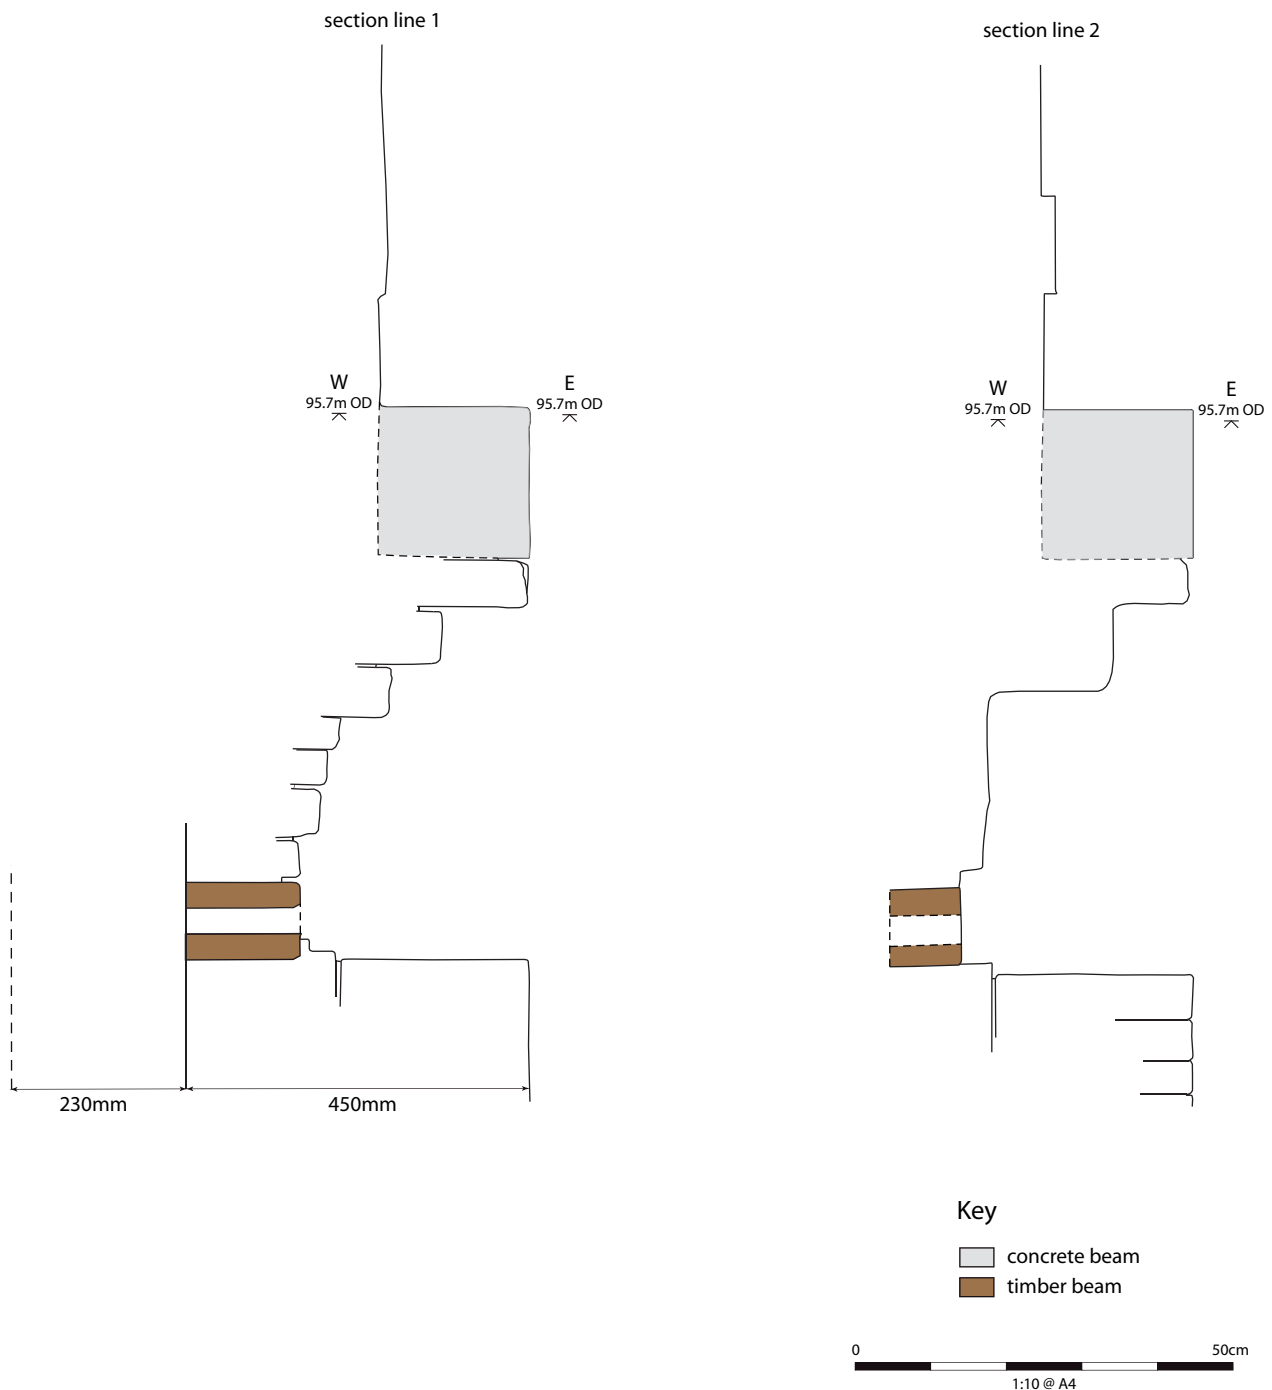
Illus 4
Area of masonry collapse in section (location shown on Illus 3)

The internal examination of the fabric that was exposed after the collapsed of the masonry, revealed another re-used timber lintel set back approximately 300mm from the inner wall face yet shorter in length than that of the front facing timber.

Examination of the mortice joint indicated that the second lintel had a depth of approximately 150mm giving

an overall wall depth of 450mm from the east face. A measurement through the existing opening indicates the total thickness of the wall to be 680mm. The recorded width of the wall and the difference exposed within the area of collapse demonstrated a discrepancy of 230mm.

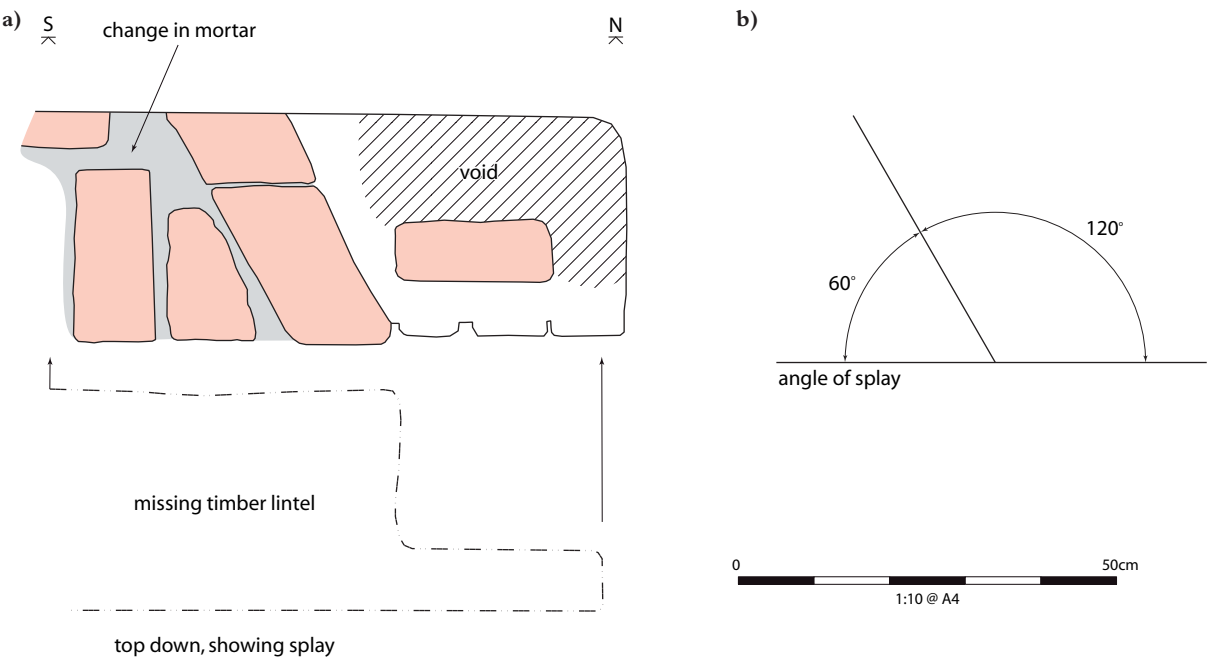
Illus 5
a) Top down plan, showing splay and missing timber lintel
b) Detail showing angle of internal splay

The key element to the understanding of the blocked area was revealed as a direct result of the collapse and was the splayed brickwork in the sides of the blocked embrasure.

This indicated that the primary use of the blocked opening was as a window and not a doorway (contemporary doorways at Witley Court having straight jambs not splayed). The angle of the splay was at approximately 120 degrees, in relation to the wall face.

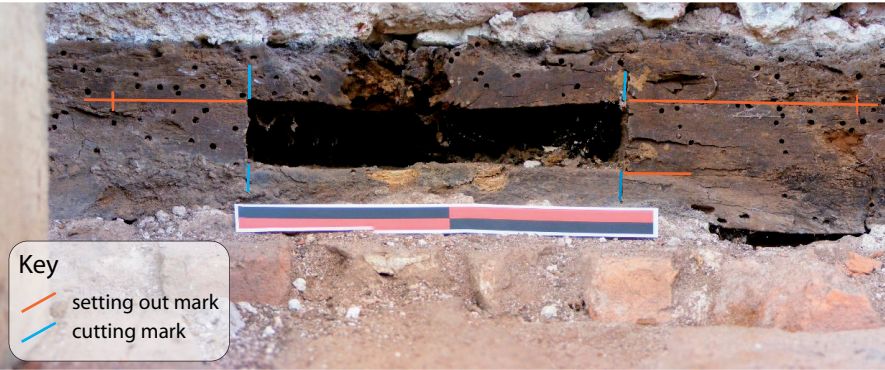
negative impression left by the collapsed timber (Illus 6) showed that the facing lintel at the northern end was cut to form a lap joint; this could further indicate the re-used nature of the timber. It could also signify that the lintel was fabricated to allow the loading of the wall either side of the lintel spread to be transferred down through the brickwork rather than extend across the lintel. Examination of the internal construction revealed that the makeup of the wall was in-fact a little below standard in this place, as behind the timber lintel is a large void in the fabric (Illus 6) which would then compliment the theory that the timber was cut before and was reused.

Close examination of the exposed face of the rear lintel revealed surviving setting out marks relating to the methods involved in the production of the two mortice joints visible on the rear timber lintel.

Illus 6
Photograph showing setting out and cutting marks on rear lintel

The marks around the mortice joint may also indicate the original width of the frame timbers associated with the joints. A series of scribed lines running parallel to the timber indicate the division for the mortice was approximately a third of the width of the timber while small vertical lines may show the width of the shouldered tenon timber. In this case the dimensions for the mortise are 30mm by 185mm, width of timber 95mm, with marks indicating that the shoulders of the tenon were offset by 65mm and 110mm giving an overall width of 365mm for the adjoining timber.

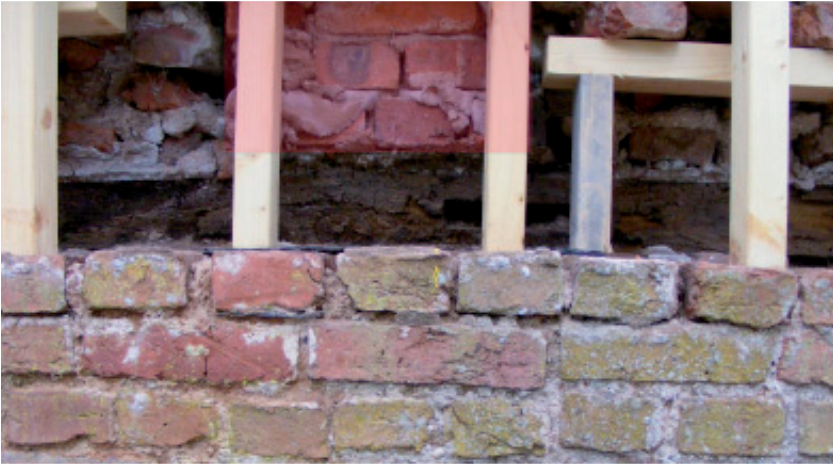
Illus 7
Area of modern brickwork (highlighted in red)

The brickwork exposed behind the collapse appeared modern and inconsistent with that around the collapse. Closer examination of the reverse face of the wall, revealed a large timber slot with modern brick infill. From this, it is possible to imply that the west face of the west wing is clad with a later skin of bricks and this is confirmed by the fact that the opening visible on the east face is not reflected on the west face. From the examination of the second lintel, the later phase brickwork forming the applied skin to the west face of the wall would be approximately 230mm in width.

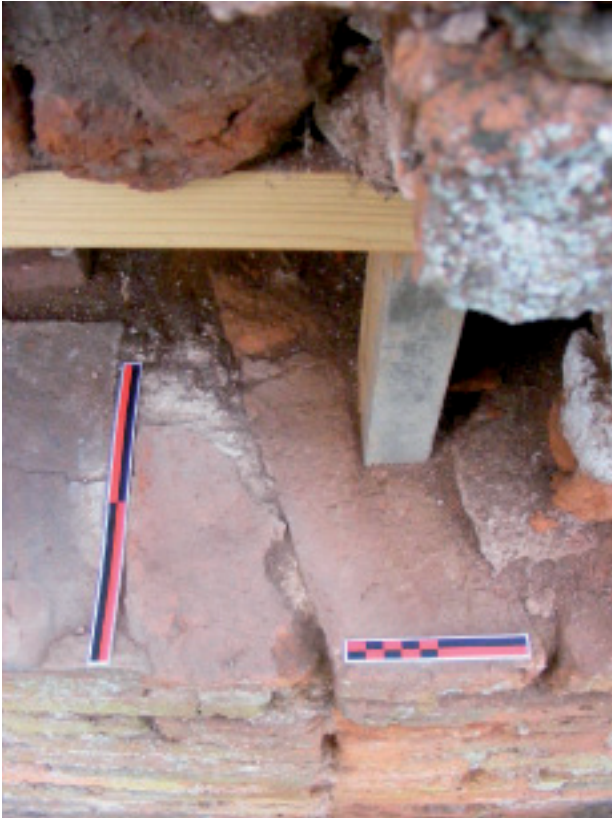
Illus 8

Photograph showing angle of internal splay

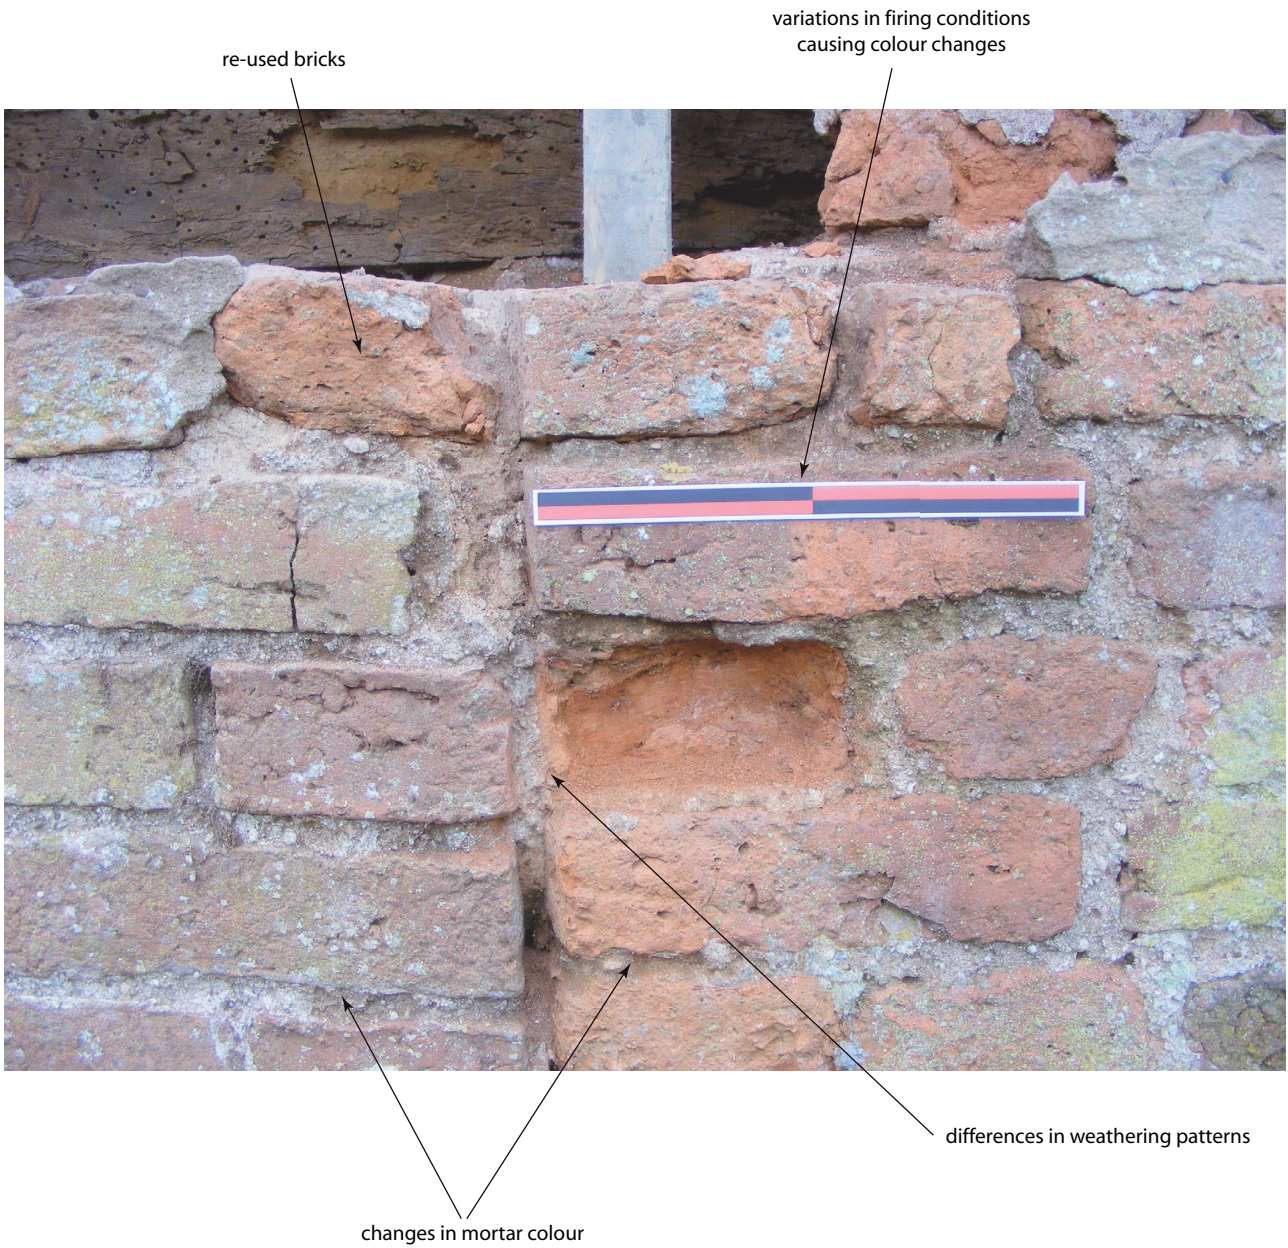
Illus 9
Photograph showing difference between blocking and original wall face
