Project Code: LIES10  
Date of Report: December 2010  
Client: Sandwell Metropolitan Borough Council  
Hereford Archaeology Series: 862

## HISTORIC BUILDING RECORDING & DOCUMENTARY RESEARCH AT LYNG INDUSTRIAL ESTATE, BELL STREET, WEST BROMWICH

## PROJECT SUMMARY SHEET

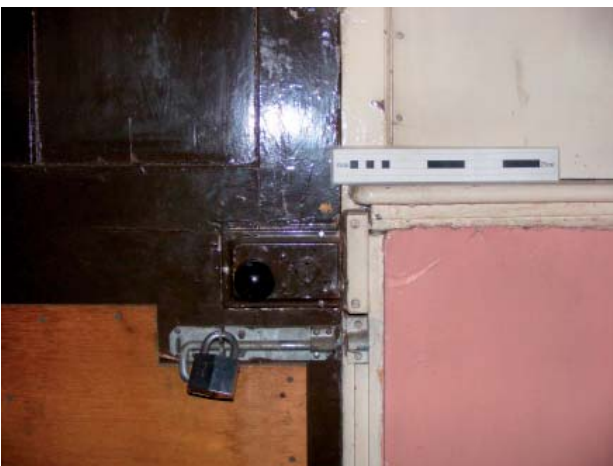
**Area:** G6  
**Structure:** Linking area  
**Element:** Internal link to out building with external access to rear yard area Y1  
**Description:** Small lobby with original door and associated furniture, possible reused original rear door to the building. The area has a reduced ceiling height when compared to G4 and the out-buildings suggest later alterations or link buildings  
**Fabric:** Painted decoration over plaster with lower portion covered with modern wallpaper finish, period door and locking arrangements  
**Alterations:** Modern security fittings. The rear door is probably an original feature of the main building that has been relocated to this position to provide an internal link to the outbuilding.  
**Links:** G6- Y1,OB,G4  
**Related photos:** LIES10-D (23-27)

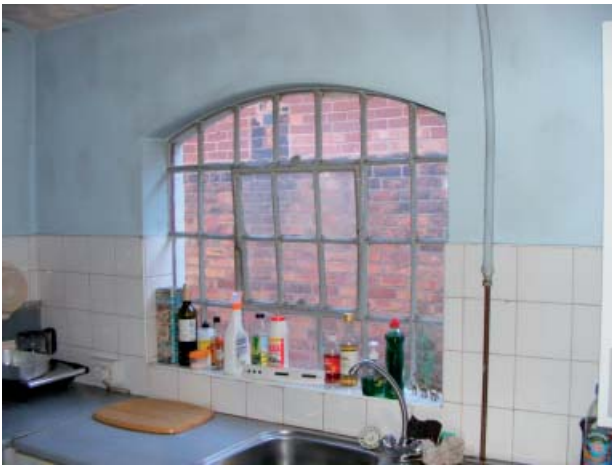
**Area:** OB  
**Structure:** Out-building  
**Element:** Internal area  
**Description:** Originally a well constructed lean-to structure with two segmental arched windows overlooking the yard area, now linked to the main building via G6. The building retains one original glazed window with central opening element. The building has undergone much alteration internally, masking the original layout. The style of construction suggests a utilitarian origin.  
**Fabric:** Modern inserted stud walling with painted decoration over plasterboard with lower portion covered with modern wallpaper finish, installation of modern heating radiators, boiler, kitchen area and toilet facilities for the works  
**Alterations:** Modern privacy glass and small rectangular window in the toilet area. Installation of kitchen  
**Links:** OB – G6  
**Related photos:** LIES10-D (79-81)

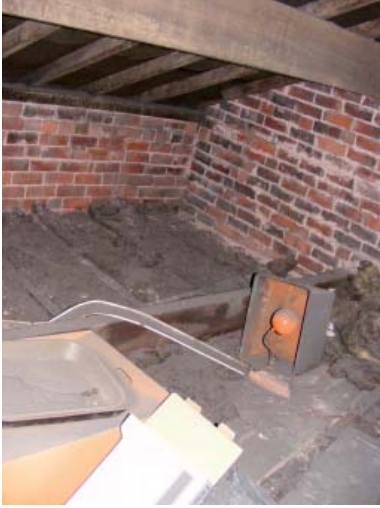
**Area:** S2  
**Structure:** Roof space  
**Element:** Internal area  
**Description:** Access is gained through a small door within room S1. .  
**Fabric:** Wood.  
**Alterations:** The roof has had a complete modernisation, the only original feature being the purlins  
**Links:** S2 – S3  
**Related photos:** LIES10-D (47-61)

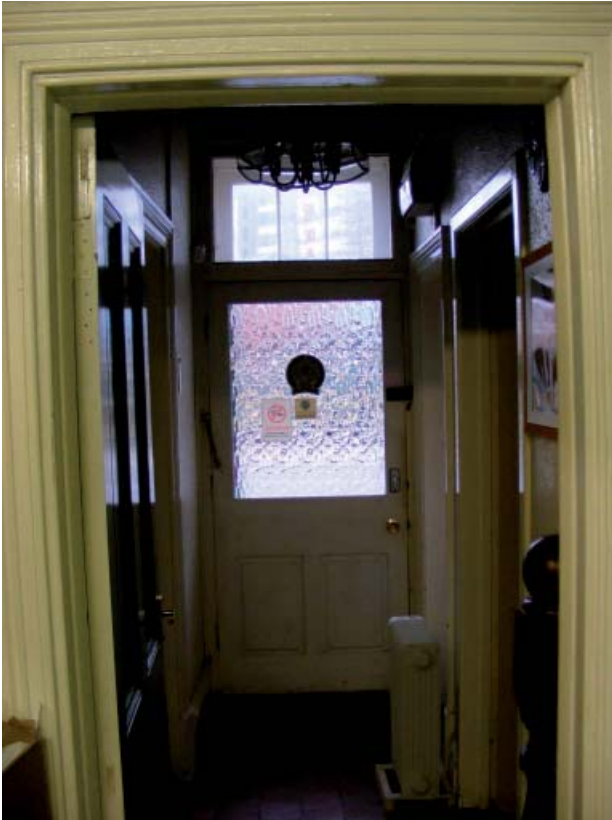
<b>Area:</b>	OF3
<b>Structure:</b>	Internal area
<b>Element:</b>	Room
<b>Description:</b>	Currently use as a small office space, the present room has been reduced in size through the addition of an internal partition between OF2 and OF3. the room once benefited from a small sash window paired with that in OF2, yet located within the eastern elevation and now blocked by wood boarding and external constructions
<b>Fabric:</b>	Modern applied painted finishes over plaster obscure original colour schemes.
<b>Detail:</b>	Overall, the room retains all of the expected period features; skirting, windows and plaster coving.
<b>Repairs:</b>	Modern alteration and repairs have sympathetically retained the period features and characteristics of this room
<b>Related photos:</b>	LIES10-D (203-205)

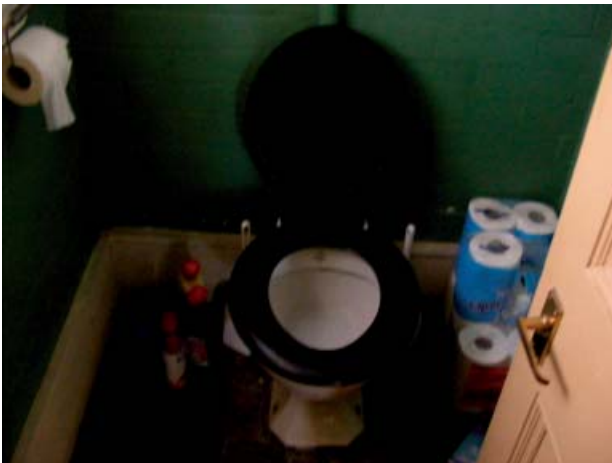
<b>Area:</b>	OF4
<b>Structure:</b>	Internal area
<b>Element:</b>	Room/ lavatory
<b>Description:</b>	Small lavatory with separate lobby (OF5). The WC system appear to be contemporary to the construction of the building and may have once serviced only the external occupants of the yard area as the external east elevation reveals a blocked doorway that would have allowed access to the lobby (OF5), the existing doorway into this area is relatively modern
<b>Fabric:</b>	Modern applied painted finishes over plaster, on the upper portions of the walling. Red brick floor tiles extend from this room into OF5 and OF6
<b>Detail:</b>	Overall, the room retains all of the expected period features; skirting, windows, and WC system with lead pipe work.
<b>Repairs:</b>	Modern alteration and repairs have sympathetically retained the period features and characteristics of this room
<b>Related photos:</b>	LIES10-D (206-207)
