Project Code: LIES10  
Date of Report: December 2010  
Client: Sandwell Metropolitan Borough Council  
Hereford Archaeology Series: 862

## HISTORIC BUILDING RECORDING & DOCUMENTARY RESEARCH AT LYNG INDUSTRIAL ESTATE, BELL STREET, WEST BROMWICH

## PROJECT SUMMARY SHEET

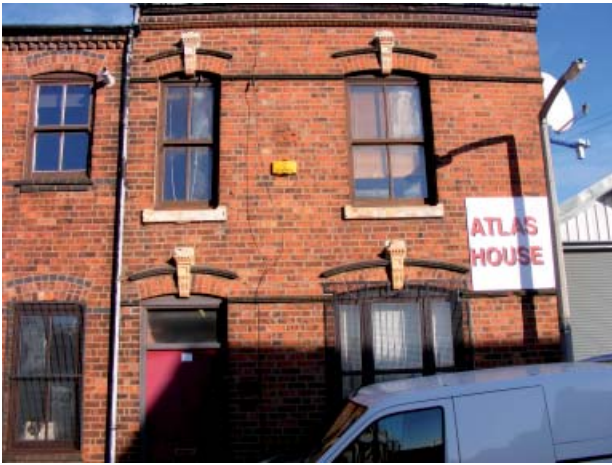
| <b>Description</b> | Highly decorative front elevation of 'two up two down' terraced house. Possibly main office for Gibson's manufacturing. Main windows have inserted moulded decorative keystone, with protruding brick arched drip course. Moulded brick dentile coursing below roofline. The front elevation although altered with a modern window, rainwater and door furniture retains its period and decorative features which make this building a distinctive feature in the street scape of the area. |
| <b>Fabric</b> | Mixed red brick forming a running Flemish bond, sandstone cills, decorative stone and brick mouldings, hard gritty grey mortar, possibly later phase of pointing. |
| <b>Repairs</b> | Modern installation of hard wood sash windows with double-glazing. Addition of security mesh on lower windows. |

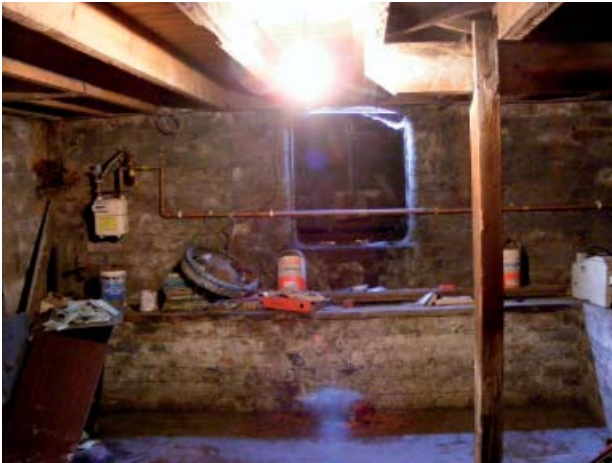
| <b>Description</b> | Front basement area, exposed brickwork, with joist details, such as cross bracing. The basement contains a raised brick and stone platform constructed around two edges of the room. The southern elevation contains an external 'coal hole'. Floor appears to be stone flagged; unfortunately at time of the survey the basement was inaccessible due to flooding. The basement also contains a typical arched brick support for the internal flue arrangements of the fireplaces in the rooms above. Access to the basement is gained through a turning brick constructed staircase from G3. |
| <b>Fabric</b> | Red brick, with white lime wash coating. |
| <b>Repairs</b> | Instillation of a wooden supporting post to support the floor above. |

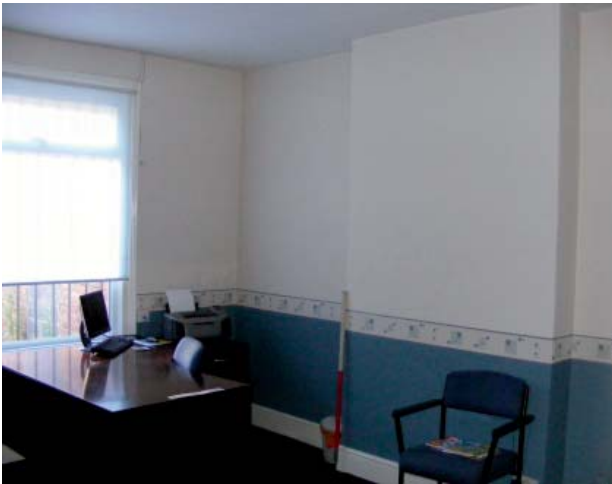
| <b>Description</b> | Rear facing room with two window openings and blocked fireplace. |
| <b>Detail</b> | Retains a portion of period skirting board, although windows have been replaced with modern Upvc window furniture. |
| <b>Repairs</b> | Modern alterations to windows, installation of modern heating radiators. |

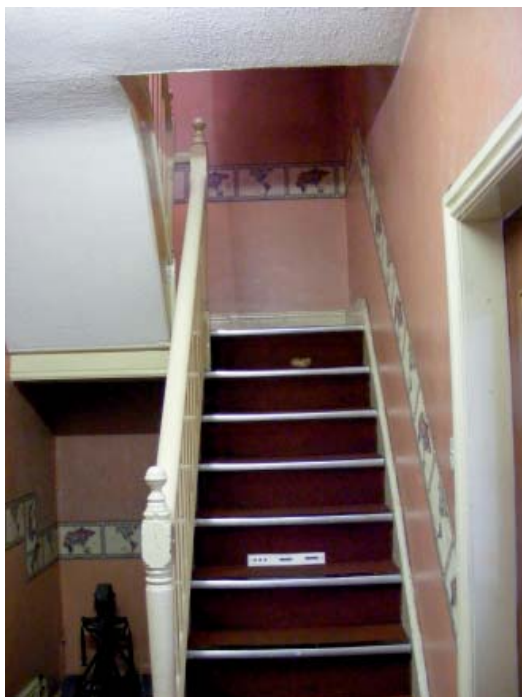
| <b>Description</b> | Lower hall way/lobby, main access area to the rooms and stairwell. |
| <b>Detail</b> | This area retains most of its originality, and has only been slightly altered, through years of applied surface finishes. The staircase is a prime example, retaining the original decorative newel posts and hand rails. External examination of the building on the east facing elevation suggests that the stairwell should have light from a small arch brick window, no sign of this feature was visible from within the building. |

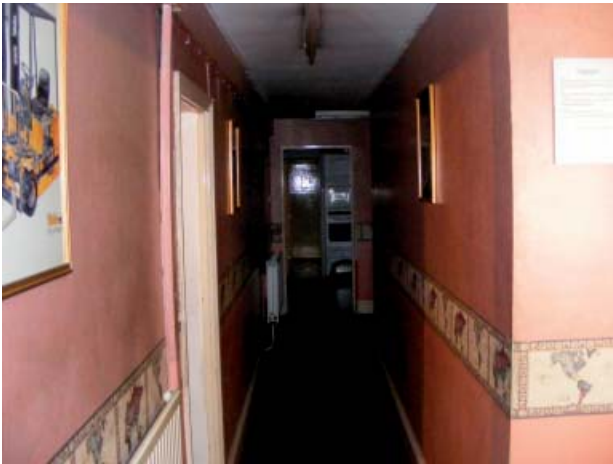
**Area:** G4  
**Structure:** Linking corridor  
**Element:** Internal corridor  
**Description:** Corridor accessing the associated out building and rear yard. Modern access has been constructed through to the adjoining building  
**Fabric:** Painted decoration over plaster with lower portion covered with modern wallpaper finish, installation of modern heating radiators  
**Detail:** The corridor contains no surviving original fabric.  
**Alterations:** Modern skirting and door fixings and furniture  
**Links:** G4-G3,G5,G6  
**Related photos:** LIES10-D (17-18)

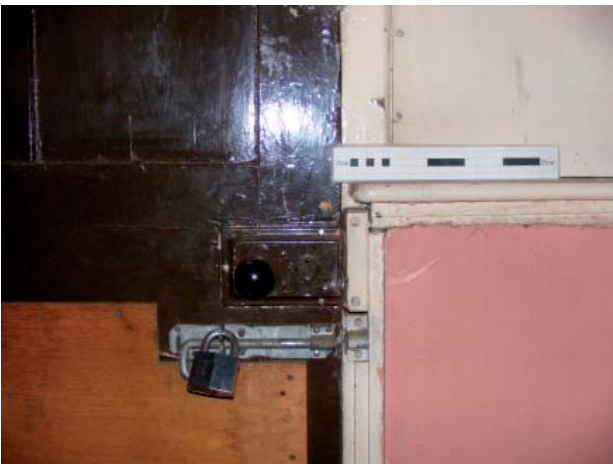
**Area:** G6  
**Structure:** Linking area  
**Element:** Internal link to out building with external access to rear yard area Y1  
**Description:** Small lobby with original door and associated furniture, possible reused original rear door to the building. The area has a reduced ceiling height when compared to G4 and the out-buildings suggest later alterations or link buildings  
**Fabric:** Painted decoration over plaster with lower portion covered with modern wallpaper finish, period door and locking arrangements  
**Alterations:** Modern security fittings. The rear door is probably an original feature of the main building that has been relocated to this position to provide an internal link to the outbuilding.  
**Links:** G6- Y1,OB,G4  
**Related photos:** LIES10-D (23-27)

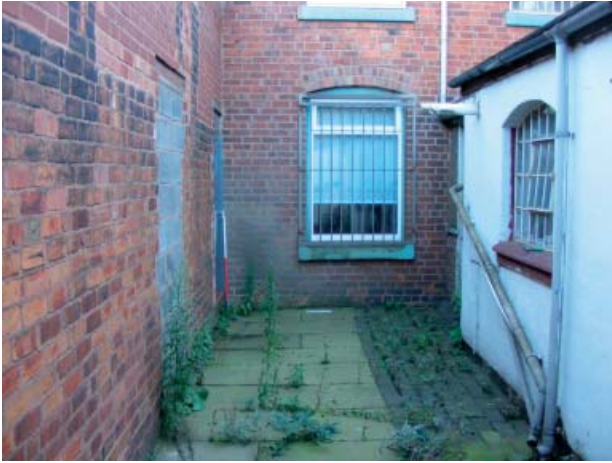
**Area:** Y1  
**Structure:** Yard area  
**Element:** External rear yard  
**Description:** Open rear yard, now enclosed by modern buildings  
**Fabric:** Brick and stone flagged  
**Detail:** Relatively large rear yard, providing access to adjoining buildings and rear elevation.  
**Alterations:** Possibly areas near G6 with brick surface repairs to stone flags  
**Links:** Y1 – G6  
**Related photos:** LIES10-D (66-78, 80-81)

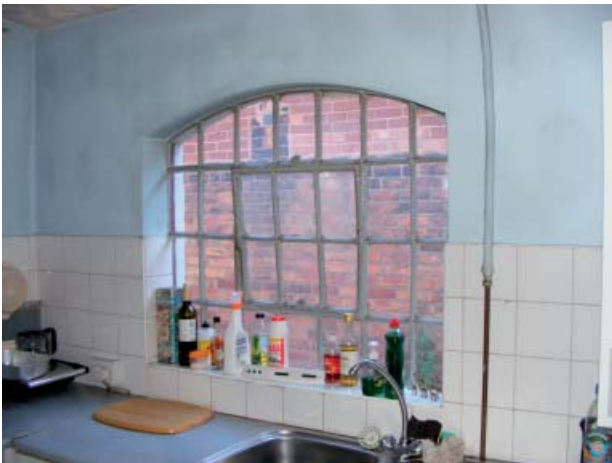
**Area:** OB  
**Structure:** Out-building  
**Element:** Internal area  
**Description:** Originally a well constructed lean-to structure with two segmental arched windows overlooking the yard area, now linked to the main building via G6. The building retains one original glazed window with central opening element. The building has undergone much alteration internally, masking the original layout. The style of construction suggests a utilitarian origin.  
**Fabric:** Modern inserted stud walling with painted decoration over plasterboard with lower portion covered with modern wallpaper finish, installation of modern heating radiators, boiler, kitchen area and toilet facilities for the works  
**Alterations:** Modern privacy glass and small rectangular window in the toilet area. Installation of kitchen  
**Links:** OB – G6  
**Related photos:** LIES10-D (79-81)

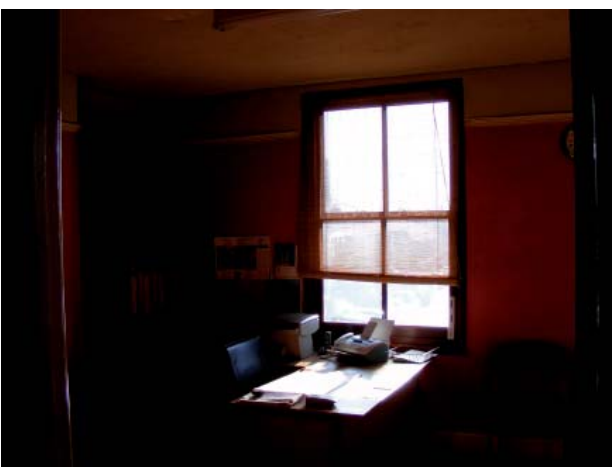
**Area:** F1  
**Structure:** room  
**Element:** Internal area  
**Description:** First floor, front room, serving as office space, the room lacks any internal period features, but retains a period door and jambs.  
**Fabric:** Painted decoration over plaster with lower portion covered with modern wallpaper finish, period door.  
**Alterations:** Insertion of modern hardwood, double-glazed window units and radiators.  
**Links:** F1 – F3  
**Related photos:** LIES10-D (31)

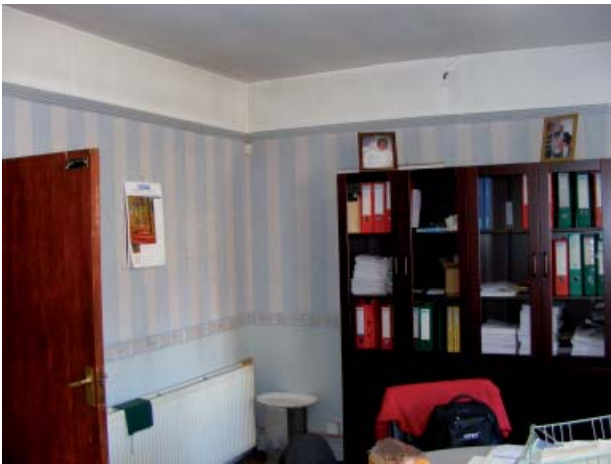
**Area:** F2  
**Structure:** Room  
**Element:** Internal area  
**Description:** First floor rear room, serving as office space, the room contains a period dido rail and retains period door and jambs. An interesting feature of the room is the change in ceiling height towards the rear elevation showing that the front and rear elevations differ in height.  
**Fabric:** Painted decoration over plaster with lower portion covered with modern wallpaper finish, period door, jamb, and wooden rail.  
**Alterations:** Insertion of modern Upvc double glazed window unit and security bars.  
**Links:** F2 – F3  
**Related photos:** LIES10-D (37-41)

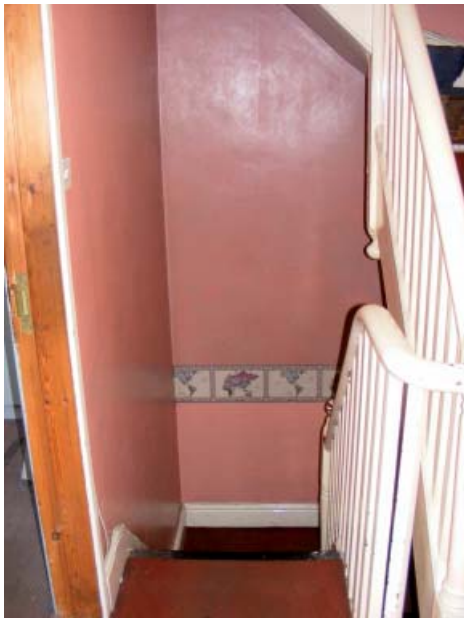
**Area:** F3  
**Structure:** Hall wall/ stairwell  
**Element:** Internal area  
**Description:** This area retains most of its originality and has been little altered, apart from applied surface finishes. The staircase being a prime example retains the original decorative newel posts and hand rails. The area services the two main rooms on this level and provides access to the adjoining building through a service door, whilst offering access to the second floor.  
**Fabric:** Painted decoration over plaster with lower portion covered with modern wallpaper finish  
**Alterations:** Overall, this area retains most of its period features, doors, jambs, skirting, and staircase.  
**Links:** F3 – F1, F2, G3, S3  
**Related photos:** LIES10-D (28-30, 32-33, 35-36)

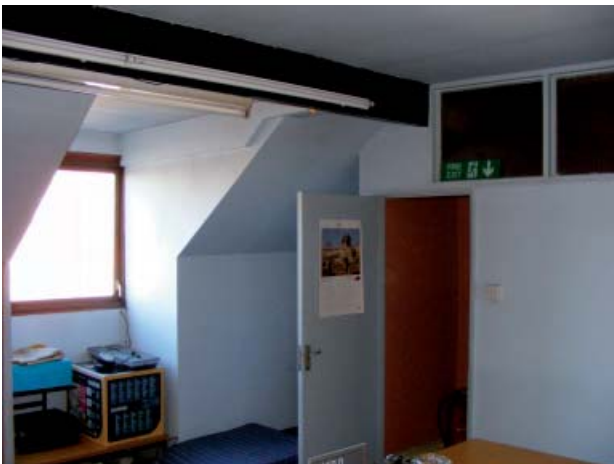
**Area:** S1  
**Structure:** Room  
**Element:** Internal area  
**Description:** Small room space constructed within the eaves of the building, the nature of the staircase would suggest that this area is an original feature of the building, but examination of the construction of the walling suggest that the room has undergone modernisation, possibly only retaining the original floor area. Later alterations have included a pitched roofed dormer with velux double glazed unit.  
**Fabric:** Applied paint finish over wood panels and plaster board walling.  
**Alterations:** Insertion of modern pitched dormer overlooking rear of building, possibly replacing original glazed roof light  
**Links:** S1 – S2, S3  
**Related photos:** LIES10-D (62-65)

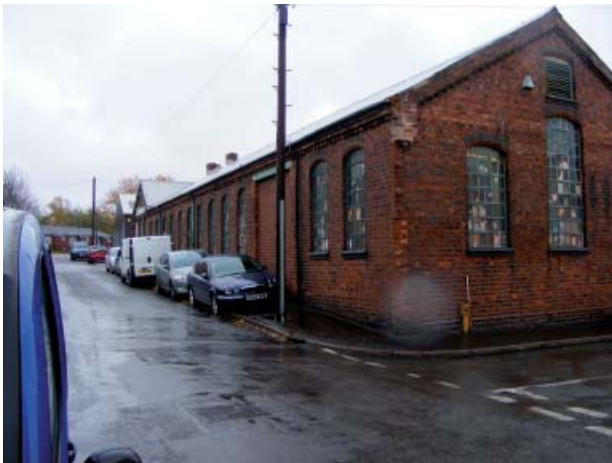
| <b>Description:</b> | <p>Main Elevation to the building exhibits a wooden sign indicating the building is known locally as the “The Old Joinery Shop”, Circa 1890. The main facade of the building is aligned with Bell street (east/west), on the southern side of the street. The building consists of a factory unit with small integral office block towards the eastern end. The main out look of the factory unit comprises of 5 pairs of double brick arched windows broken by a blocked works doorway and flank by a single pair of arched window at the western end. The roofline of the entire building maintains an unbroken and level run from west to east, where as the office roof is aligned north south. The street frontage slopes down towards the western end of the building, requiring the western end of the building to be raised above street level in relation to the internal floor level. Viewed from the western end, the main works area can be seen to consist of two parallel pitch roofs with a central rain gully draining at the western end, both gables share the same window patterns. A pattern of three double brick arched windows is surmounted by a small central arched window high within the eaves of the building. This pattern of windows is also repeated on the eastern end of the main unit, (now concealed and obscured), suggesting that the office is a latter addition to the development. The small openings within the western and eastern eaves are now blocked; these may have once been louvered for ventilation</p> |
| <b>Fabric:</b> | <p>Constructed from brick, medium reds, deep plums and pinks, the bricks exhibit a range of mixed firing conditions, both affecting the colour differences and also indicate the bricks were stacked in an angled pattern when drying, suggesting a firing date post 1860. the bricks are rough edged and laid in a stretcher – header pattern (English bond) and bonded with yellow and grey mortar (later modern re-pointing)</p> <p><i>All of the windows remain original, although suffering from urban wear and tear. (5 by 7 small rectangular glazed panes in wooden frames, with small central ventilation opening panels. The office windows are Yorkshire sash windows the top elements retaining there original double pane layout, where as the lower portions have been replaced with large single panes.</i></p> |
| <b>Repairs:</b> | <p>The overall appearance suggests that the building has been re-pointed yet retains an original appearance. The main works door on the street frontage has been blocked with relatively modern bricks and roof has been covered with a layer of felt and bitumen.</p> |

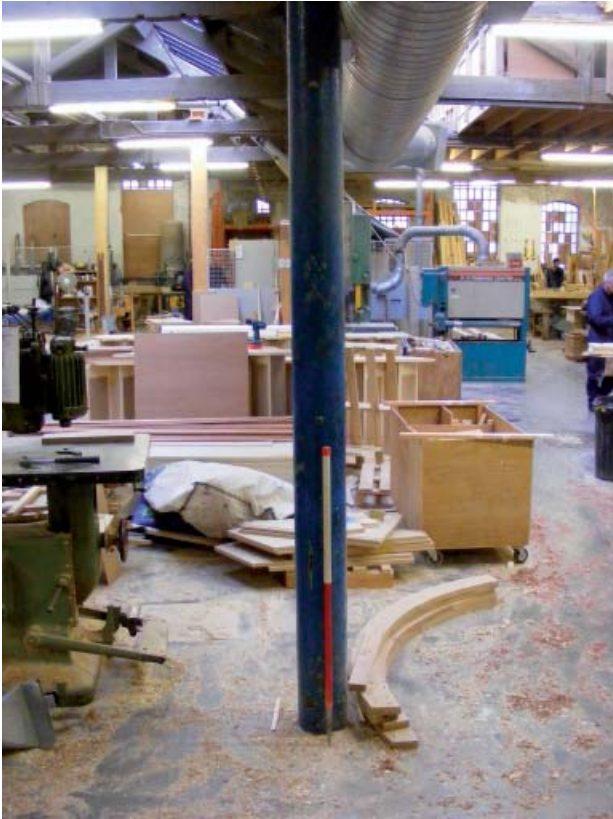
**Description:** Large working open area much altered to encompass modern machinery, yet still exhibiting many original features, such as central iron uprights, windows, and roof trusses.

**Fabric:** Brick, with white lime wash coatings. Queen post wooden trusses with Fe bolts and fixings. Fe central upright supports, supplemented with steel beams take the main loading of the roof and central gully. Concrete flooring, possibly over a formerly flagged surface.

**Repairs:** Blocked window on the southern side, eastern end, originally blocked with brick, then breezeblock, suggesting that it was once used as a doorway (LIES10-D (140)). Evidence for a central arched window, now blocked, which would indicate that the office was of a slightly later date to the main unit (LIES10-D (169)), although no obvious construction break can be seen on the outside brickwork of the main elevation contradicting the internal modifications and further suggesting the alterations may have occurred during the original construction phase. Double width works opening within the north elevation blocked with modern red brick. (LIES10-D(114)) Original central iron supports have been removed and replaced with large H beam to support gully and trusses, allowing less restricted working area. Some repairs to the wooden fabric of the central drainage gully, Inserted door into rectangular office windows and modern staircase providing access to office and work area.

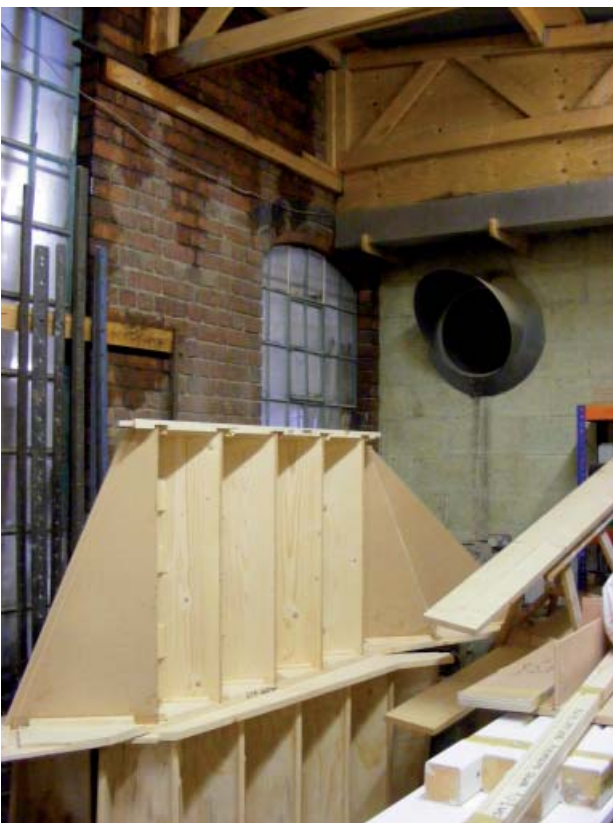
**Description:** Modern block built store on the southeastern corner of the building, allowing the external elevation of the eastern gable windows to be viewed.

**Alterations:** Inserted doorway into this area from the main unit G1.

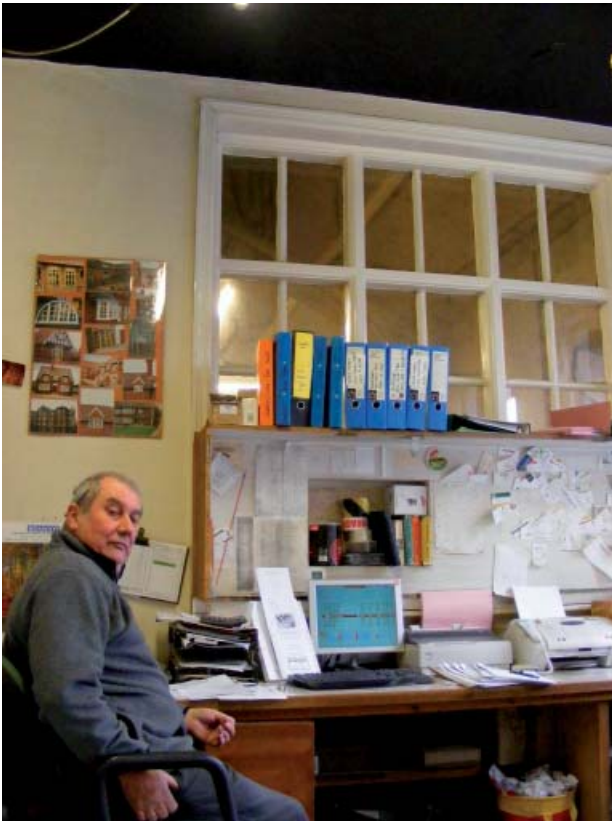
| <b>Description:</b> | Internal office space, with blocked fireplace, centrally located on the southern wall. The room retains two period Yorkshire sash windows facing onto the street frontage, but more unusually has a large rectangular multi paned window, occupying the western wall and allowing visual observation into the main works area (G1). |
| <b>Detail:</b> | Overall the room retains all of the expected period features, skirting, windows, although no evidence of plaster coving remains, yet there is no indication that this room ever had any, perhaps indicating that the status of the room was considered lower than others in the building |
| <b>Repairs:</b> | The pair of front windows has undergone some alteration, consisting of the lower panes being replaced by single large panes. |
