ST MARY'S CHURCH, ALFRICK, WORCESTERSHIRE

Watching brief and Historic Building Survey

for S T Walker & Duckham on behalf of Alfrick PCC

3 March 2011

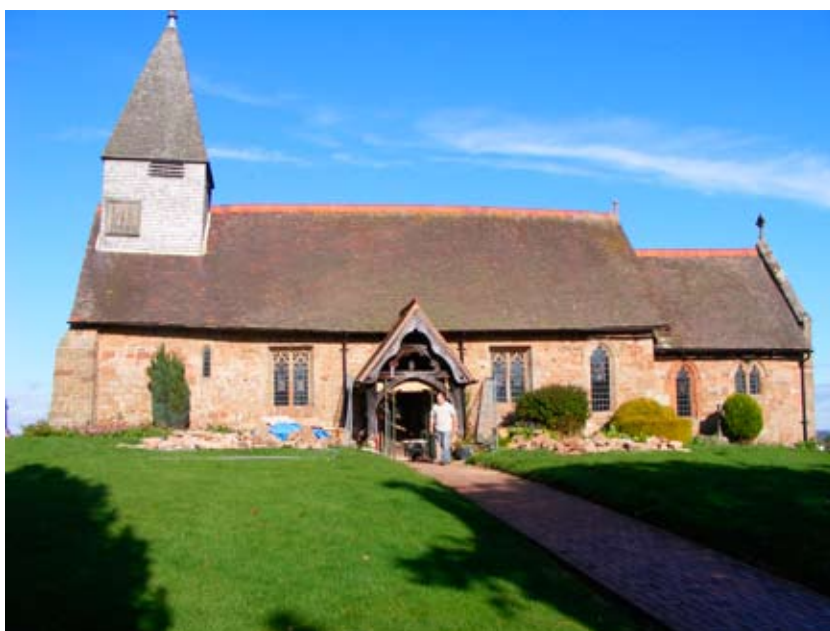
Illus 2

General view of church and porch looking N

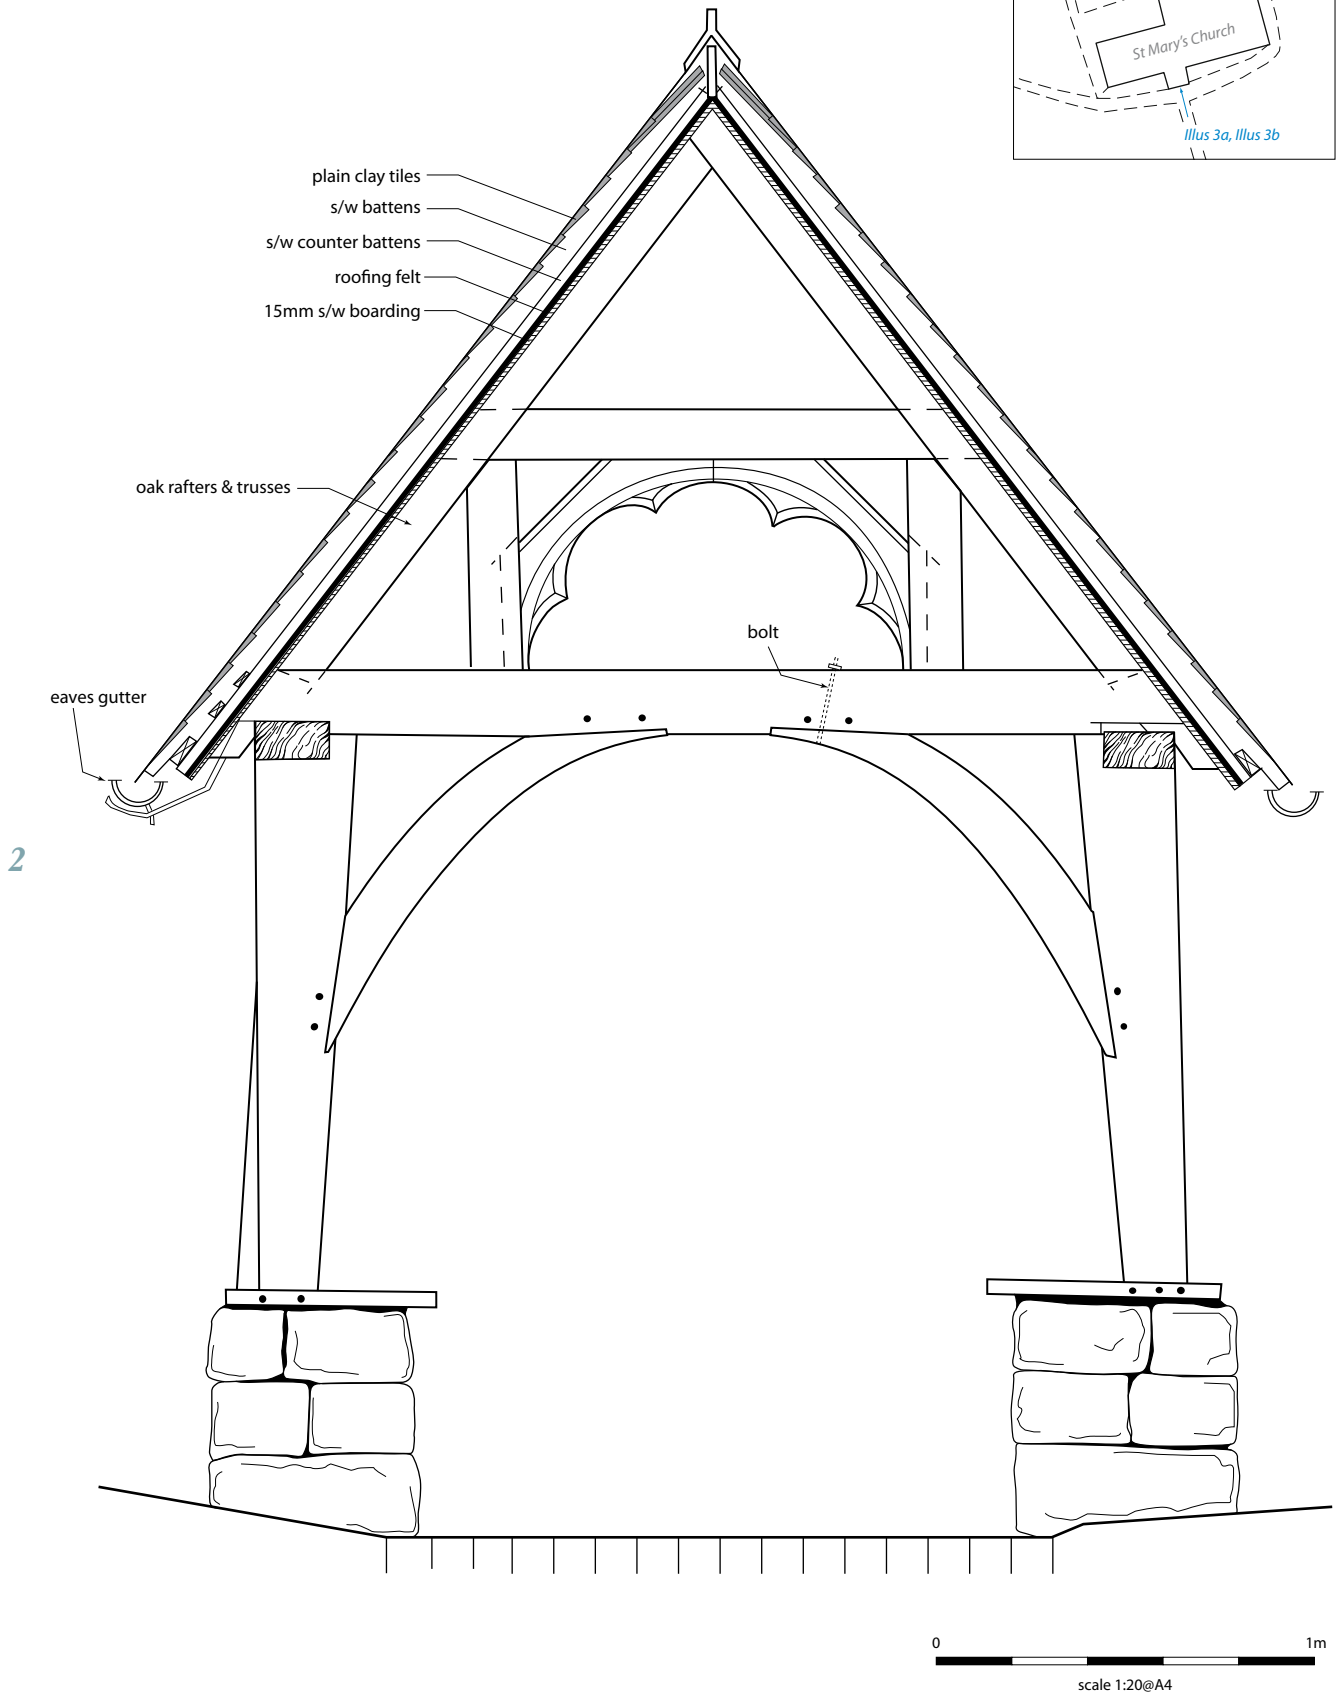
Illus 3
South facing front elevation of porch

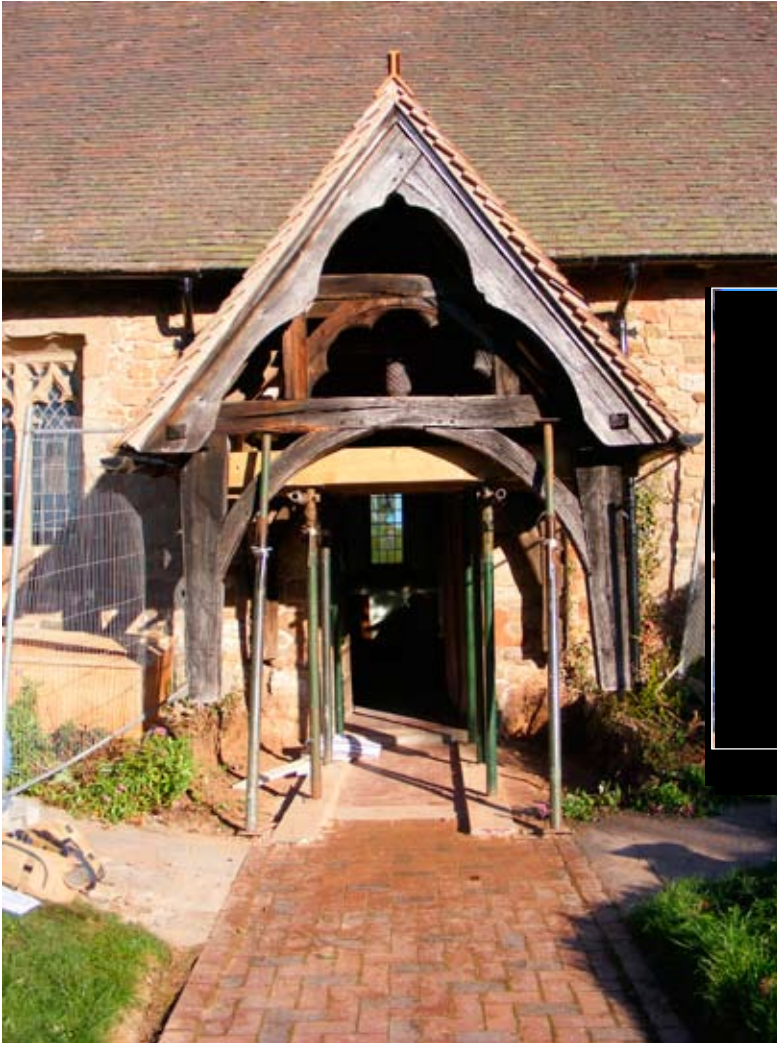
Illus 3a

Front elevation of porch looking N

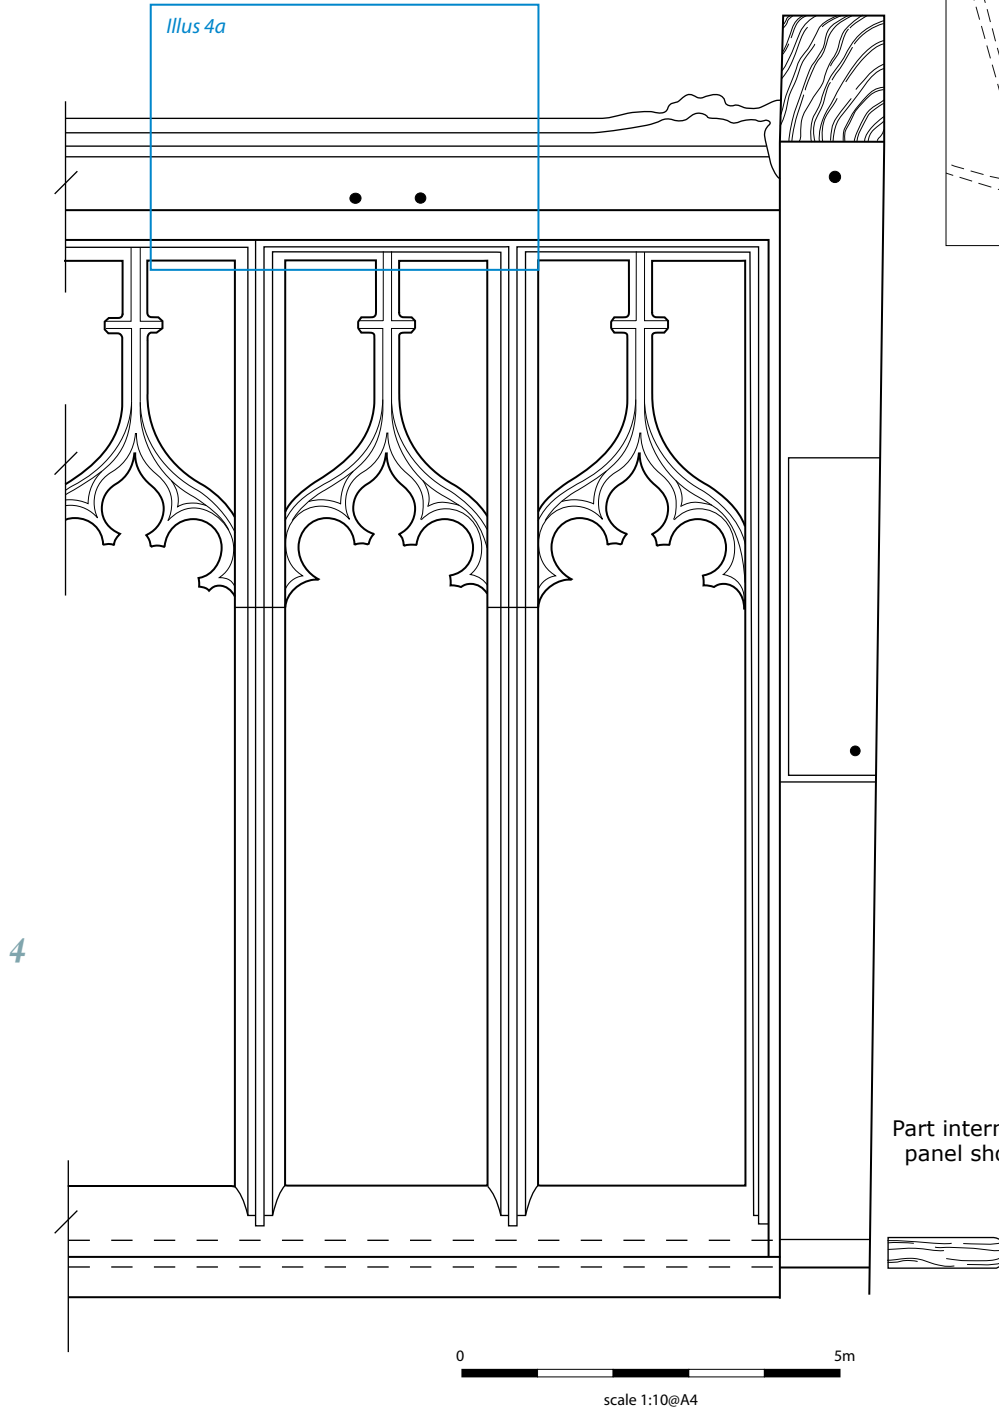
Illus 4
Part internal elevation of oak tracery wall panel showing re-used timber in E wall plate

The eastern wall plate is a re-used timber with a molded projection and redundant tenon joints. It is likely that the timber originates from another building which has been cut and split to fit the porch.

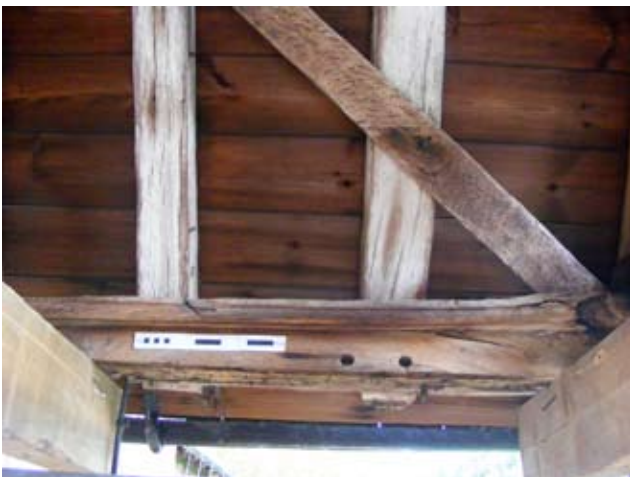
Illus 4a
Close up of re-used timber in east wall plate looking E

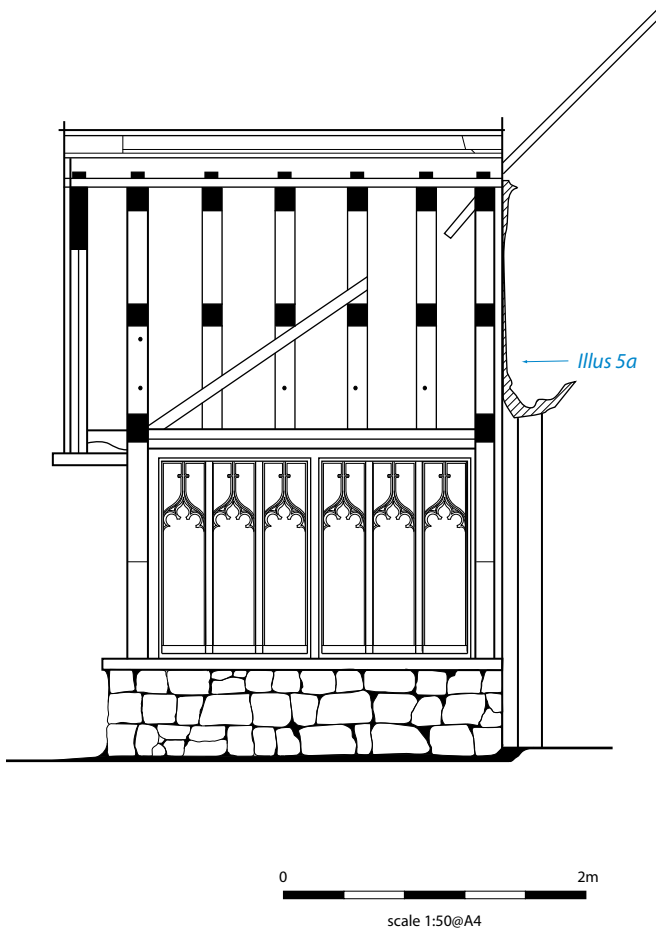
Illus 5

Section through porch

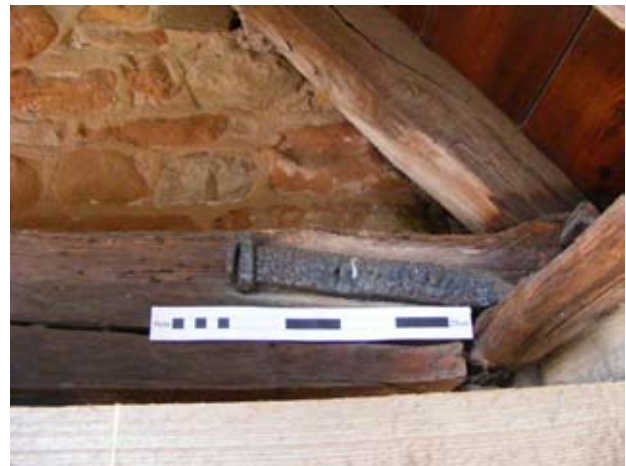
Illus 5a

Repairs to northernmost tie beam and E wall plate using iron strapping looking E

A large iron strapping is visible on the north tie beam near the east wall plate, most likely from a secondary repair in order to stop movement of the tie beam (Illus 6). Additional planks have been inserted between the front

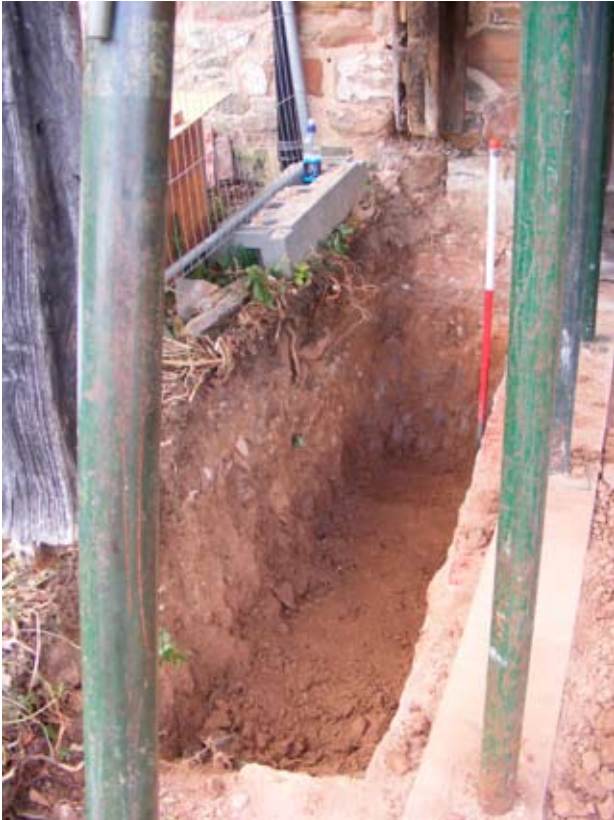
Topsoil [001] had already been removed at the time of the porch's original construction, but on the section face this could clearly be seen to extend to a maximum depth of 0.22 metres and was a friable light-grey loamy sand with profuse root action. A bright red-orange compact clay [002] lay underneath the topsoil/porch stone wall. This context seemed to be a sterile geological interface extending for 0.34 metres in depth at the south end of the trench to 0.53 metres at the north. The sterile geological deposit [003] underneath was very similar to [002], however, of a slightly darker hue (mid red-orange). This also had a variable depth of 0.16 metres to 0.28 metres. Nothing of archaeological significance was uncovered during excavation.

Illus 7
Trench 1 looking N
