LONGBRIDGE EAST REMEDIATION

Archaeological Watching Brief

*commissioned by St Modwen Developments Ltd
and Persimmon Homes*

B/2008/0333

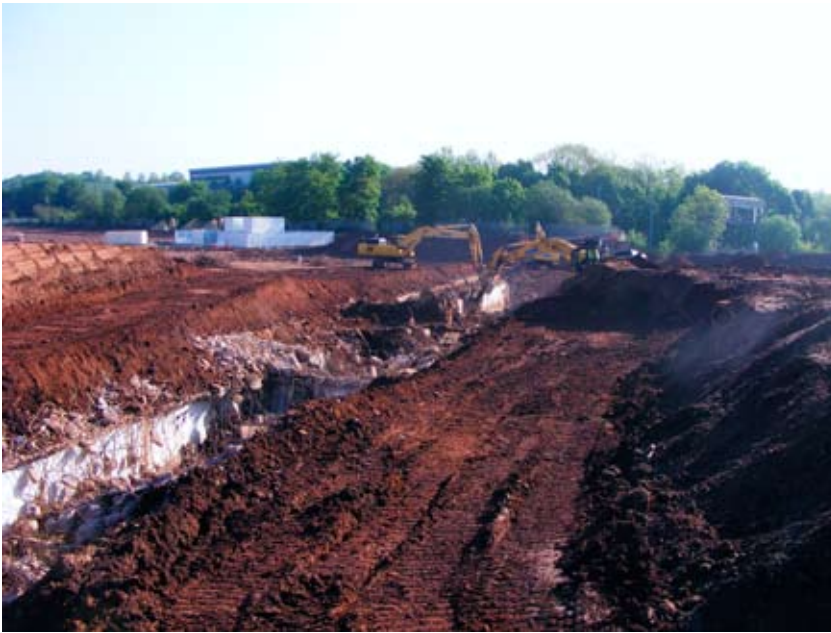
▲ Illus 2

Demolition of the underground hospital in progress

The underground hospital was demolished on order to create more stable ground conditions for future construction. This involved the removal of the upper deposits which cover the hospital, in order to expose its extent. The hospital was demolished by working from one end to the other removing all associated material. Access to the interior of the hospital was restricted due to health and safety reasons therefore recording the structure, method of construction and other details was undertaken during its demolition. Demolition involved the removal of the NE entrance stairwell and removing in sections from this end by mechanical excavator.

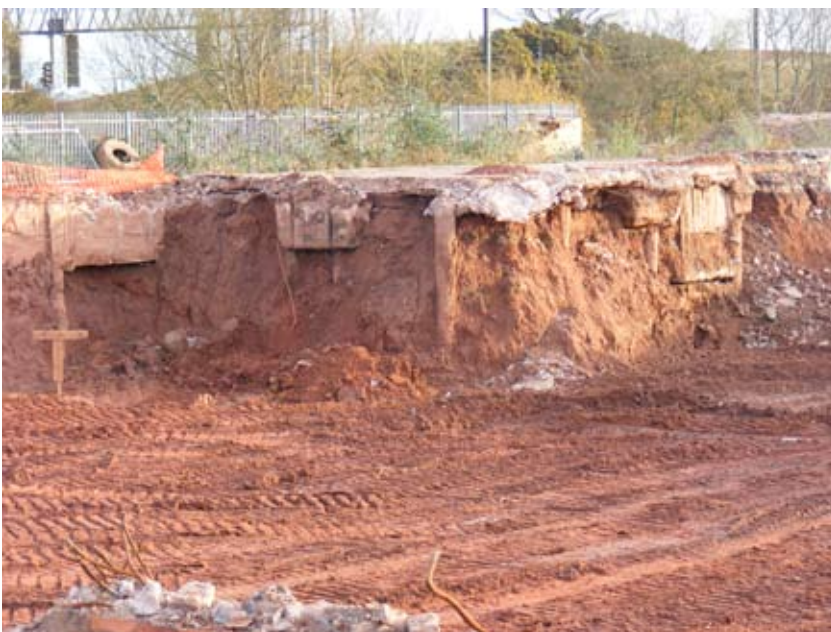
▲ Illus 3

Truncation of lower deposits by modern factory construction

Contexts [102–6] represent deposits disturbed as a result of modern construction. Due to this high level of disturbance across the site no evidence for the presence of Parsonage Farm or for any activity which pre-dates the farm, was detected. Small brick and concrete constructions were encountered associated with cellars and other buildings belonging to the factory that was previously present on site (**Illus 3**). The lowest deposit [107] represents natural stratigraphy in the form of a reddish brown sand layer, the material that the underground hospital cuts into. Up to 4m of deposits were removed during the initial site strip.

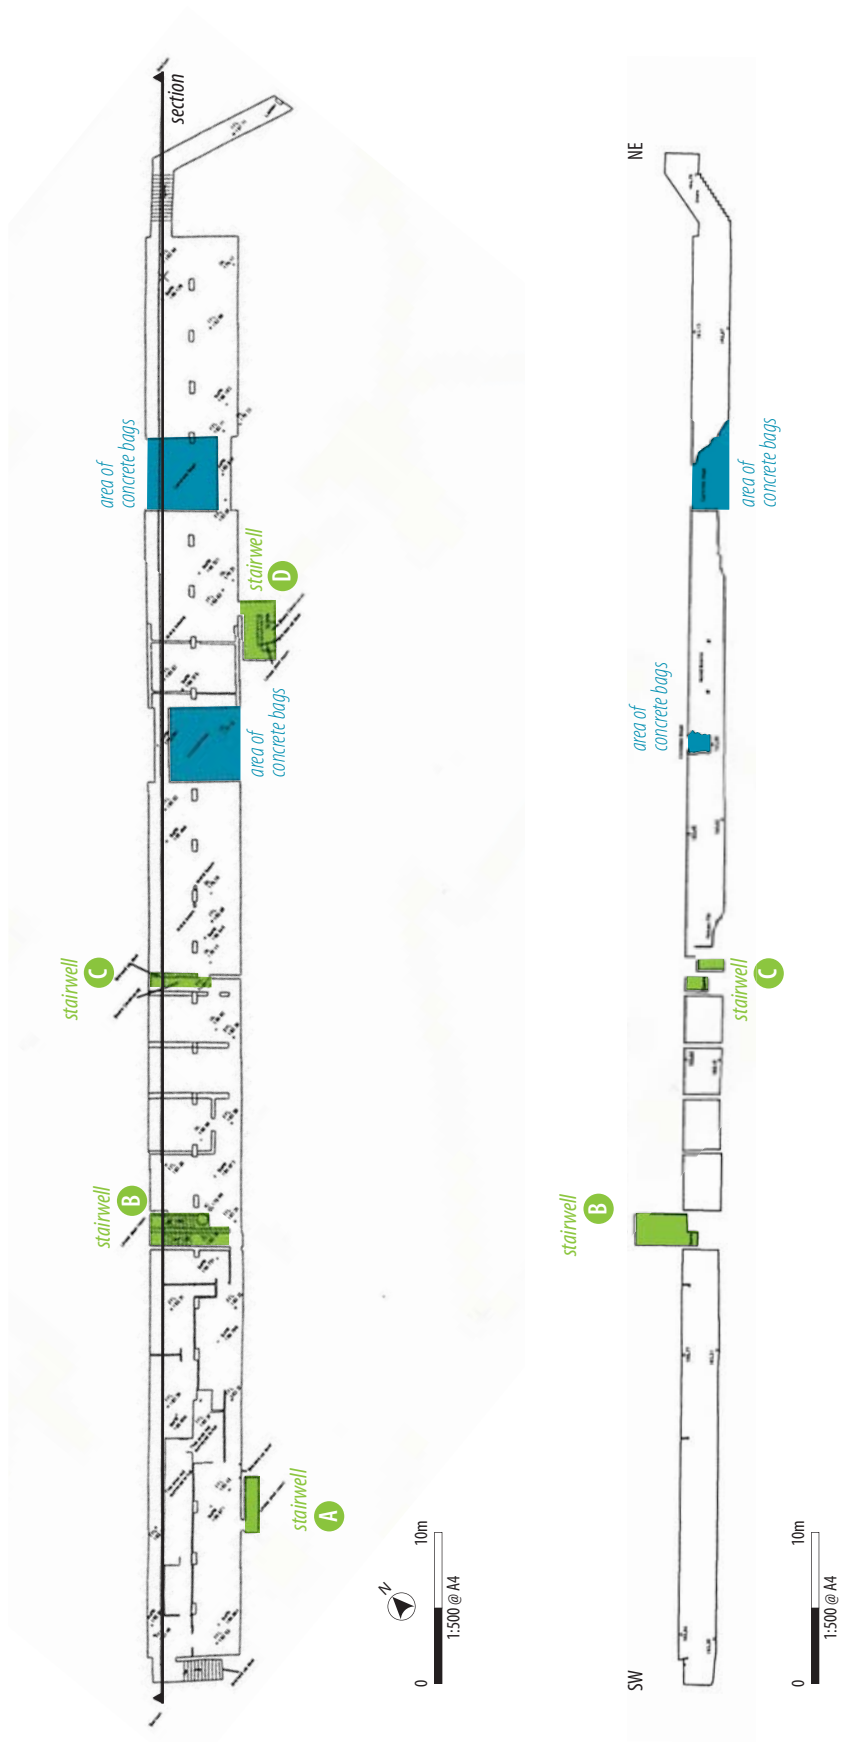
Illus 4
Floor plan and section of underground hospital

The underground hospital was not revealed during the site visits in 2011. It was later uncovered in 2013 when construction began within the southern area and therefore needed to be removed. A plan of the hospital can be seen in (**Illus 4**). The hospital measures 104m x 6m x 2.5m. The hospital lies on an NE-SW axis and remained largely undisturbed until present construction commenced. Both stairwells were uncovered first in order to establish the extent of the hospital (**Illus 7**). The stairwells, as well as the entirety of the hospital walls and roof were constructed of concrete reinforced with steel rods.

The SW entrance was located 1.5m down from the current level of the site, it extended straight downwards and took a sharp turn NE into the main hospital structure. The entrance was comprised of a rectangular doorway with steps leading down c.1m in to the hospital. The NE stairwell had been truncated during the search for the entrance.

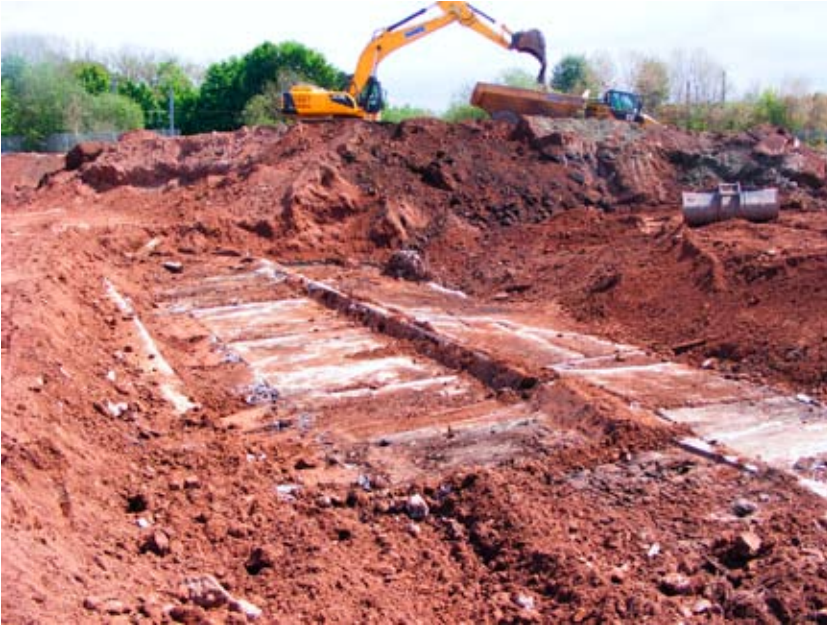
◀ **Illus 5**
Exposed roof with timber sleepers in situ

Deposits over the hospital were removed, exposing the roof. There was a concrete ridge which ran the length of the hospital (**Illus 5**). On either side of this ridge was a row of

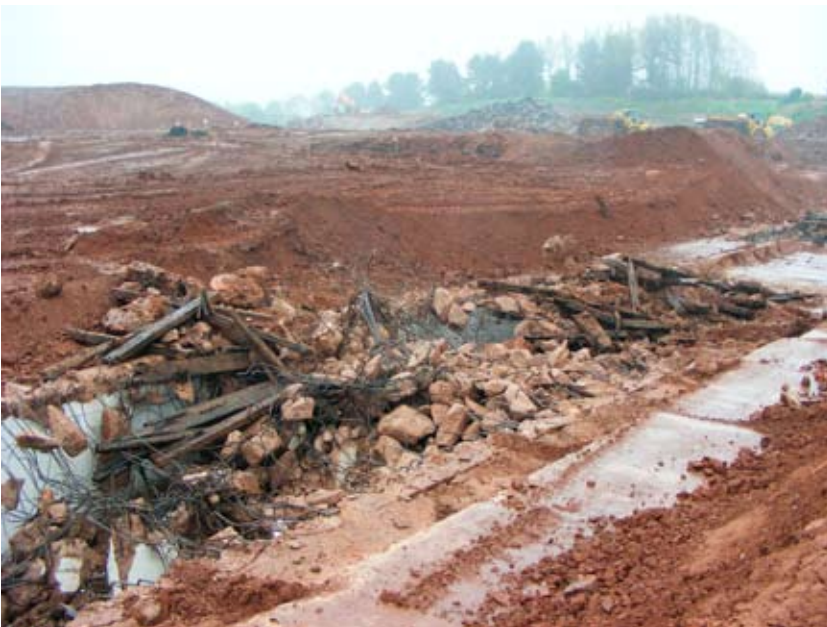
◀ **Illus 6**
Disturbed sleepers which formed the outer roof layer

timber railway sleepers each c.3m x 0.25m x 0.25m (Illus 6). Beneath the sleepers was a concrete roof.

The roof, covered with two rows of timber sleepers, may have been constructed this way in order to provide a cushioning effect the physical compression on the ground as the result of air raid bombing.

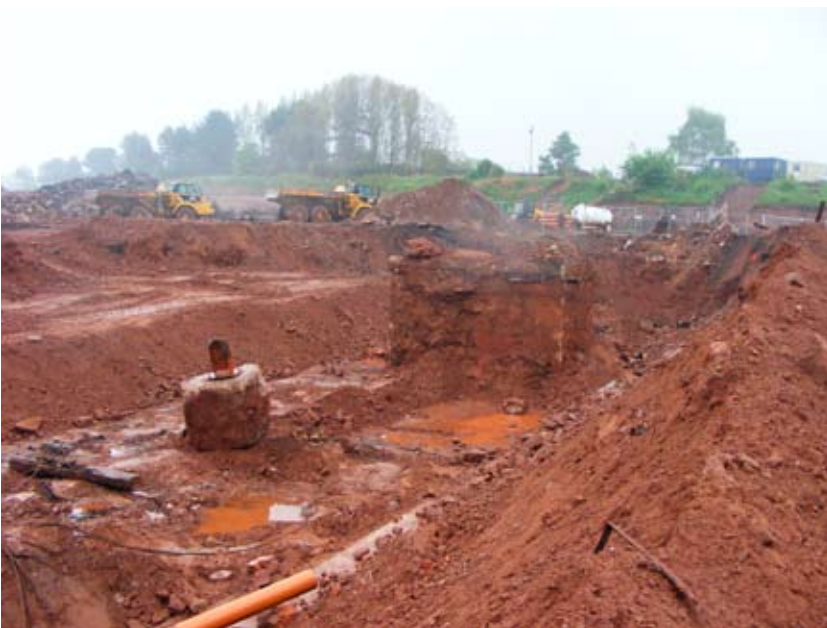
◀ **Illus 7**
Stairwell B – brick shaft to the surface

Four stairwells were observed within the hospital. These stairwells were brick shafts which extended to surface level and probably acted as emergency exits during the hospital's use

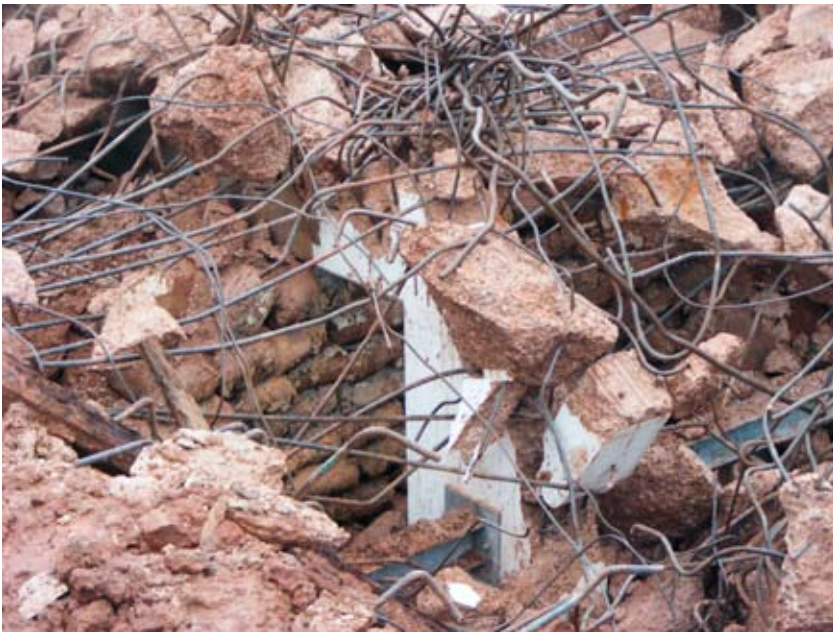
▲ **Illus 8**
Concrete bags in situ

The north-east end of the structure was subdivided by piles of concrete-filled 'sand bags' (Illus 4 & 8). These seemed to divide the NE half of the hospital into two medium sized rooms each connected by a narrow hallway.

The hospital was constructed in a simple fashion; concrete poured into a steel frame. It remained intact prior to the current demolition. The two sections of concrete 'sand bags' may represent a form of blast protection for the primary entrance to the structure. This suggests that even during an air raid the hospital entrance was kept accessible.

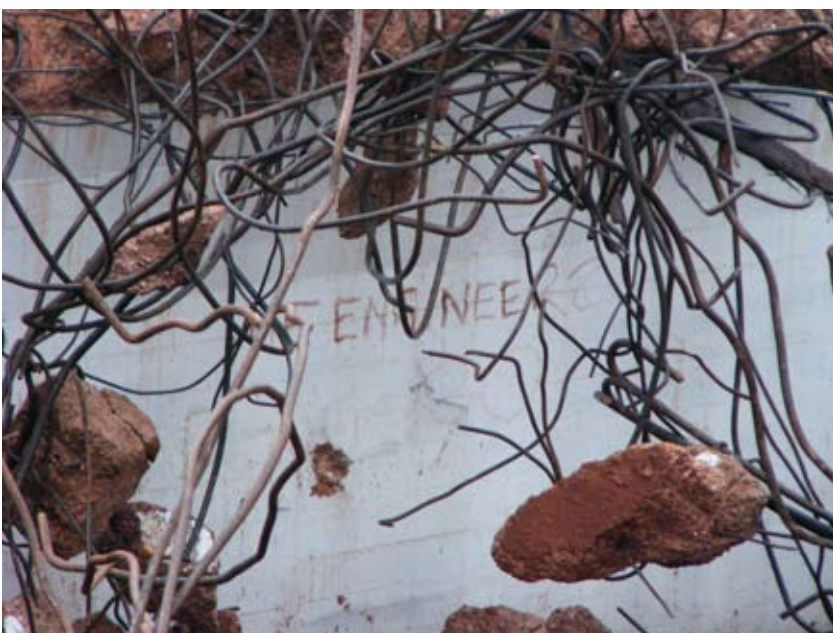
▲ **Illus 9**
Graffiti on internal walls 'THE ENGINEERS'

In the area between stairwell D and the NE entrance an area of graffiti was noted on the NW facing wall 'The Engineers'. However this may have been created by modern activity and may not be linked to the construction of the hospital.
