# NEWARK FARM, HEMPSTED, GLOUCESTERSHIRE

Historic Building Recording

commissioned by CgMs Consulting on behalf of Newland Homes Limited

13/01203/FUL

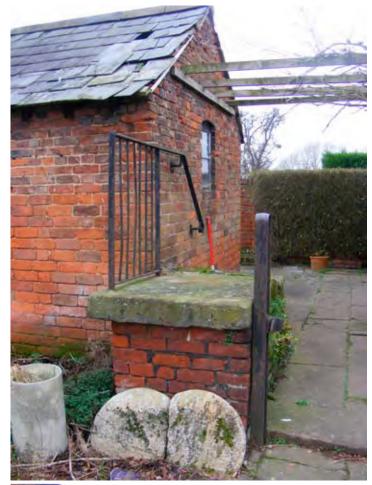
**Illus 12**WSW view of eastern elevation of Building 1
showing change in masonry

within the construction of the building change from 2300 x 800 x 100mm at approximately 1.50m from present ground level to that of  $230 \times 600 \times 700$ mm (Illus 12).

The change in the size and type of brick use in the construction may indicate that the height of the building has been increased which could suggest that the building was not original conceived for domestic use and may in fact reflect an open structure associated with animals. However the change in the brick work is constant within the building, including the construction of the chimney stack and therefore may only represent a change in supply of building materials used during the construction of the building.

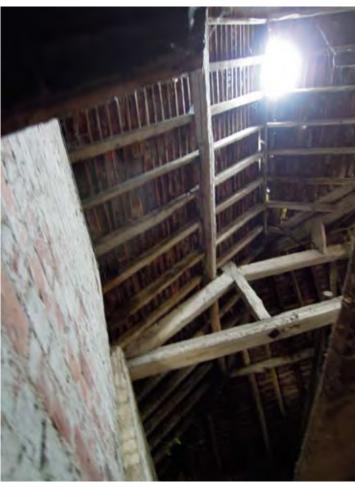
Illus 15a

The building is currently roofed in a mixture of slate and red clay tiles, reflecting both episodes of repair and re-roofing. Due to the derelict nature of the building no close internal examination of the roof structure was possible at the time of the survey (**Illus 14**). Photographs of the internal roof structure taken from a distance suggest a Queen post truss design similar to that in Building 6 (**Illus 15a**) (see below).

Internal view of Building 2 roof structure taken by Integral Engineering Design

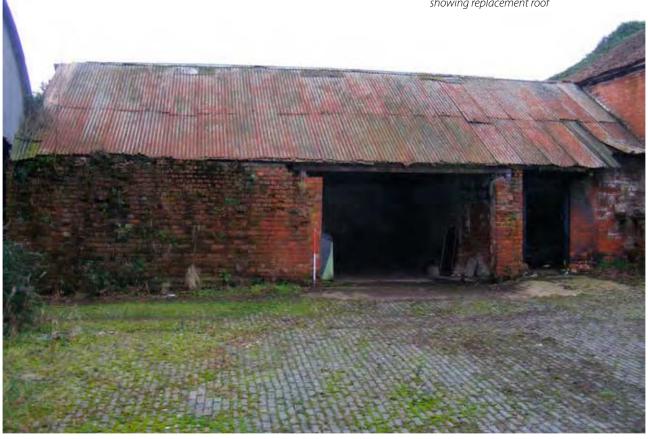
**Illus 18**WSW view of eastern elevation of Building 2 showing original wall height of Building 2a

The hipped form of the existing roof of Building 2 suggests that the roof of Building 2a would have joined on in a 'lean-to' arrangement, and therefore that the original height of Building 2 was not a full two stories. However, without inspection of the internal roof structure of Building 2 this is presently conjecture.

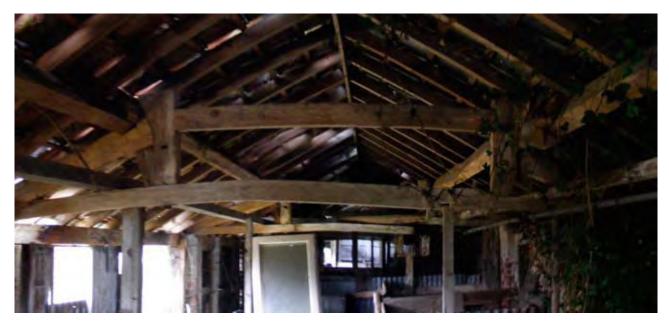
**Illus 26** Roof detail of building 6

The truss is constructed from a strutting beam or tie beam spanning the width of the building with two short Queen post strut beams braced by a straining beam. The two Queen posts are attached to the tie beam through the use of a captive nut and bolt within the tie beam. Two small angled braces run from the strutting beam and attached to the principal rafter upon which the purlins are cut, the purlins then support the common rafters and the common rafters meet at the pitch of the roof in a running ridge board, leaving the roof open between the trusses (**Illus 26**). The construction of the roof trusses is an unusual design and possibly reflects a local vernacular adaptation unique to the building at Newark Farm. In particular its

reliance on only one set of purlins supporting the main rafters and the unusually short braces between the Queen post and principal rafter may reflect a desire to achieve the low pitch seen on the roof.
